# Report Narrative

## Wyoming State Capitol Dome Investigation Cheyenne, WY

Vertical Access LLC  
PO Box 4135, Ithaca, NY 14852  
Tel: 607 257 4049 / Fax: 607 257 2129

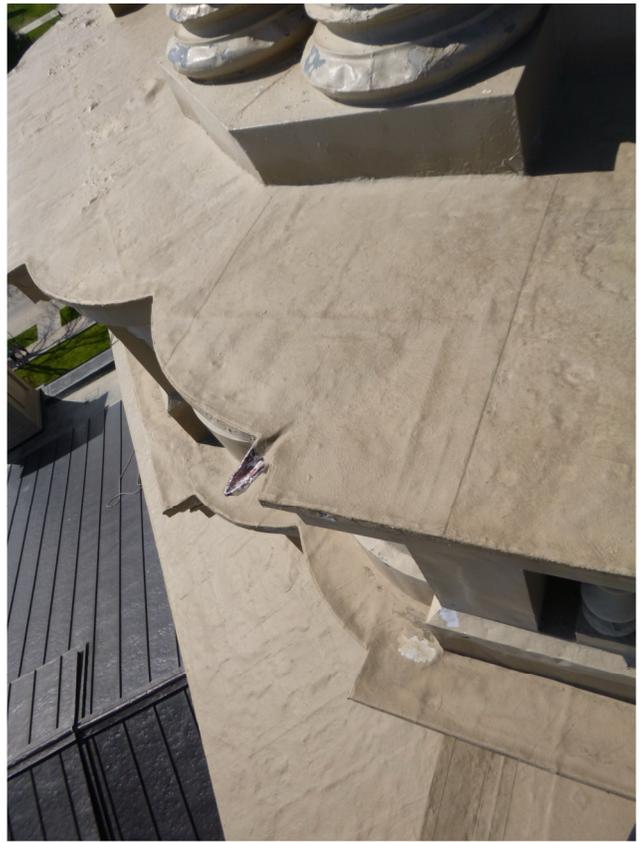
168-73 SheetMetal\_Note Photo-scupper 2013-1

- There are scuppers at some of the wash surfaces and downspouts on four sides of the drum. The scuppers, which are formed from sheet lead, are typically bent and deformed but do not appear to be blocked. (See photographs 462-73, 168-73). The square-section downspouts run from a galvanized box gutter that sits on the outer edge of the wash surface at the drum attic to the next wash surface below and empty above the colonnade level. The paint coatings at the downspouts and gutter are in poor condition and there is surface corrosion at the inside of the gutter. (See photograph 25-95).

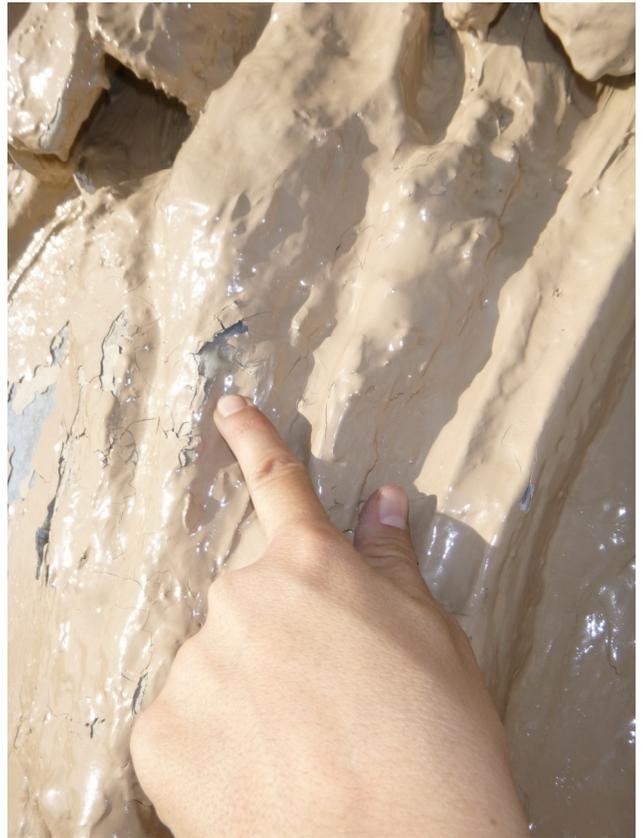
175-122 SheetMetal\_Note Photo-coating over damaged

- The lead ornament is in poor condition with dents, tears and punctures noted at many locations. The tears and punctures occur on all sides of the dome, but are most numerous on the east side. (See 393-122, 392-104, 248-121). Some of the perforations have been filled with clear silicone sealant, automotive metal patching compounds such as “Bondo” or other materials. (See photograph 175-122).

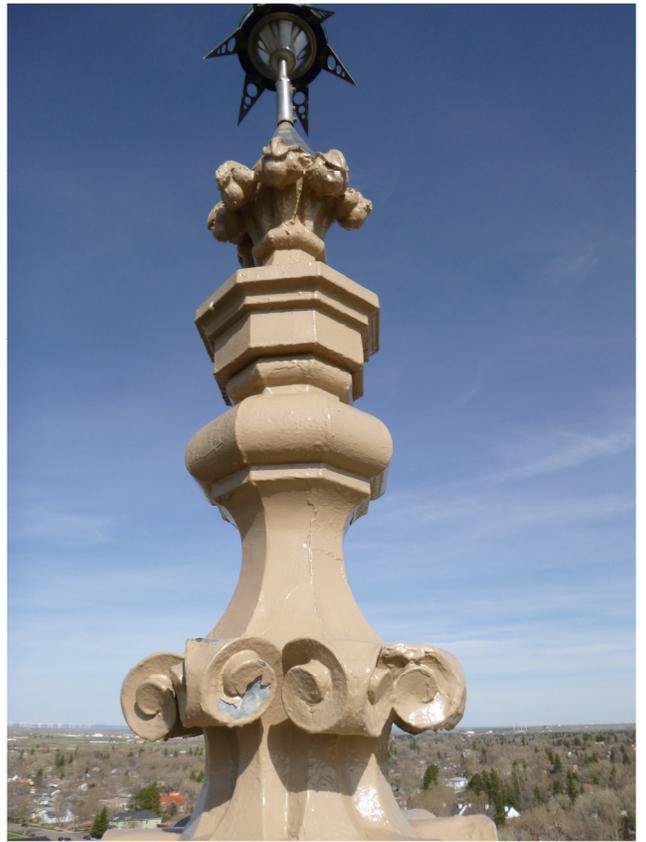
244-137 SheetMetal\_Coating Coating Failed 2013-1

- The galvanized sheet metal finial at the top of the lantern is in good condition. There is a missing crocket on the north side of the finial. (See photograph 22-140). The paint coatings at the finial exhibit discrete areas of loss. Where the paint coatings are missing, traces of gilding as the earliest coatings on the sheet metal are visible. (See photographs 245-136, 244-137).

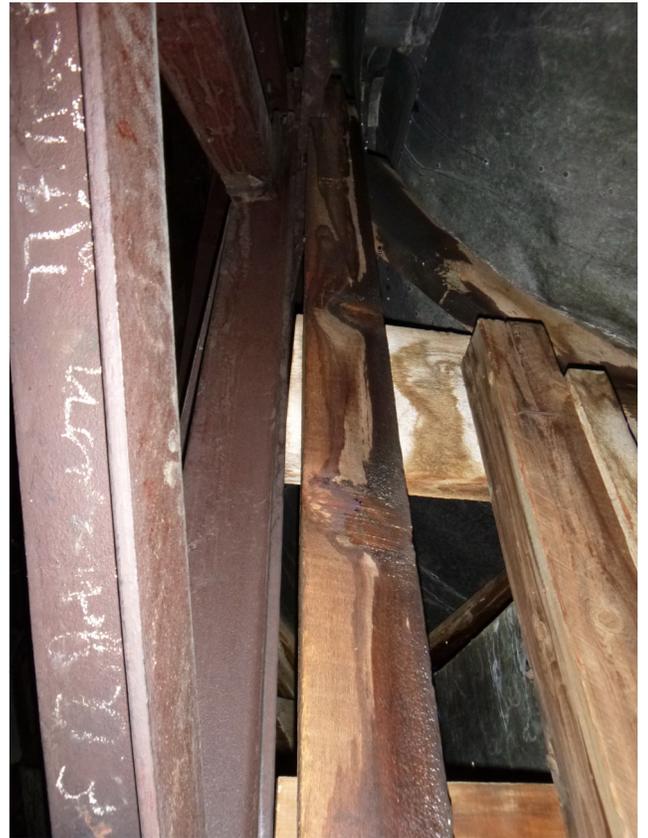
630-105 SheetMetal\_Note Photo-active leaks 2013-2

- The wood decking at the interior of the dome exhibits water staining but is otherwise in good condition. A split was noted in one of the decking boards on the north side of the dome. (See photograph 630-113). Most of the wood decking appears to be original, with replacement boards evidence by the lack of water staining and dated by graffiti to previous reroofing campaigns. During a brief thunderstorm the afternoon of May 14<sup>th</sup>, water was observed running down the inside of the dome in line with a rib at the northwest side. Water was also noted coming in the dome at the north side above the round window of the drum attic. (See photographs 572-99, 630-105).

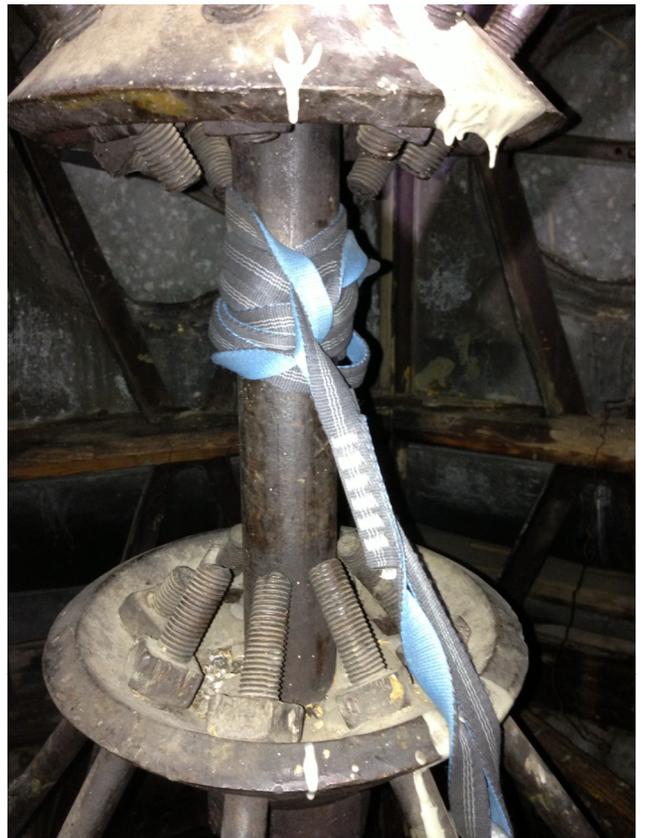
653-126 ArchMetal\_Note Photo-loose nut at hub 2013-1

- of the diagonal tension rods on the southeast side of the lantern is loose, with the nut at the connection hub not fully threaded. (See photograph 653-126).
