WYOMING STATE CAPITOL RENOVATION & RESTORATION LEVEL RECONNAISSANCE & LEVEL II FEASIBILITY

LEGISLATOR BRIEFING

FEBRUARY 11, 2014

Level I Reconnaissance / Level II Feasibility Study

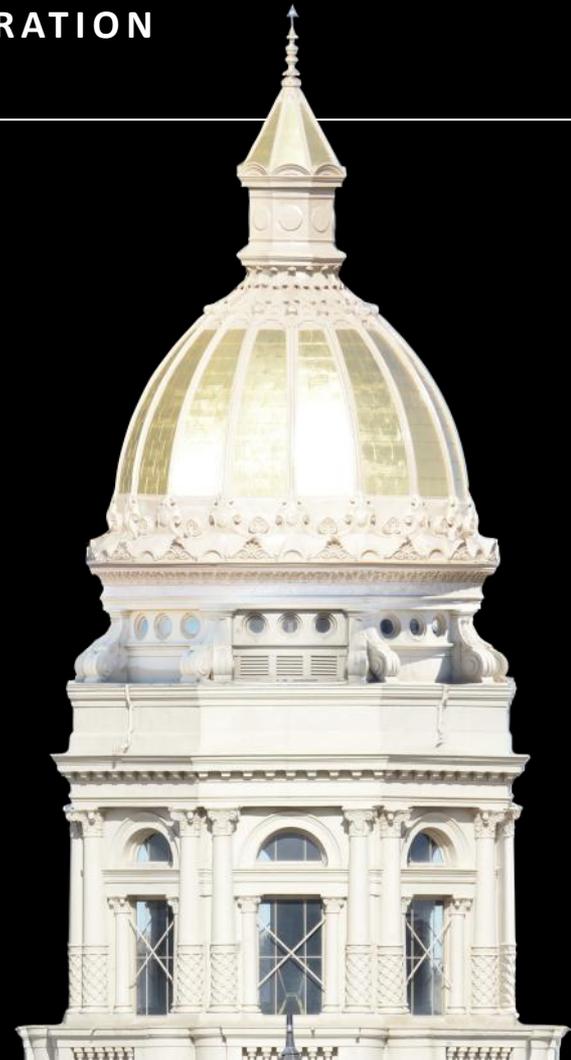
1. The building does not have any fire protection systems, i.e.:

- ✓ smoke detection
- ✓ smoke evacuation
- ✓ fire suppression

This is a serious life safety issue, as well as protection of the building and its contents

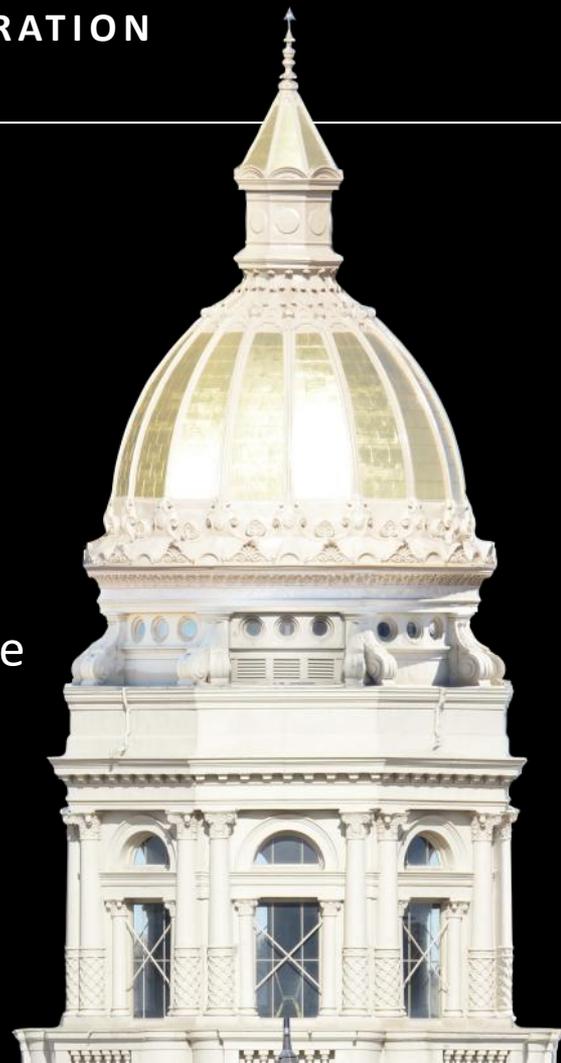
2. There several significant code deficiencies throughout the building.

The deficiencies range from egress to ADA compliance, and from ventilation to plumbing compliance

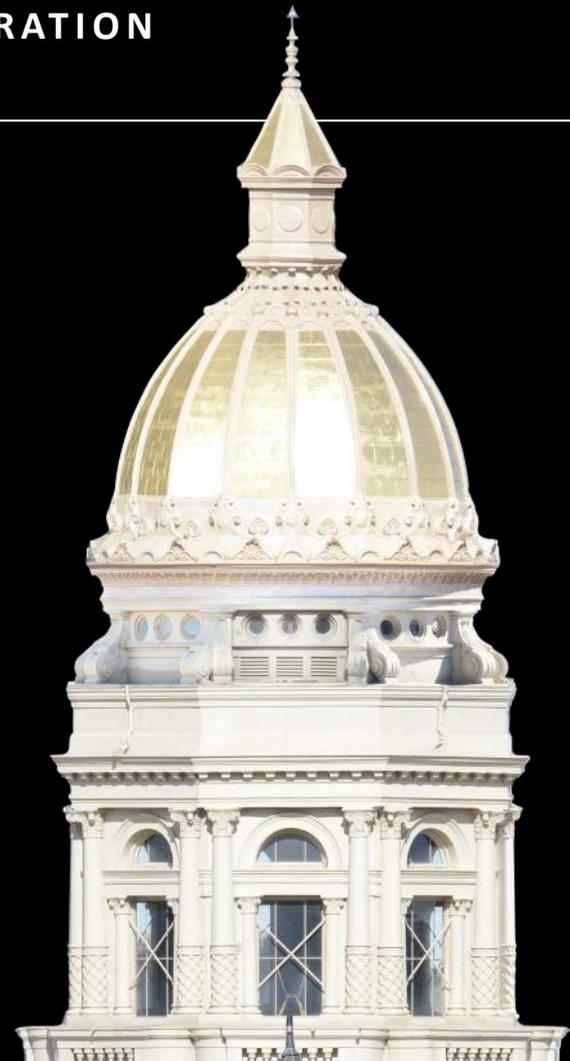
3. The existing building infrastructure has far exceeded its useful life and has started failing.

There are several cases throughout the building that indicate that this is a serious issue.

This is a risk that can result in **disruption of operations** and cause serious risk [fire].

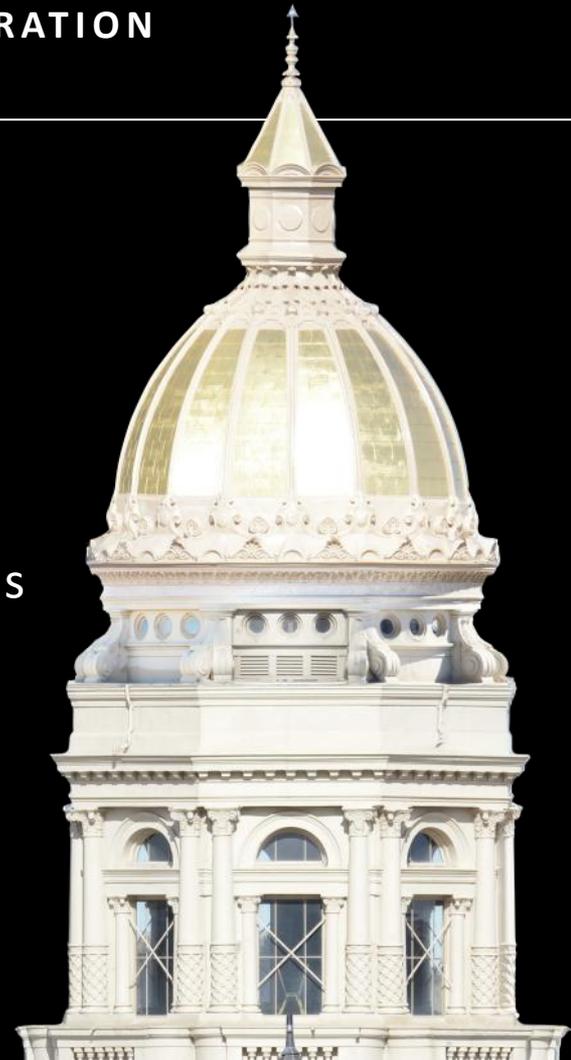
The existing infrastructure is not a system. It is a collection of components that were installed in a reactive way to address an urgent need.

Evidence: approximately 27% of the building does not have proper heating, ventilation and air conditioning.

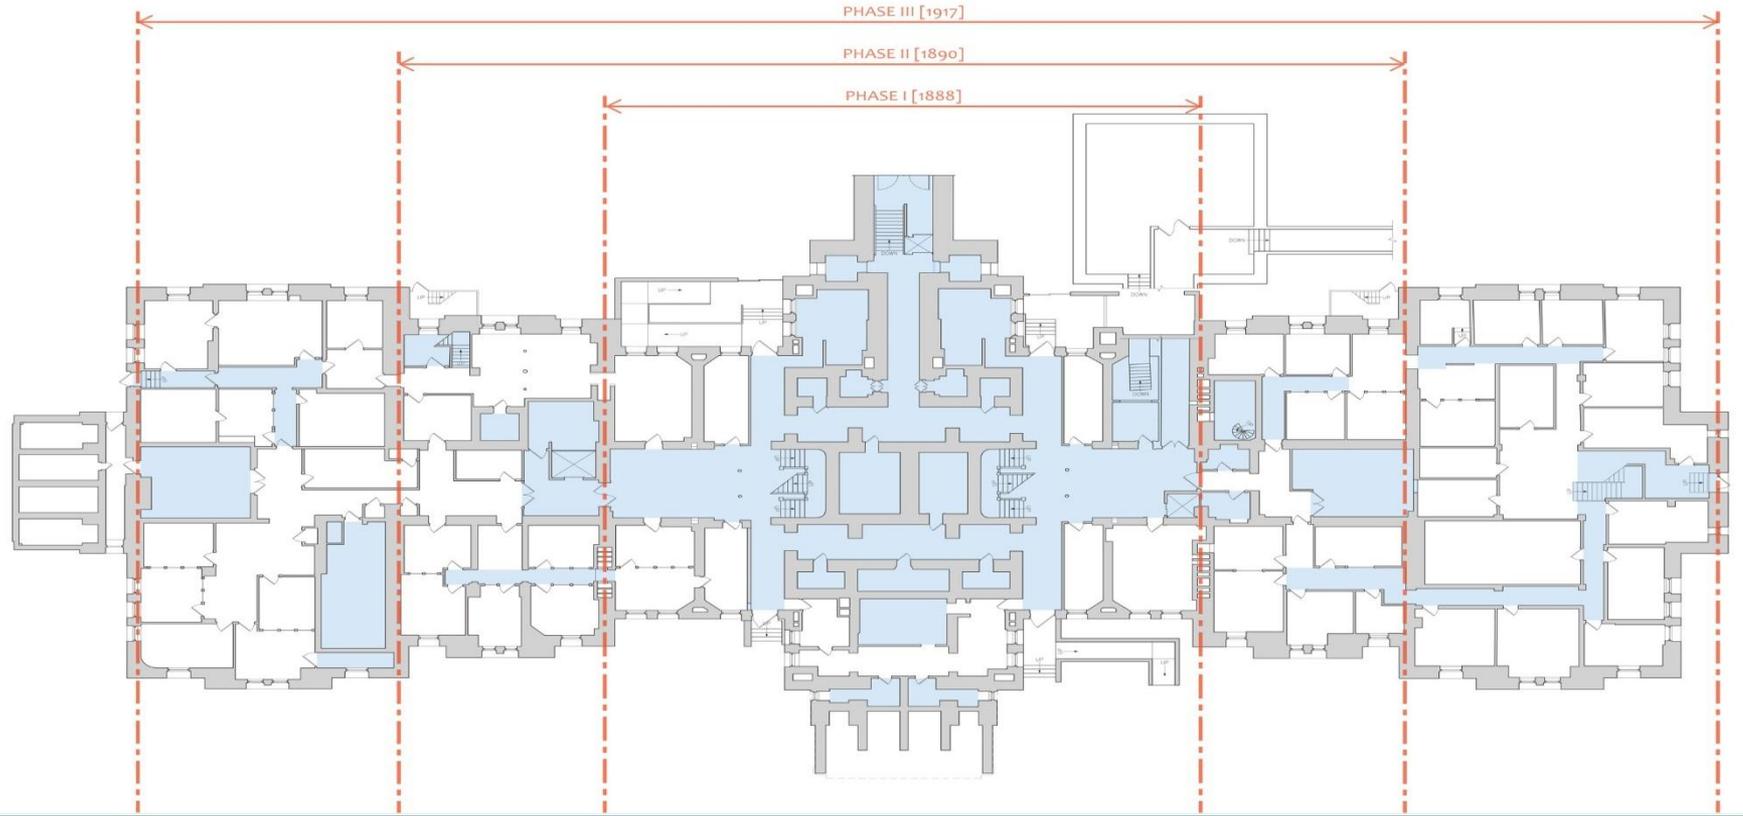
Basement Level Plan

Non-Conditioned Spaces

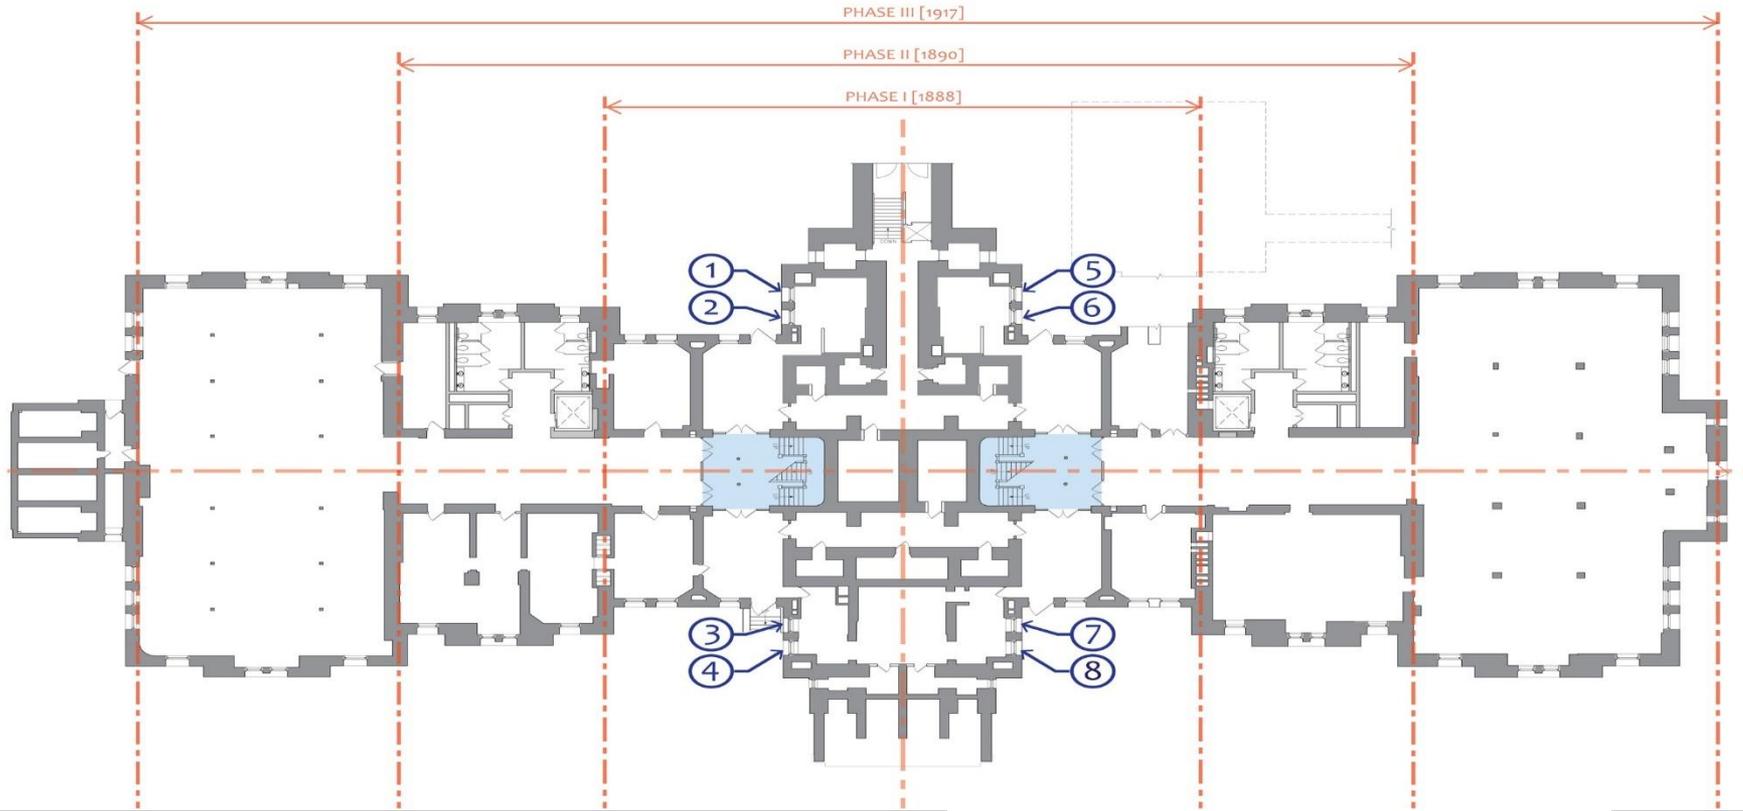
Basement Level Plan

MAKE-UP AIR AT FOUR
[4] DOOR LOCATIONS

MAKE-UP AIR AT EIGHT
[8] WINDOW LOCATIONS

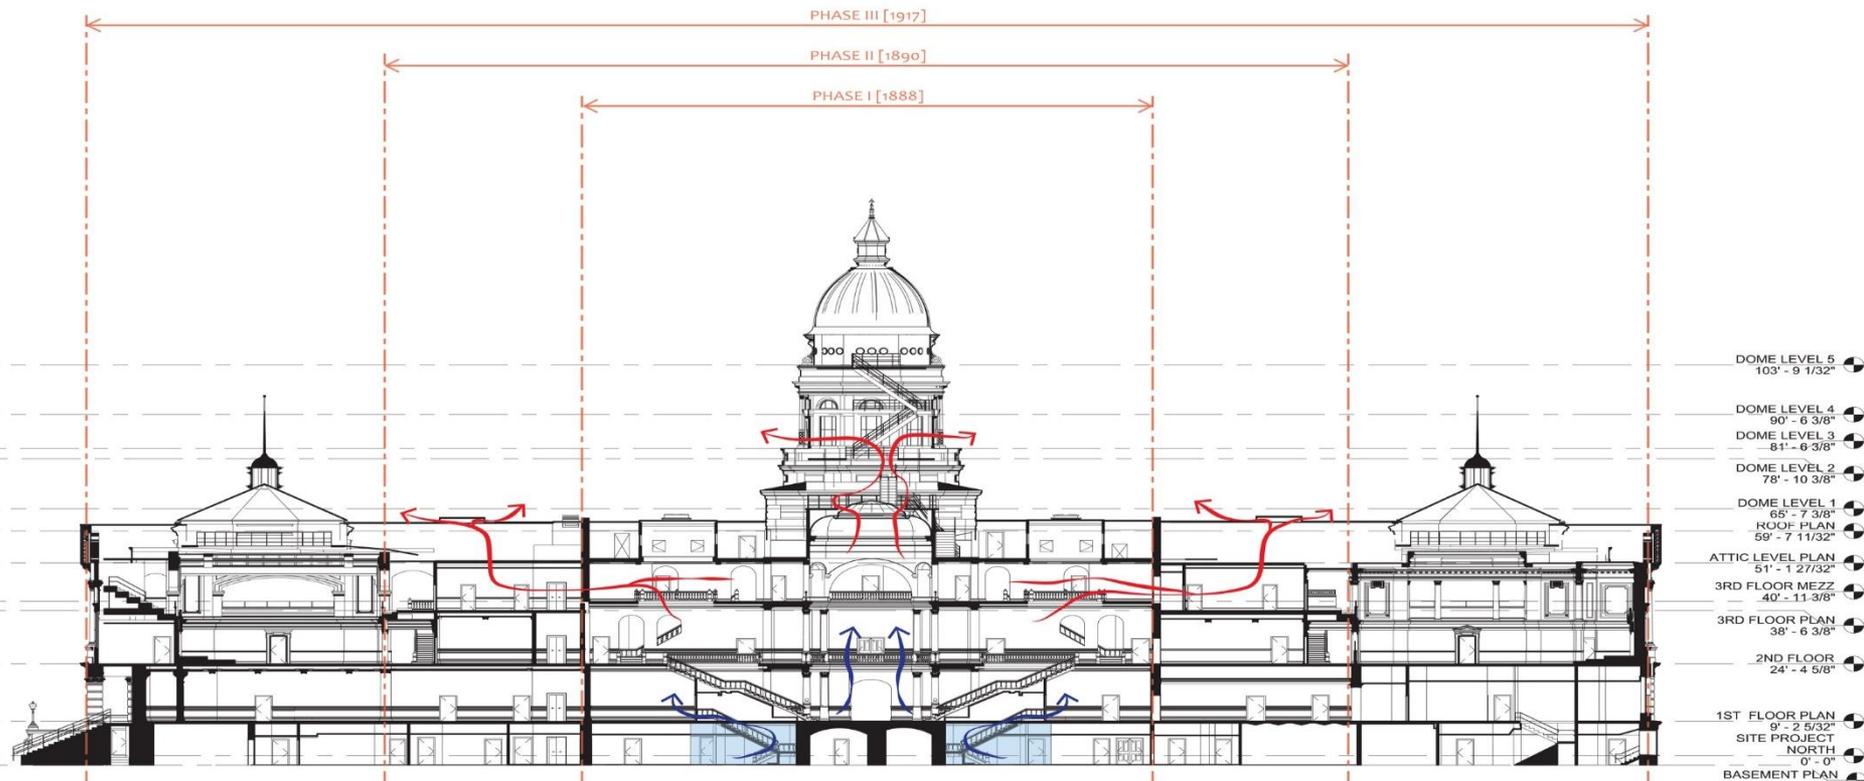
Longitudinal Section – Looking North Toward Herschler

← SMOKE EXHAUST AIR
 ← MAKE-UP AIR AT EIGHT [8] WINDOW LOCATIONS

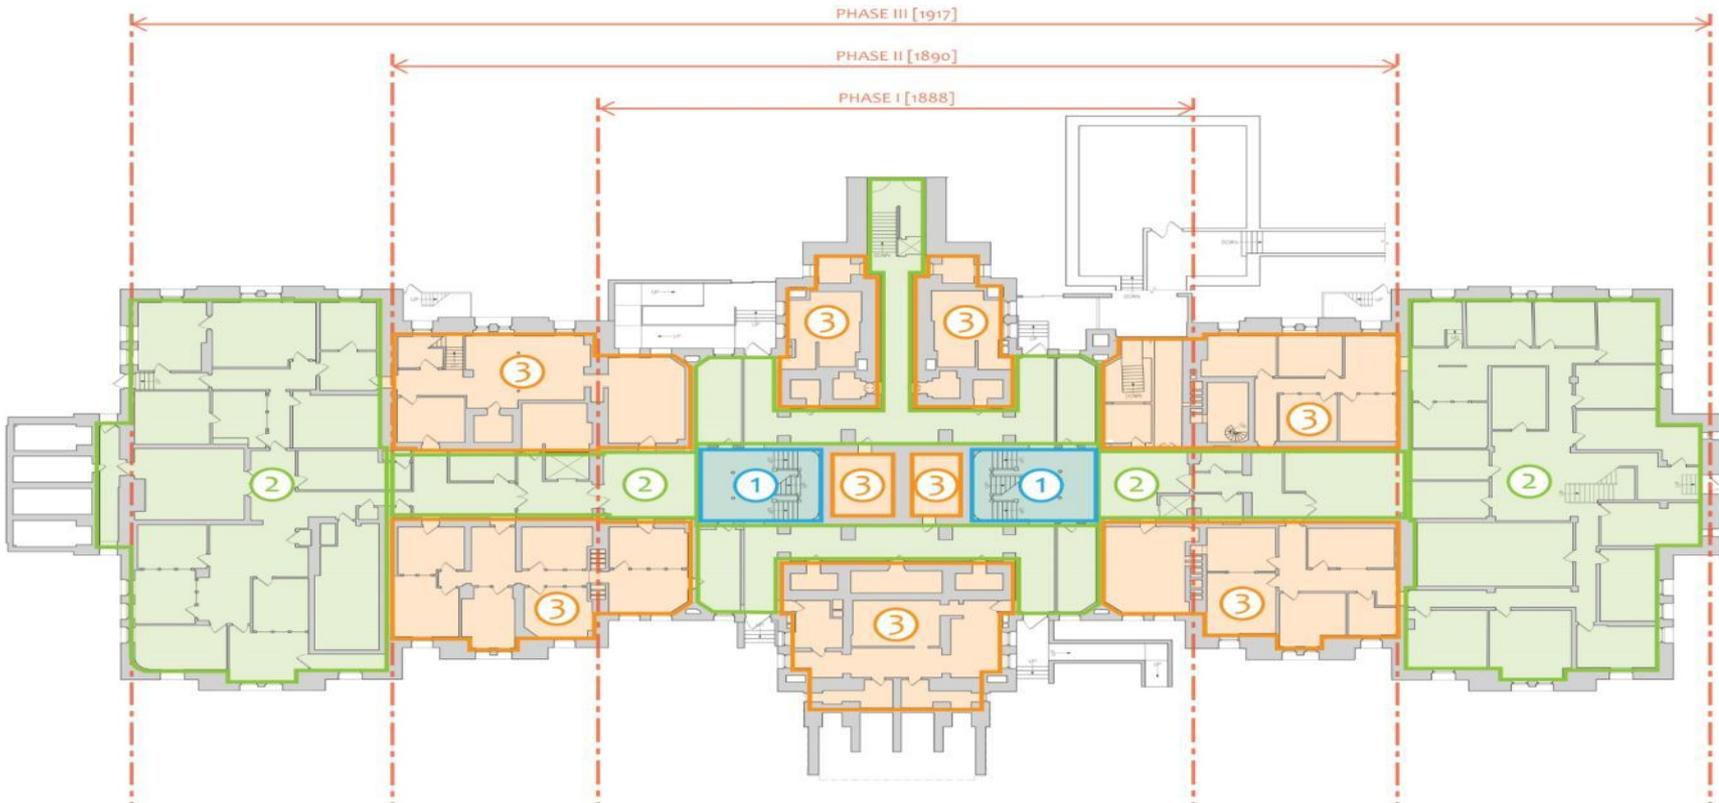
Basement Level Plan

- 1** PRESERVATION ZONE #1 RESTORATION
- 2** PRESERVATION ZONE #2 PRESERVATION
- 3** PRESERVATION ZONE #3 REHABILITATION
- 4** PRESERVATION ZONE #4 SERVICE AREA
[DEPENDENT ON MECHANICAL LAYOUT, SOME BASEMENT AREAS MAY BECOME ZONE #4]

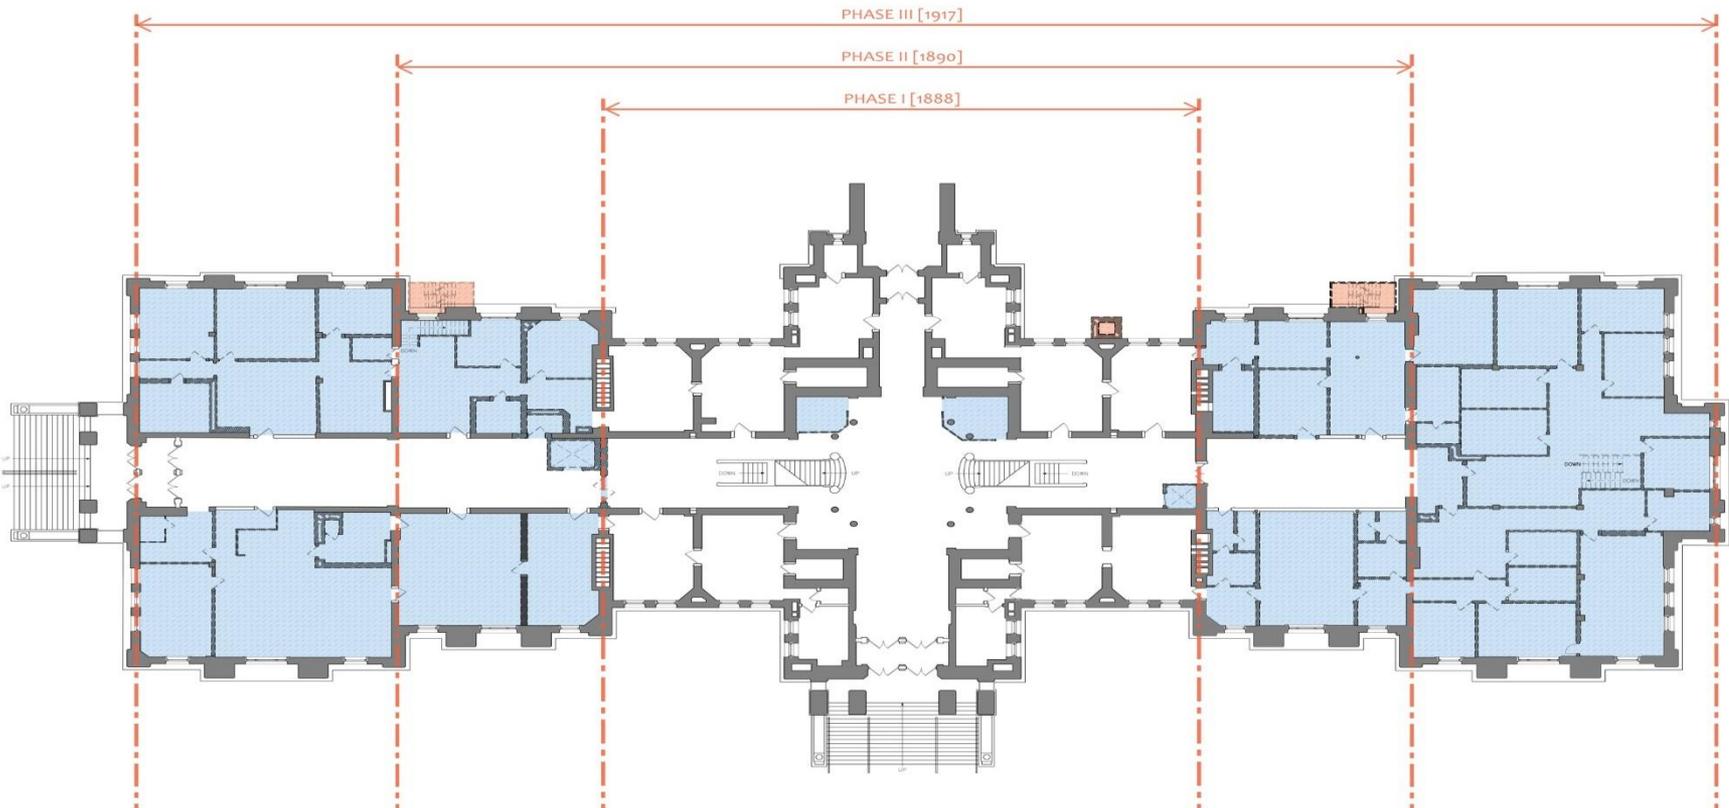
First Floor Selective Removals Plan

PROPOSED SELECTIVE REMOVALS AT BUILDING INTERIOR

PROPOSED SELECTIVE REMOVALS AT BUILDING EXTERIOR
