**STATE CAPITOL REHABILITATION AND
RENOVATION / CAPITOL SQUARE PROJECT**

**SERIES 2 - WYOMING STATE CAPITOL
SD OWNER REVIEW**

**LEVEL III SCHEMATIC DESIGN REPORT
VOLUME II OF III**

SUPPLEMENTAL WINDOW PACKAGE

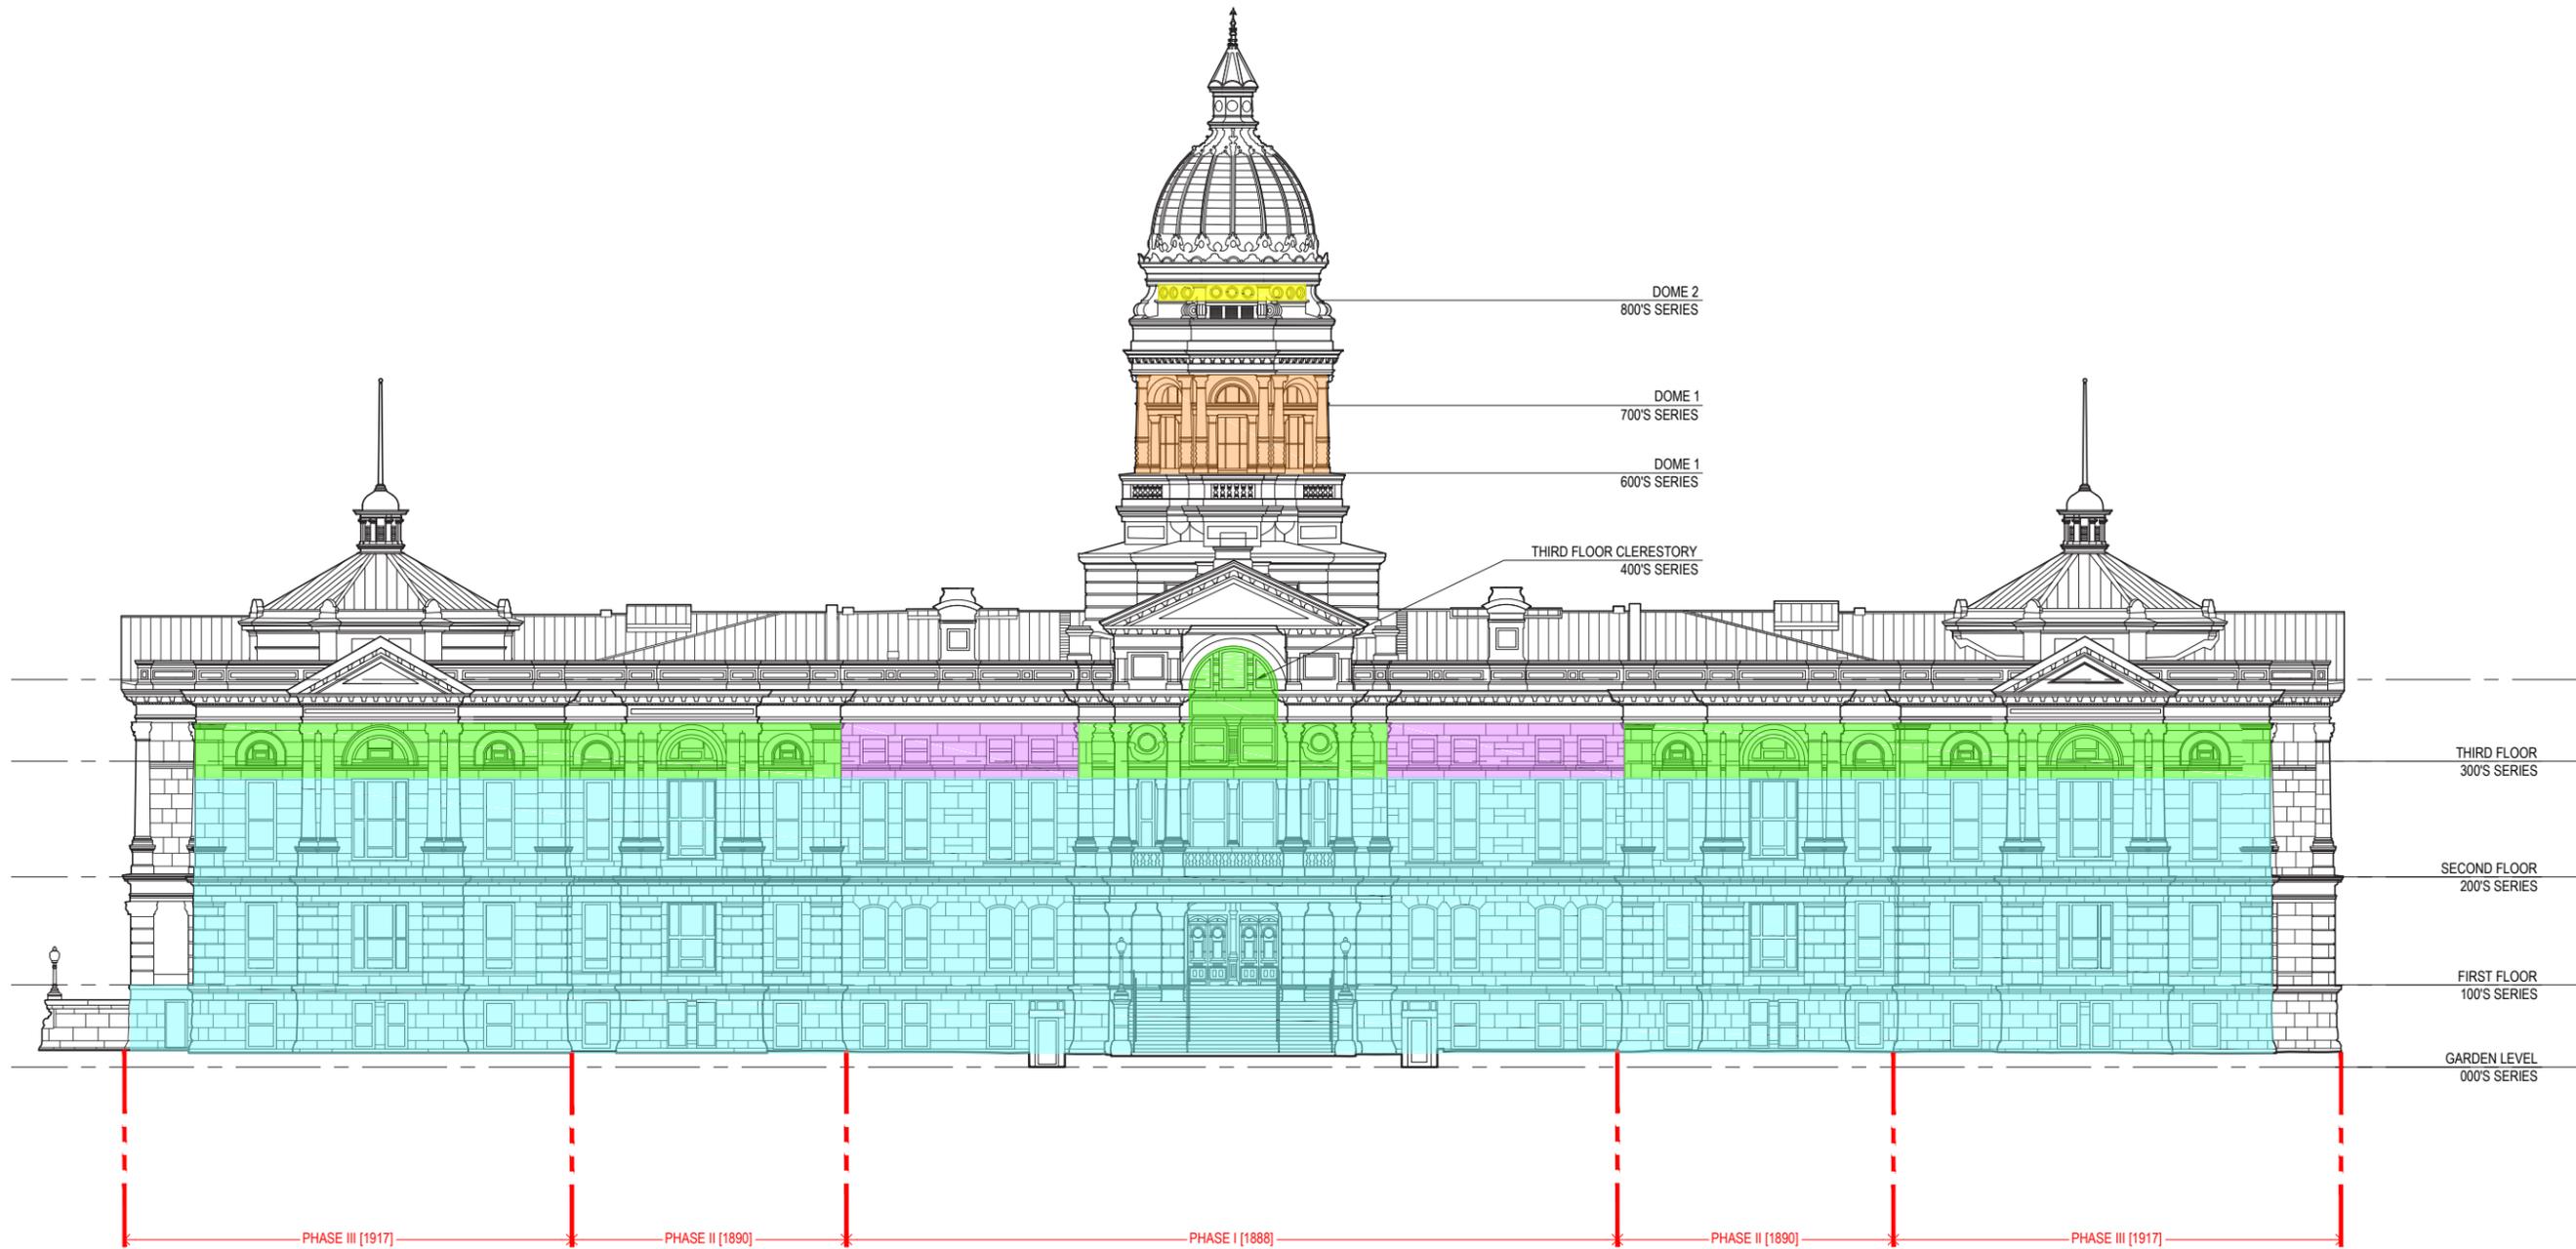
1 SOUTH ELEVATION - HISTORIC WINDOW INSTALLATION AND REPLACEMENT CAMPAIGNS

Figure 1: Diagram displaying the various window replacement campaigns.

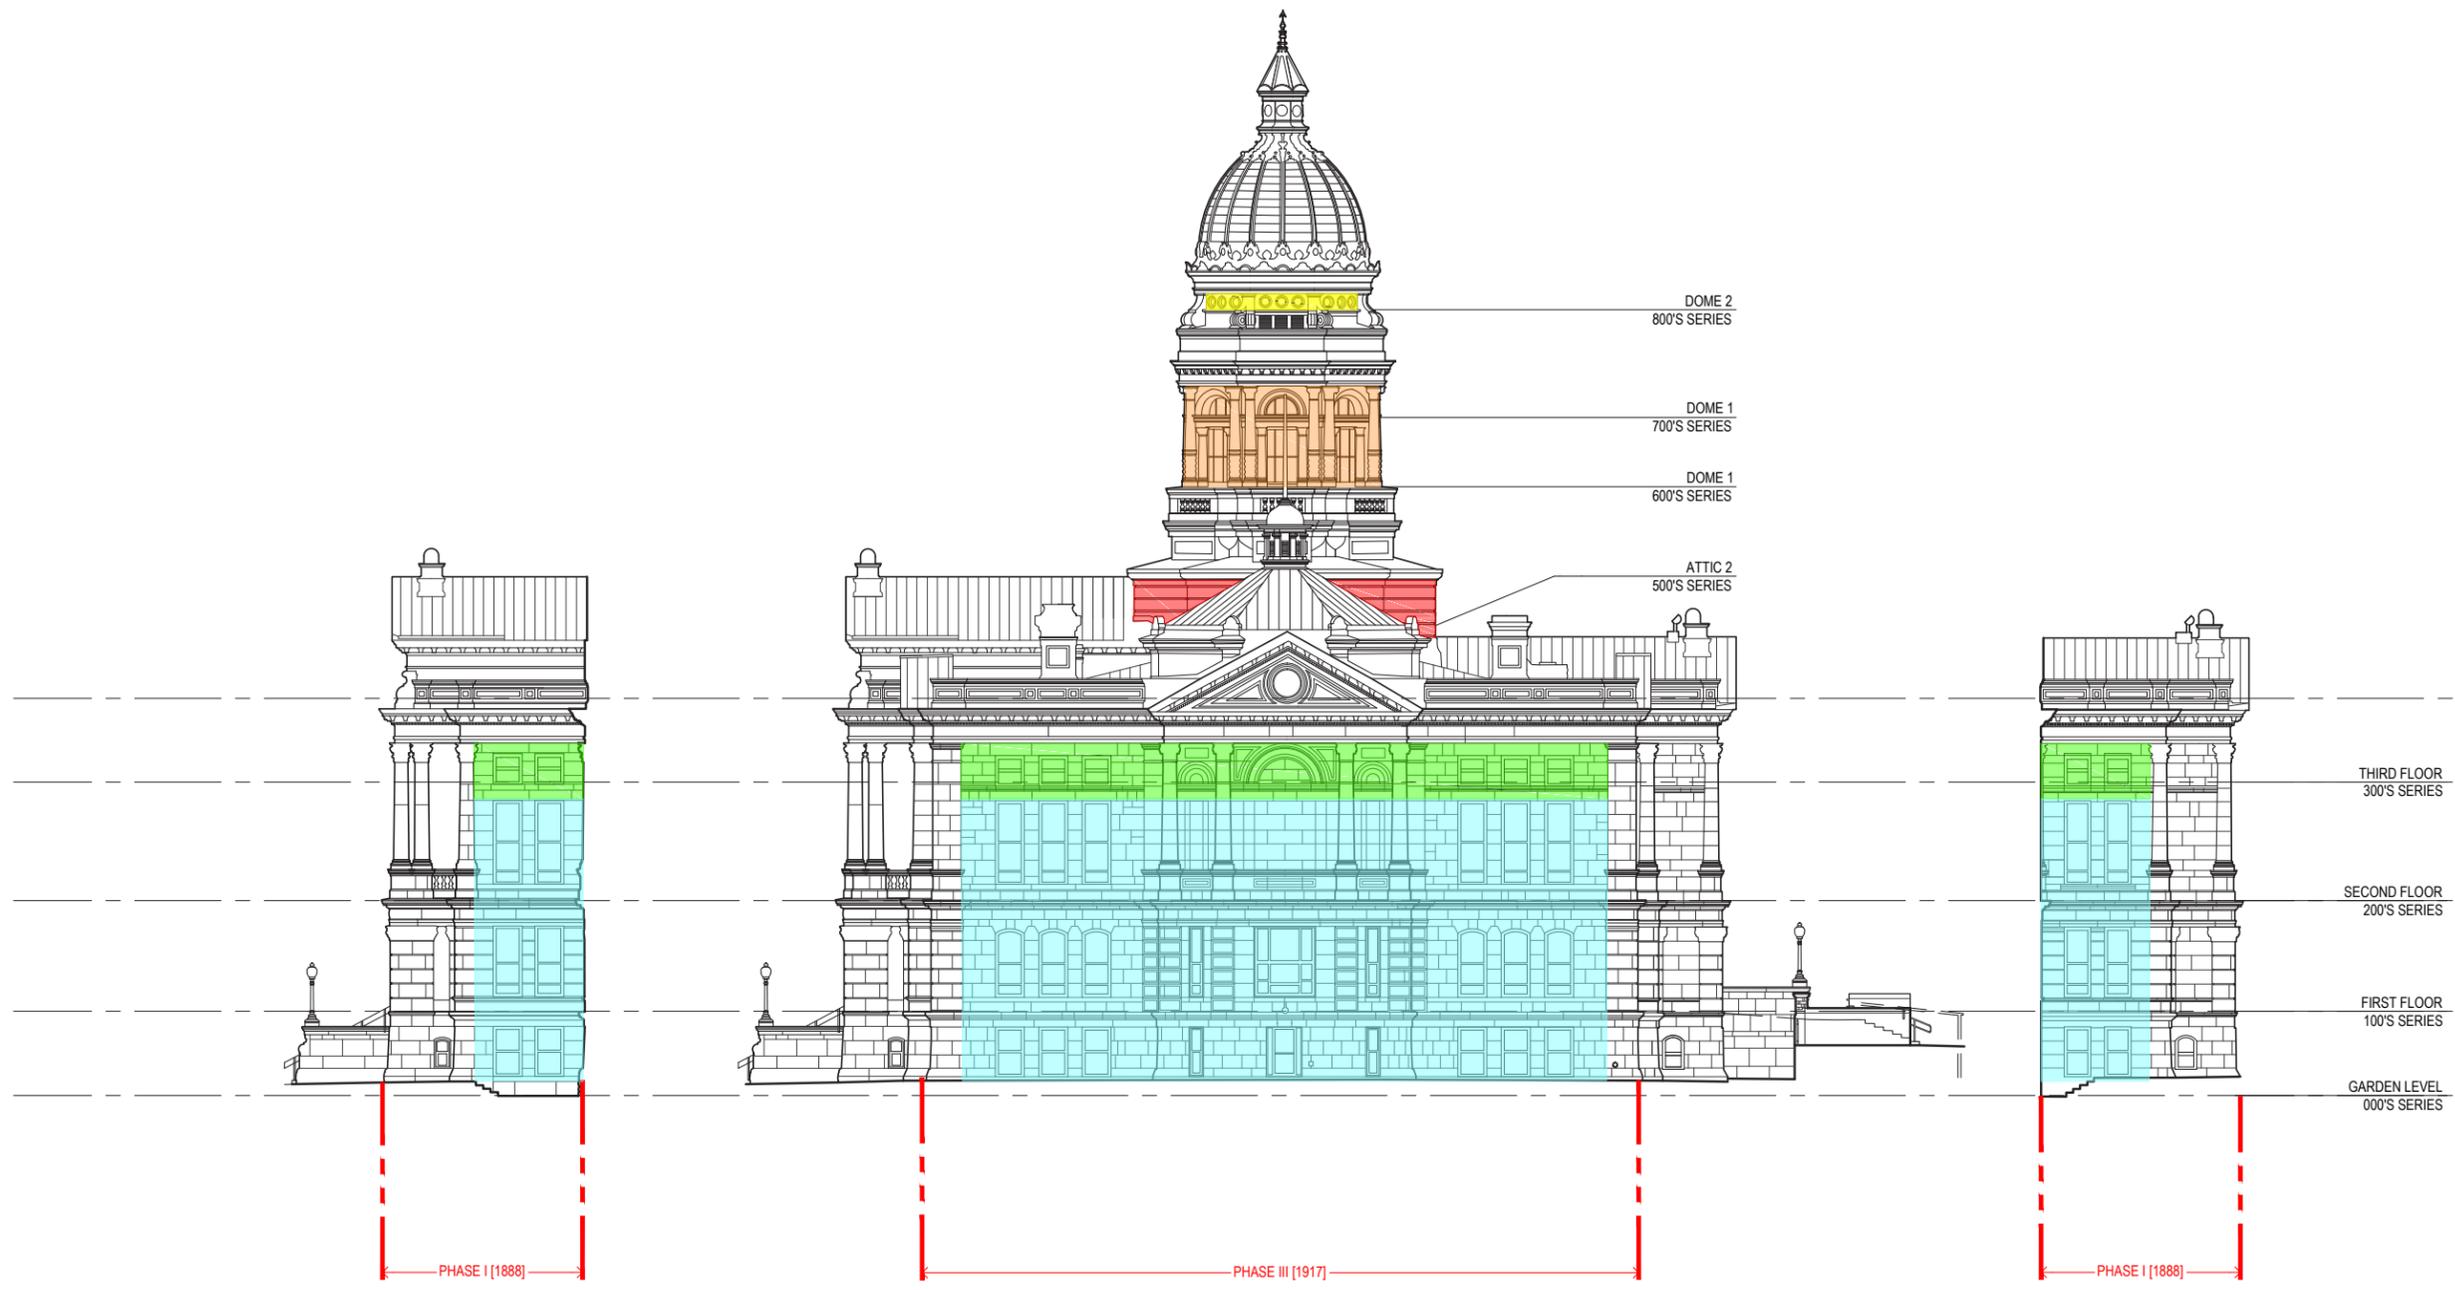
1 EAST ELEVATION - HISTORIC WINDOW INSTALLATION AND REPLACEMENT CAMPAIGNS

Figure 1: Diagram displaying the various window replacement campaigns.

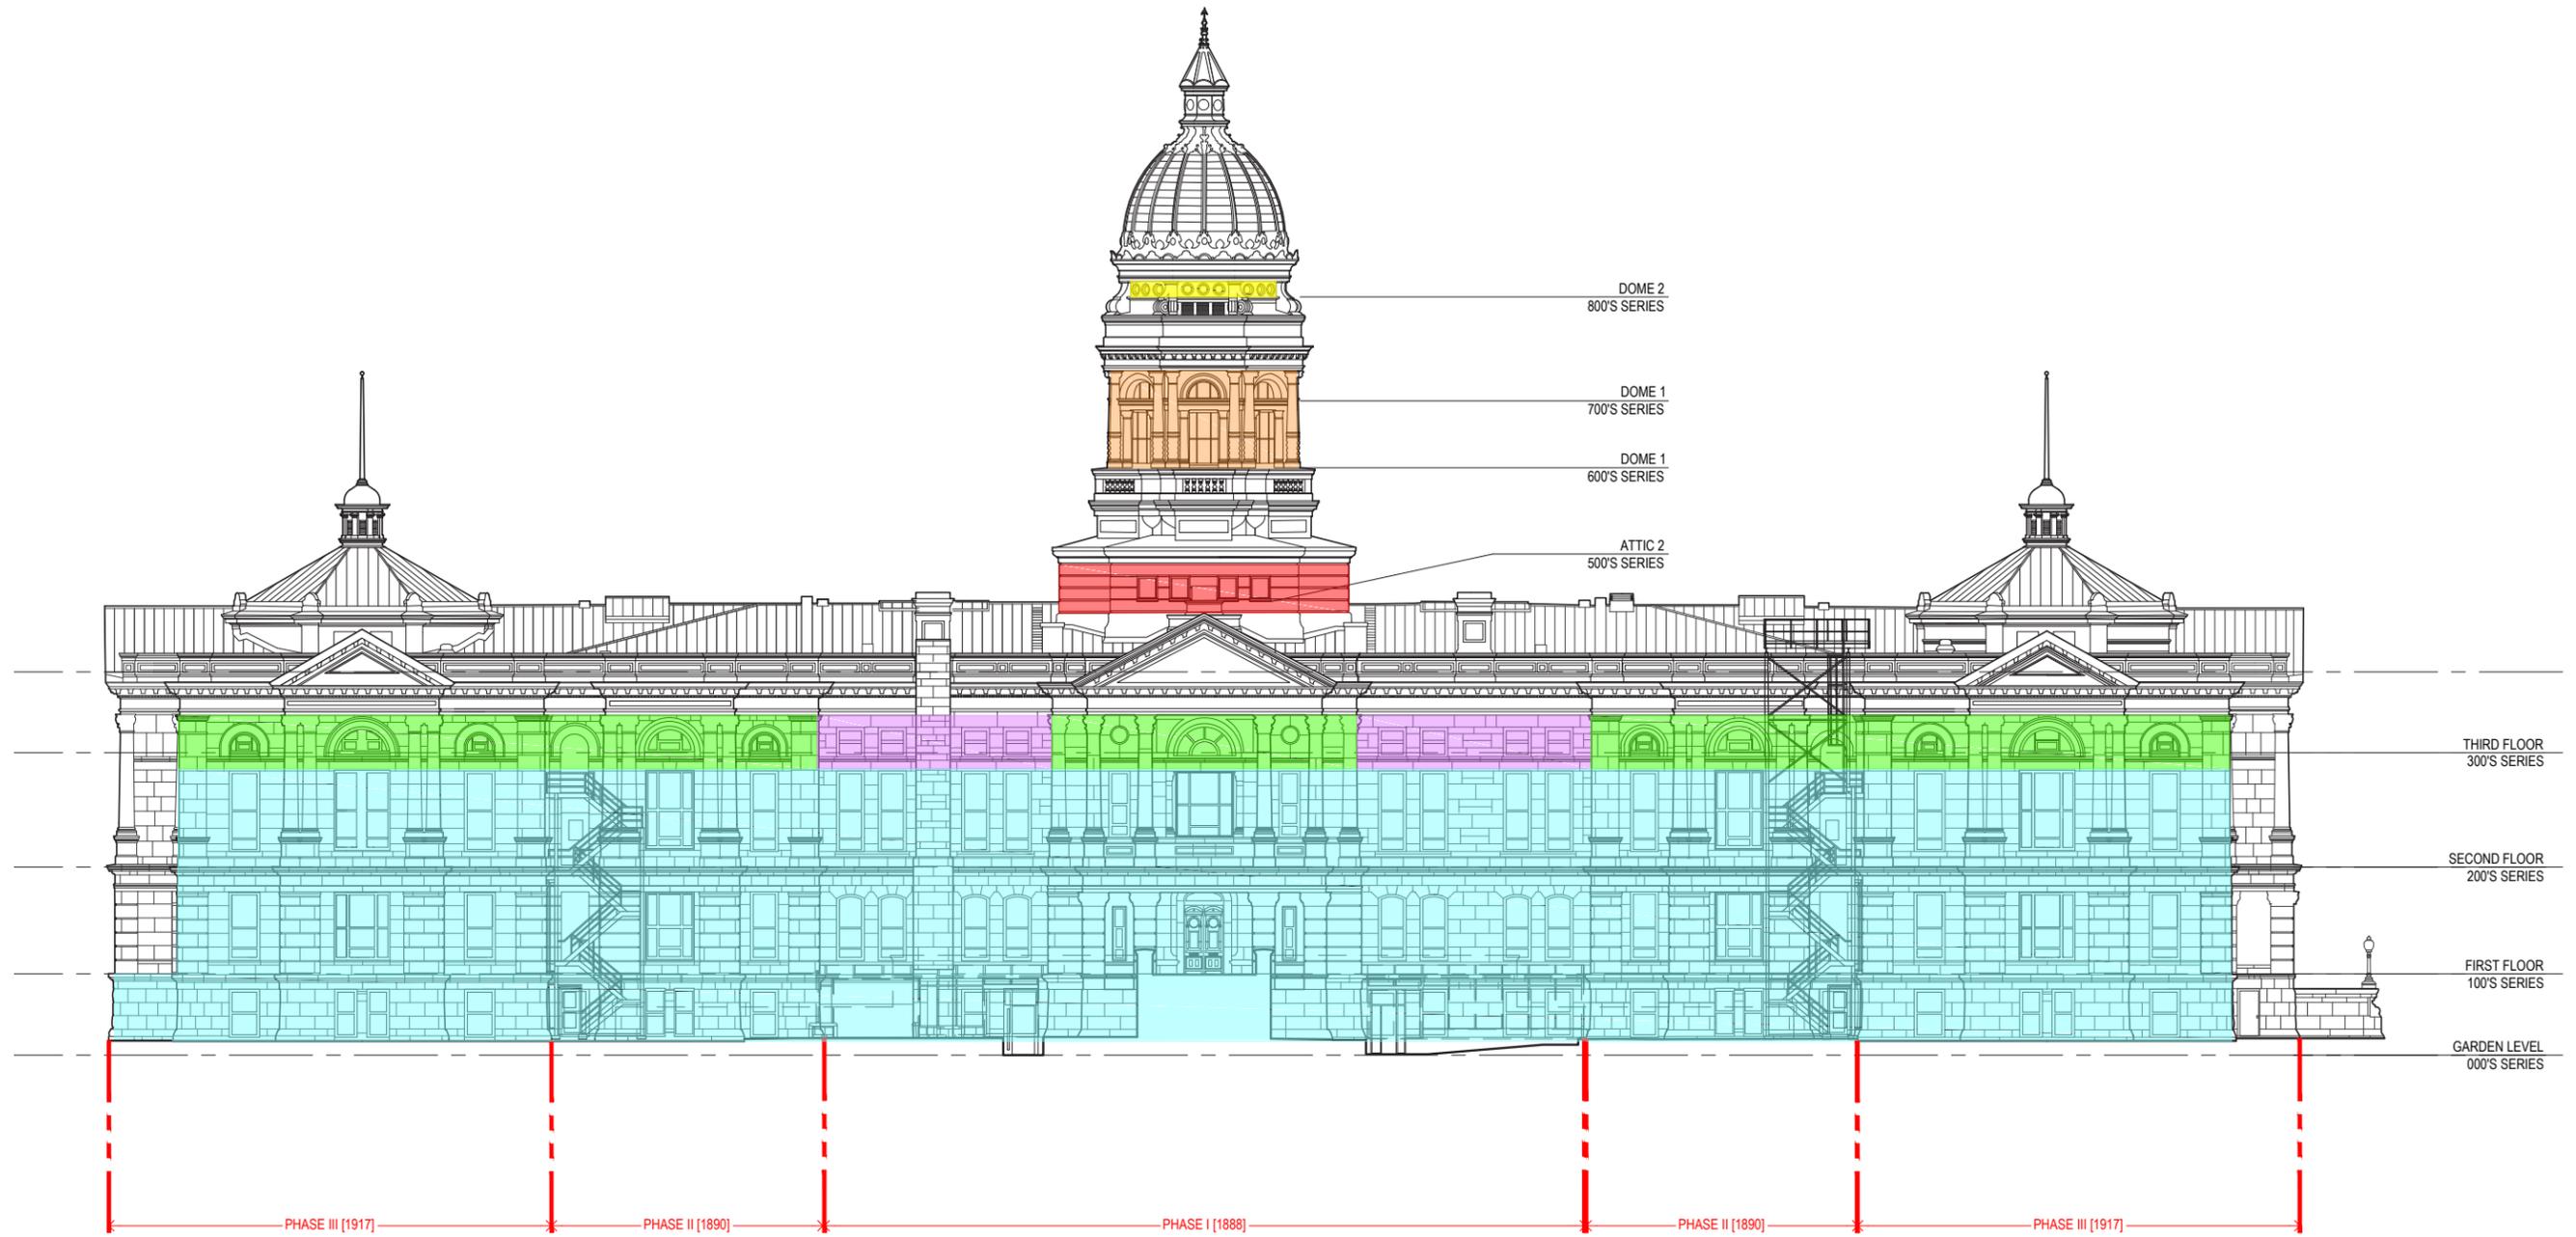
1 NORTH ELEVATION - HISTORIC WINDOW INSTALLATION AND REPLACEMENT CAMPAIGNS

Figure 1: Diagram displaying the various window replacement campaigns.

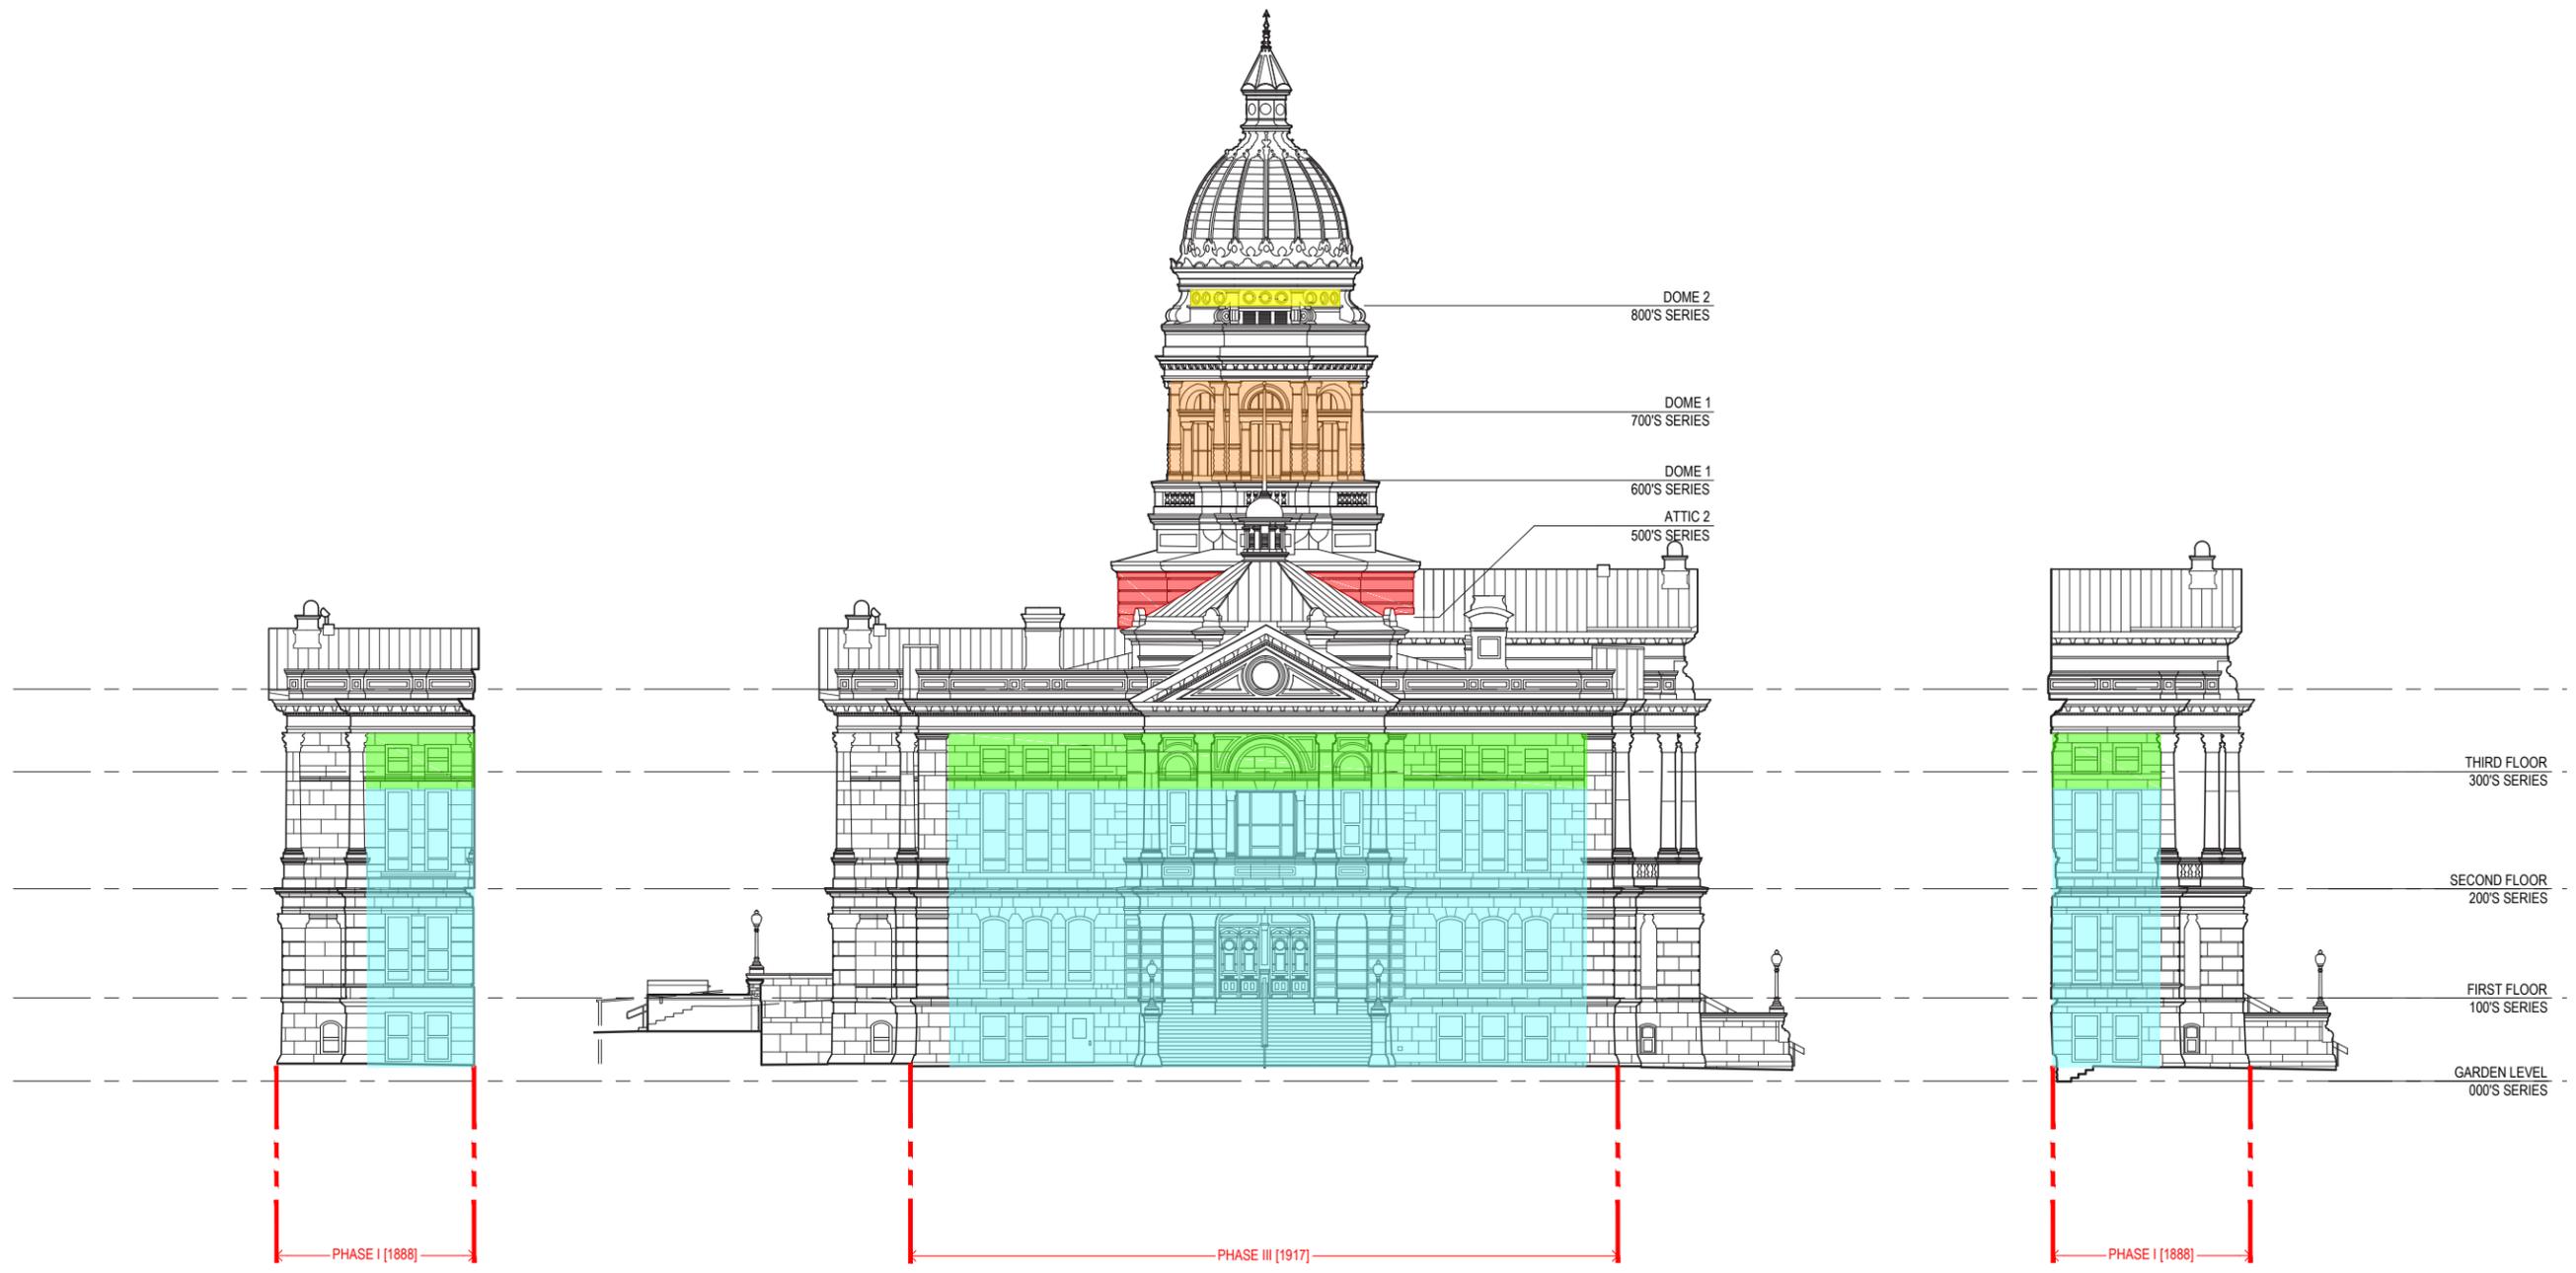
1 WEST ELEVATION - HISTORIC WINDOW INSTALLATION AND REPLACEMENT CAMPAIGNS

Figure 1: Diagram displaying the various window replacement campaigns.

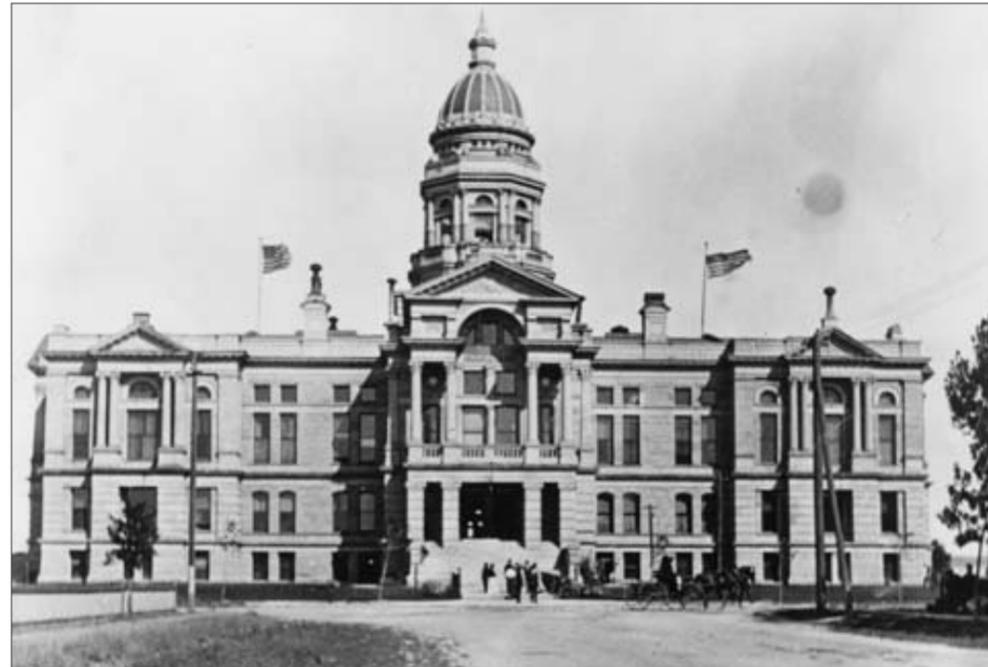
Figure 2: Historic Photograph of the Recently-Completed [Phase II] Capitol Building from the South, ca. 1890.

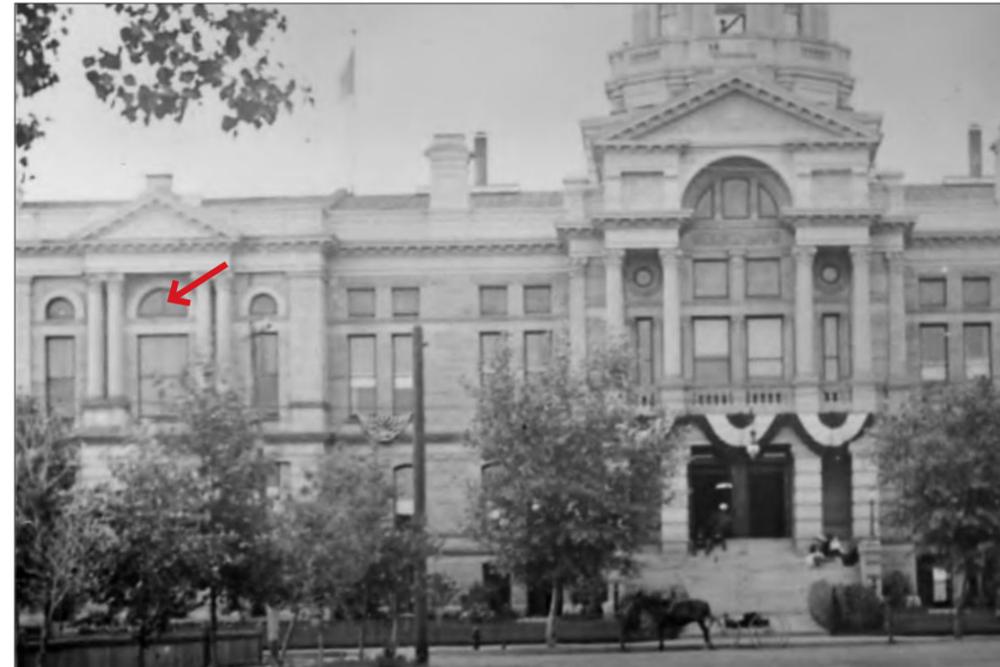
Figure 3: Historic Photograph of the [Phase II] Capitol Building from the South, ca. 1910. Arrow indicates original vertical center muntins.

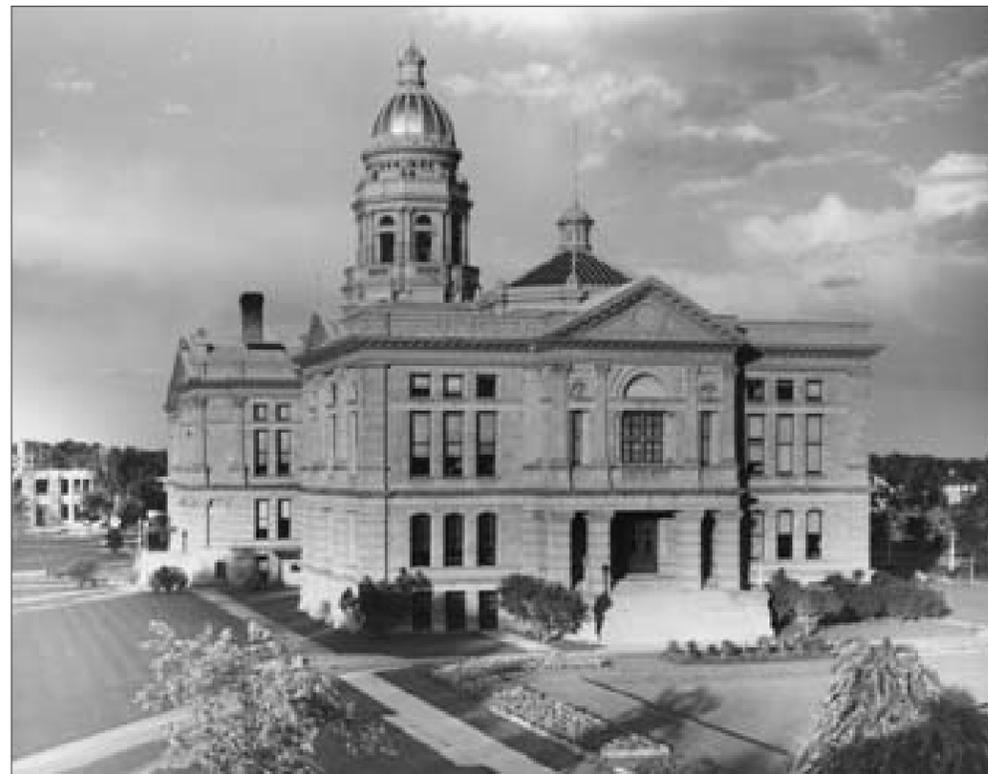
Figure 4: Historic Photograph of the [Phase III] Capitol Building from the East, ca. 1938.

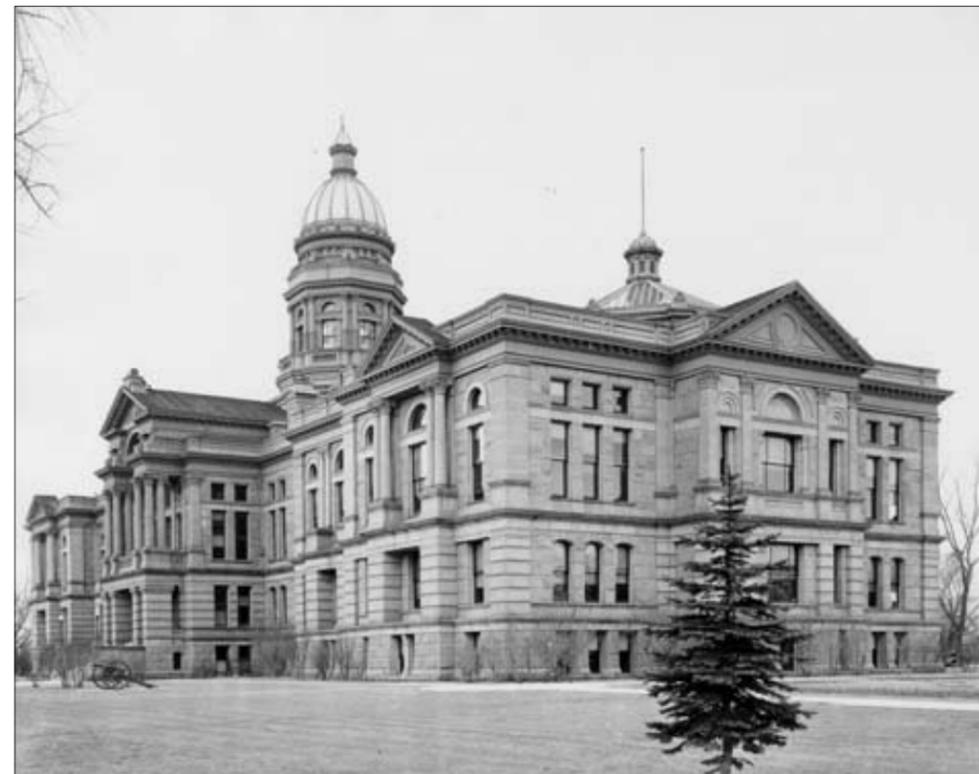
Figure 5: Historic Photograph of the [Phase III] Capitol Building from the Southeast, ca. 1930.

- Original sashes and frames were wood throughout. Most sashes were operable. Fixed sash occurred at the Third Floor clerestory window at the south portico, and at the round and half-round windows in the Dome. The majority of sash appear to be double-hung, with single-hung rather than double hung sash at the Third Floor. [Figures 5, 6, 7 & 8]

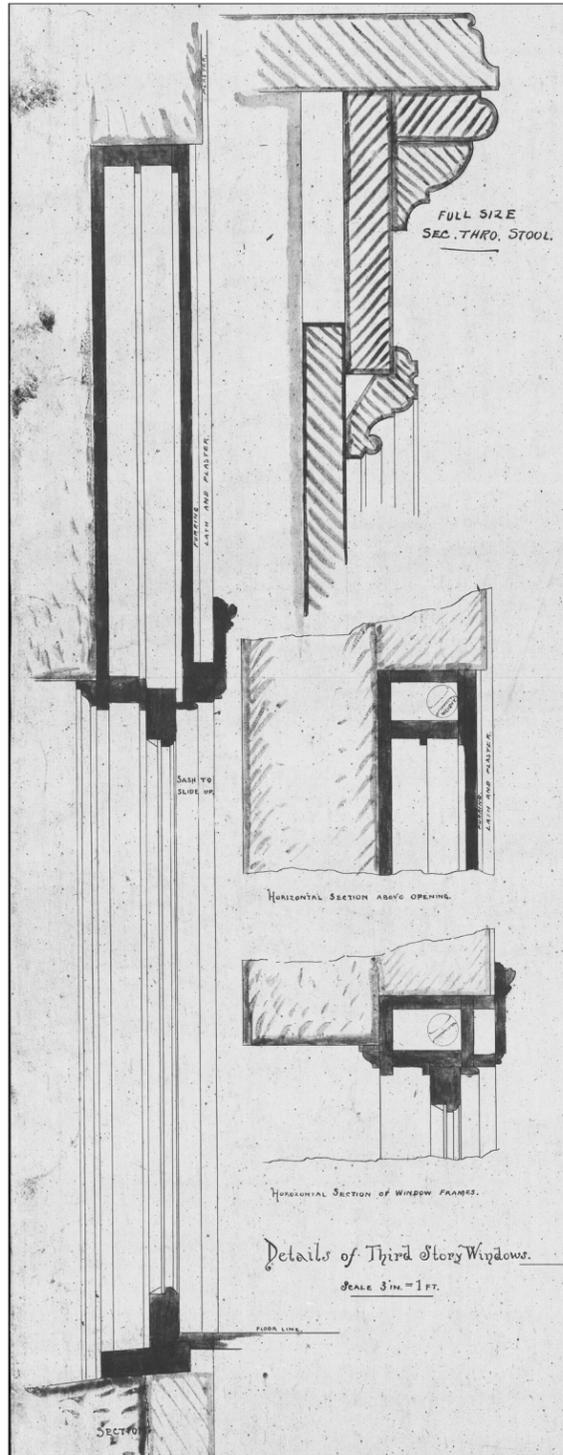
Figure 6: Architectural Section Drawing, ca. 1888. The drawing shows sash pocket at typical Third Floor window openings.

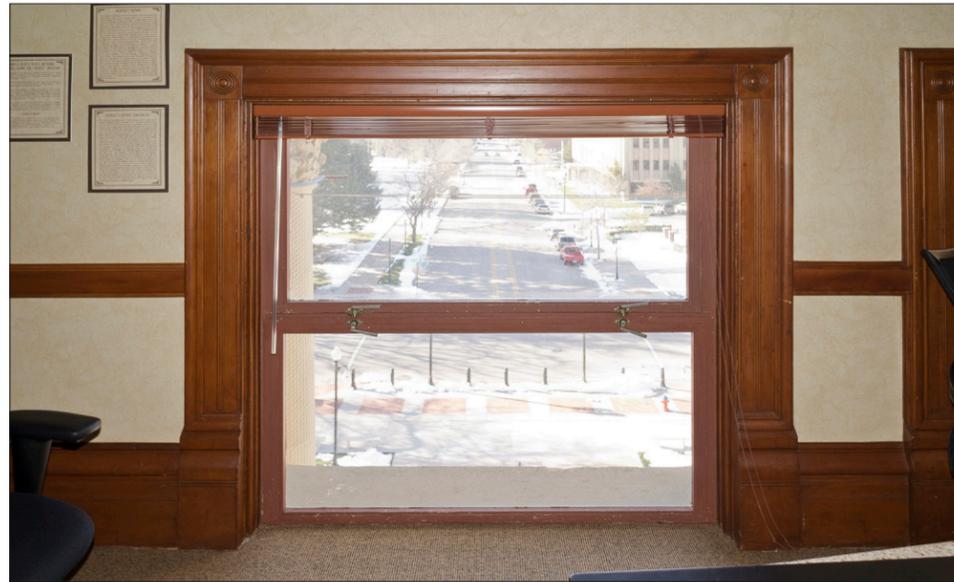
Figure 7: Third Floor Opening in Phase I Portion of Capitol. The historic sash has been replaced with an aluminum hopper/awning type window. A sash pocket above the opening may be present within the wall. Note carpet over window stool.

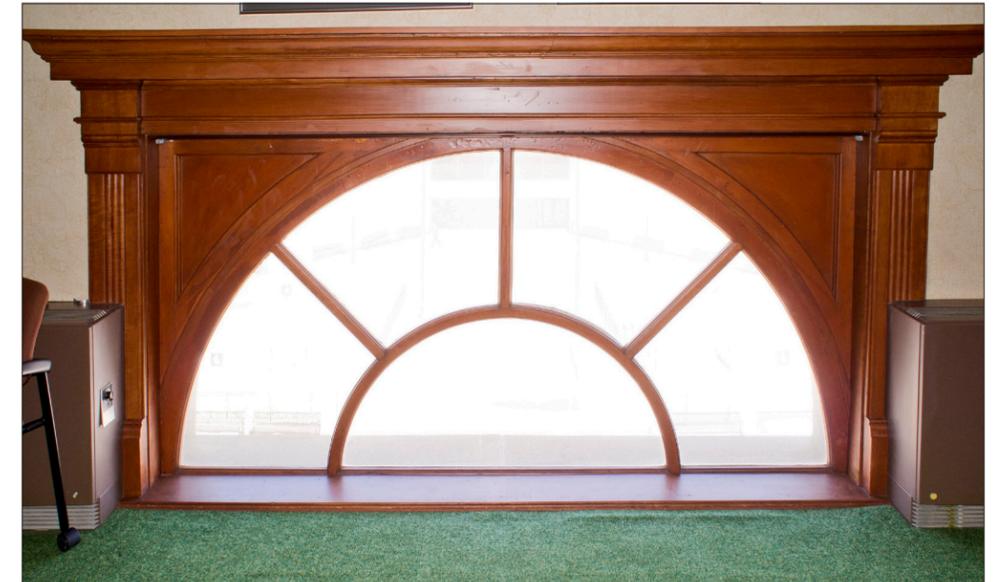
Figure 8: Third Floor Arched Window in Phase I Portion of Capitol. The sash, frame, and surround appear historic, and match the configuration for this window location in a c. 1905 historic photograph of the exterior. The interior stool is located at the top of the bottom rail.

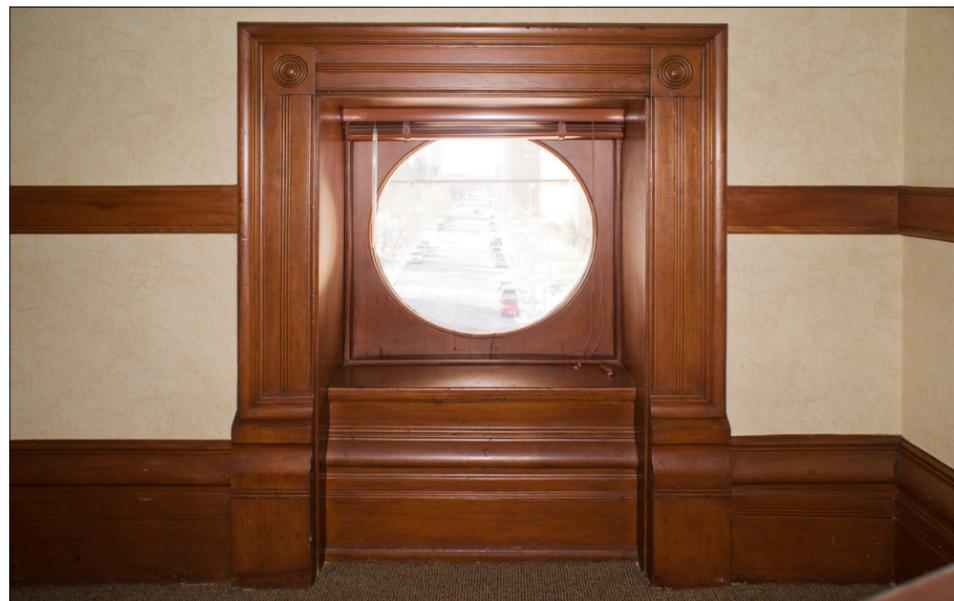
Figure 9: Third Floor Round Window in Phase I Portion of Capitol. The sash, frame, and surround appear to be historic.

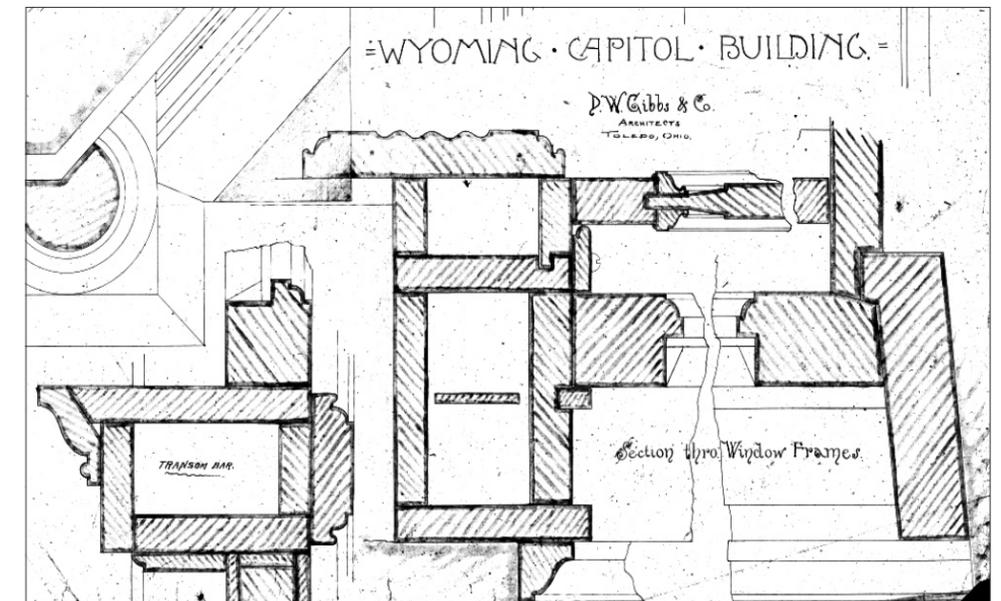
Figure 10: Architectural Detail Drawing, ca. 1888. The drawing shows sash weight pocket and interior shutter. The drawing also shows the profiled molding at the exterior frame and interior trim.

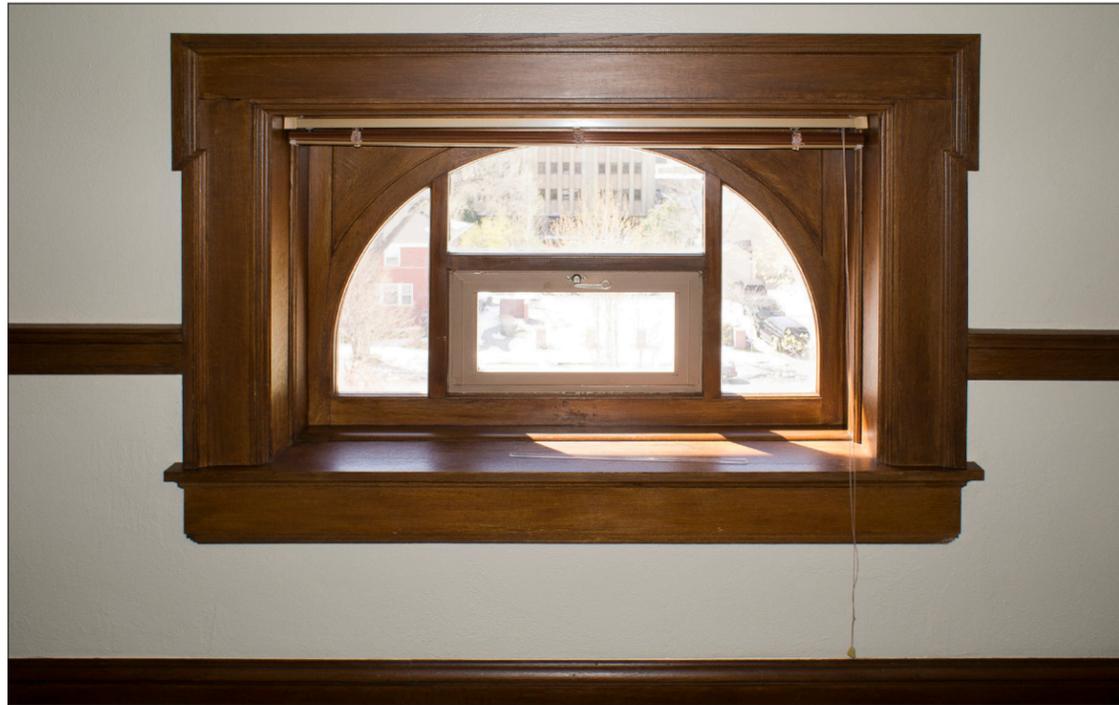
Figure 11: Third Floor Small Arched Window. The sash, frame, and surround appear historic, but the sash has been modified with muntins and operable hopper sash.

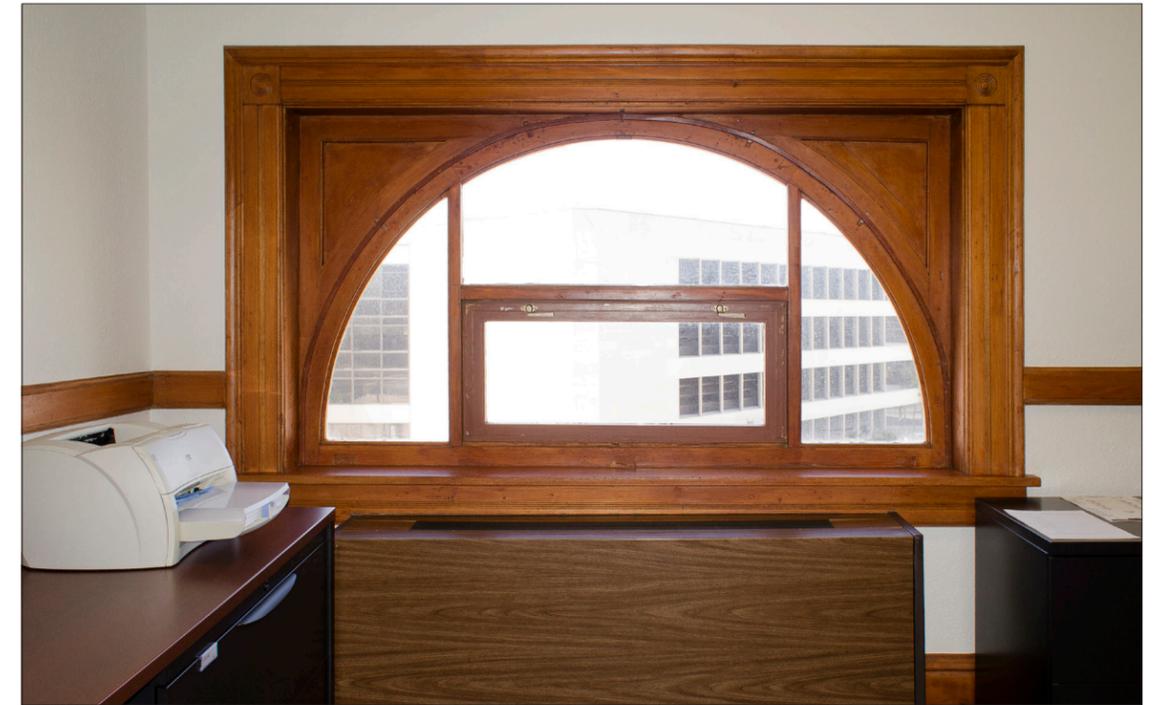
Figure 12: Third Floor Small Arched Window. The sash, frame, and surround appear historic, but the sash has been modified with muntins and operable hopper sash.

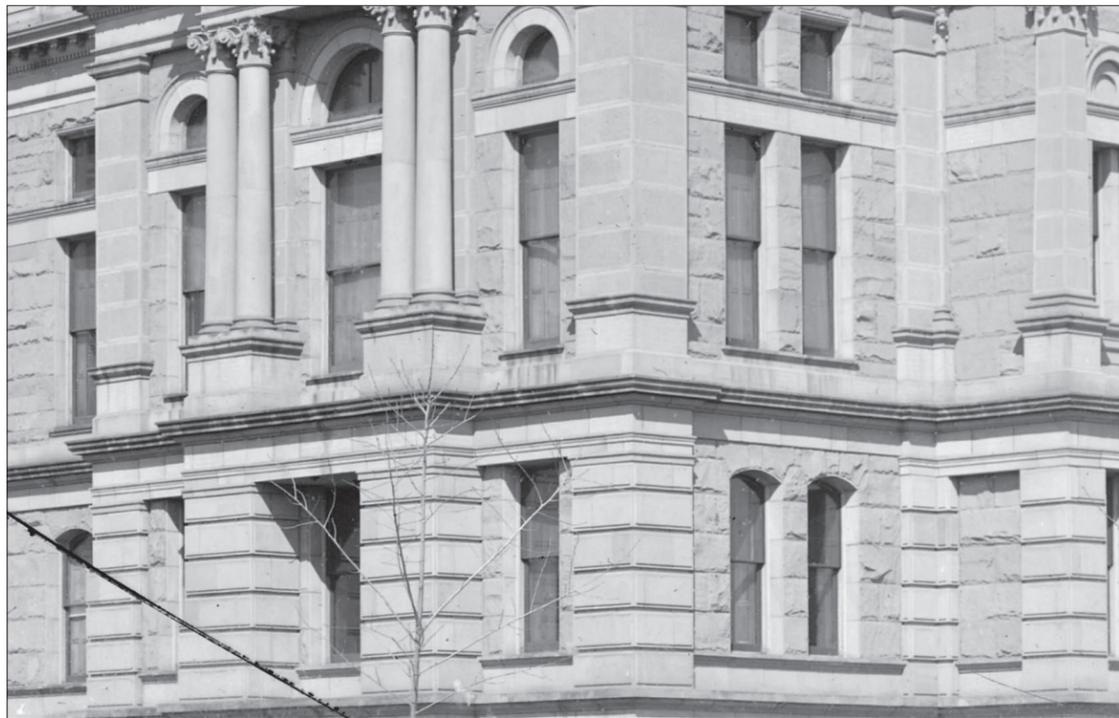
Figure 13: Historic Photograph, ca. 1902. The interior shutters are visible through windows.

- The 1890 specifications require the shutters to be 1 1/8" thick, 8-fold and finished with hard oil. [Figure 13, 16 & 17]
- The historic specifications for the interior finishes were for varnish at the basement, office rooms, and Third Floor rooms. Finished carpentry was specified as the following wood species:

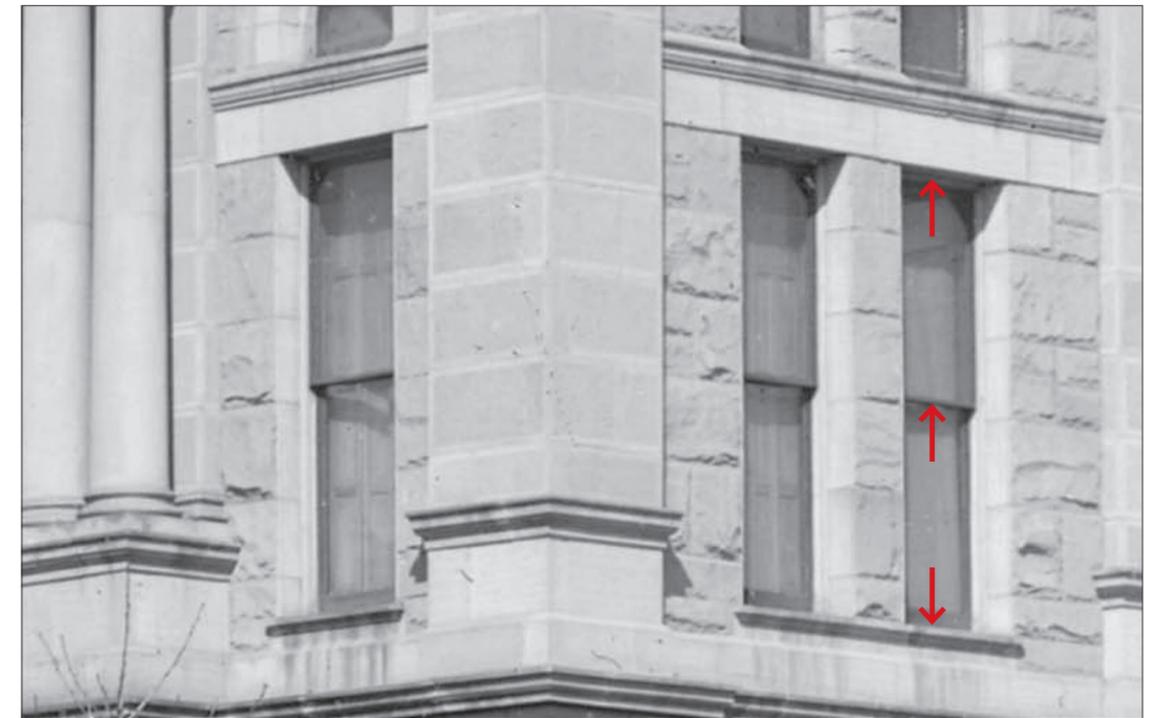
Figure 14: Detail of Historic Wood Windows, ca.1902. The frame, painted to match the stone color, is highlighted at right. The dark painted sash is indicated with the red arrows.

- o In the Phase 2 and 3 sections of the building, the remaining Third Floor half-round windows originally had no muntins, excepting the arched windows in the North and South central pavilions. One horizontal and two vertical muntins were added to install a hopper/awning. [Figure 14]
