**STATE CAPITOL REHABILITATION AND
RENOVATION / CAPITOL SQUARE PROJECT**

**SERIES 2 - WYOMING STATE CAPITOL
SD OWNER REVIEW**

**LEVEL III SCHEMATIC DESIGN REPORT
VOLUME II OF III**

SUPPLEMENTAL WINDOW PACKAGE

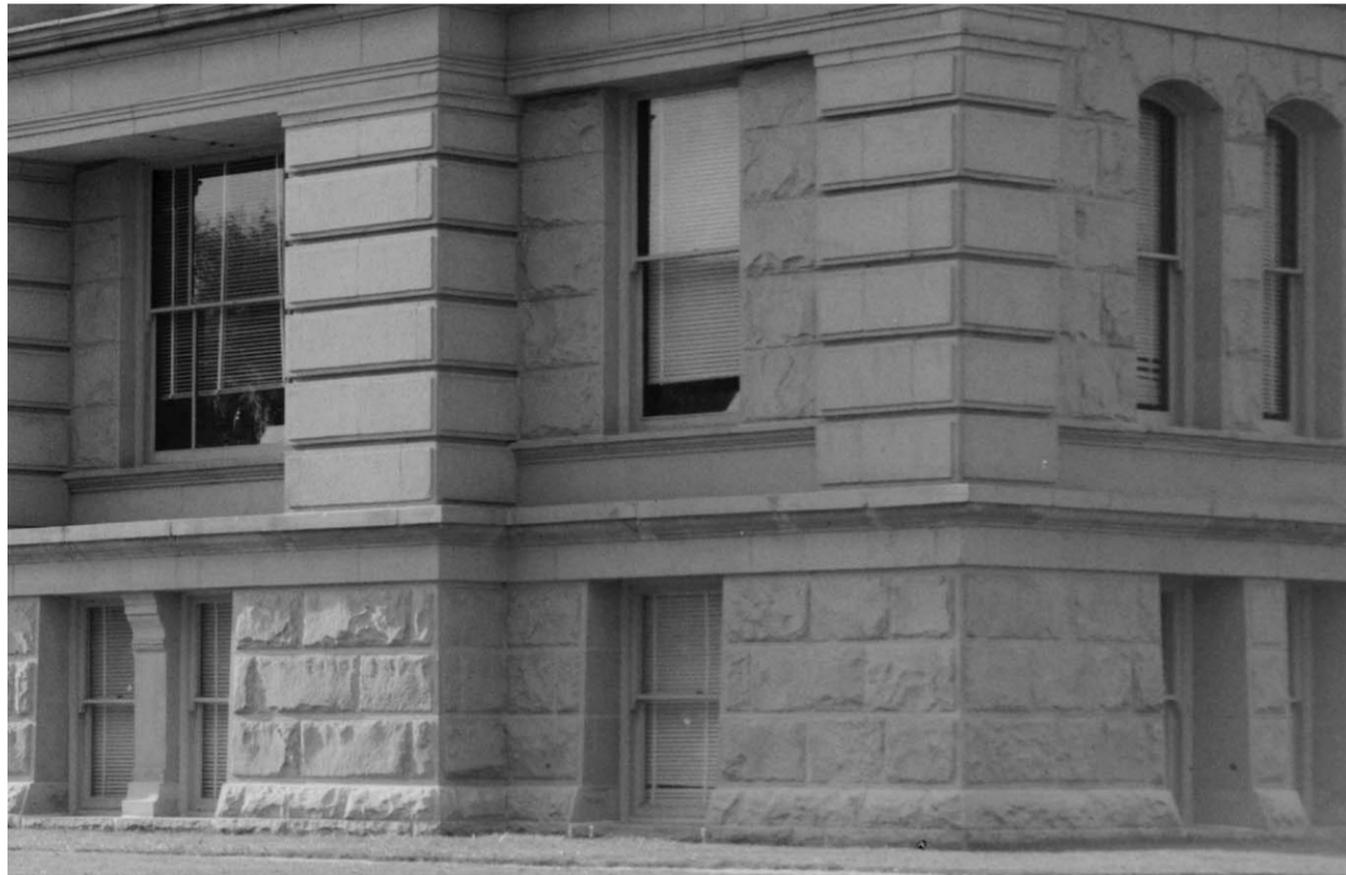
Figure 15: ca. 1979 HABS Survey Photograph Indicating the 'Joggles' Present on Upper Sash in Phase III Addition.

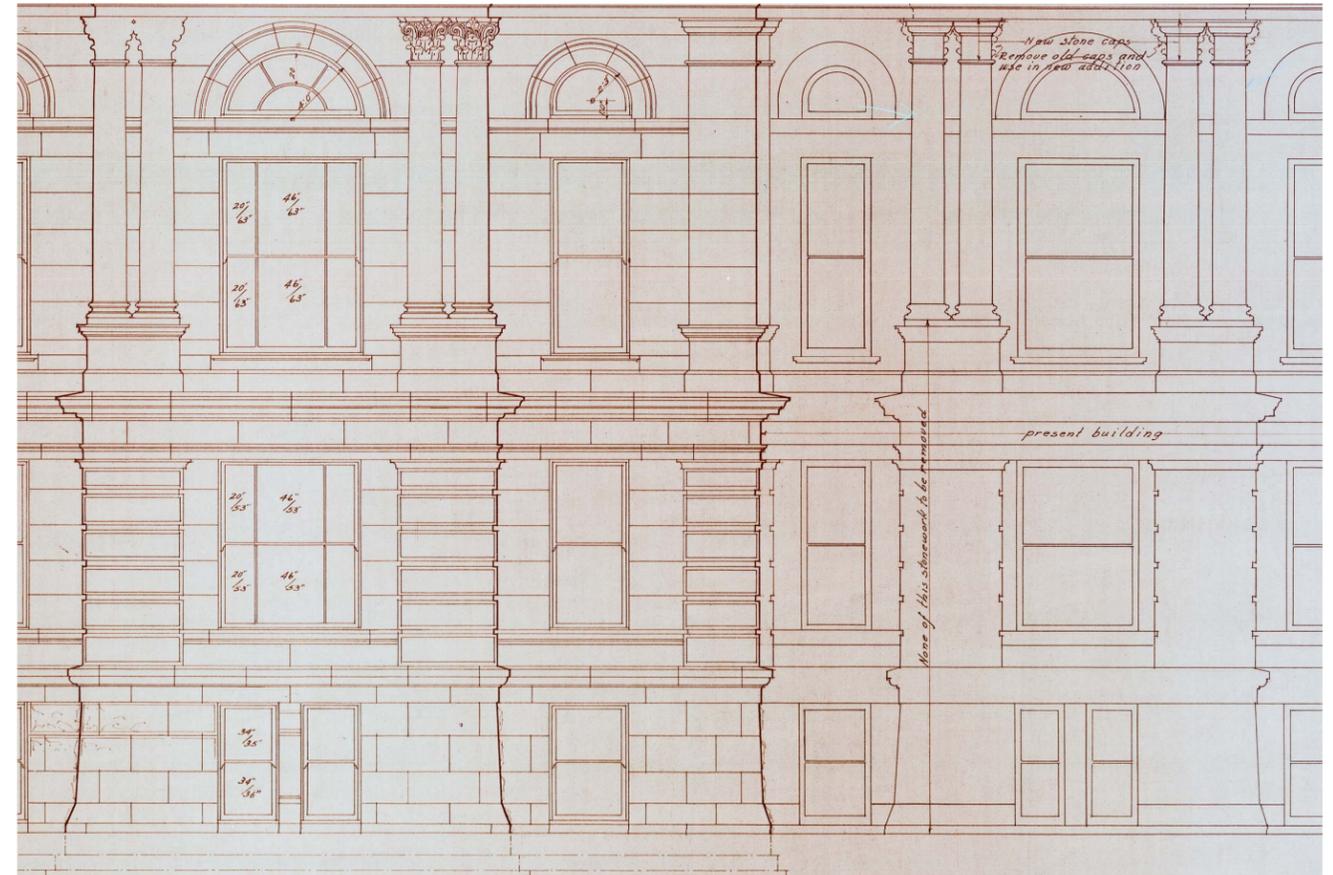
Figure 16: Historic DuBois Addition Drawing at South Elevation at 1890 / 1917 Interface Illustrating 'Joggles' on Upper Sash.

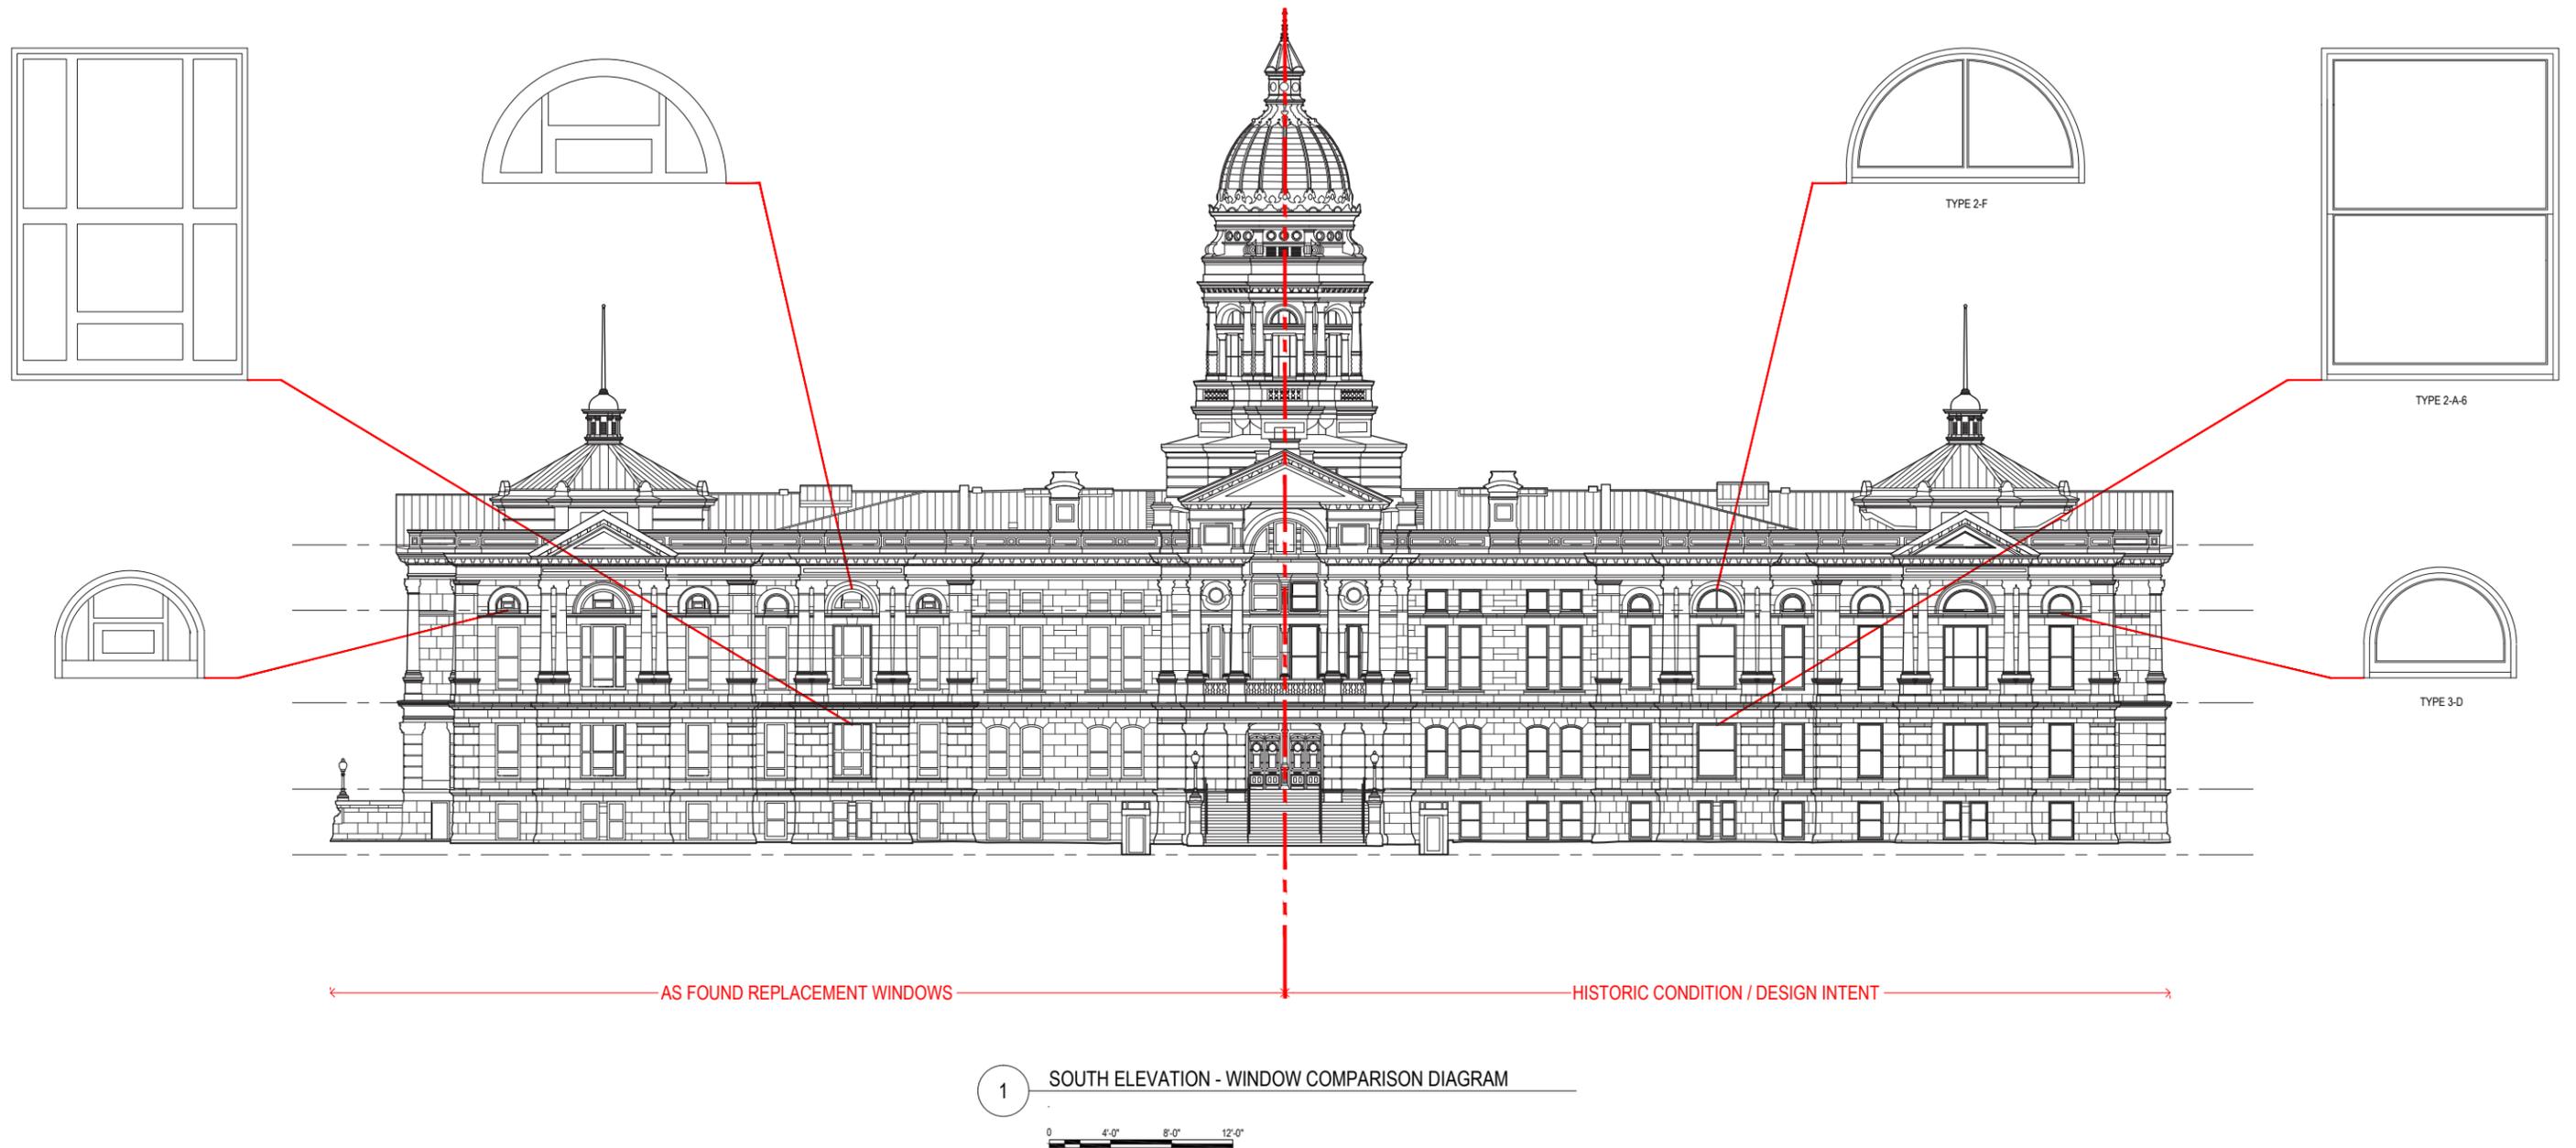
Figure 17: South Elevation, Displaying Change in Appearance Caused by Replacement Windows.

- Replacement of nearly all the sash in the building resulted in a significant change in the appearance of the building through alteration in the visual rhythm of the muntins, a change in the historic architectural aesthetic. [Figure 17] These changes resulted from removing the original single hung and double hung units and replacing them with small hopper/awning units set in areas of fixed lites. These alterations occurred as follows:

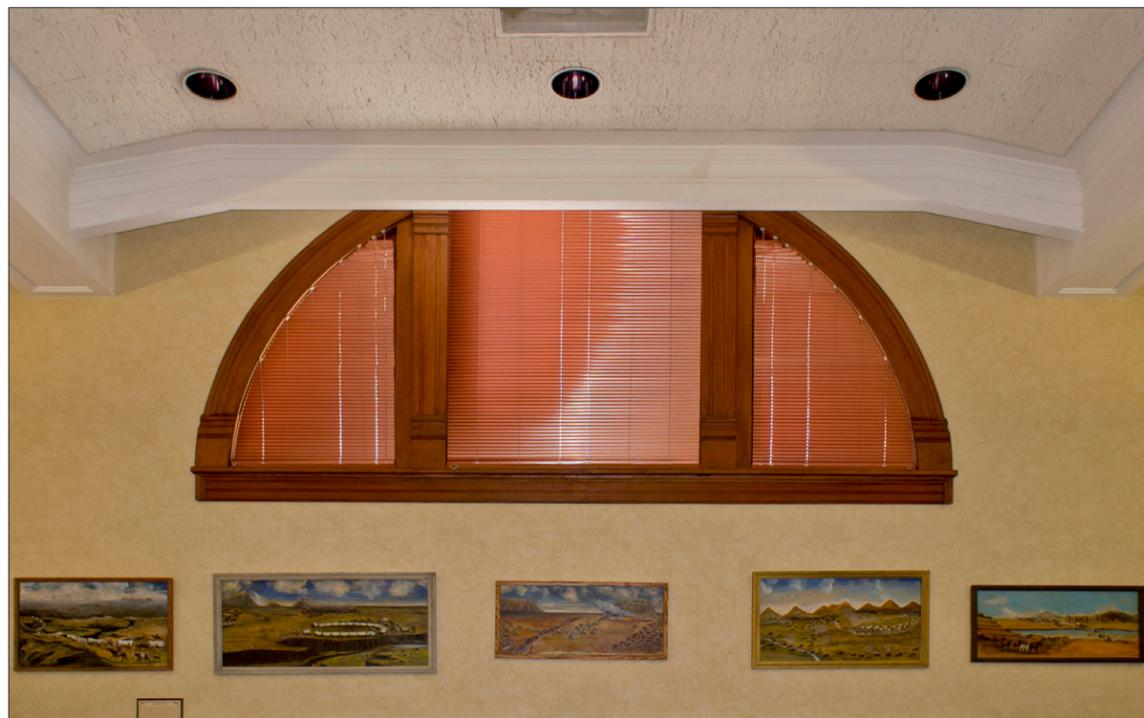
Figure 19: Half-Round Window with Two Vertical Mullions Located Near the Vaulted Ceiling of the Third Floor. The sashes are believed to be historic.

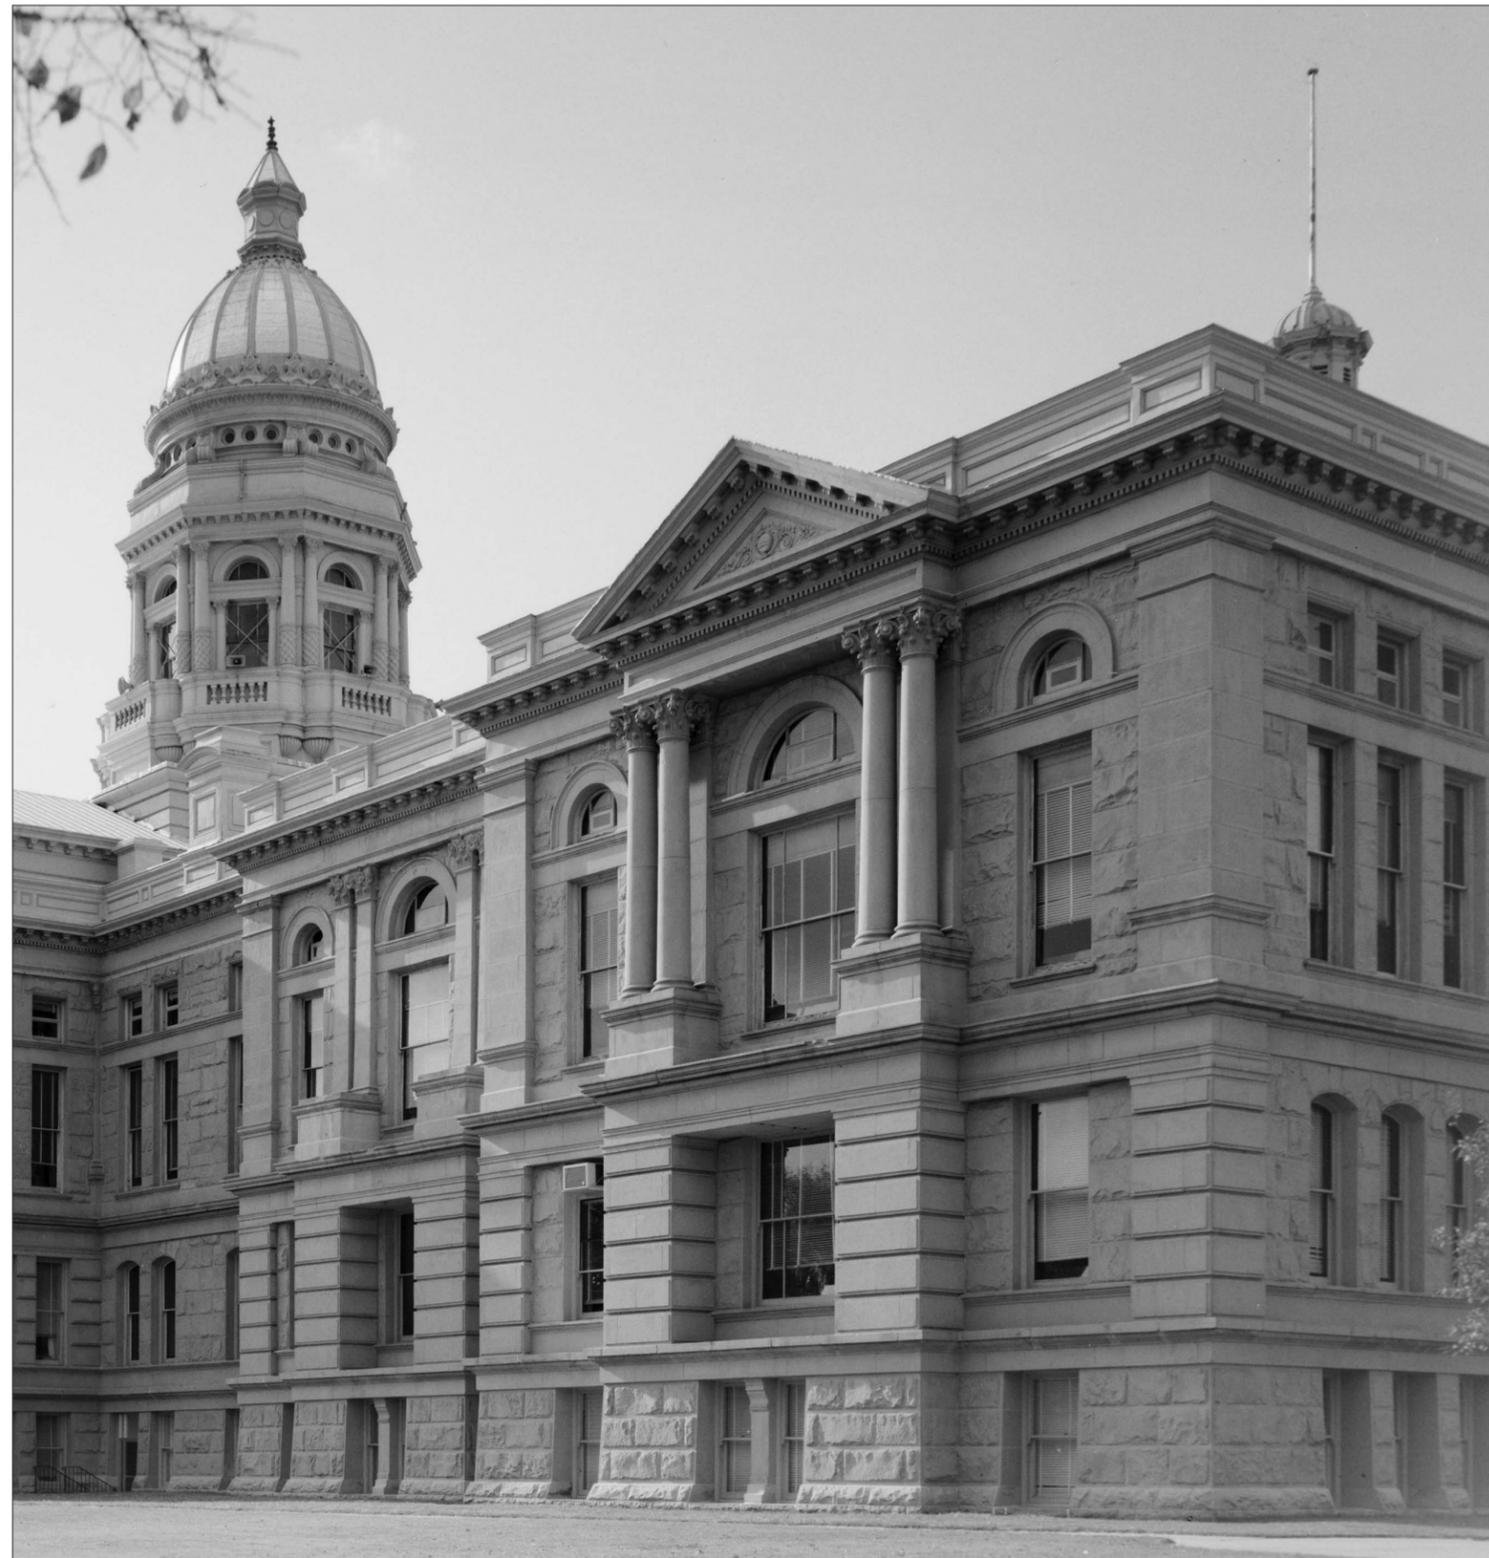
Figure 20: Historic Photograph of Capitol taken from the HABS survey, ca. 1979. Photograph indicates that all rectangular Third Floor window sash was replaced with aluminum sash.

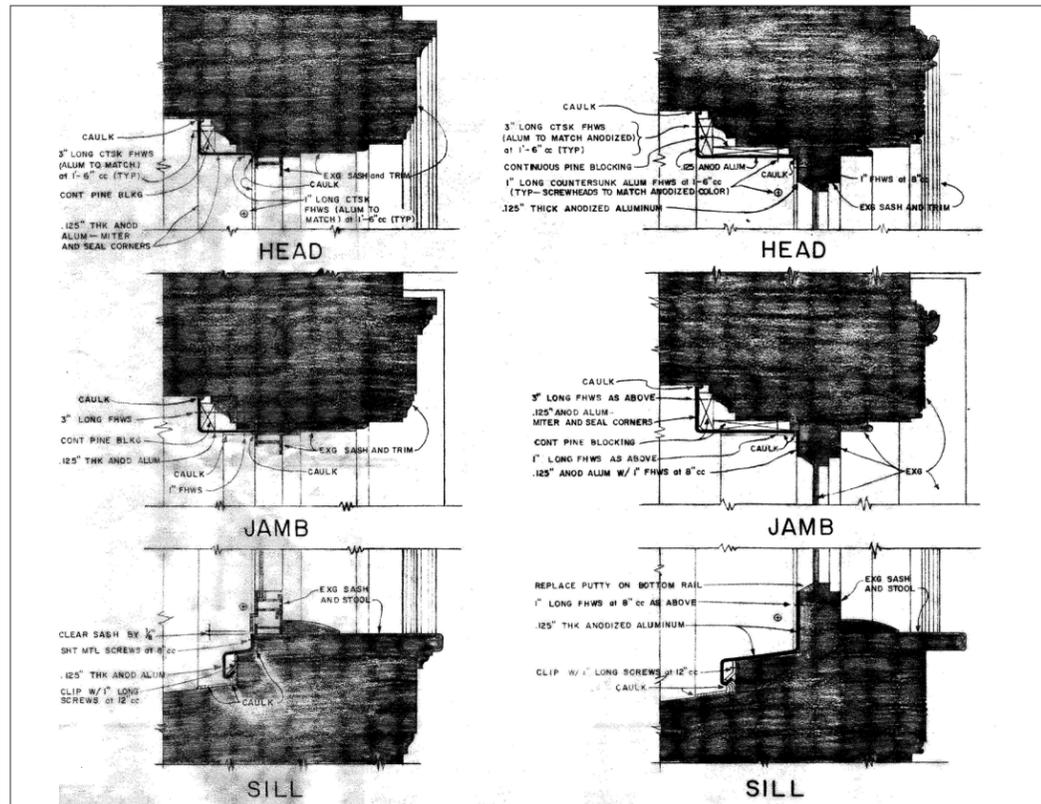
Figure 21: Architectural Detail Drawings, ca. 1977. The drawing indicates installation of aluminum cladding at two different conditions at exterior window frames on the Third Floor. The drawings indicate that the molded exterior profile of the original wood frame is to be enclosed by aluminum cladding, the assumed current condition at nearly all window frames at the Capitol.

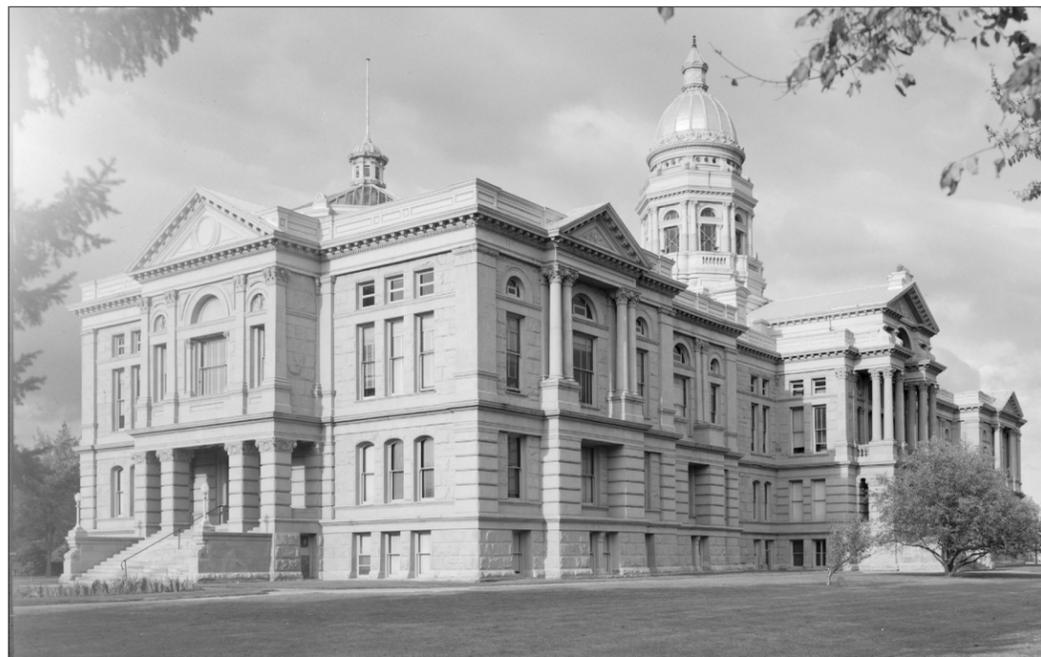
Figure 22: Historic Photograph of Capitol from Southwest Taken for 1979 HABS Documentation.

- HABS photographs indicate that a majority of the third floor rectangular window sashes with operable aluminum double-paned replacement window units were in place prior to 1979, consistent with 1977 H&H documents. [Figure 23]
- The HABS photographs indicate that window openings at the Second Floor through Garden level contain wood sash in 1979 [Figures 23 & 22]

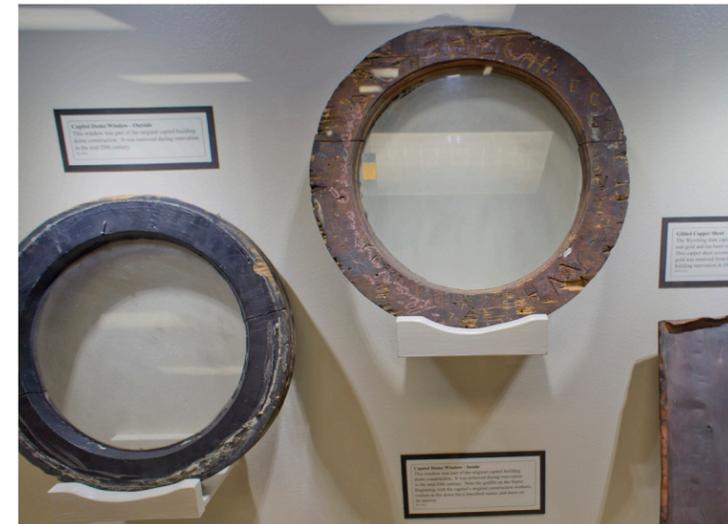
Figure 23: Display Case in Capitol Building, Garden Level. Samples of the historic sash from the Dome show the historic configuration of the interior and exterior.

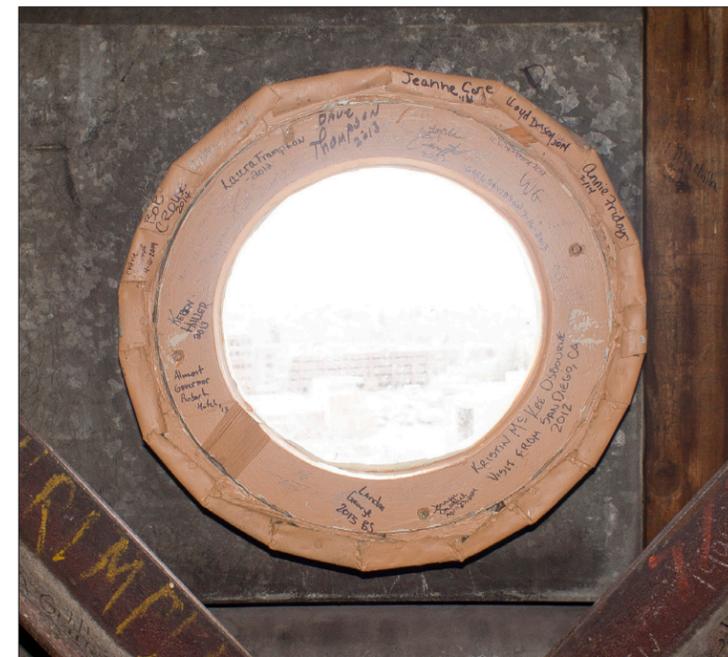
Figure 23: Round Sash at Dome 2. The historic sash has been replaced with wood sash that appears to match the historic design intent, although the sashes were installed with the glazing putty on the interior side.

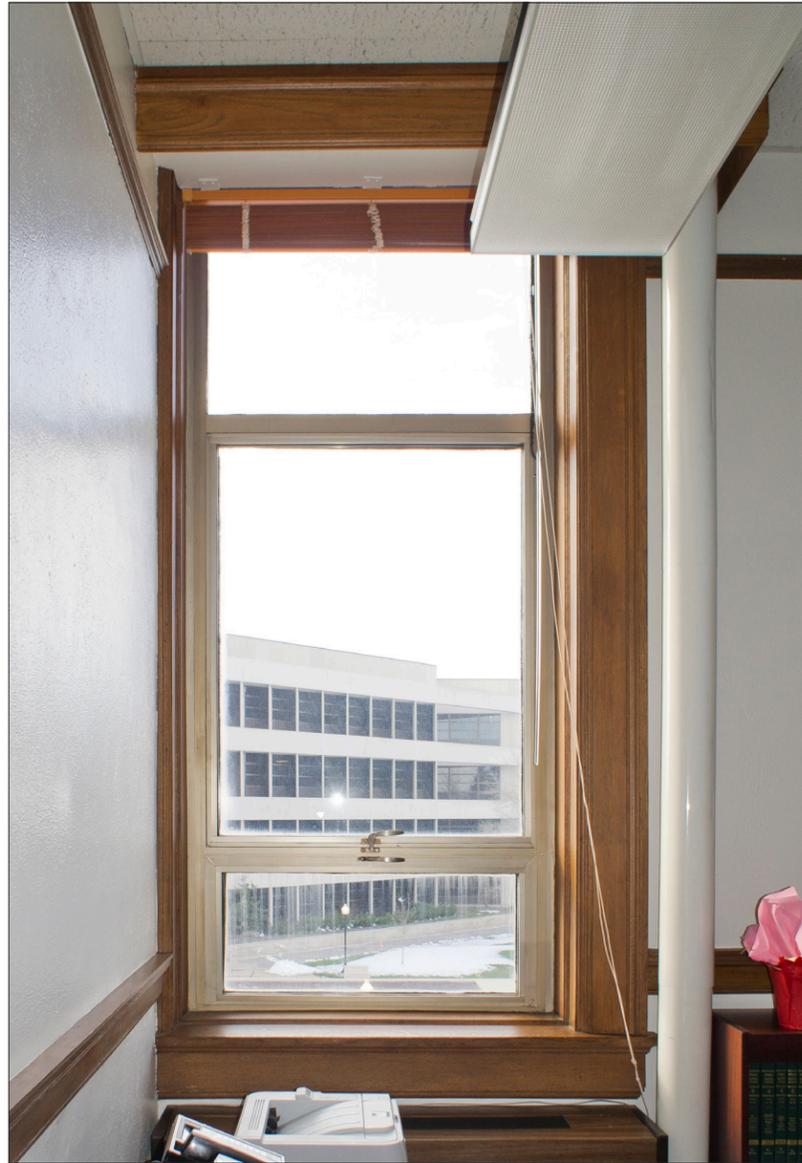
Figure 24: Second Floor Aluminum Replacement Window Unit with Operating Awning and Hopper Sashes [Window N-240A]. The interior frame and surround appear historic, consistent with Phase 3 detailing. Note dropped ceiling, supply for steam radiator on right, and historic partition on left.

1. Window heads are hidden by dropped acoustic tile ceilings or drapery pockets in most locations. [Figures 24, 27, 30 & 46]
2. Window surrounds and interior frames appear to be historic and original to the construction date of their phase, with the exception of the new wood sash stop added at the junction of aluminum replacement sash and historic trim. [Figure 42].

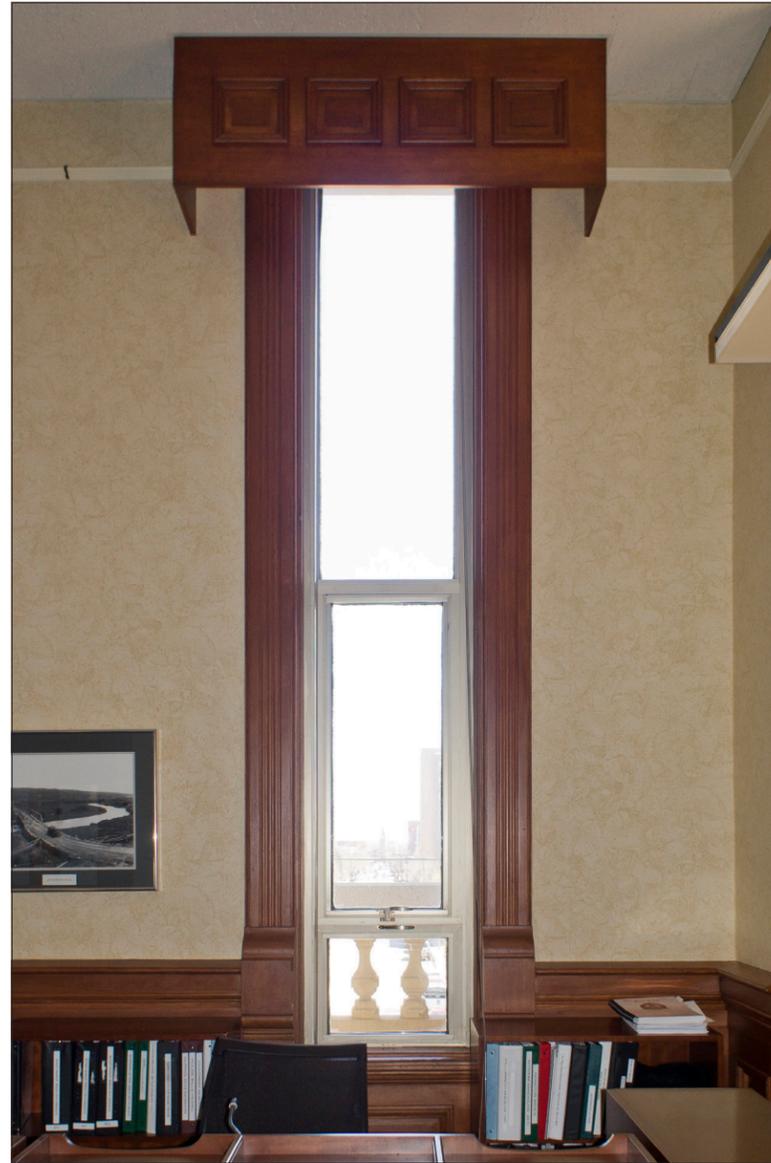
Figure 25: Second Floor Narrow Aluminum Replacement Window Unit with Operating Awning and Hopper Sashes [Window S-214]. The interior frame and surround appear historic, consistent with Phase 1 detailing.

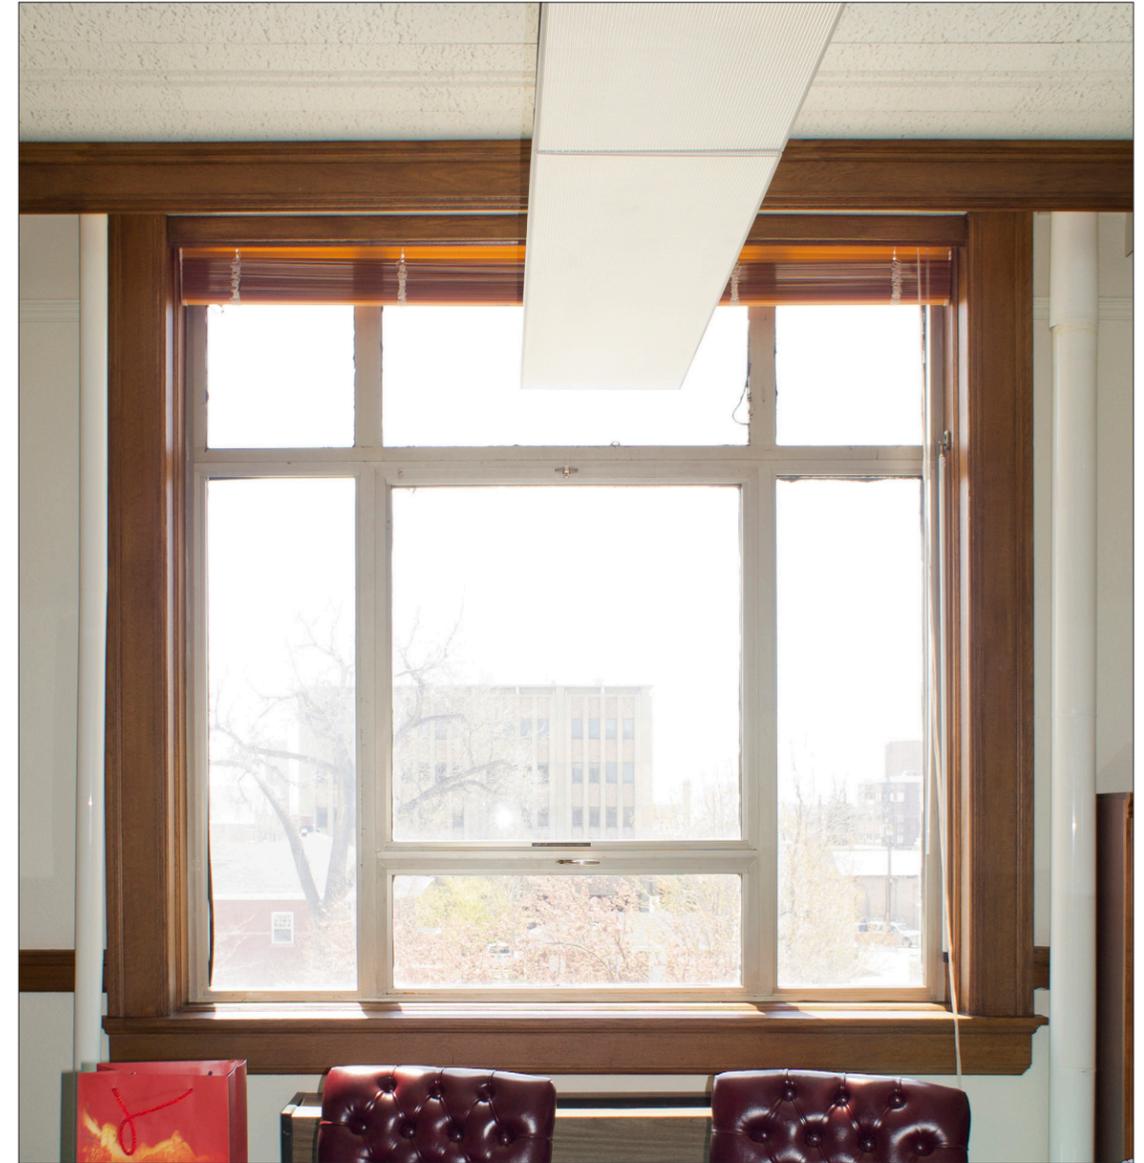
Figure 26: Second Floor Grouped Aluminum Replacement Window Unit with Operating Hopper Sashes [Window S-202]. The interior frame and surround appear historic, consistent with Phase 3 detailing. Note dropped ceiling, and insulated supply riser and condensate line for steam radiator at the sides of the window frame.

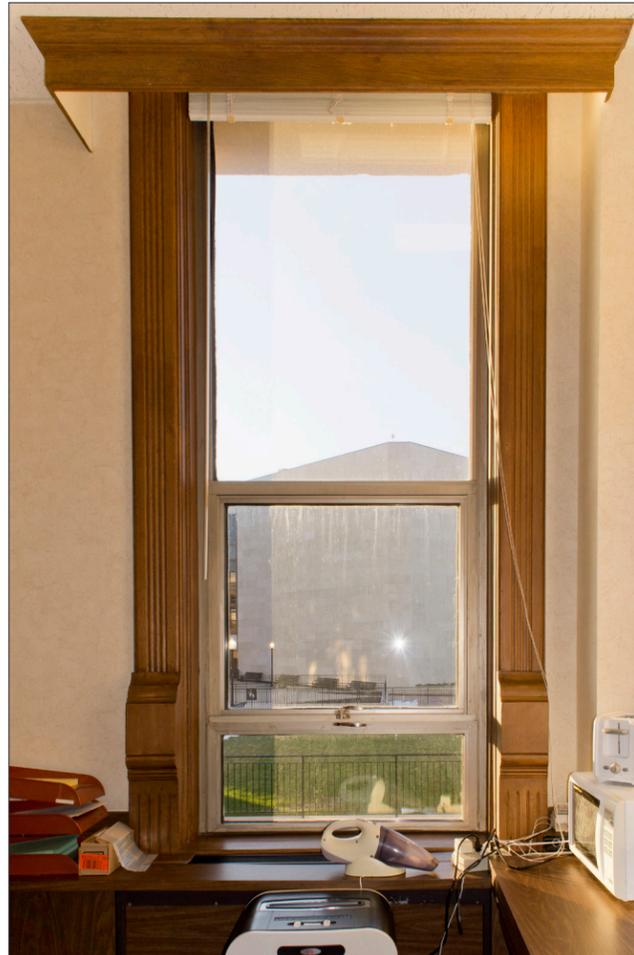
Figure 27: First Floor Aluminum Replacement Window Unit with Operating Awning and Hopper Sashes [Window N-144]. The interior frame and surround appear historic, consistent with Phase 2 detailing.

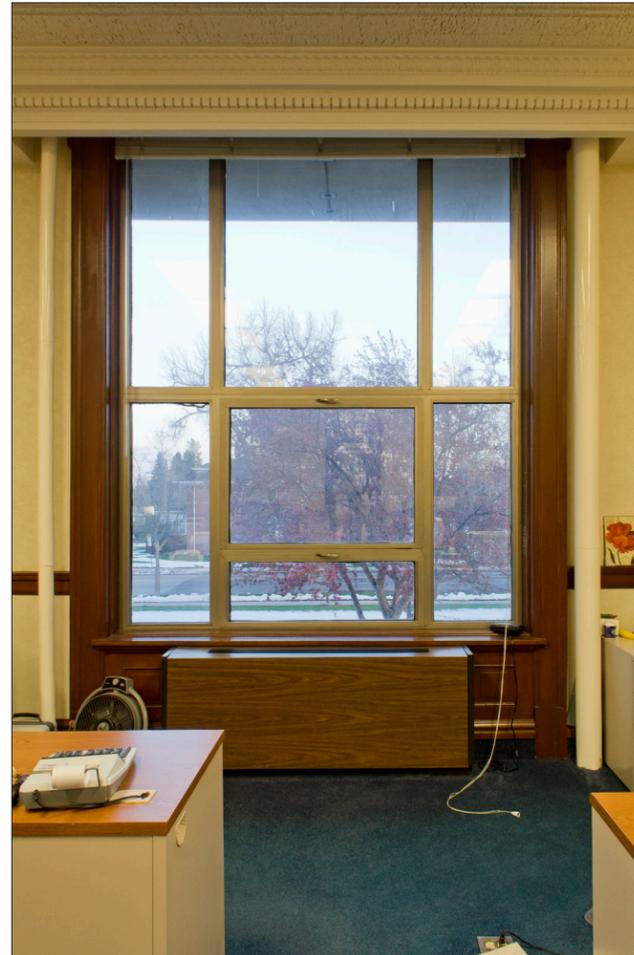
Figure 28: First Floor Grouped Aluminum Replacement Window Unit with Operating Awning and Hopper Sashes [Window S-102]. The interior frame and surround appear historic, consistent with Phase 3 detailing. Note dropped ceiling with crown molding, and insulated supply riser and condensate line for steam radiator at the sides of the window frame.

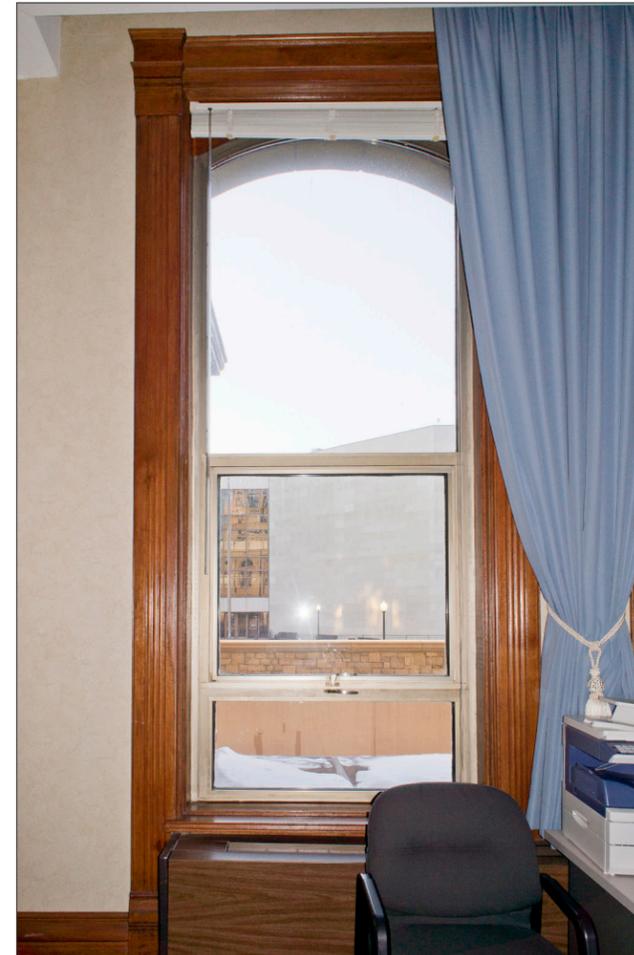
Figure 29: First Floor Aluminum Replacement Window Unit With Operating Hopper Sashes and Segmental Arched Top [Window N-148]. The interior frame and surround appear historic, consistent with Phase 1 detailing.

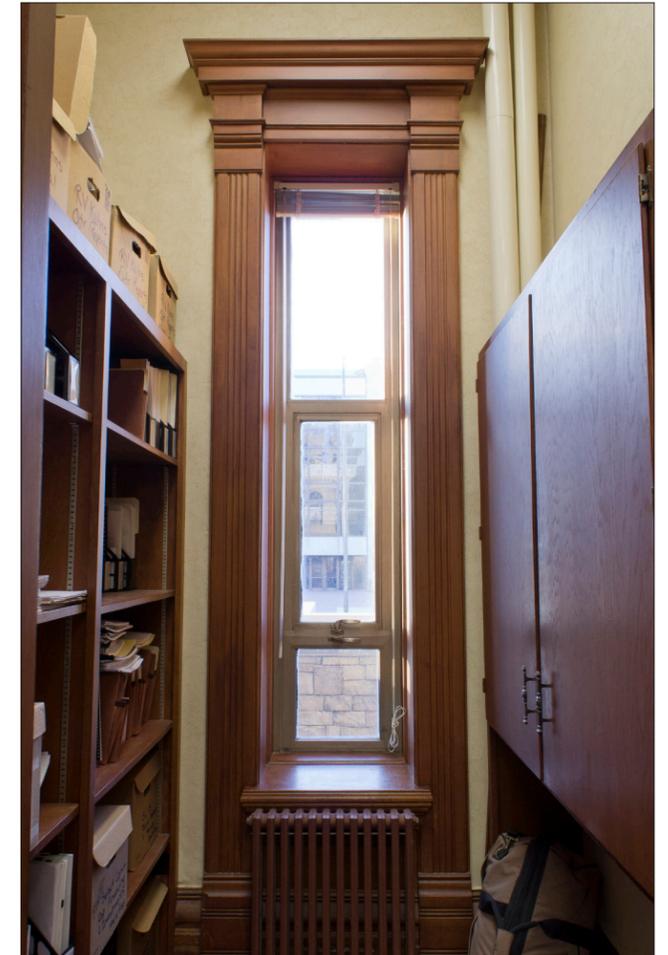
Figure 30: First Floor Narrow Aluminum Replacement Window Unit with Operating Awning and Hopper Sashes [Window N-152]. The interior frame and surround appear historic, consistent with Phase 1 detailing.

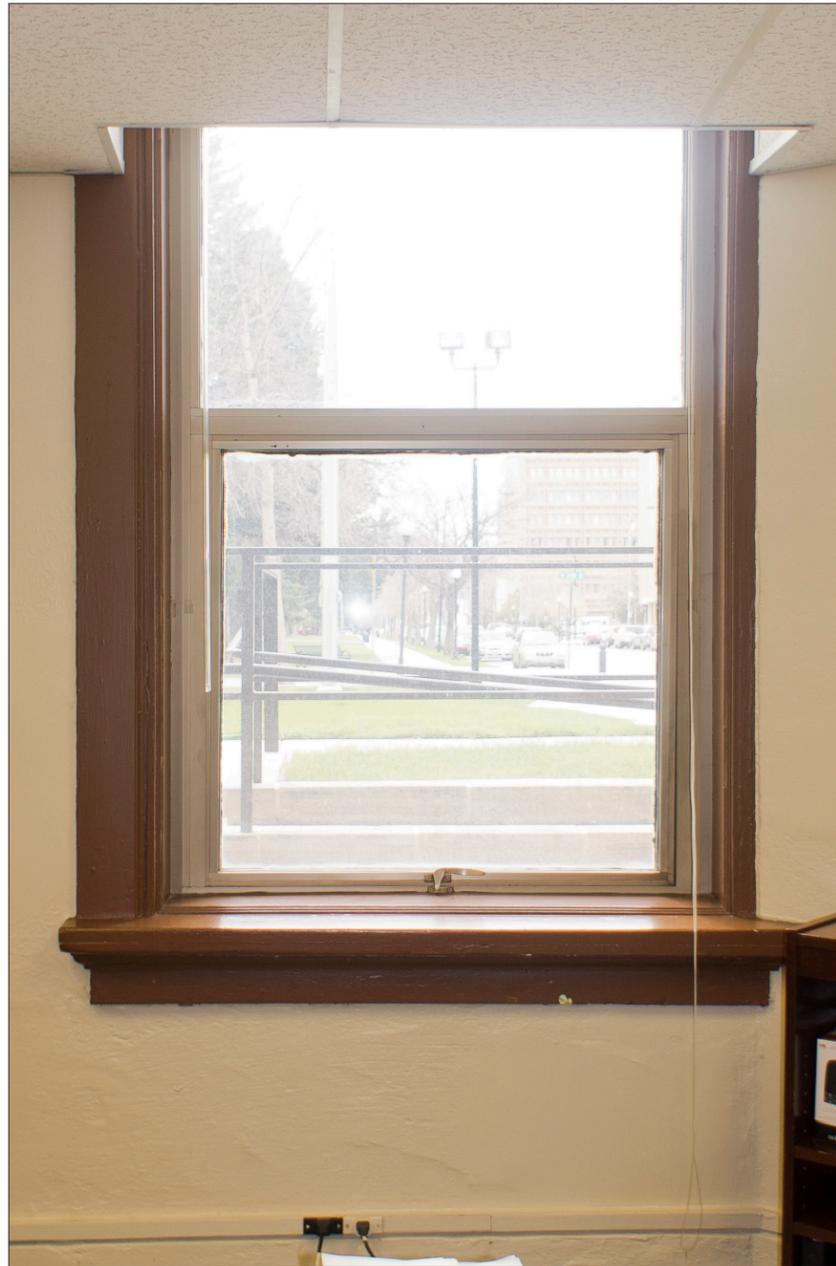
Figure 31: Garden Level Aluminum Replacement Window Unit with Operating Awning Sash [Window S-022]. The interior frame and surround appear historic, consistent with Phase 1 detailing, and historic specifications for painted wood surrounds at the Garden Level. Note dropped ceiling.

4. At the Garden Level, the historic surrounds and stools exist in Phase 1 but have been removed and replaced with drywall that wraps the jamb to the replacement window stop. Historic stools in Phase 2 and 3 have been removed and replaced with non-historic stools. [Figures 31, 32, 44 & 46]

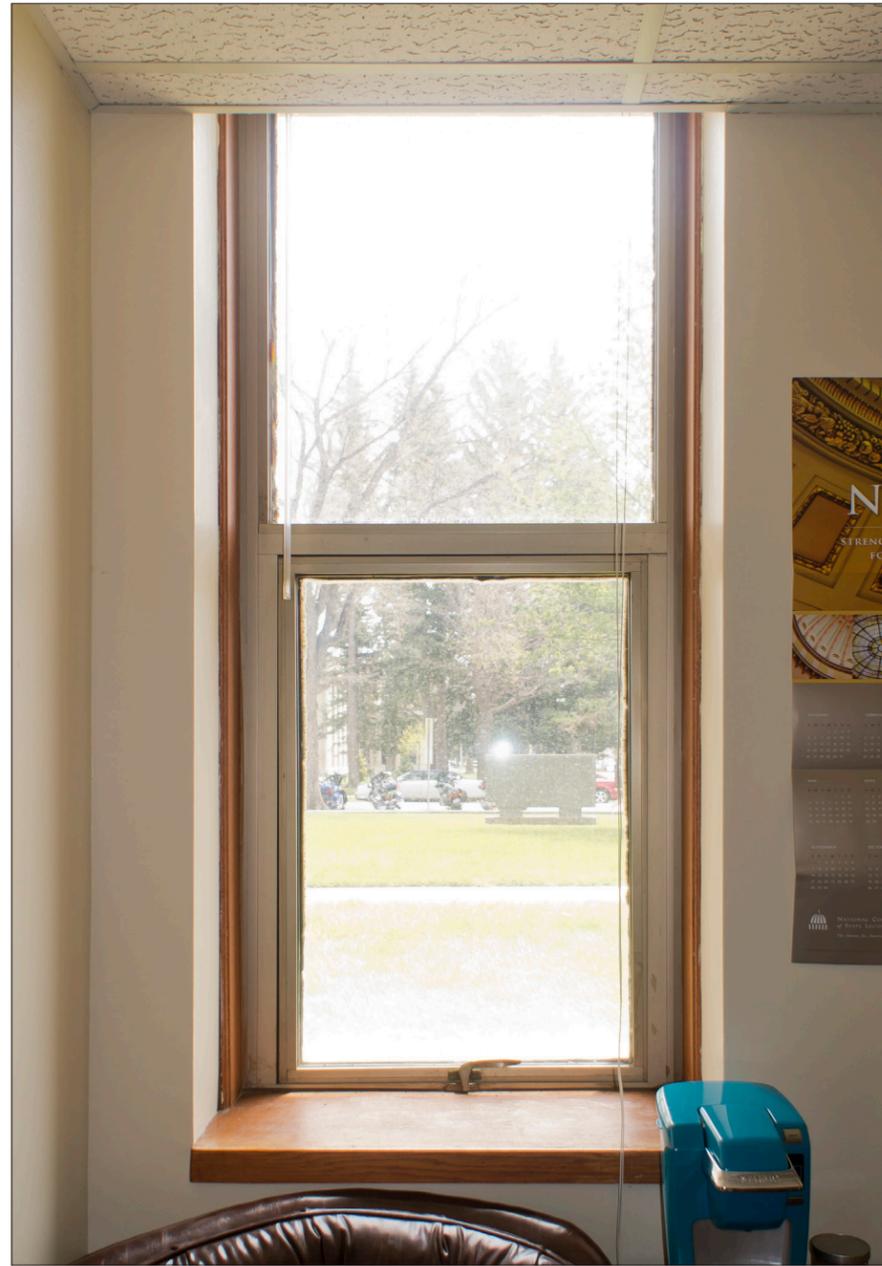
Figure 32: Garden Level Aluminum Replacement Window Unit with Operating Awning Sash [Window S-025B]. Historic surrounds are not present at Phase 2. Note drywall jambs, dropped ceiling, and replacement wood stool.

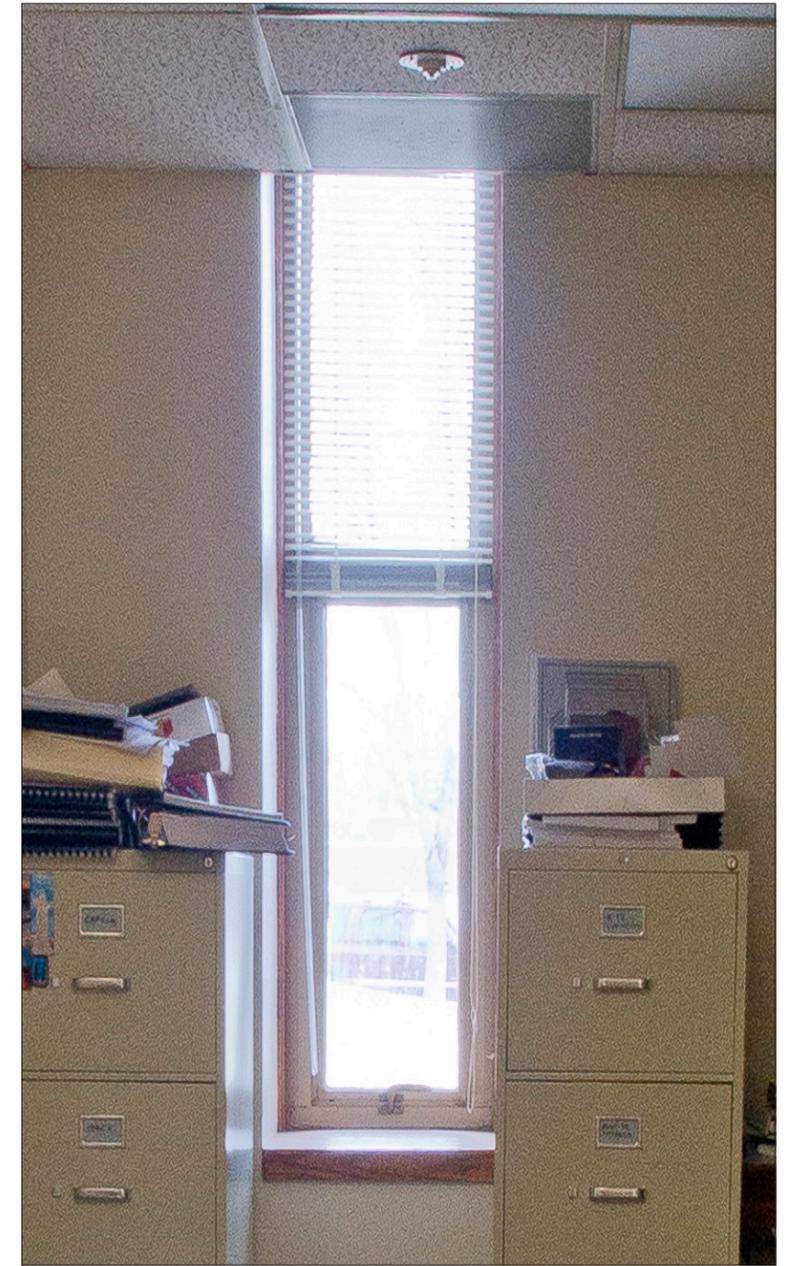
Figure 33: Garden Level Narrow Aluminum Replacement Window Unit with Operating Awning Sash [Window S-035]. Historic surrounds are not present at Phase 3. Note drywall jambs, dropped ceiling, and replacement wood stool.

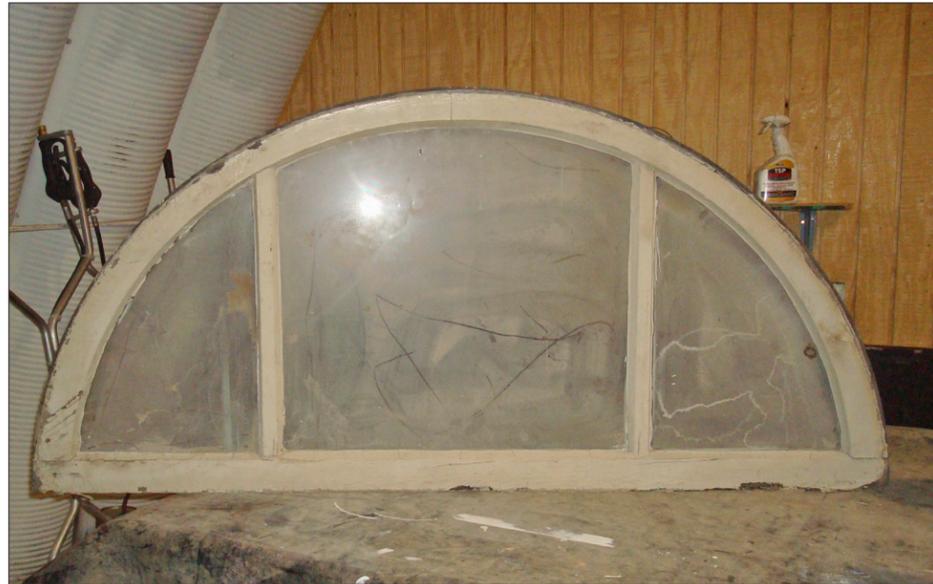
Figure 34: Historic Half-round Sash from Dome Base. Historic sash from base of dome, stored in Fort Collins. Note the Half-round form with 2 vertical muntins [Diocletian pattern].

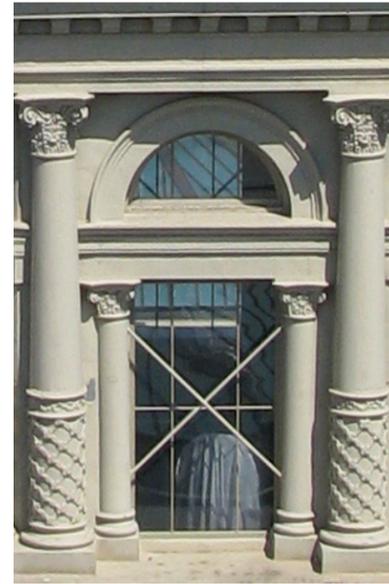
Figure 34: Half-round Sash at the Dome Base. The Half-round sash at the base of dome [700 series] and rectangular double-hung windows [600-series] were replaced with aluminum sash.
