**STATE CAPITOL REHABILITATION AND
RENOVATION / CAPITOL SQUARE PROJECT**

**SERIES 2 - WYOMING STATE CAPITOL
SD OWNER REVIEW**

**LEVEL III SCHEMATIC DESIGN REPORT
VOLUME II OF III**

SUPPLEMENTAL WINDOW PACKAGE

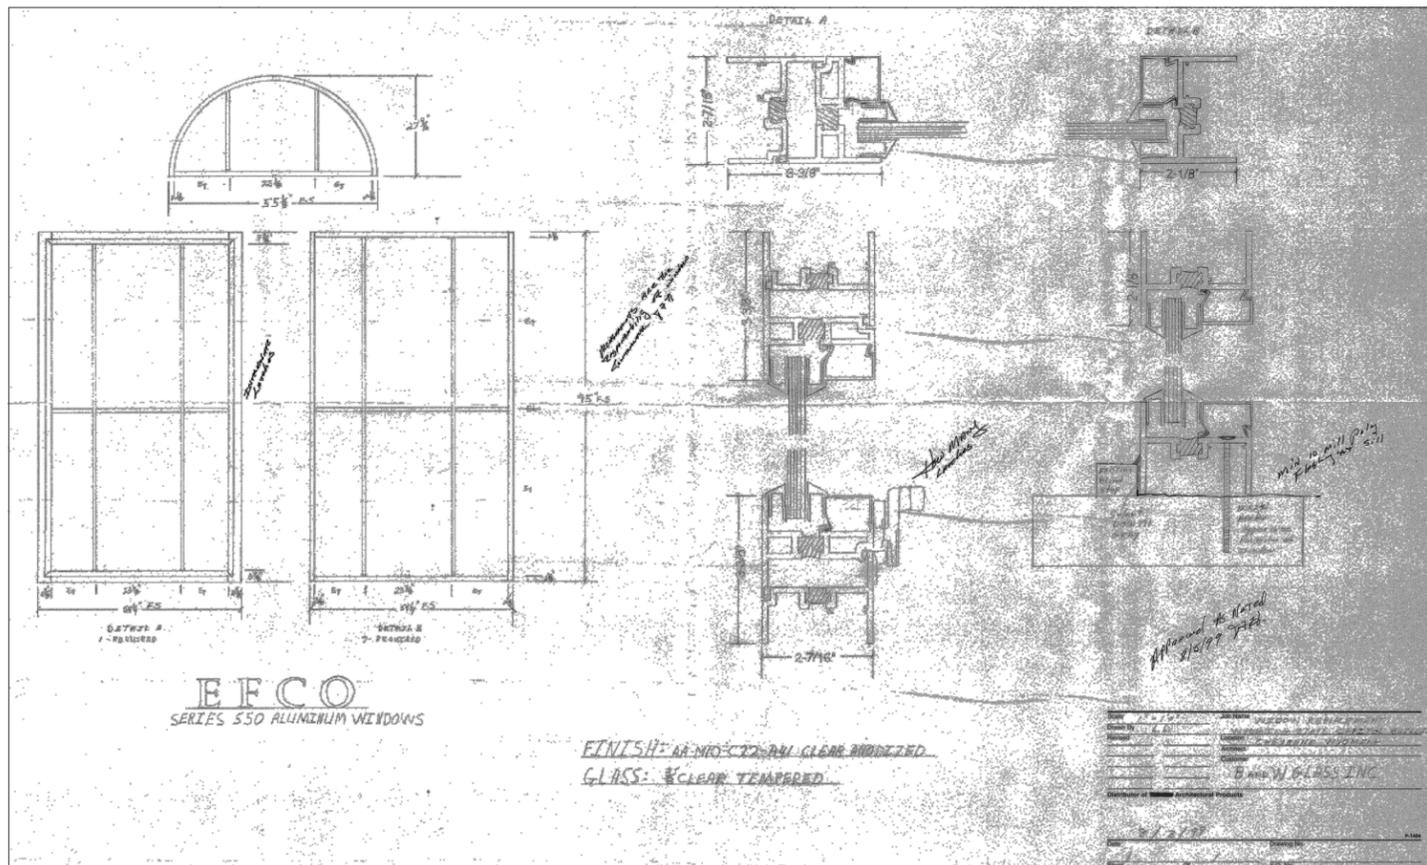
Figure 35: Shop Drawings ca. 1999, For Half-round and Rectangular Sash at the Dome Base. The drawings indicate the aluminum sash with applied muntins, manufactured by EFCO.

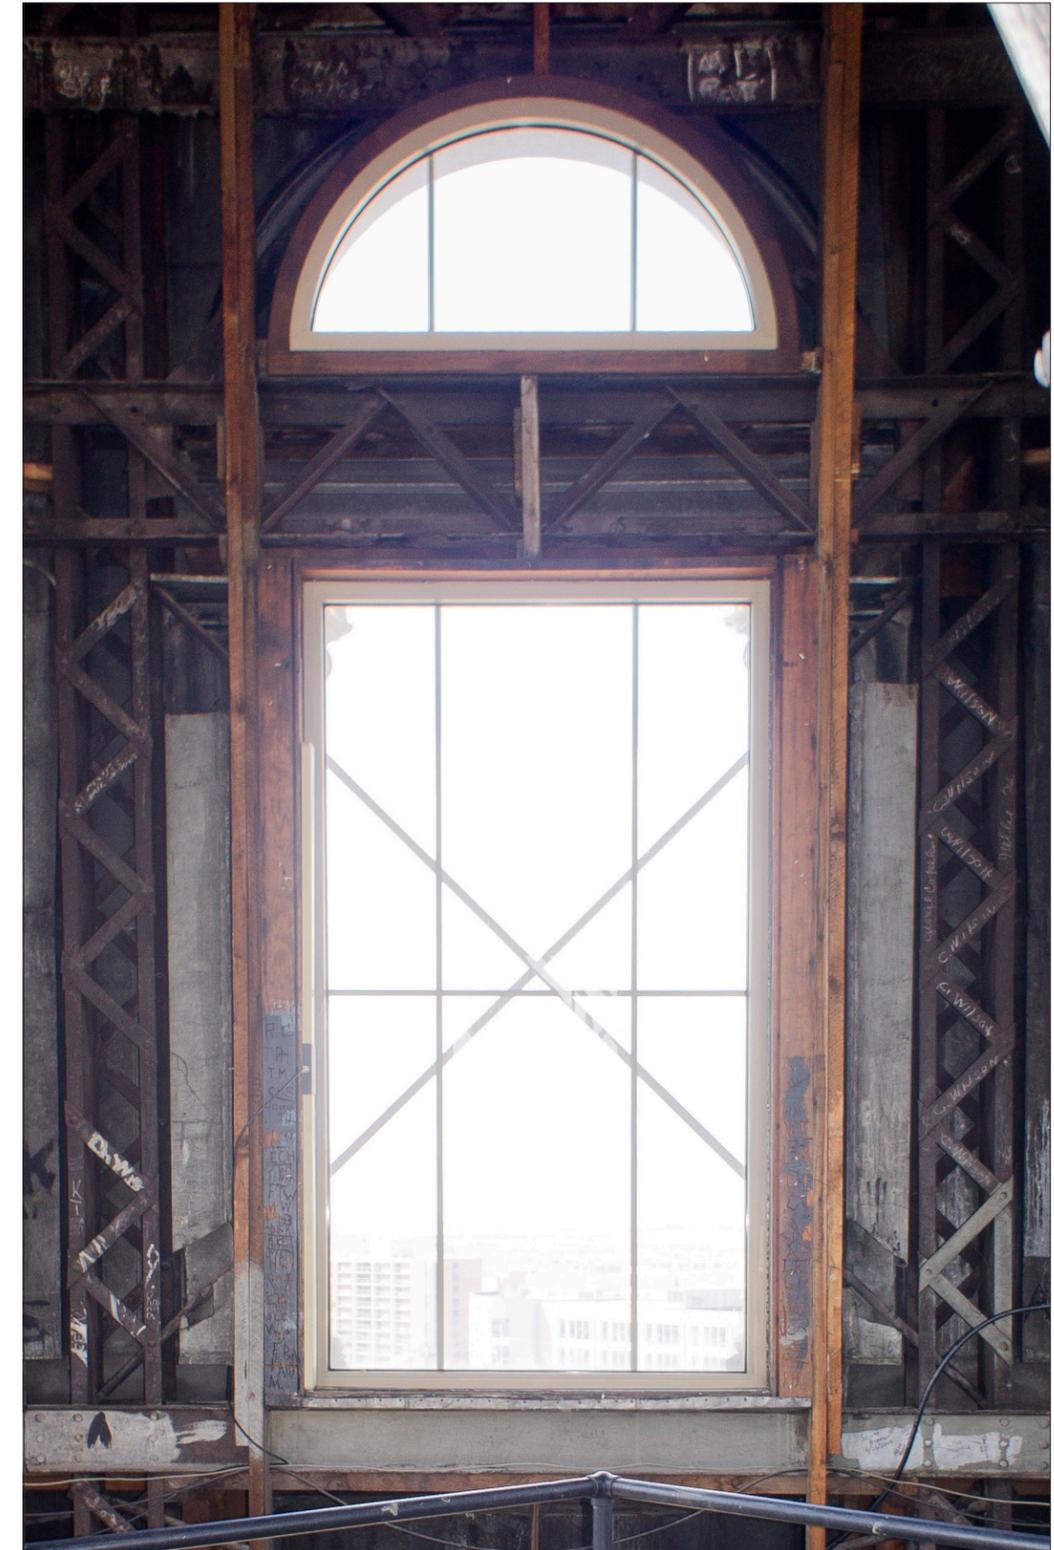
Figure 36: Half-round and Rectangular Sash at the Dome Base. The original sash has been replaced with aluminum replacement sash with applied muntins.

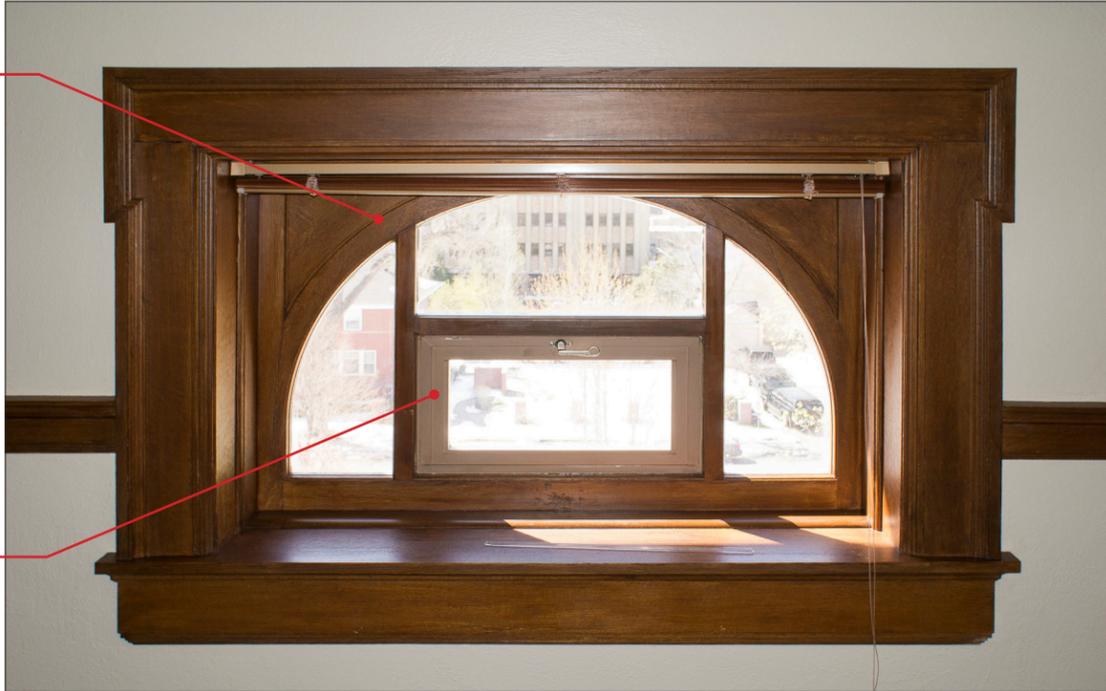
[Window Schedule Note Number 1].

[Window Schedule Note Number 3].

Figure 39: Window Number S-301. The exterior of original sash and frame are covered with metal cladding, visible from interior [Window Schedule Note Number 1]. Note modified sash components with wood muntins and operable metal sash [Window Schedule Note Number 3].

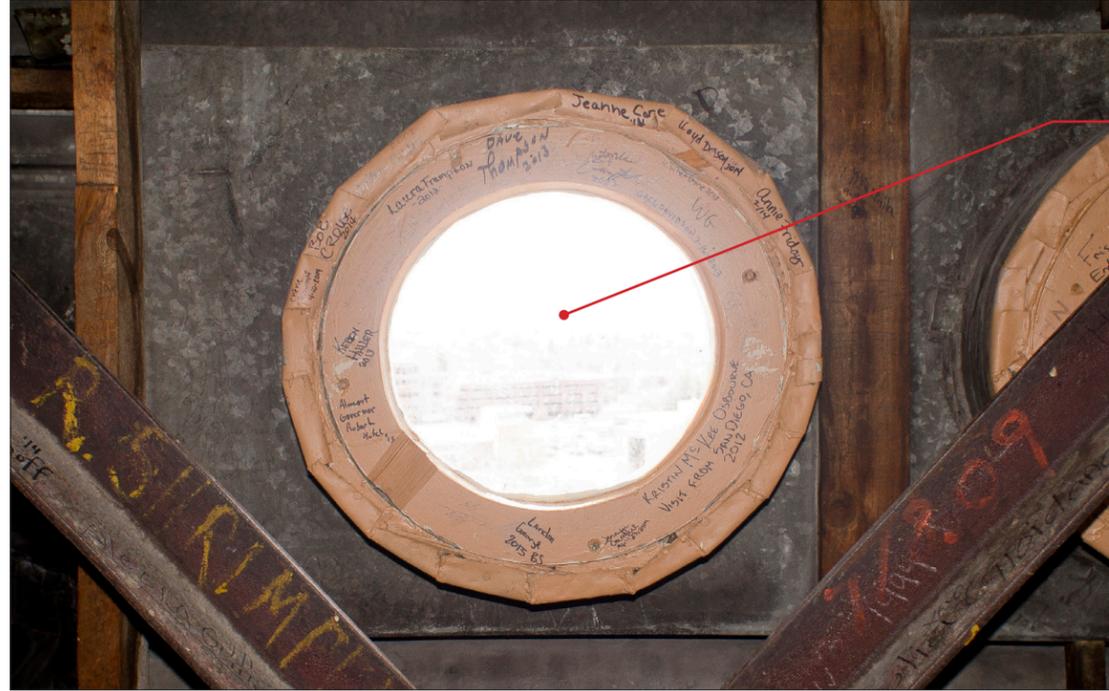
Figure 40: Round Sash at Dome 2. These are replacement fixed single-pane wood windows, attached with four screws [Window Schedule Note Number 11].

1. Third Floor and Third Floor Clerestory Windows – 300 and 400-Series:
 - Arched and circular sash are wood and appear to be original, with some modifications, including the fact that the original sash is no longer operable [Figures 11, 12, 14, 15 & 39].
2. Windows in Attic 2 – 500 Series
 - Rectangular sash appear to be original, although some openings have been modified with louvers. [Figure 41]
3. Windows in Dome 1 – 600 & 700 Series
 - Rectangular and half-round wood sash were replaced with aluminum replacement single-paned sash in configuration similar to the original. [Figure 45]
4. Windows Below Dome Roof – 800 Series:
 - Round wood replacement sashes secured with screws from the interior [Figure 40].

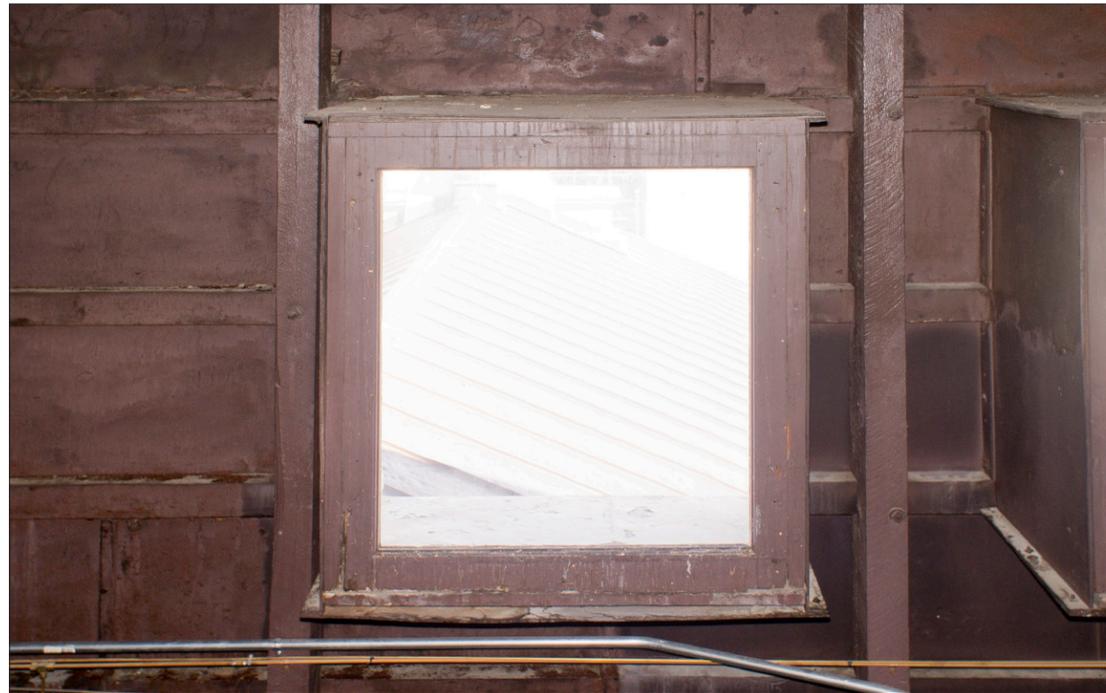
Figure 41: Rectangular Fixed Sash at the Attic 2 Level [500-Series Windows]. The wood sash appears to be original. One opening on the east elevation has been repurposed as a Roof Access Hatch. Several openings [2 on the east elevation, and all 4 on the west elevation] have been repurposed for mechanical ventilation.

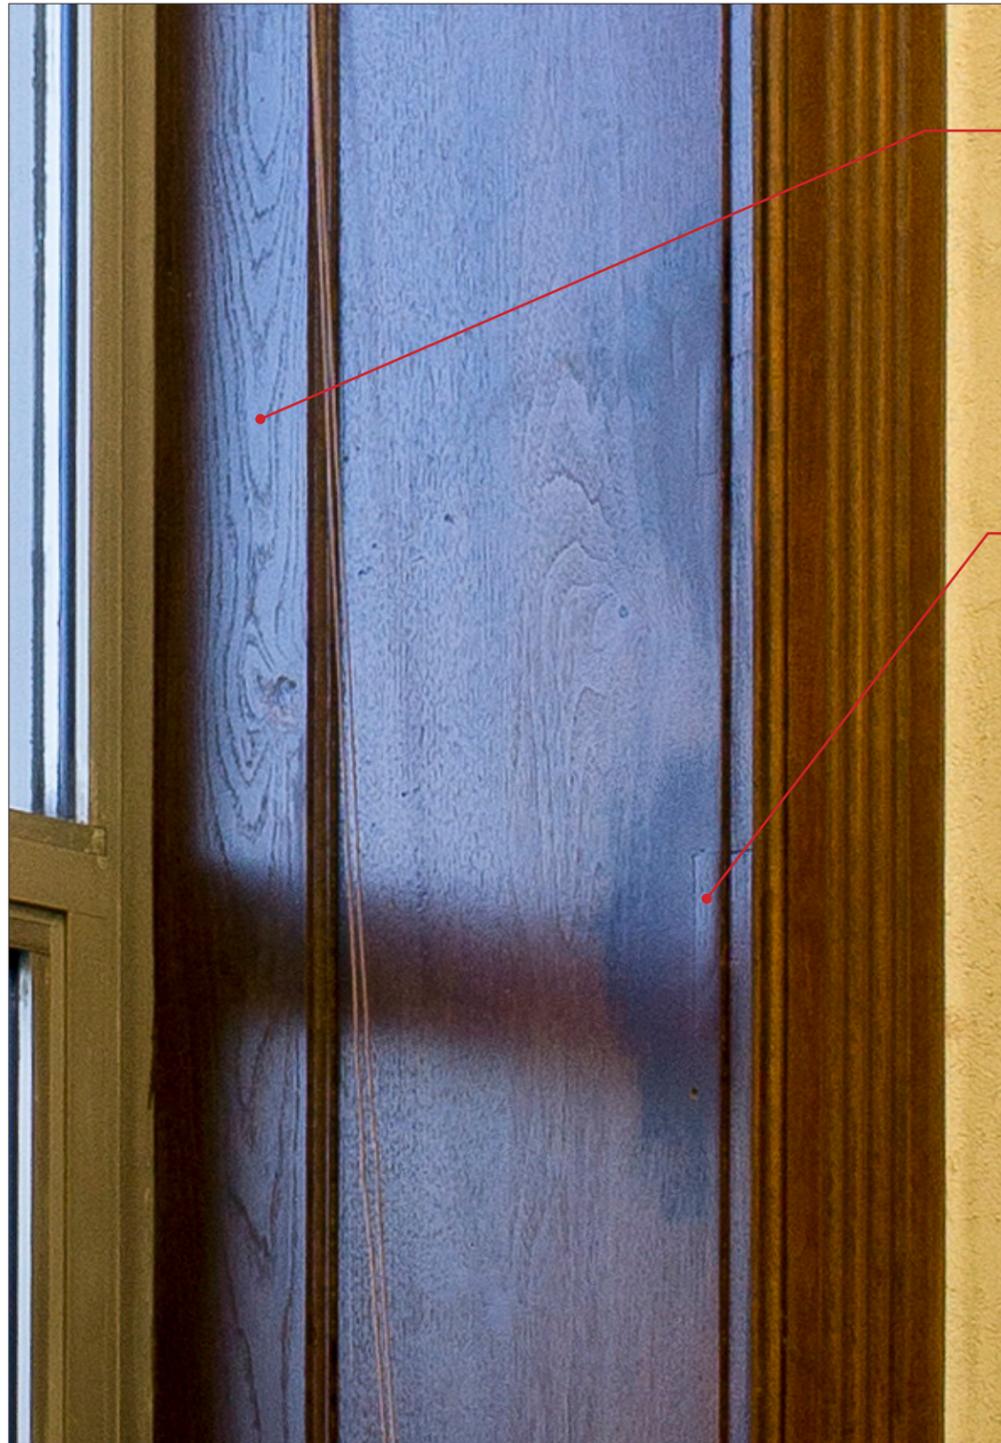
New wood sash stop at junction of replacement sash and historic trim. [Window Schedule Note Number 4].

Dutchman repairs at jambs, indicating locations of former interior shutter hardware. The hinge locations are emphasized by discoloration of the adjacent wood. [Window Schedule Note Number 8].

Figure 42: Window Number W-111. This is an example of both a replacement wood sash stop, as well as dutchman repairs at jambs. These conditions are called out as notes number 4 and 8 respectively, in the window schedule notation key.

1. Window heads are hidden by dropped acoustic tile ceilings or drapery pockets in most locations. [Figures 24, 27, 30 & 46]
2. Window surrounds and interior frames appear to be historic and original to the construction date of their phase, with the exception of the new wood sash stop added at the junction of aluminum replacement sash and historic trim. [Figure 42].

3. At the First Floor and Second Floors of Phase 1 and 2, Dutchman repairs at the jambs indicate locations of former interior shutter hardware. [Figure 42]

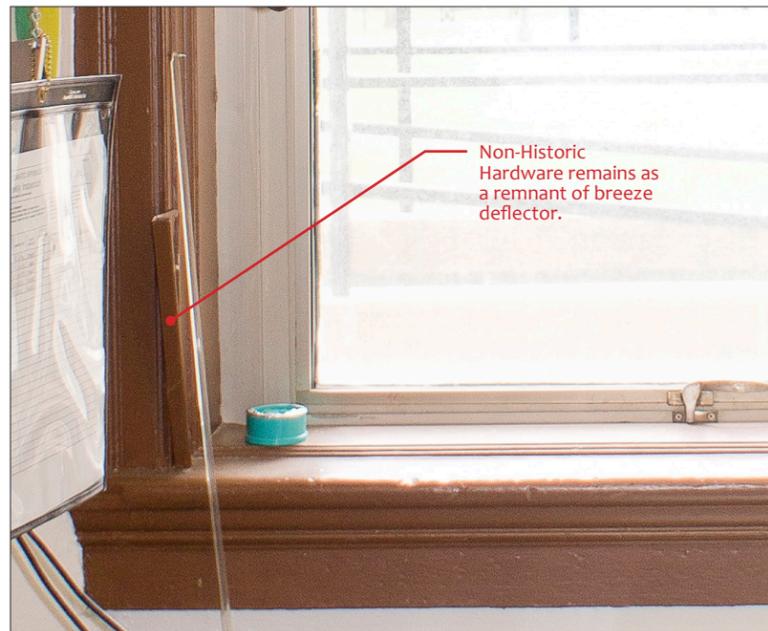
Non-Historic Hardware remains as a remnant of breeze deflector.

5. At the Garden Level, there is evidence of non-historic hardware to hold former glass pane to deflect breezes. [Figure 43]
6. Condition:
 - a. A minimal pattern of water staining at the interior stools indicates that this is probably a result of condensation due to indoor/outdoor temperature differential, rather than the result of an active leak. [Figure 47]

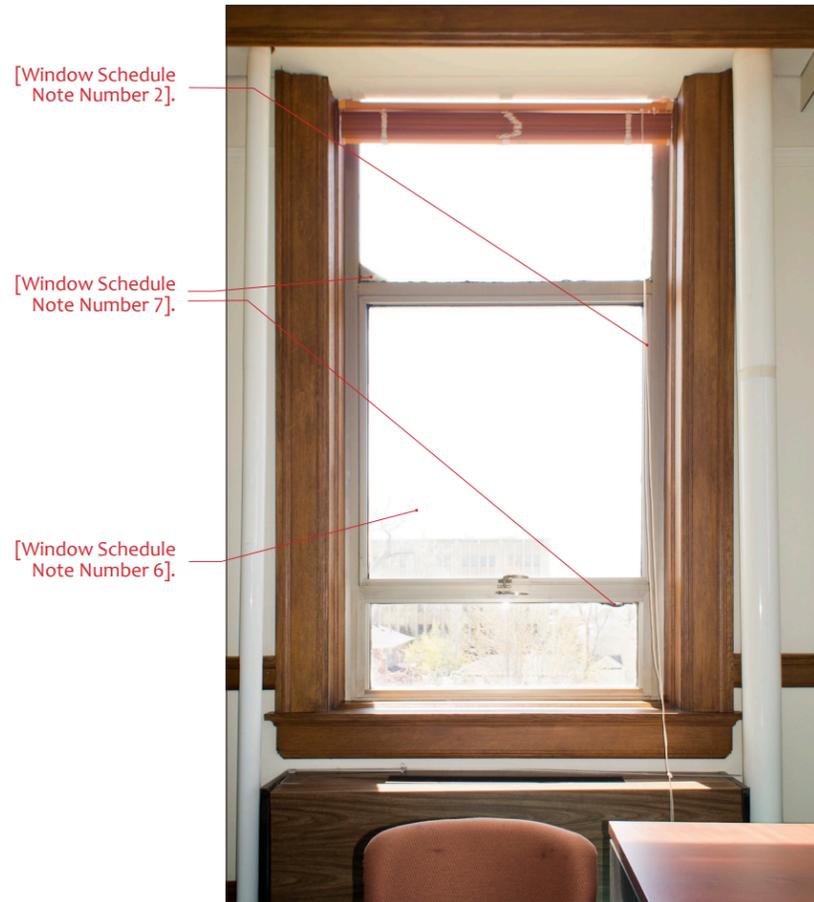
[Window Schedule Note Number 2].

[Window Schedule Note Number 7].

Figure 44: Garden Level Aluminum Replacement Window Unit with Operating Awning and Hopper Sashes. Note extruded metal sash and frame [Window Schedule Note Number 2], double-paned replacement windows [Window Schedule Note Number 6], failing seals and resulting condensation between insulated glass panes at sash [Window Schedule Note Number 7].

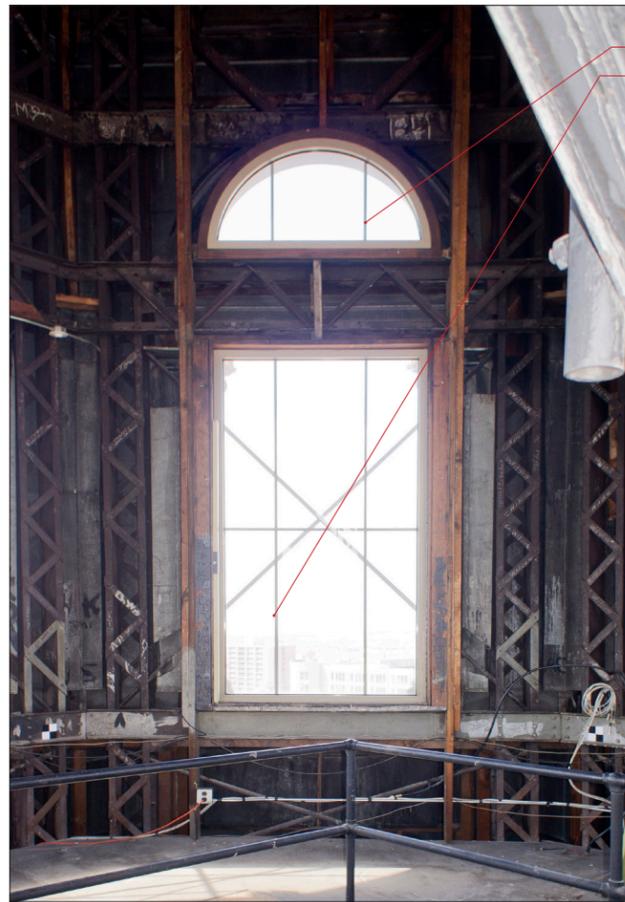
[Window Schedule Note Number 10].

Figure 45: Half-round and Rectangular Sash at Dome 1. Note replacement aluminum windows with single-pane glass and applied exterior muntins [Window Schedule Note Number 10].

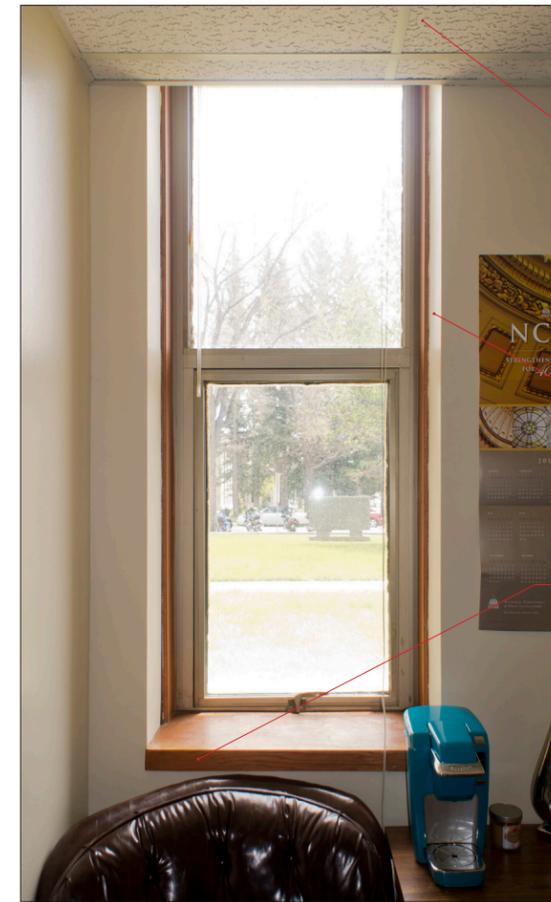
[Window Schedule Note Number 14].

Figure 46: Photograph of window number S-025B showing dropped acoustic ceiling tile [Window Schedule Note Number 14] and drywall jambs [Window Schedule Note Number 13] and replacement wood stool [Window Schedule Note Number 12].

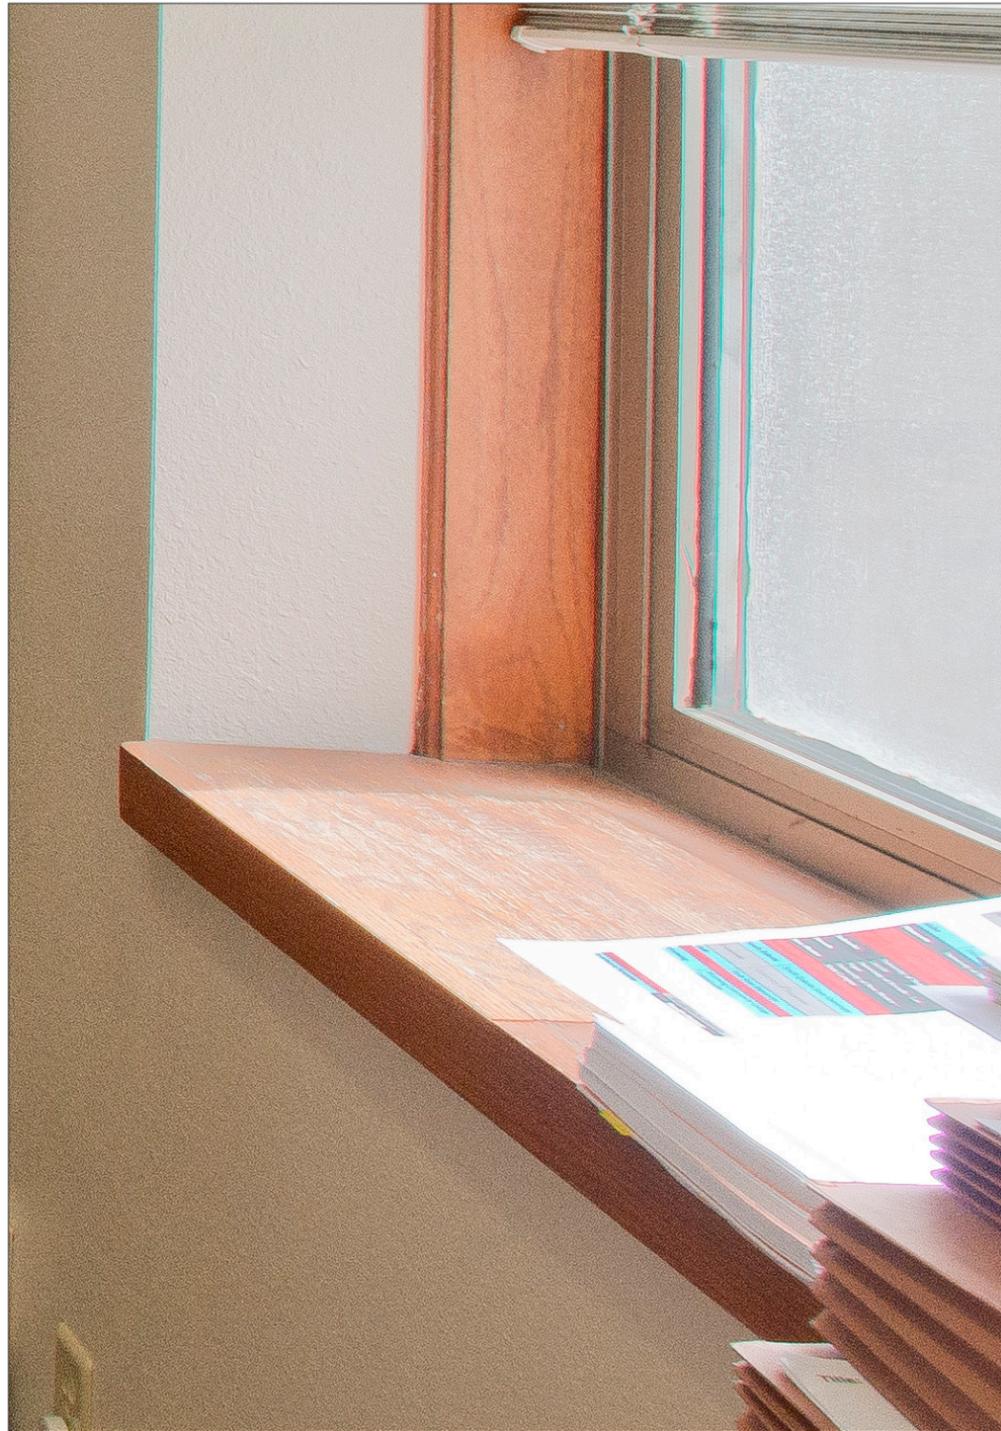
Figure 47: Window Number S-029. Note slight water staining at sill, probably as a result of condensation due to indoor/outdoor temperature differential, rather than the result of an active leak.

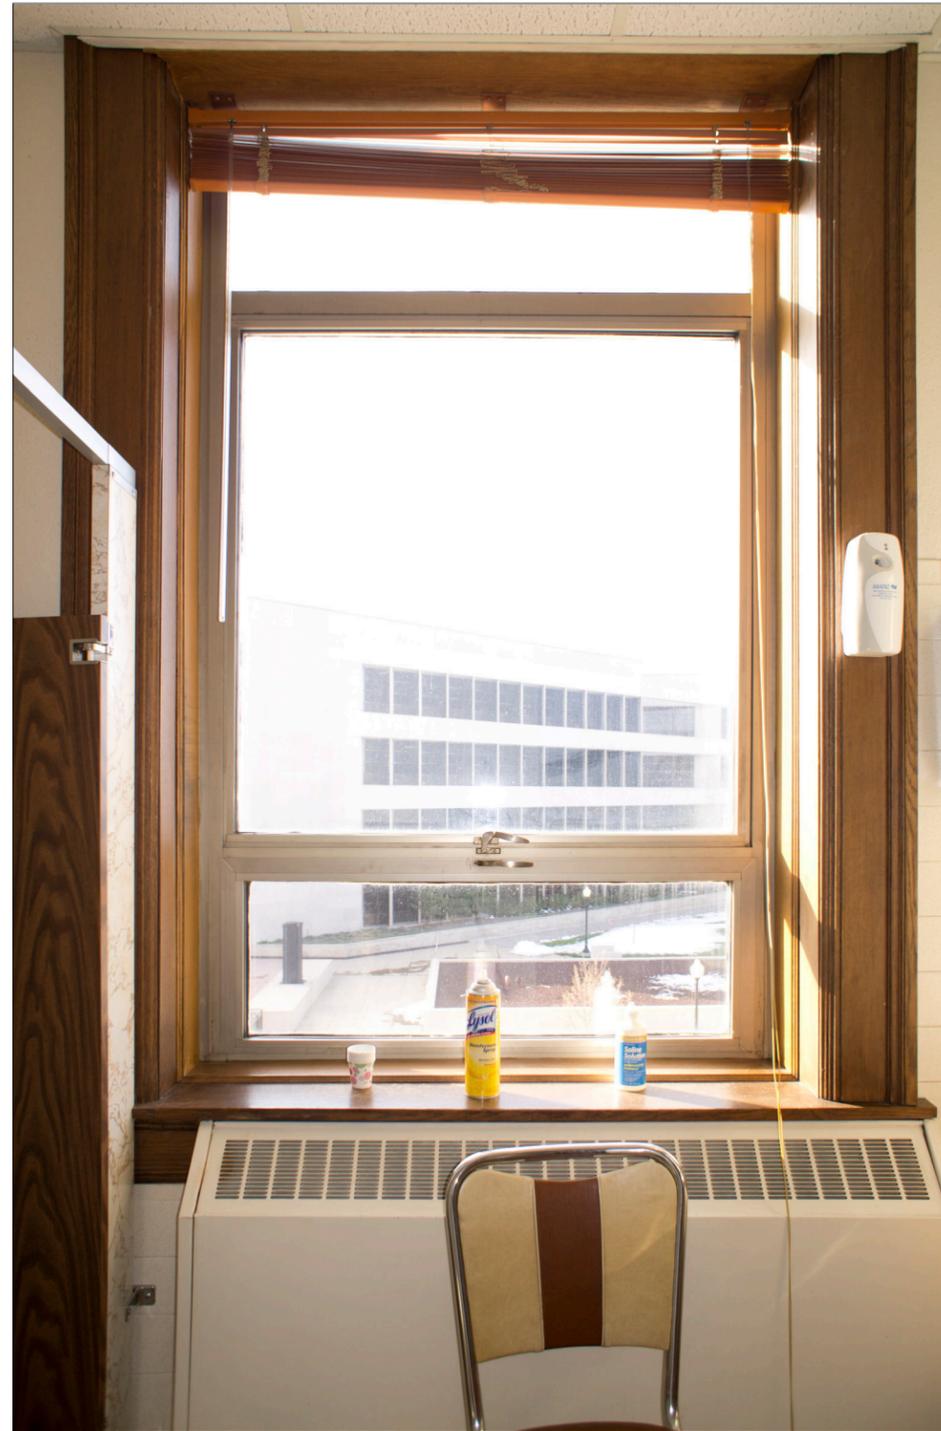
Figure 48: Window Number N-241 [Room H6.2]. Note modifications to sill to accommodate bathroom partition and items fastened to interior trim.

- b. No indication of damage from water infiltration was observed.
7. Interior Stools have been notched and items fastened to jamb trim to accommodate bathroom partitions at 2 restrooms on the Third Floor [Room LR, Room UR], and 2 restrooms on the Second Floor [10.1, Room H6.2]. [Figure 48].

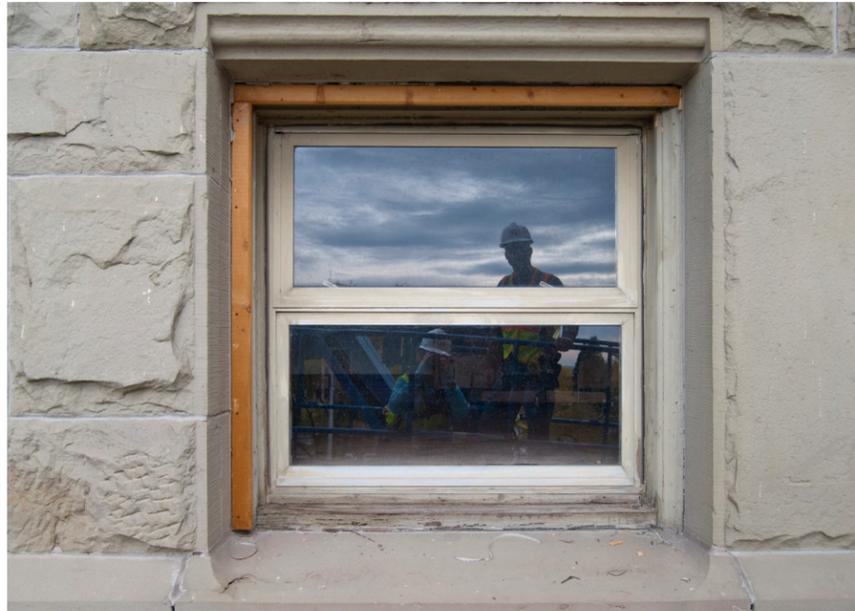
Figure 49: Window Number S-309, Exterior Window Exposure. Profiled wood frame and sill observed to be in good condition. Note that the bright-colored wood was added at the time that aluminum cladding was added to the frames.

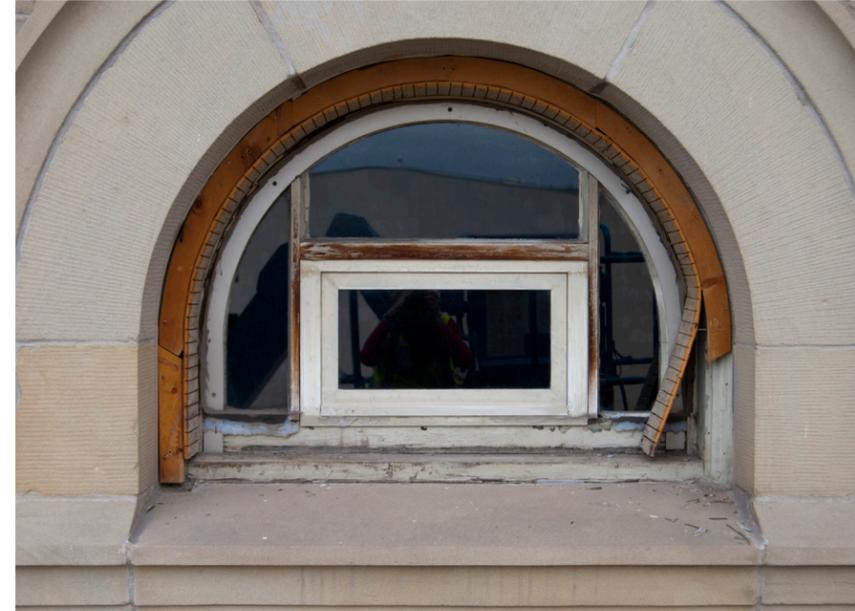
Figure 50: Window Number N-344, Exterior Window Exposure. Profiled wood frame and sill observed to be in good condition. Note that the bright-colored wood was added at the time that aluminum cladding was added to the frames.

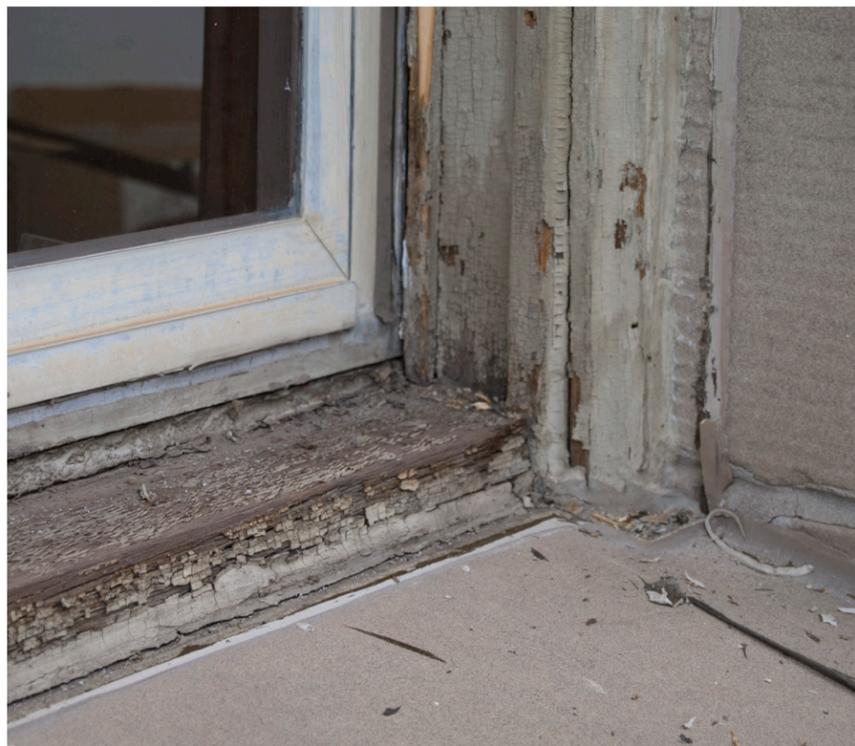
Figure 51: Window Number E-331, Exterior Window Exposure. Profiled wood frame and sill observed to be in good condition
