**STATE CAPITOL REHABILITATION AND  
RENOVATION / CAPITOL SQUARE PROJECT**

**SERIES 2 - WYOMING STATE CAPITOL  
SD OWNER REVIEW**

**LEVEL III SCHEMATIC DESIGN REPORT**  
**VOLUME III OF III**

**SUPPLEMENTAL DOOR PACKAGE**  
December 19, 2014

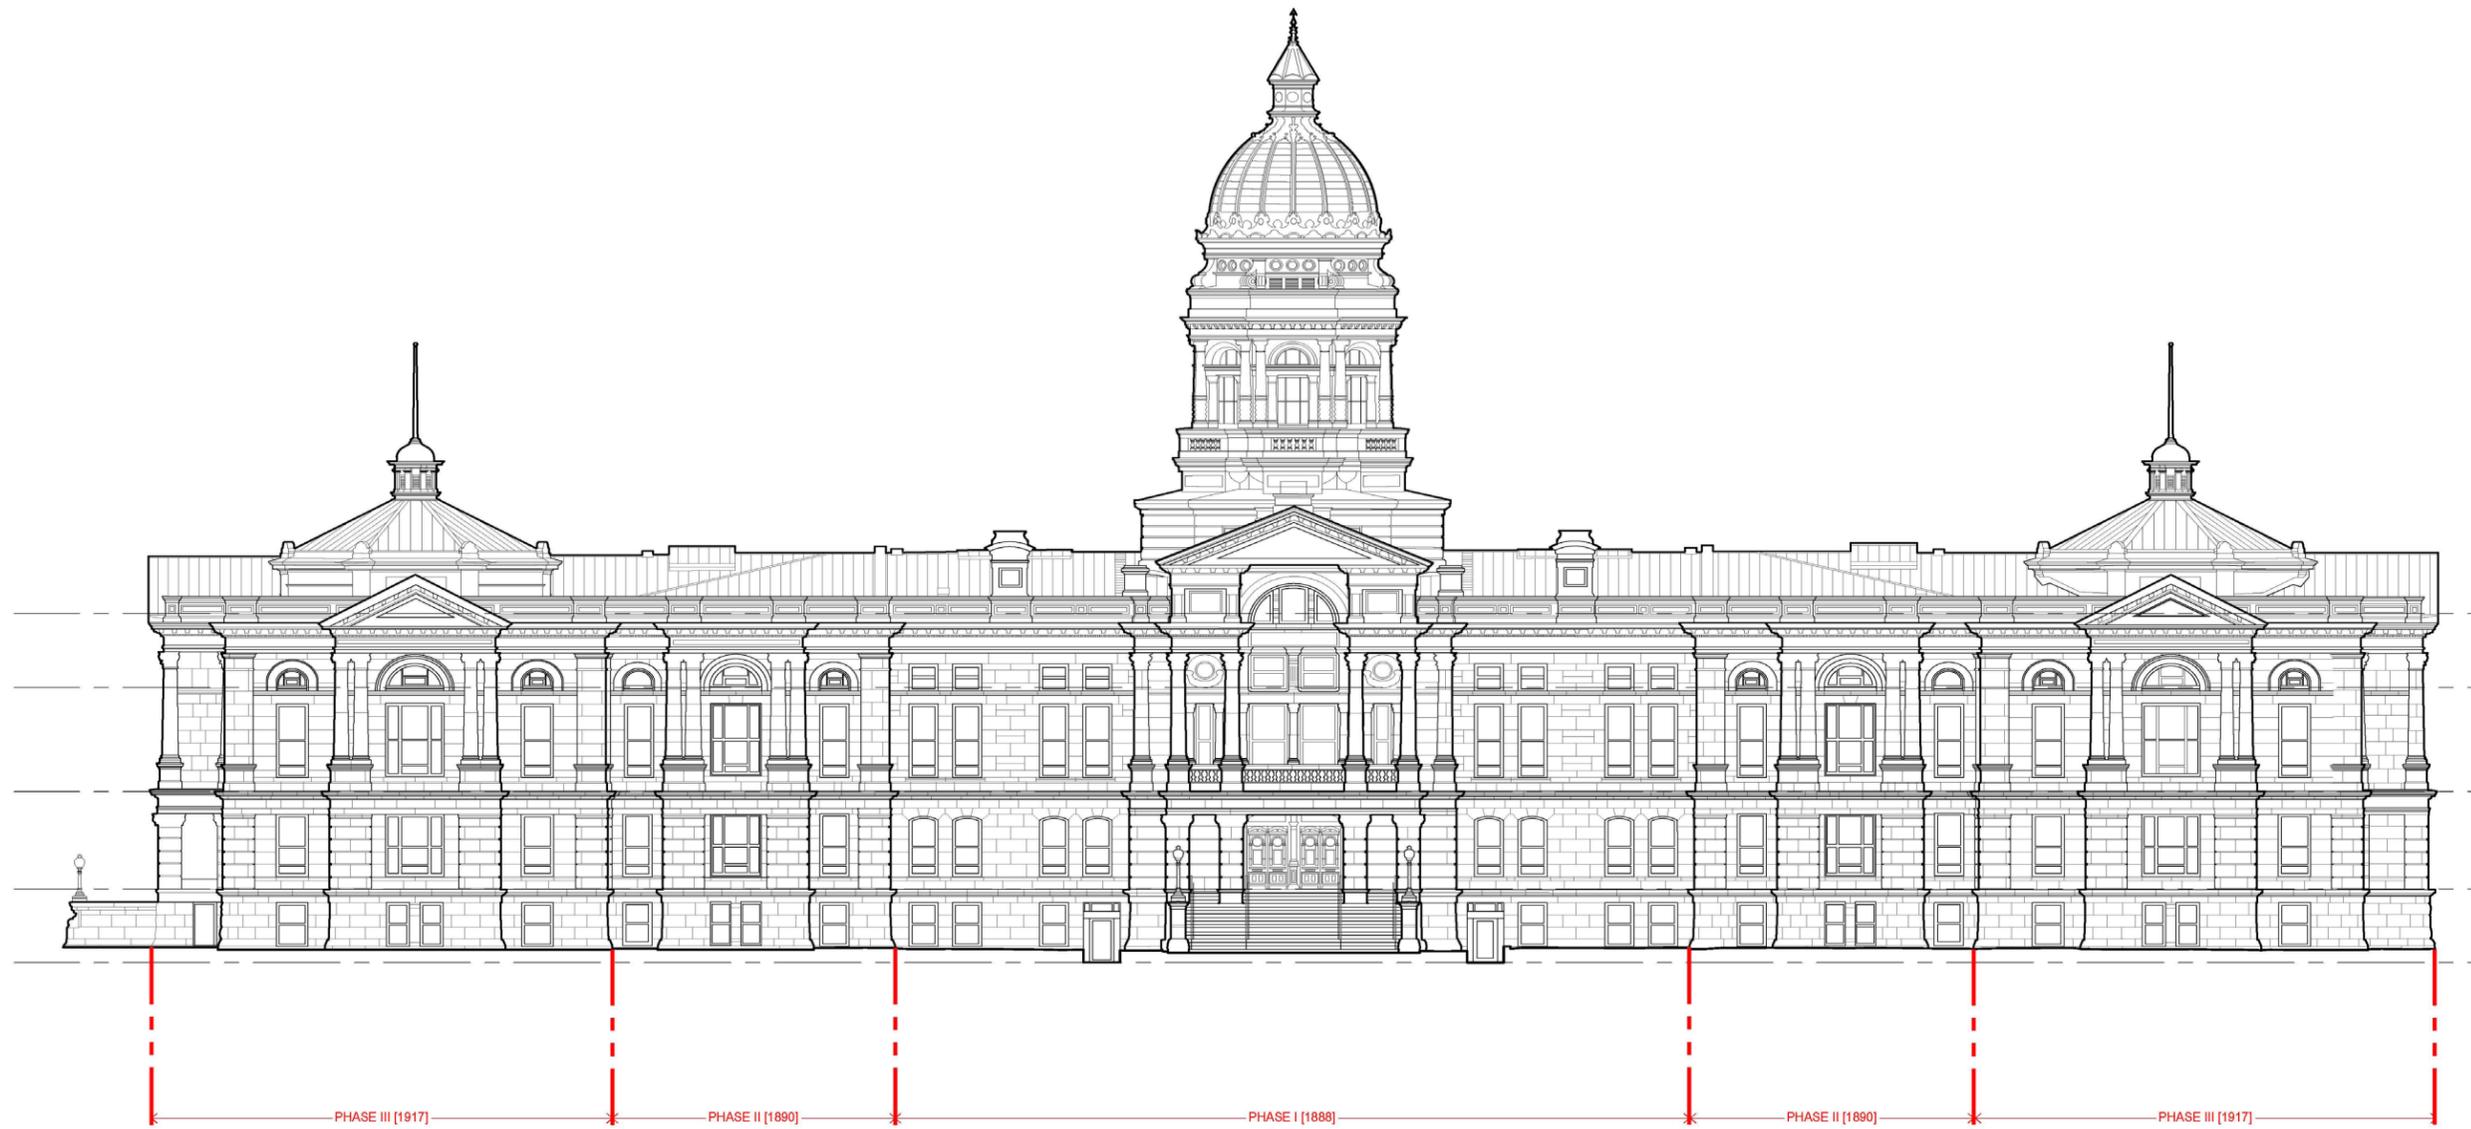
Figure 1: Diagram displaying the building construction phases.

The Design Team has discerned the following chronology [Figure 1]:  
[Refer to Figures 17-20 for floor plans indicating Room and Door Numbers].

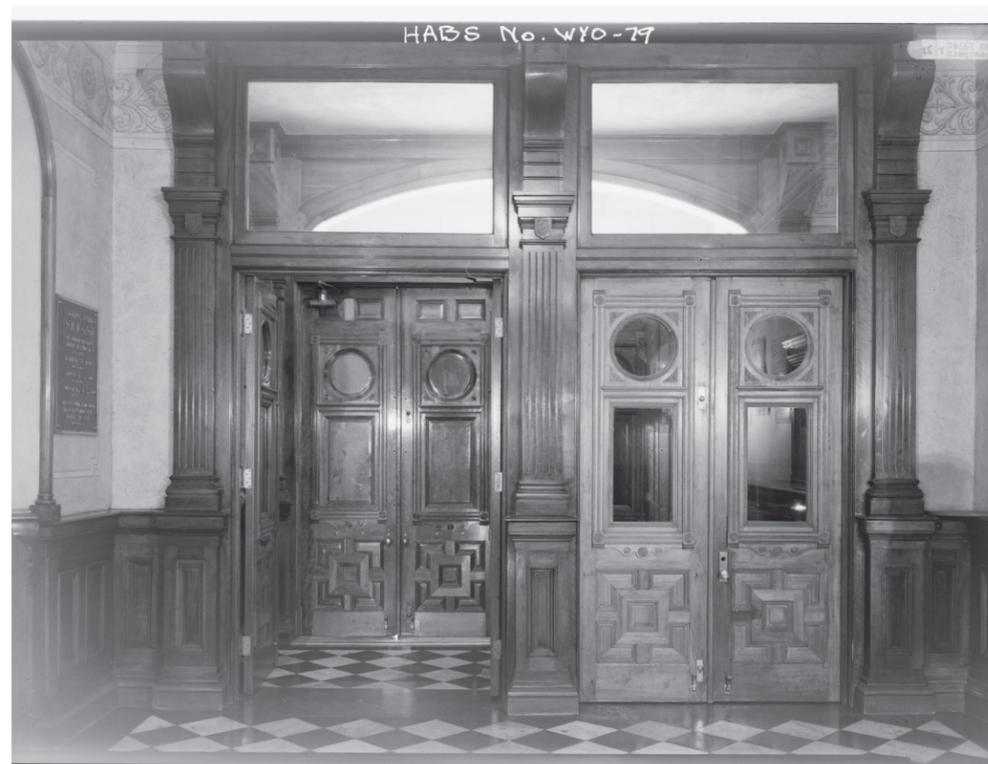
Figure 4: Historic Photograph of the Interior of the South Monumental Doors

The monumental wood doors at the south and north entrances and vestibules appear to be original and reflect what is shown in the 1888 Gibbs drawings. [Figures 2, 4 & 7]

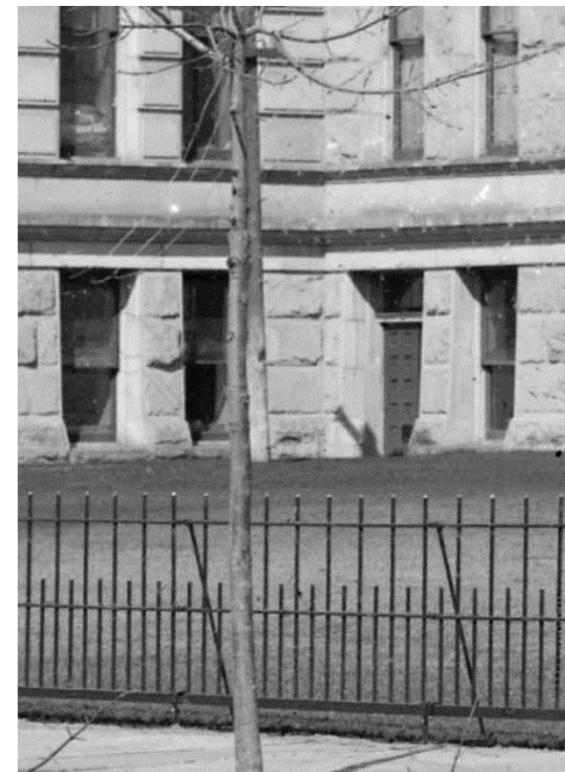
Figure 5: Historic Photograph from the Southeast Showing a Paneled Garden Level Door.

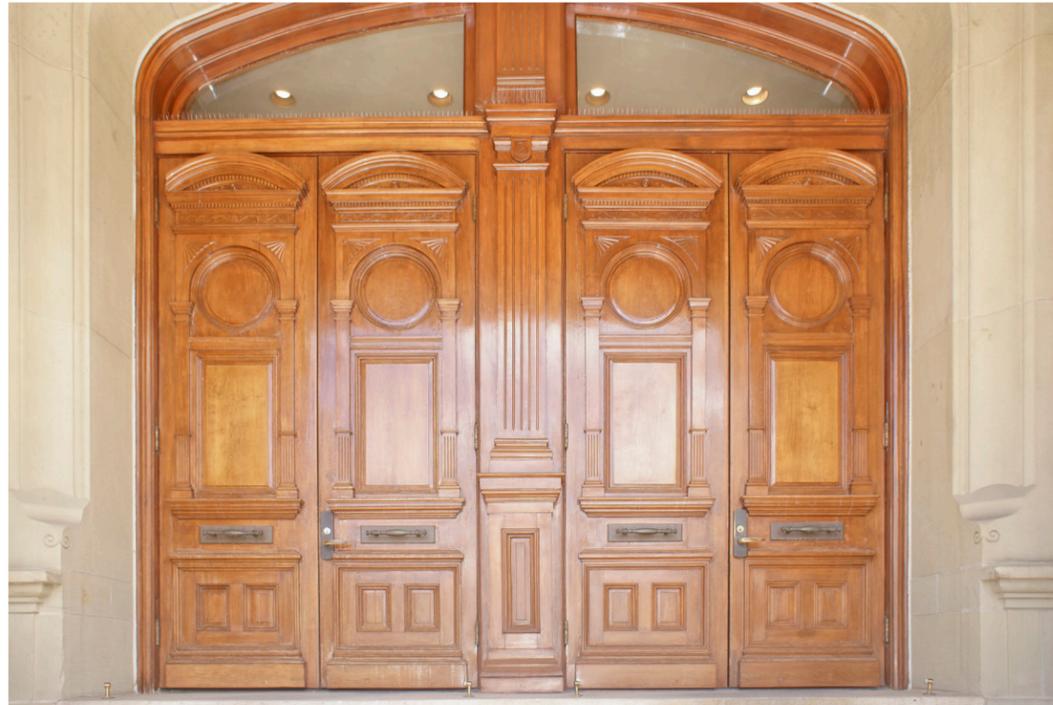
Figure 6: Existing South Entry [Exterior View].

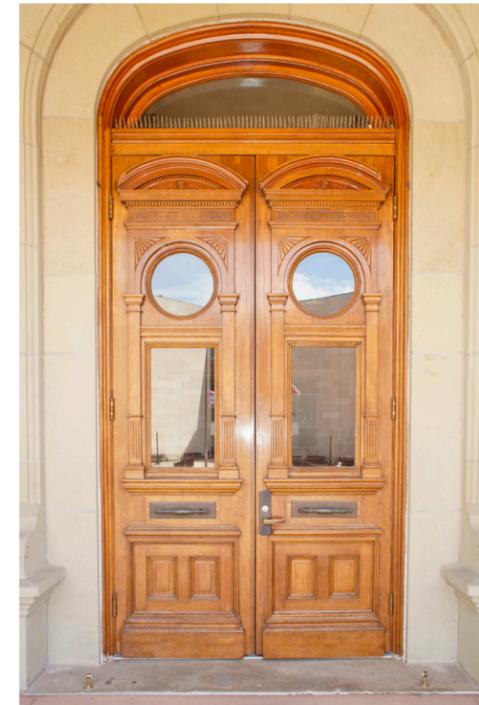
Figure 7: Existing North Entry [Exterior View].

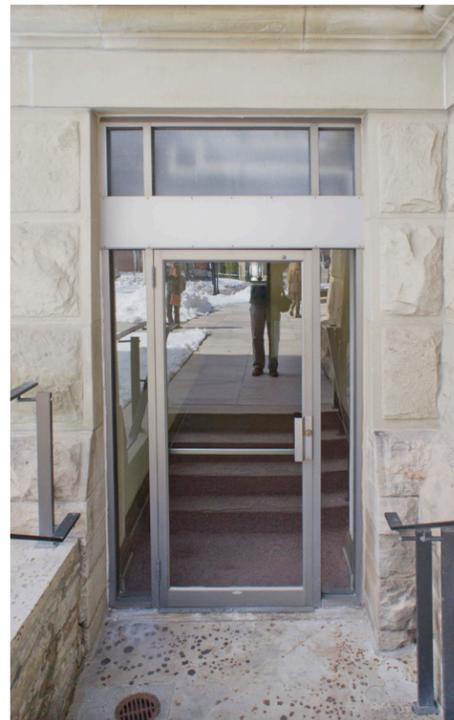
Figure 8: Existing South Garden Level Doors

The above-described arrangement is repeated for the single pair of doors at the north entry with the exception that the circular and rectangular panels are glass, rather than wood, for both the interior and exterior doors. [Figure 8].

HABS photographs indicate that the four exterior doors in the 1888 portion were replaced with aluminum framed “storefront” units sometime prior to 1979. [Figures 8 & 9]

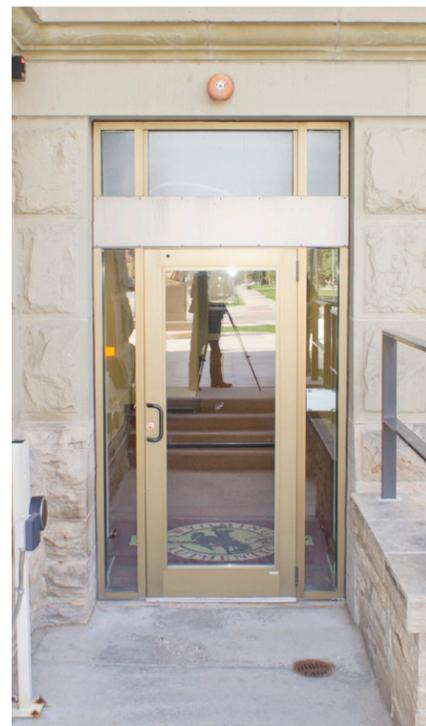
Figure 9: Existing North Garden Level Doors

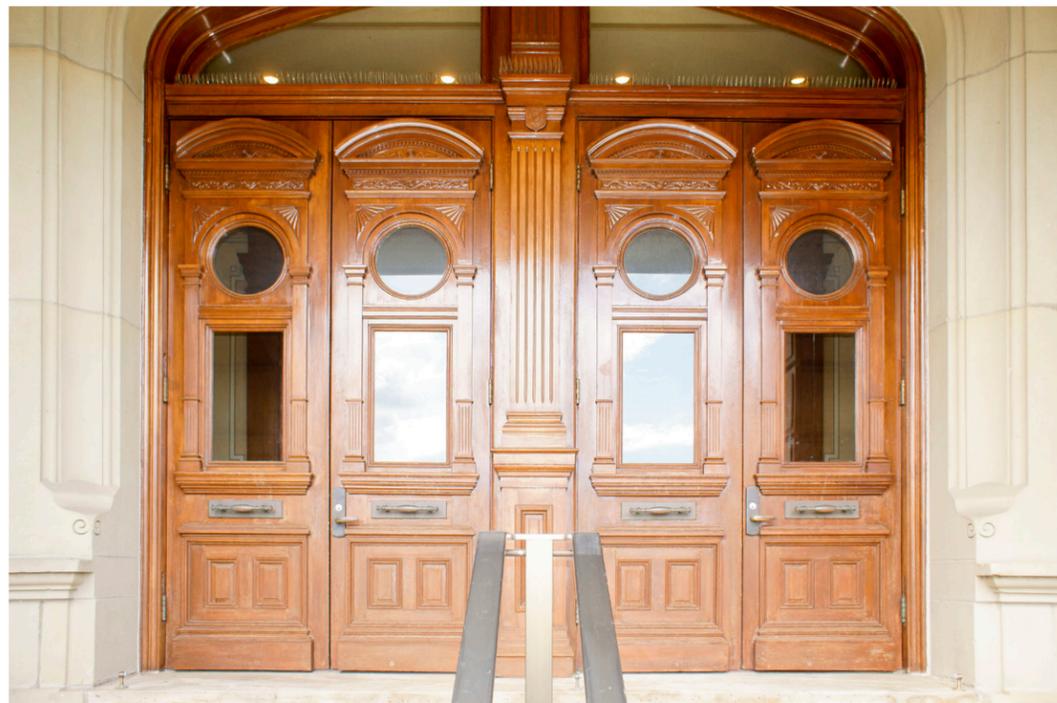
Figure 10: Existing West Entry [Exterior View].

These two sets of paired doors at the west entry reflect the same design and detailing as the doors at the south and north monumental doors. However, the circular and rectangular panels are glass for both the interior and exterior doors. [Figure 10]

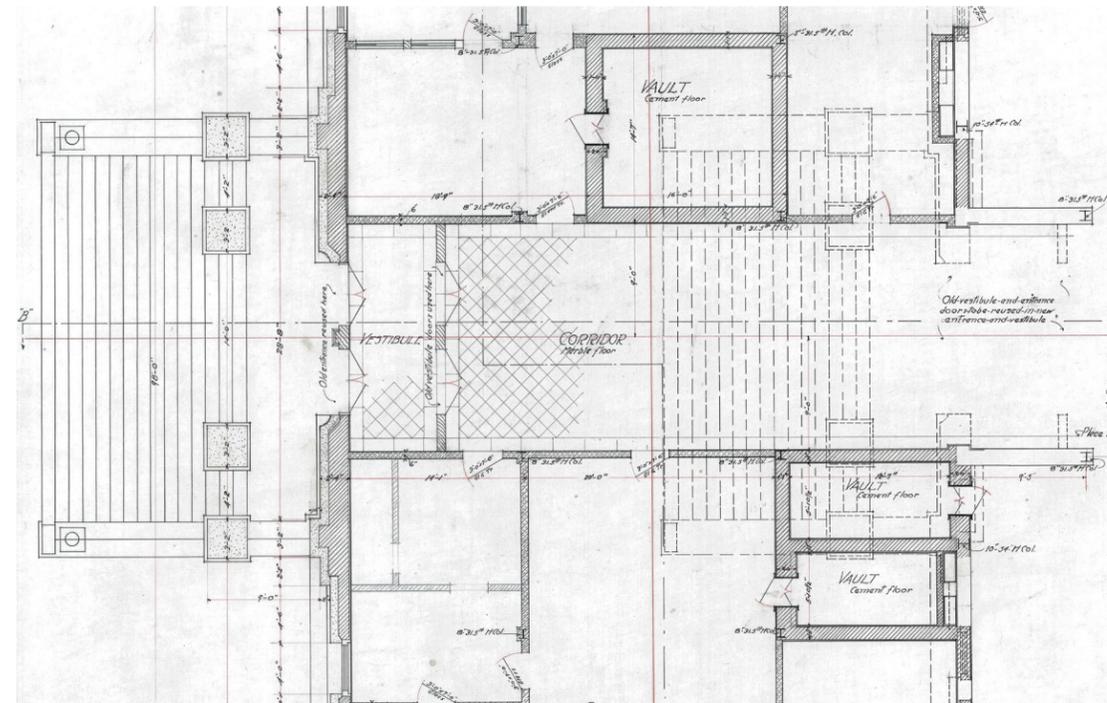
Figure 12: Historic Plan Showing First Floor West Entry.

The 1915 drawings indicate a door within the north cheekwall of the west entry stairs, and a window on the south cheekwall. The 1890s drawings do not indicate any openings within the cheekwalls of the west stair.

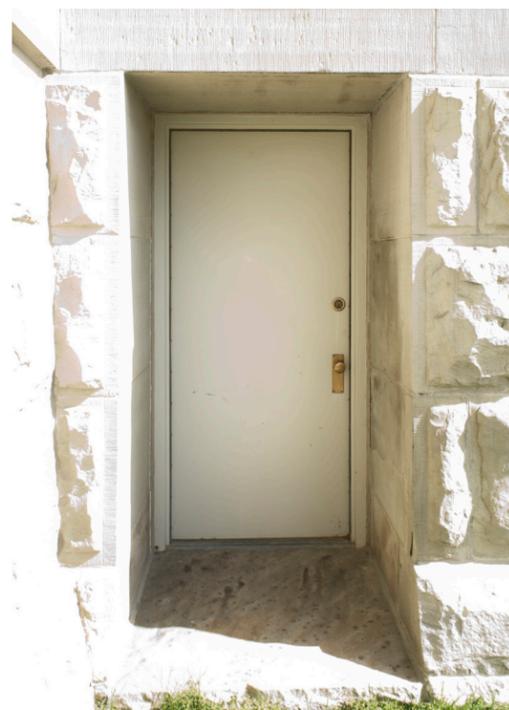
Figure 11: Existing Garden Level Door beneath West Entry Stairs.

The four exterior doors at the Garden Level in the 1888 portion were paired [2] 2'-4" x 7'-6" x 2 1/4" wood doors with a pattern of 12 raised panels with a glass transom above, as indicated by the 1888 door detail drawings and photographic evidence. [Figures 3 & 5] These doors were replaced at an unknown date by the existing glass 'storefront' doors. [Figures 10 & 11]

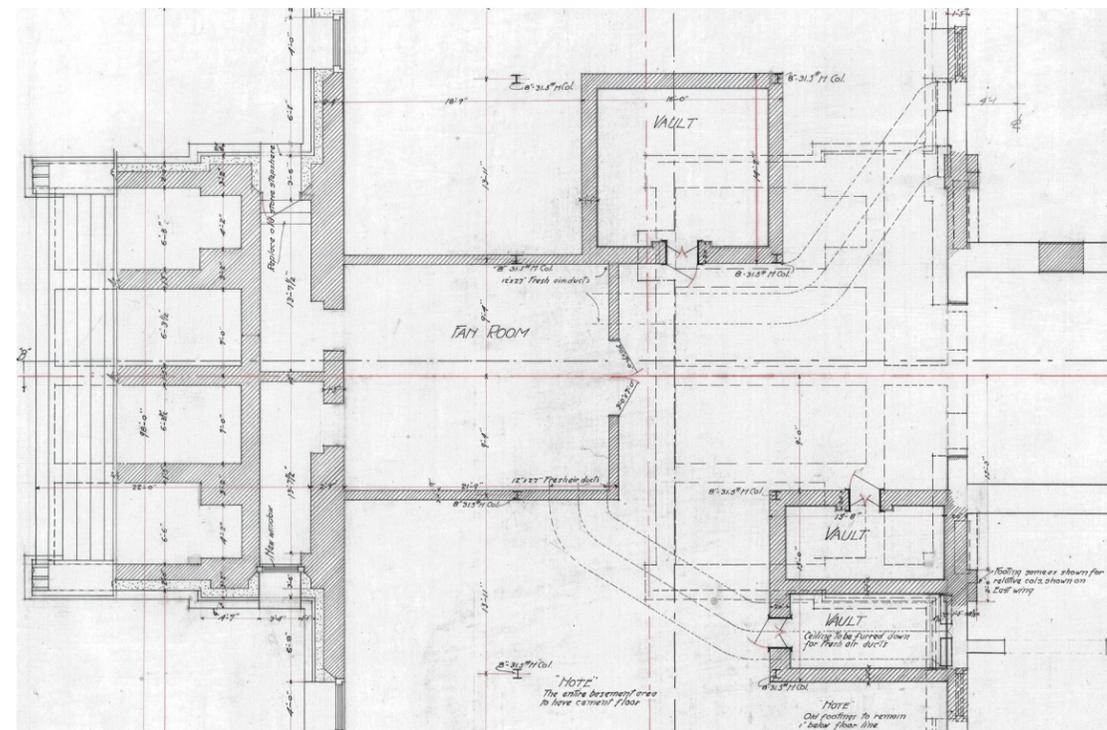
Figure 13: Historic Plan Showing Garden Level Doors at West Entry.

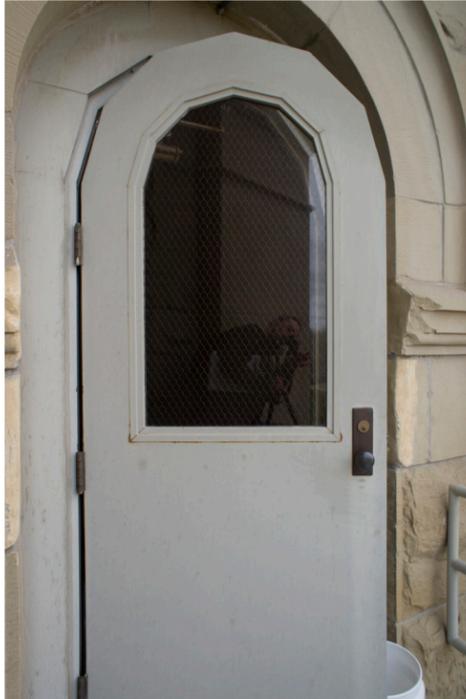
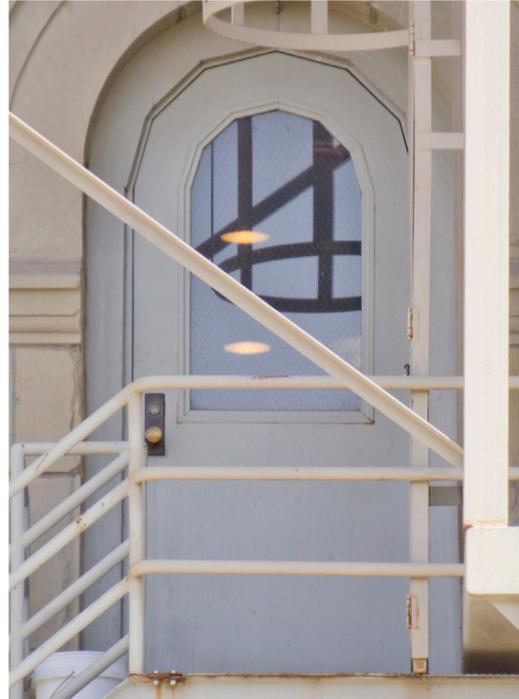
**Figure 14:** Existing Third Floor Fire Escape Doors at North Elevation. Doors [HG.c and SG.c] are located in former window openings at existing stairs at House and Senate Galleries. The doors will be replaced with windows at these locations [N-342 and N-364].

Doors at the Second and Third Floors that lead to the fire escape stairs on the north elevation were retrofitted into former window openings [Figures 14 & 15].

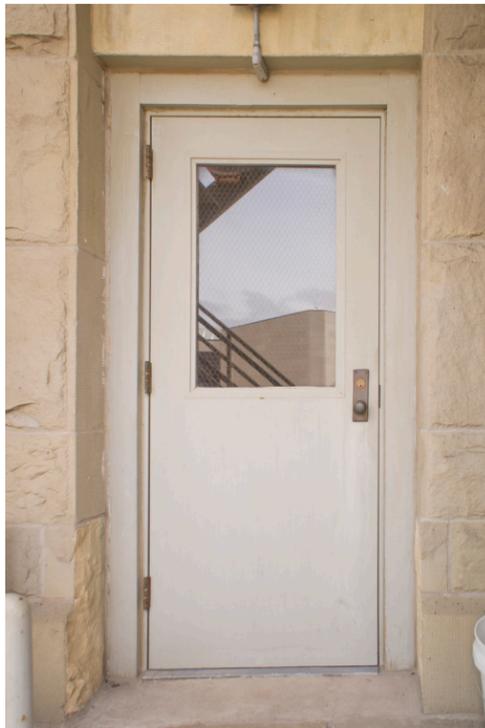
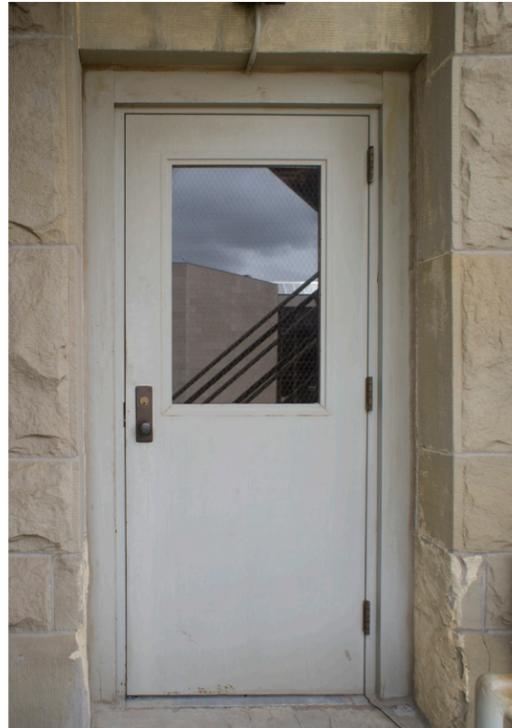
**Figure 15:** Existing Second Floor Fire Escape Doors at North Elevation. Doors [HC-WH.c and SC-EH.c] are located in former window openings at existing stairs at House and Senate Halls. The doors will be replaced with windows at these locations [N-242 and N-264].

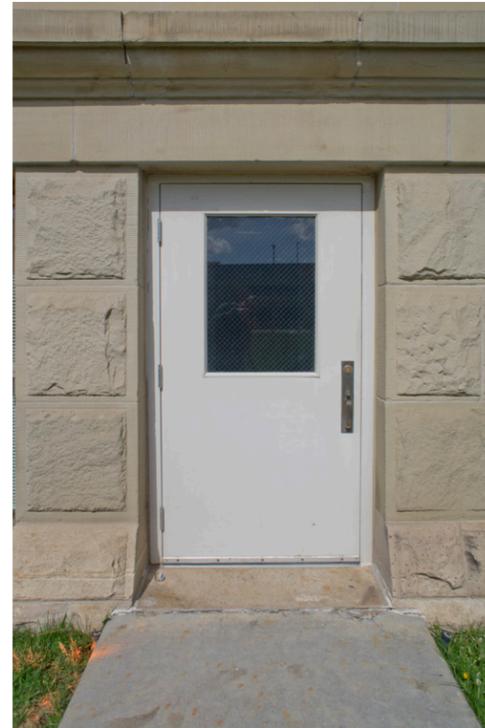
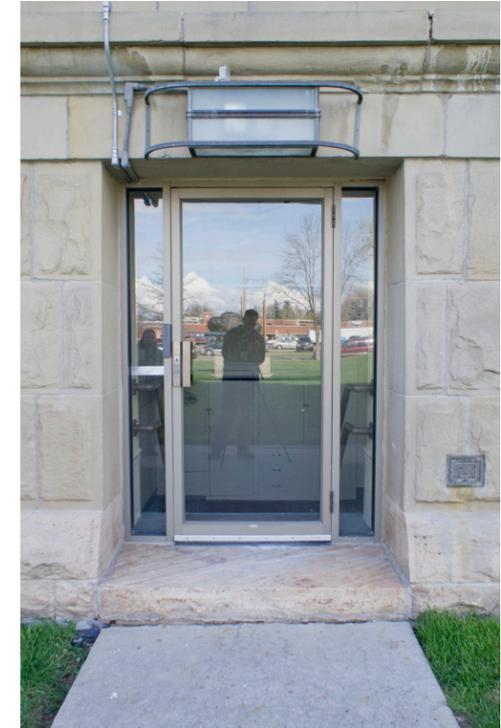
**Figure 16:** Existing Garden Level Doors on West and East Elevations at Former Window Openings. The doors will be replaced with windows at these locations [W-070 and E-034].

A door on the west elevation, north of the west entry stairs, was retrofitted within a former window opening [Figure 16].

A door on the east elevation was retrofitted within a former window opening [Figure 16].

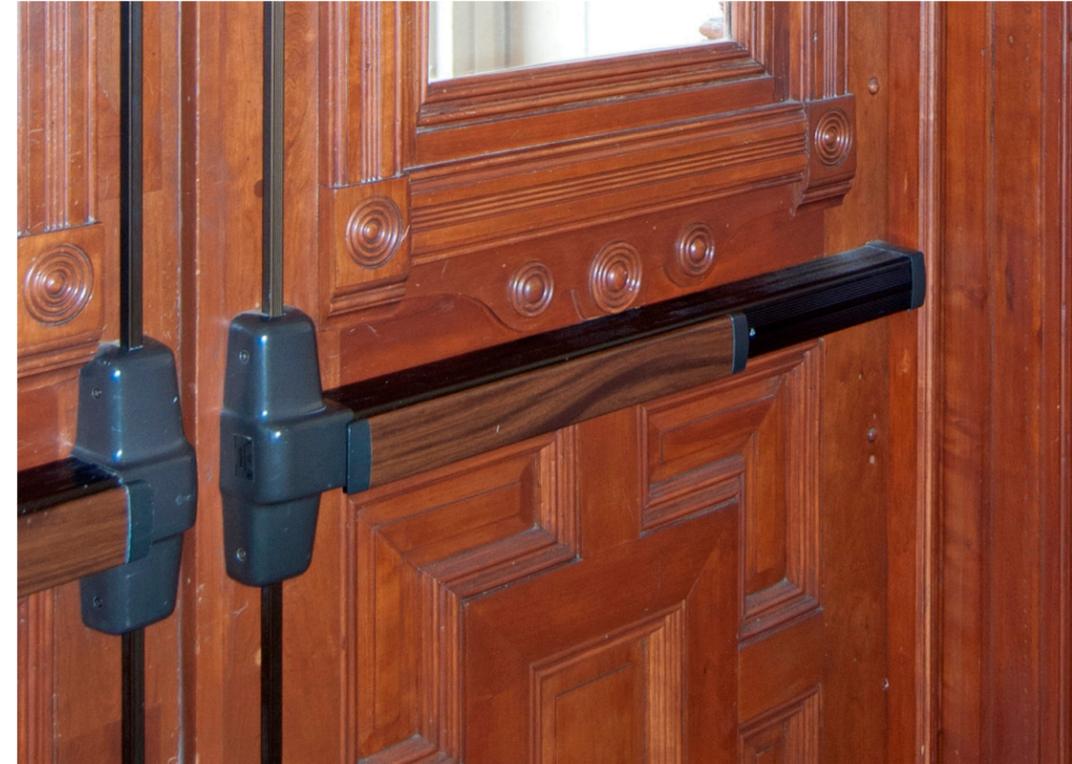
Figure 17: Non-Historic Panic Bars Cut Across the Original Molding Profiles

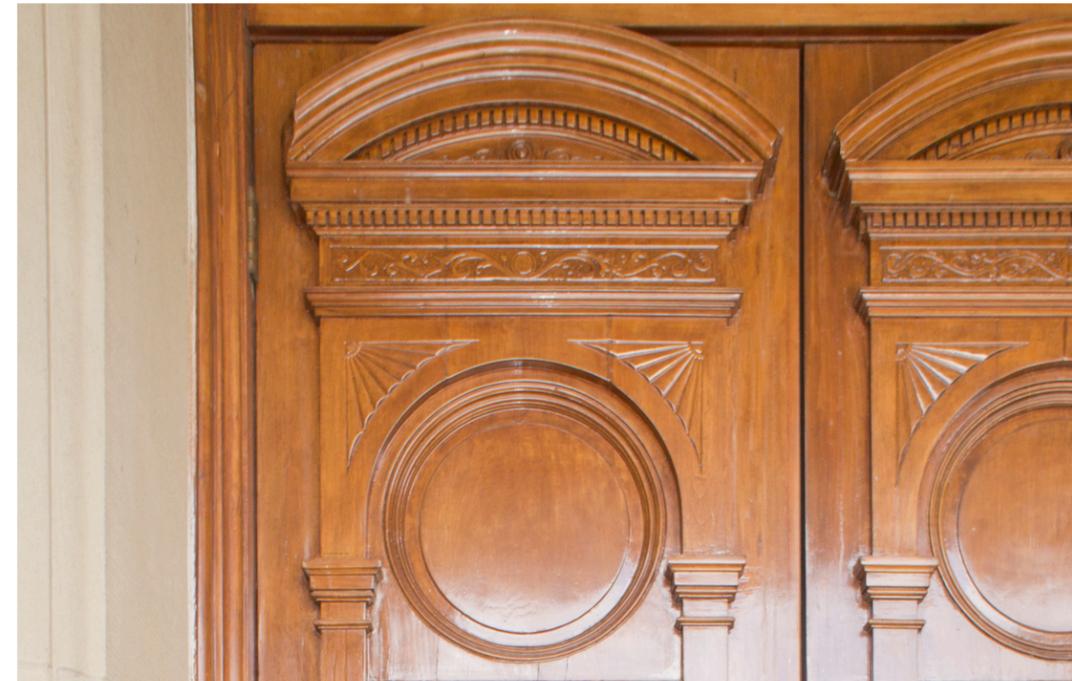
- Dutchman repairs at the door frame indicate in-filled mortised hinge locations consistent with the inswing of the doors, as illustrated in historic photographs.
- As a part of retrofitting the exterior doors for outswing operation, the outside edges of the exterior arched pediments at each pair of doors was modified to allow the door to open fully [Figure 18].
- The wood frames at the monumental exterior doors exhibit some drying and cracking where they come in contact with the stone landing.

Figure 18: Modified Arched Pediment [Left Side] for Outswing Operation. The pediment was clipped to swing fully open at historic frame.

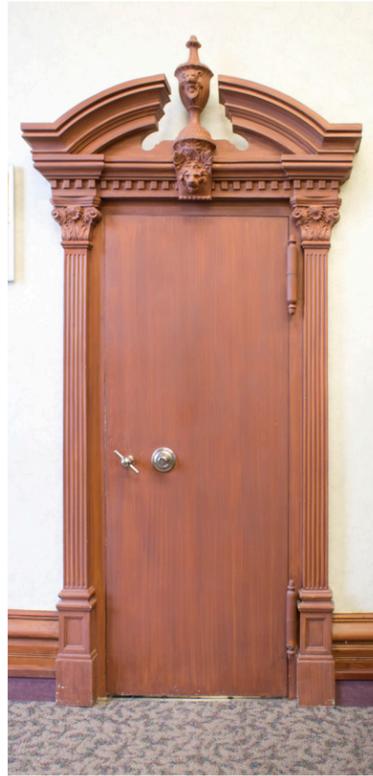
Figure 19: First Floor Safe Door with Elaborate Metal Surround.

- Metal doors painted brown
- Elaborate metal surrounds with fluted pilasters and arched broken pediments topped by a decorative urn [Figure 19].
- One modern safe door exists in an area planned for reorganization, and the door’s relocation will need to be carefully considered

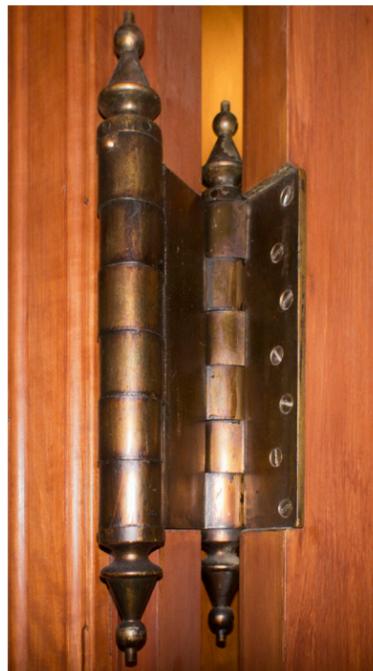
Figure 20: Double Action Hinges at Second Floor Double Doors on North and Sides of Rotunda.

- Although the original drawings indicate glass at the majority of the doors, and the doors appear historic, many of the glass panels have been replaced with wood panels.
- Some historic [wavy] glass panels exist, but many of the panes are flat glass, or glass that is translucent.
- Paired doors to spaces north and south of the Rotunda have large double action hinges [Figure 20].
