WYOMING STATE CAPITOL RENOVATION & RESTORATION CAPITOL SQUARE PROJECT

CAPITOL SQUARE PROJECT OVERVIEW

JANUARY 15, 2014

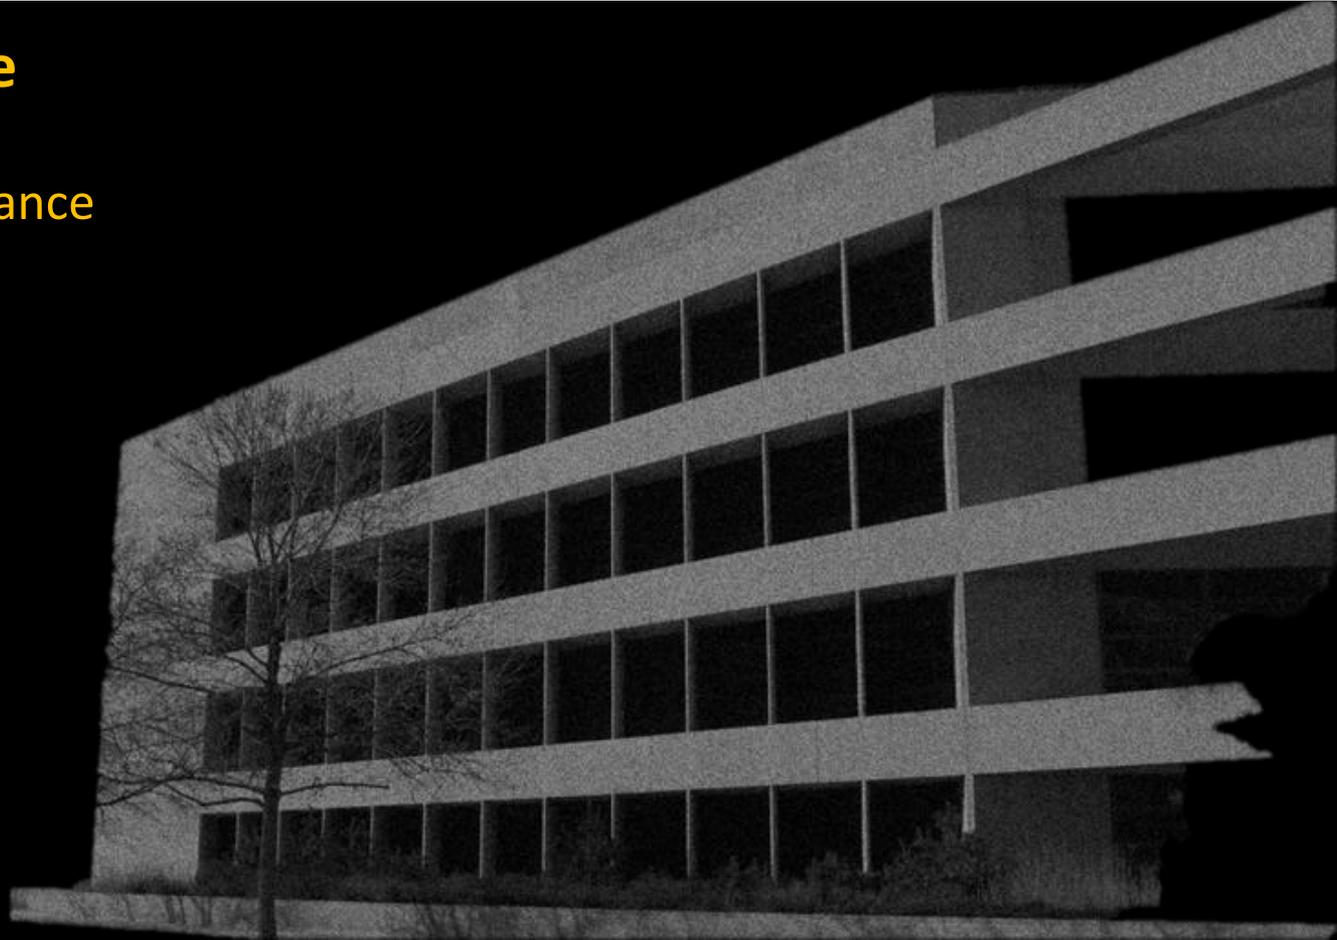
Herschler Update

- Deferred Maintenance
 - Exterior Wall

An additional concern with the Herschler building, that is being investigated further, is to understand the condition of the exterior walls. These walls have indications of leaks and require review to determine if these leaks are creating problems within the wall. Whereas this seems likely, the issue is open at this time.

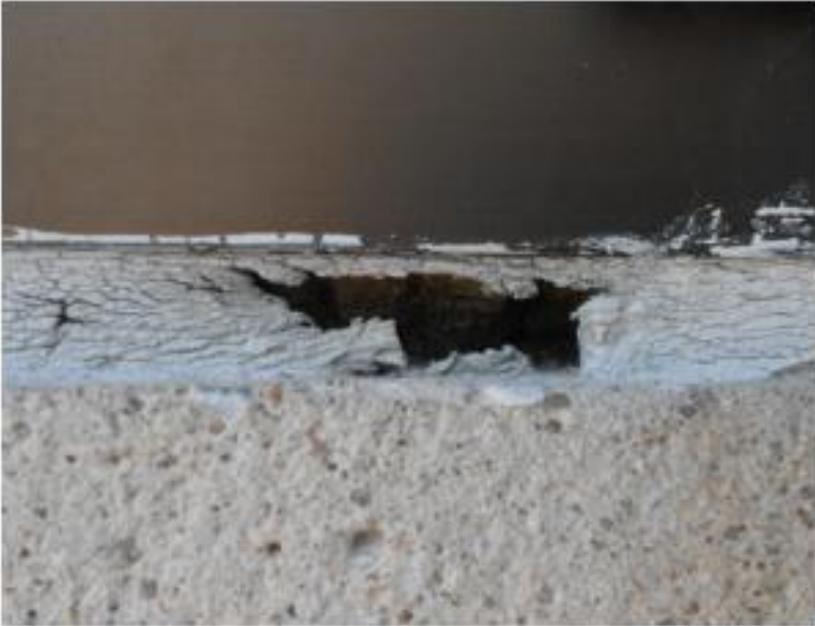
Photo #3 Typical condition of the exterior joint sealants. (Approx. 1.25 in. X 0.375 in.)

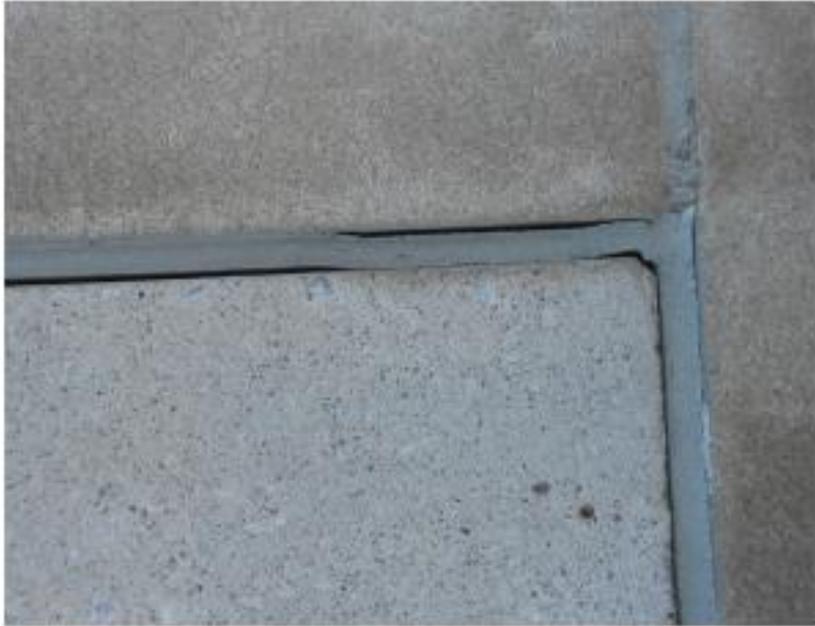
Photo #4 Typical condition of the exterior joint sealants.

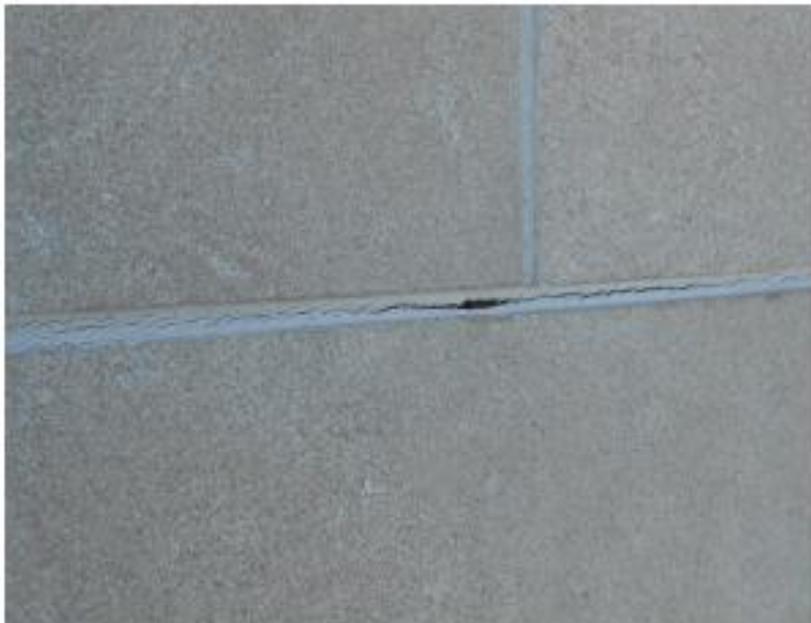
Photo #5 Typical condition of the exterior joint sealants.

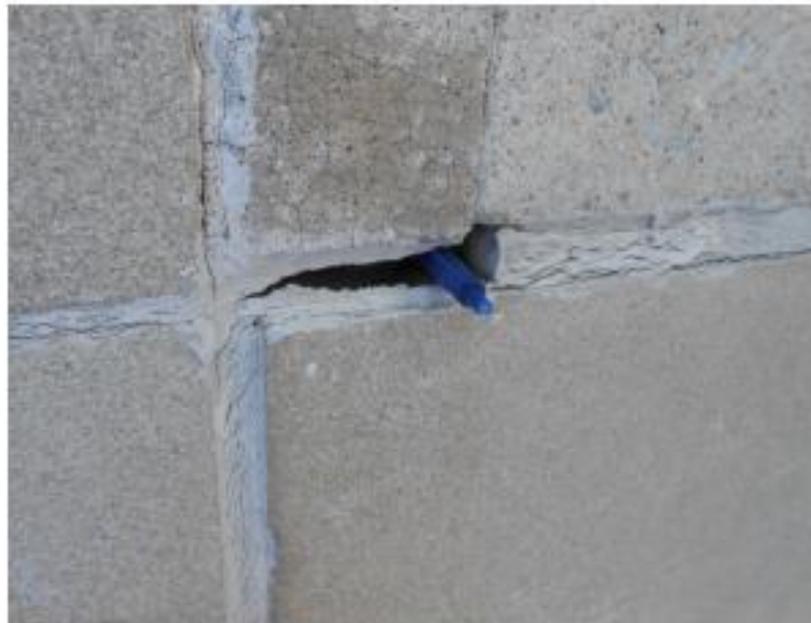
Photo #6 Typical condition of the exterior joint sealants. (Approx. 0.375 in. X 1.5 in.)

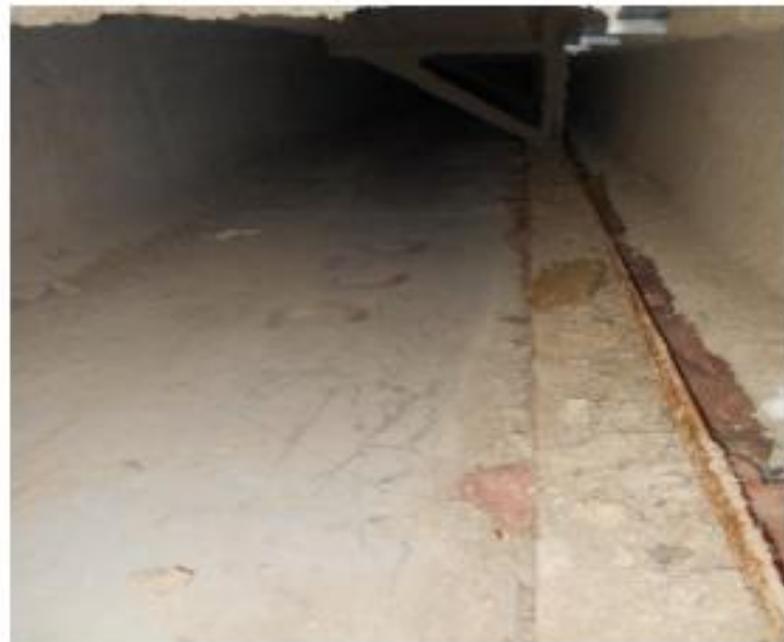
Photo #27 Fiberglass insulation separating the precast soffit area and drop-ceiling area with 4-inch max thickness.

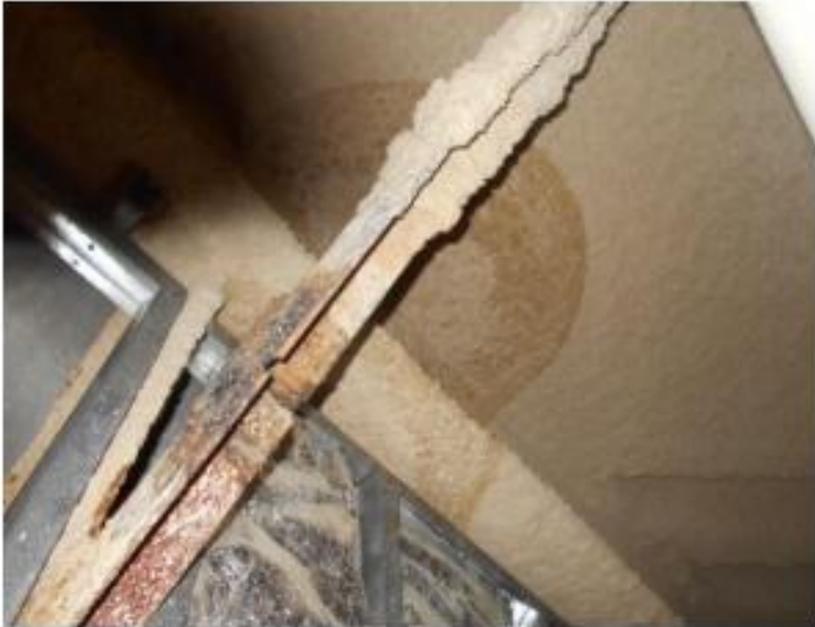
Photo #28 Representative view of inside the precast soffits. Typical surface rust is visible on steel bracing.

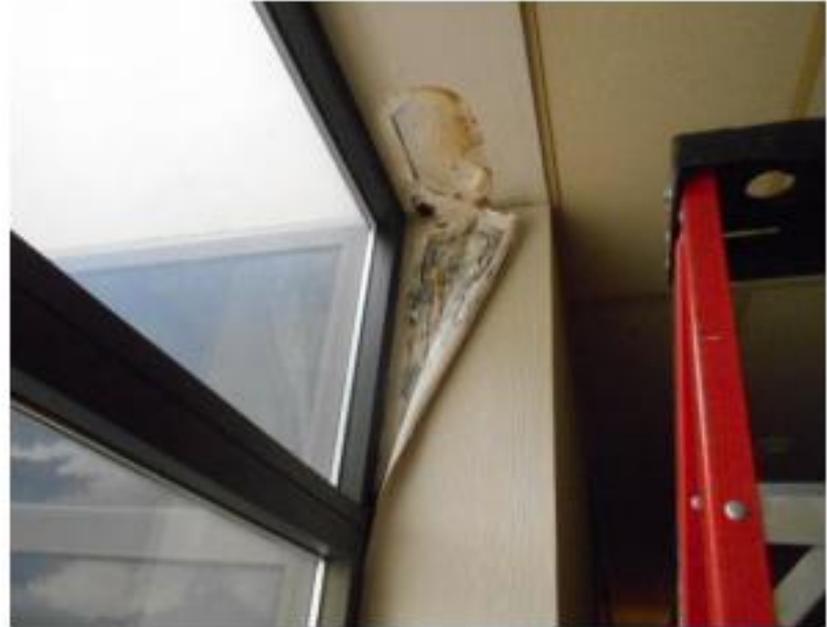
Photo #23 Representative view of inside the precast soffit. Typical surface rust on the steel bracing. Note the stain on the fireproofing.

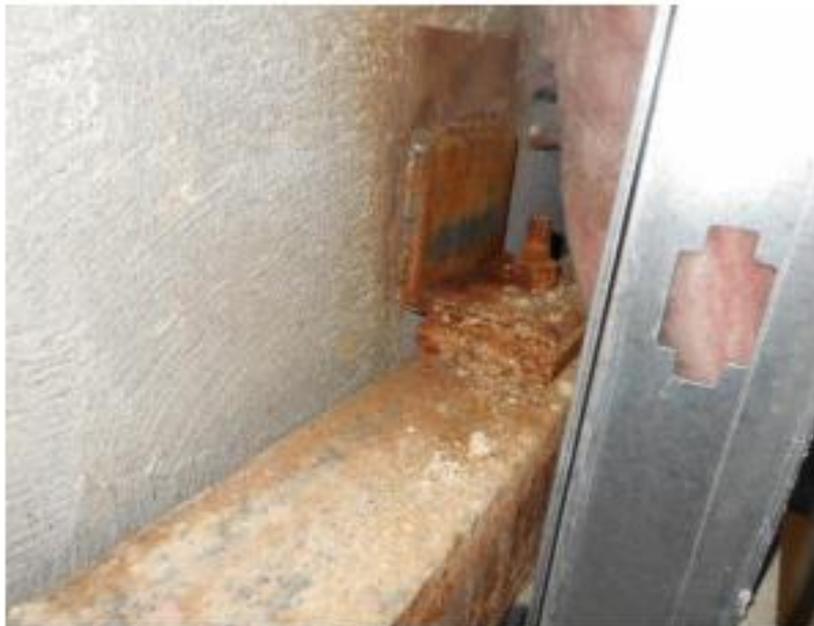
Photo #24 Evidence of interior water intrusion.

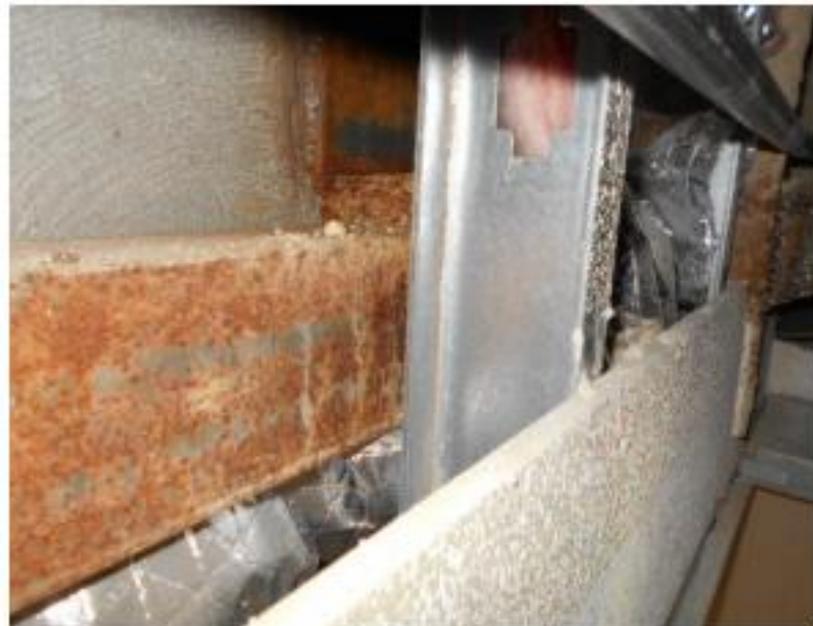
Photo #25 Representative view above the drop-ceiling, where the exterior precast panels tie into the steel bracing; typical surface rusting.
