# Report Narrative

## Wyoming State Capitol Dome Investigation Cheyenne, WY

Vertical Access LLC  
PO Box 4135, Ithaca, NY 14852  
Tel: 607 257 4049 / Fax: 607 257 2129

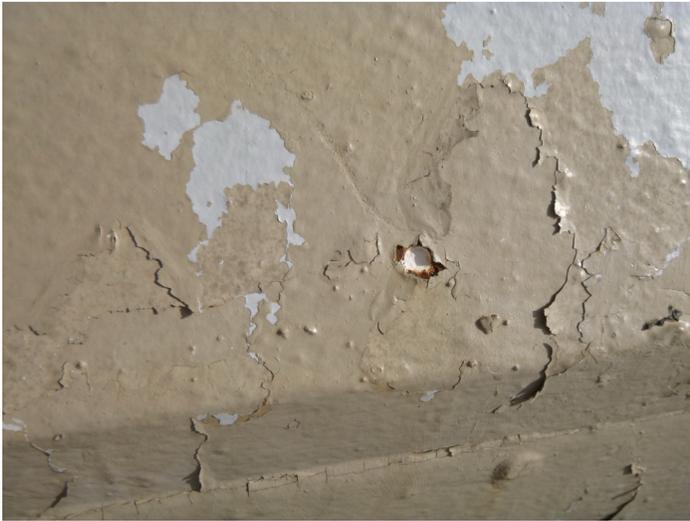
**12-50 ArchMetal\_Corrosion Perforated 2013-1**

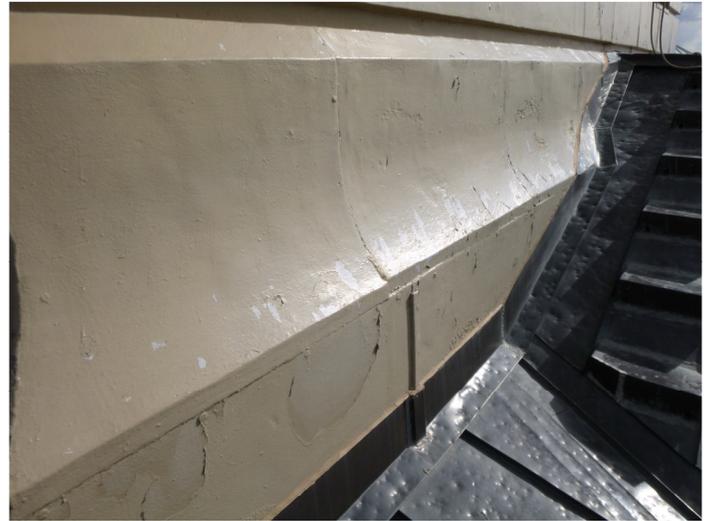
**13-51 ArchMetal\_Coating Coating Failed 2013-1**

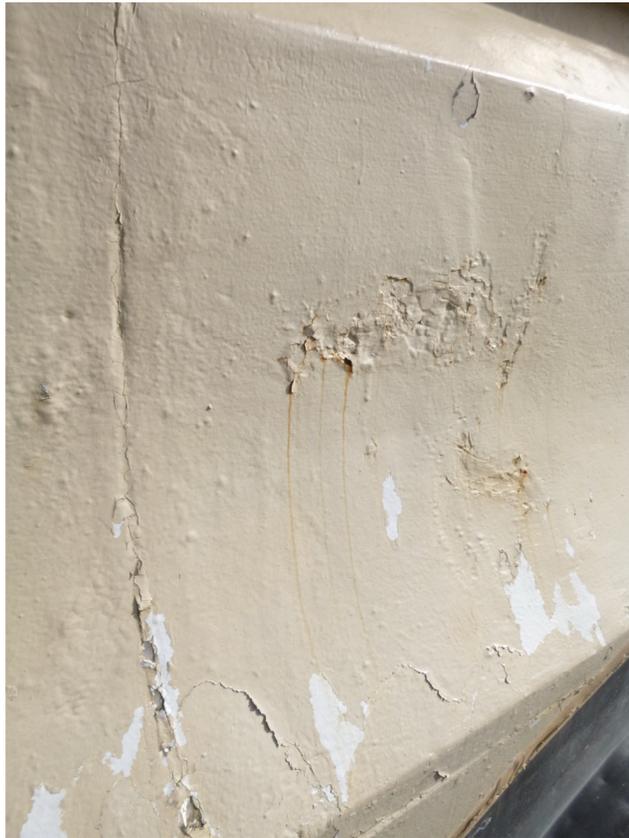
**13-51 ArchMetal\_Coating Coating Failed 2013-2**

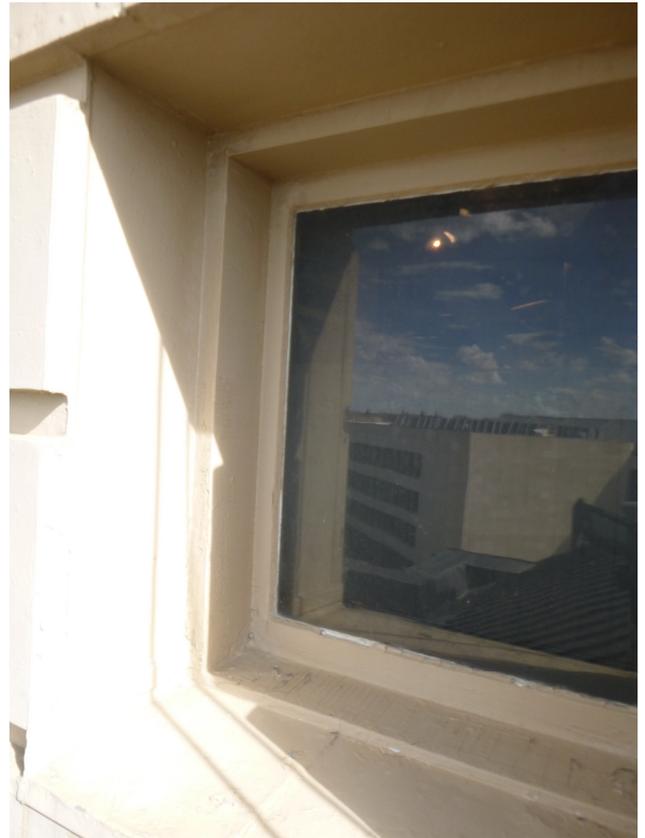
**14-56 SheetMetal\_Coating Coating Failed 2013-1**

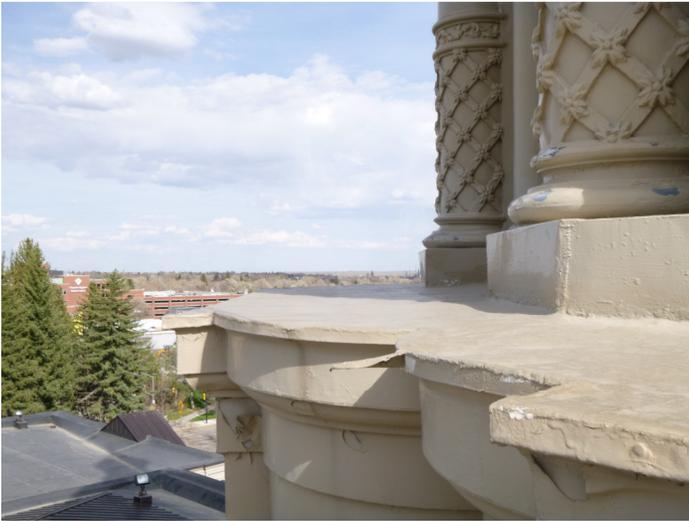
**16-73 SheetMetal\_Note Misc condition 2013-1**

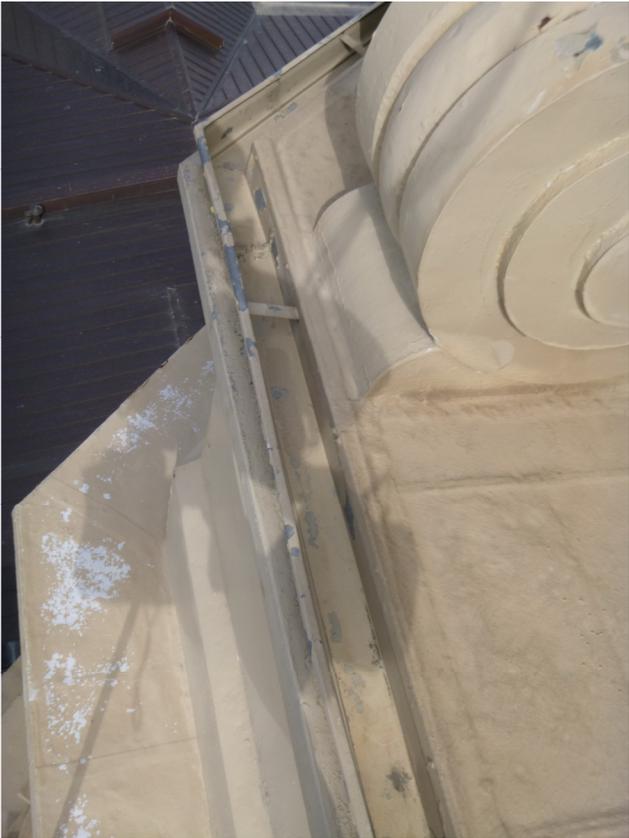
**16-95 SheetMetal\_Coating Coating Failed 2013-1**

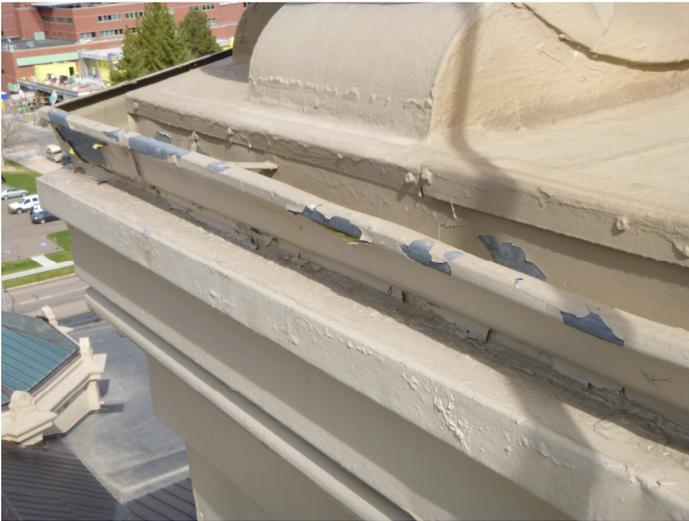
**16-95 SheetMetal\_Coating Coating Failed 2013-2**

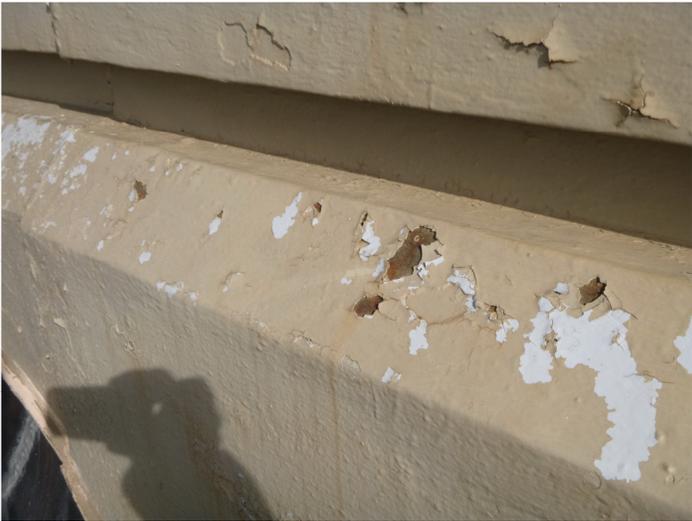
**17-52 ArchMetal\_Corrosion Surface 2013-1**

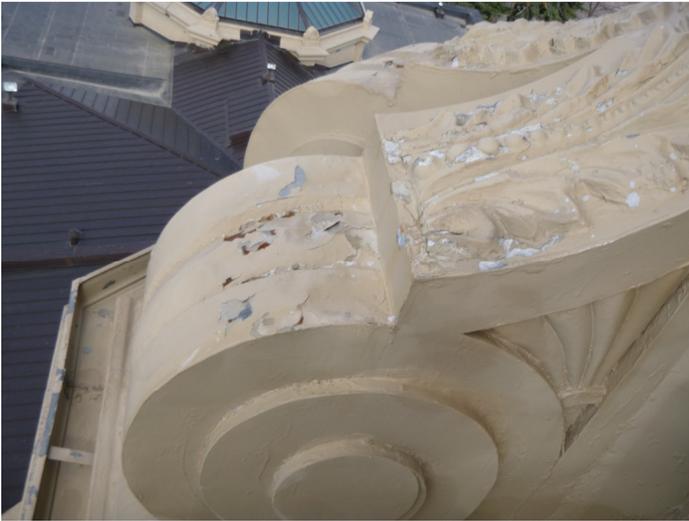
**17-97 SheetMetal\_Corrosion Surface 2013-1**

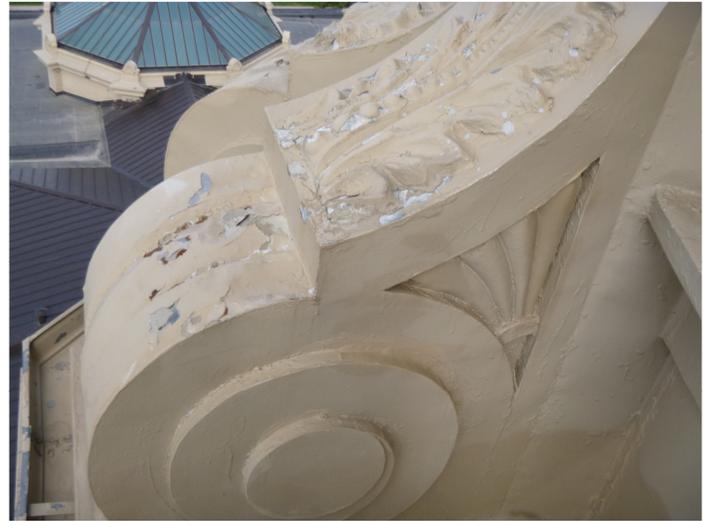
**17-98 SheetMetal\_Coating Coating Failed 2013-1**

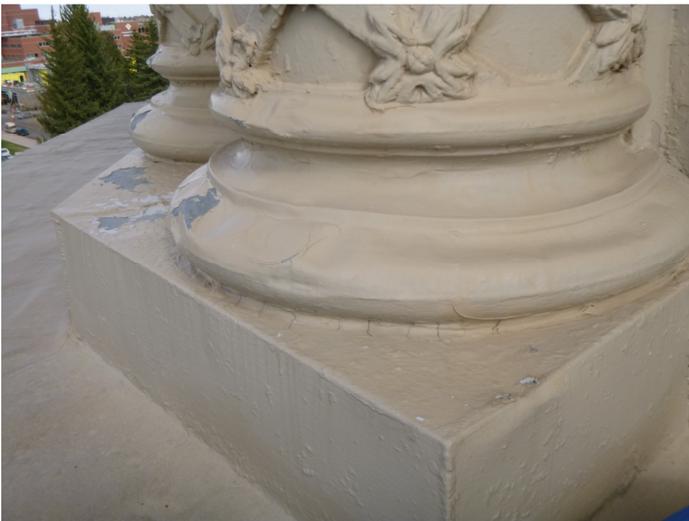
**18-75 SheetMetal\_Damaged Dented 2013-1**

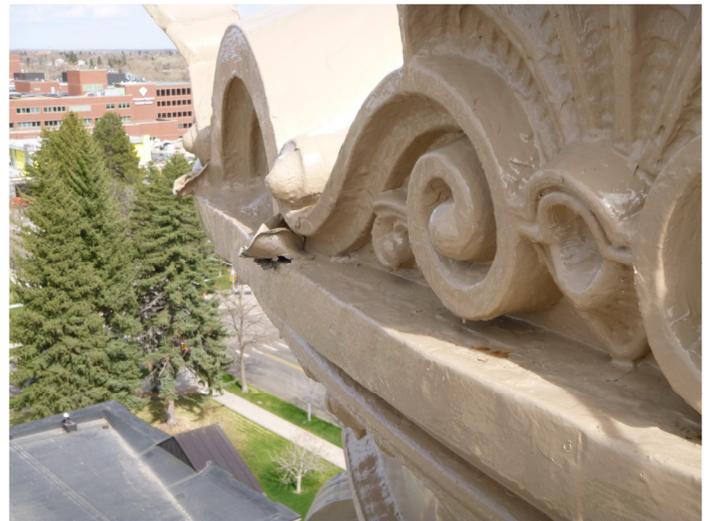
**18-104 SheetMetal\_Damaged Torn 2013-1**

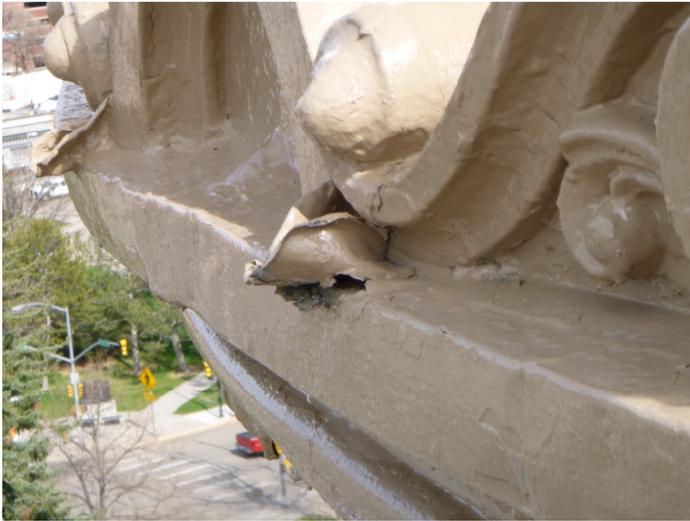
**18-104 SheetMetal\_Damaged Torn 2013-2**

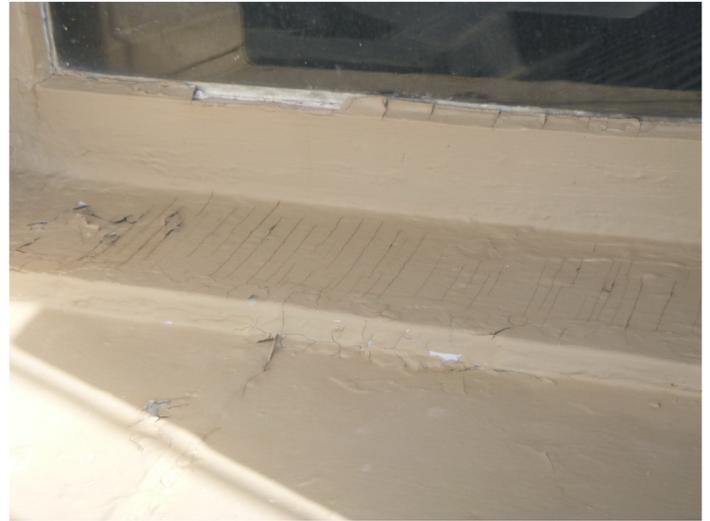
**19-56 Wood\_Coating Coating Failed 2013-1**

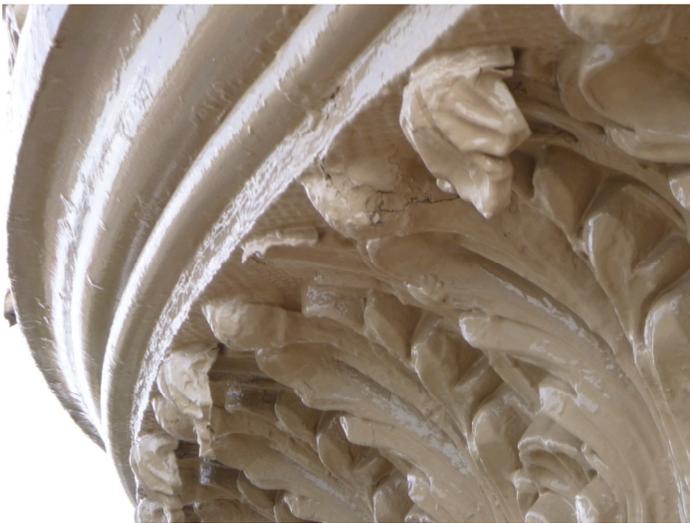
**19-103 SheetMetal\_Unsecured Missing 2013-1**

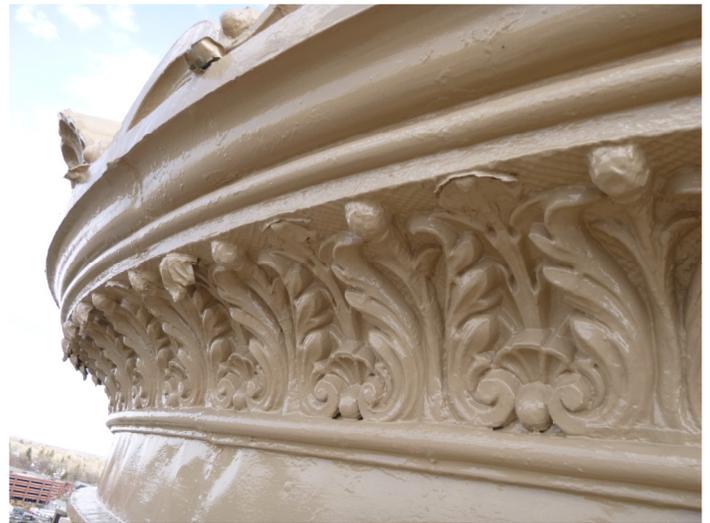
**19-103 SheetMetal\_Unsecured Missing 2013-2**

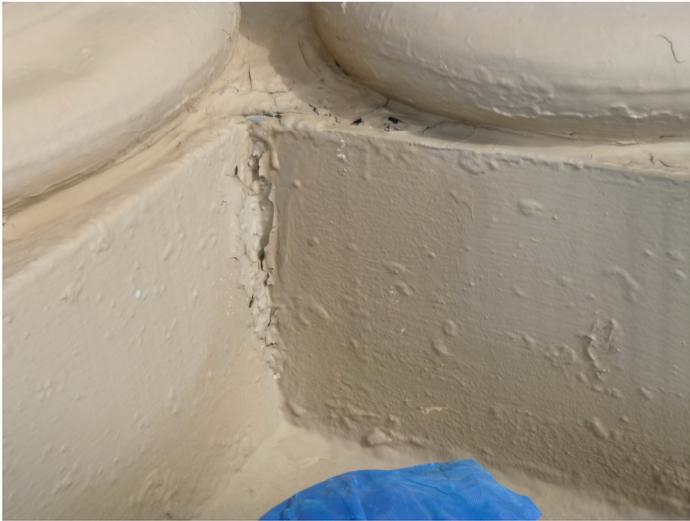
**20-74 SheetMetal\_Coating Coating Failed 2013-1**

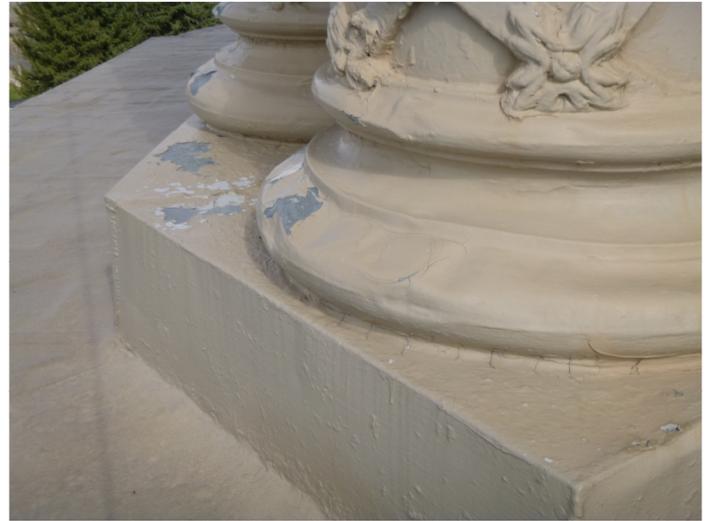
**20-74 SheetMetal\_Coating Coating Failed 2013-2**

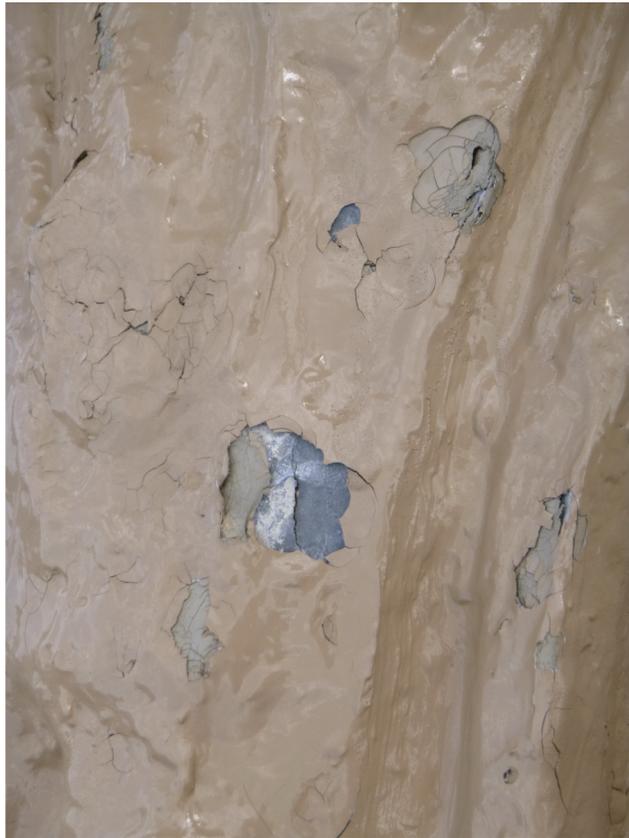
**20-120 SheetMetal\_Damaged Torn 2013-1**

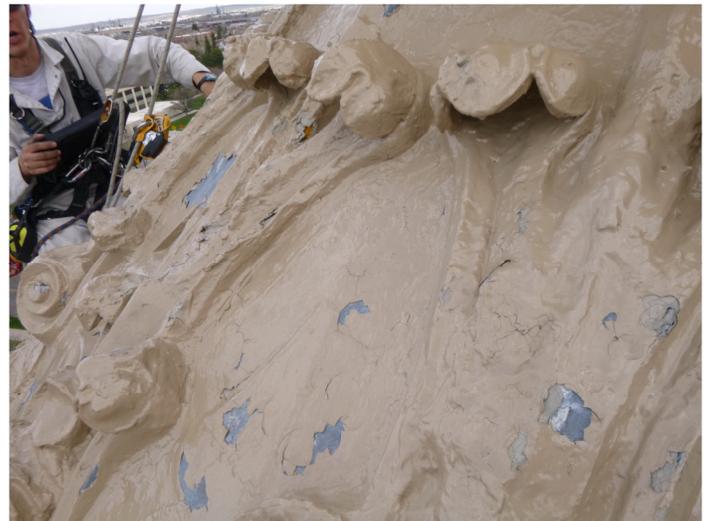
**20-120 SheetMetal\_Damaged Torn 2013-2**

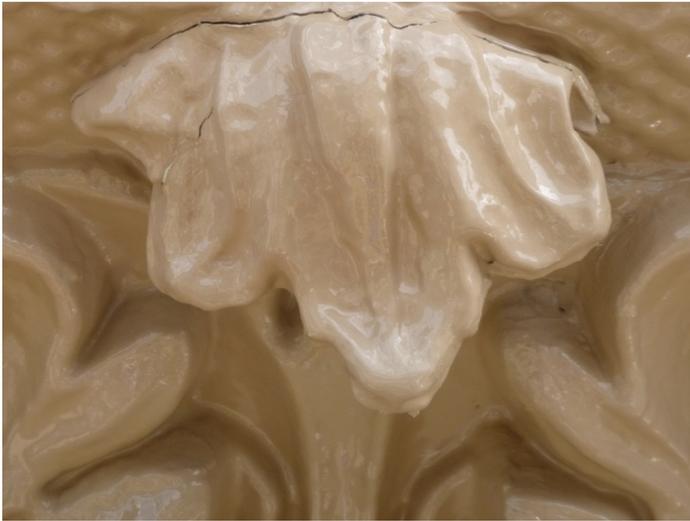
**21-103 SheetMetal\_Unsecured Loose 2013-1**

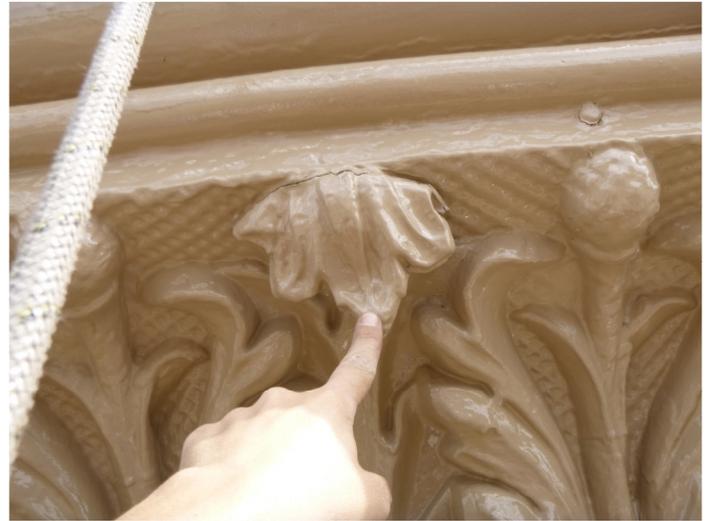
**21-103 SheetMetal\_Unsecured Loose 2013-2**

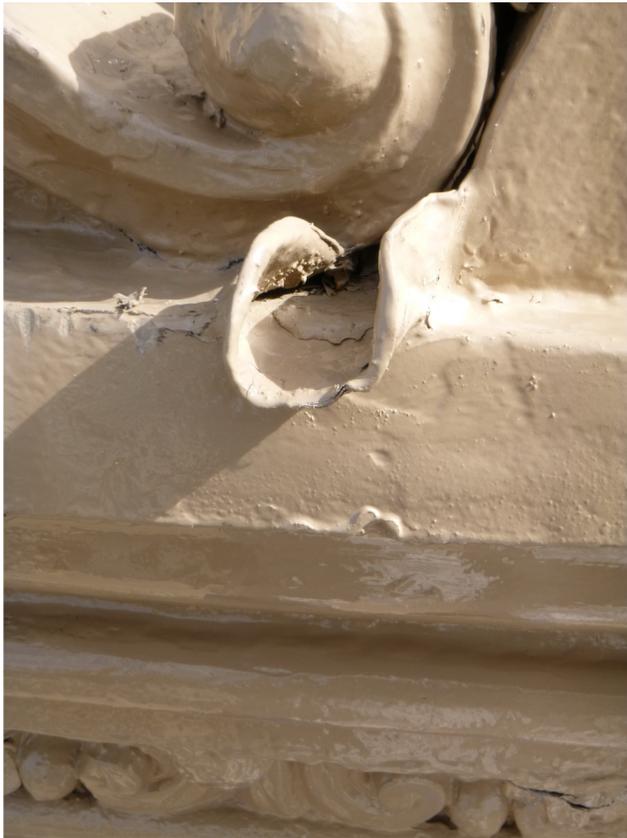
**21-104 SheetMetal\_Damaged Dented 2013-1**

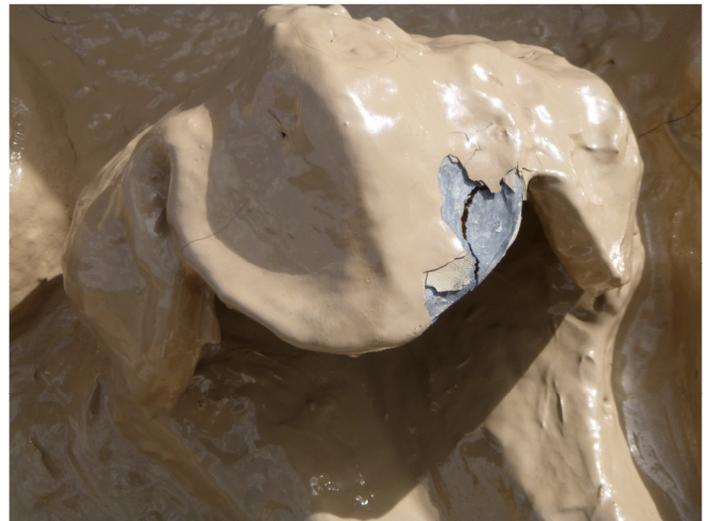
**21-122 SheetMetal\_Damaged Punctured 2013-1**

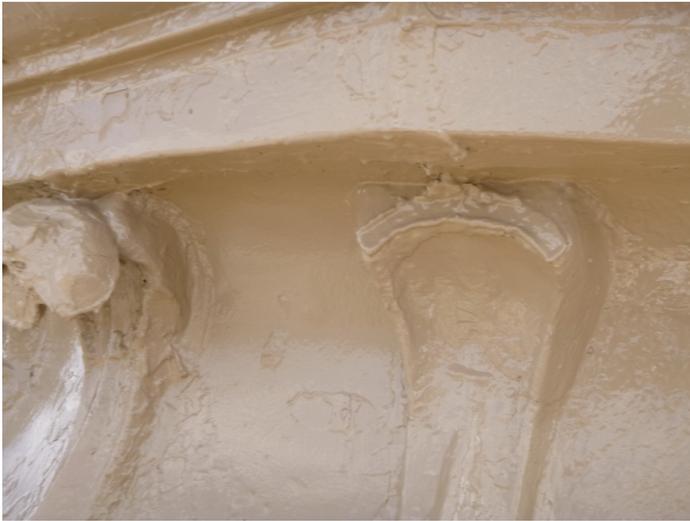
**21-122 SheetMetal\_Unsecured Missing 2013-1**

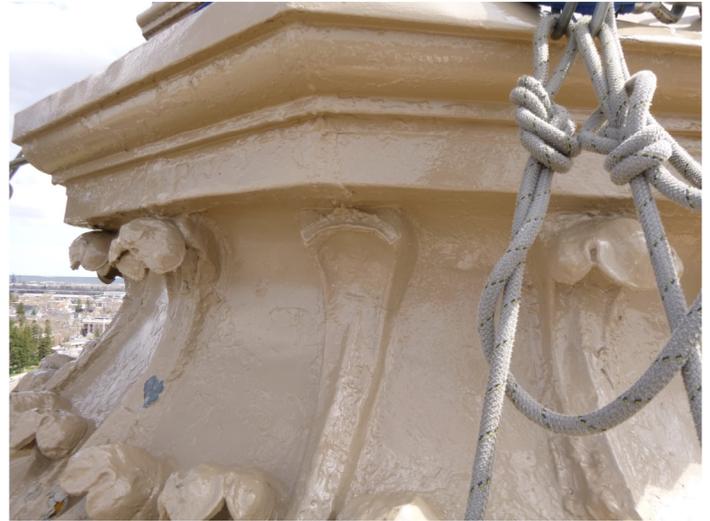
**21-122 SheetMetal\_Unsecured Missing 2013-2**

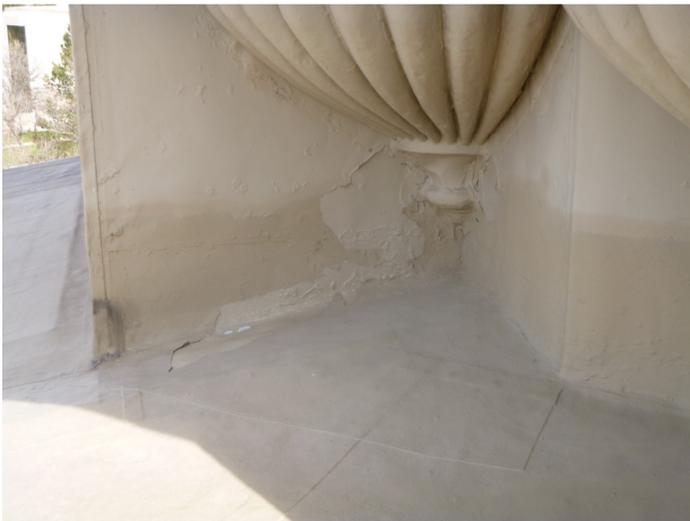
**22-65 SheetMetal\_Coating Coating Failed 2013-1**

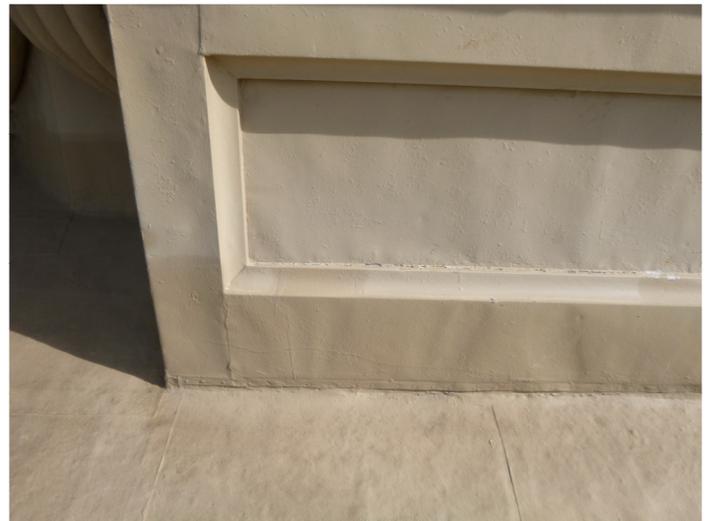
**22-65 SheetMetal\_Coating Coating Failed 2013-2**

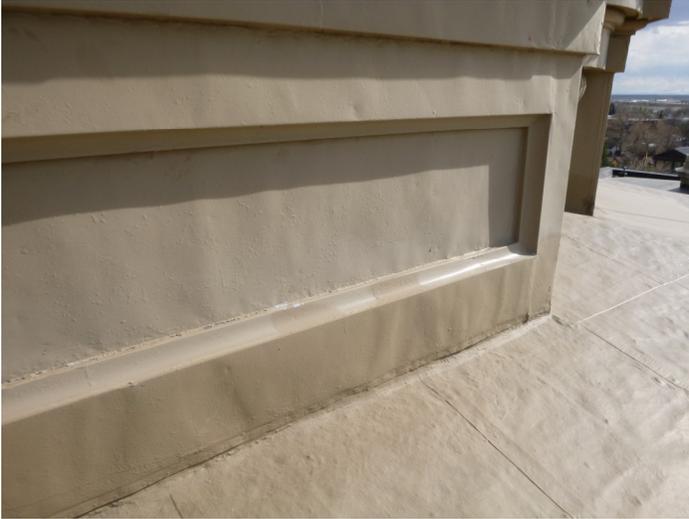
**22-65 SheetMetal\_Coating Coating Failed 2013-3**

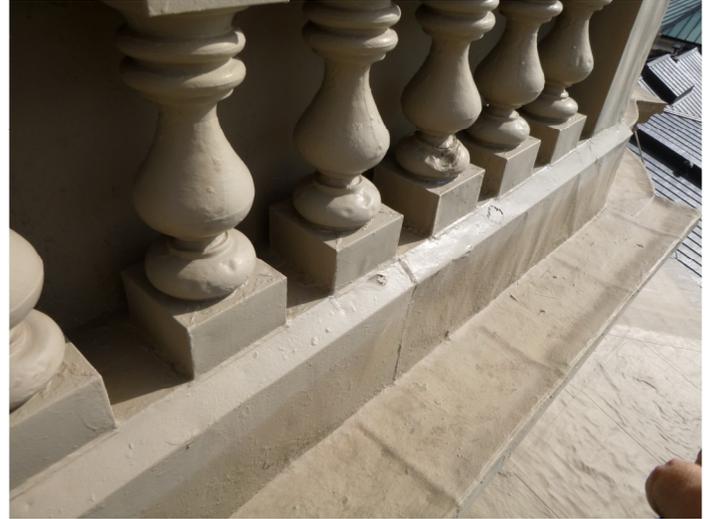
**22-70 SheetMetal\_Coating Coating Failed 2013-1**

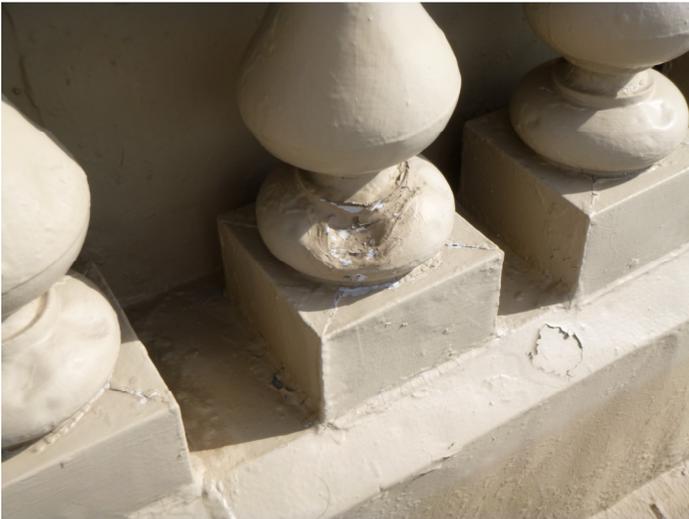
**22-71 SheetMetal\_Damaged Dented 2013-1**

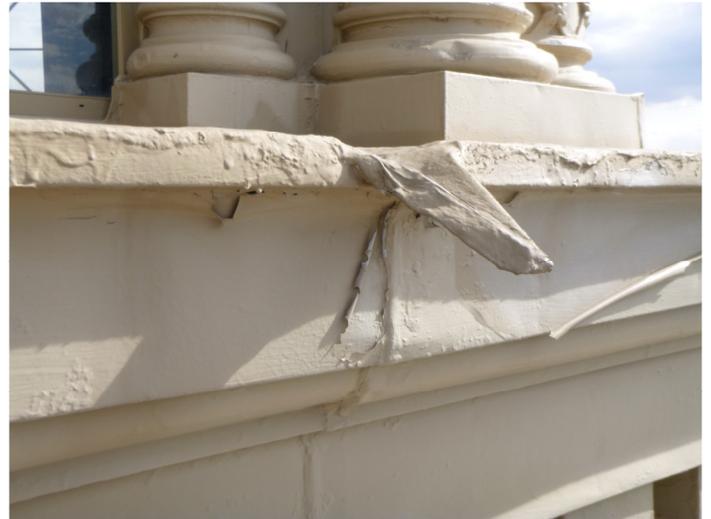
**22-74 SheetMetal\_Note Misc condition 2013-1**

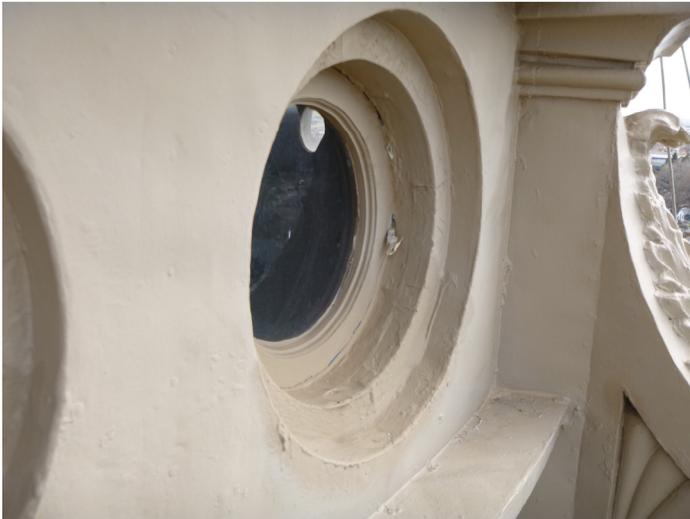
**22-99 SheetMetal\_Coating Coating Failed 2013-1**

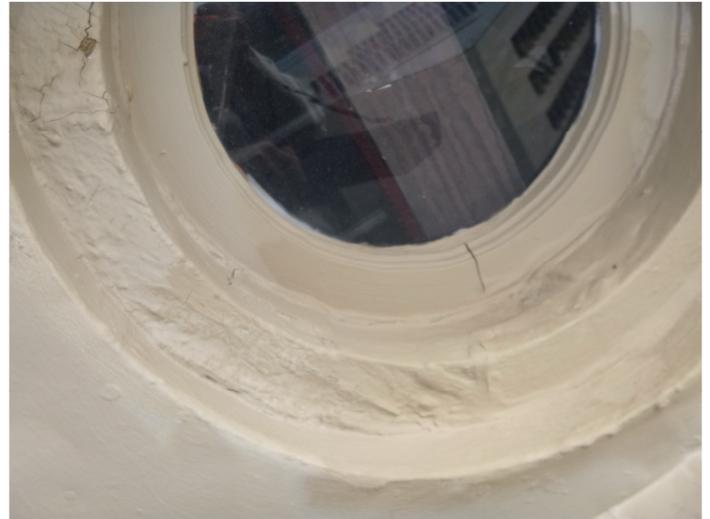
**22-99 SheetMetal\_Coating Coating Failed 2013-2**

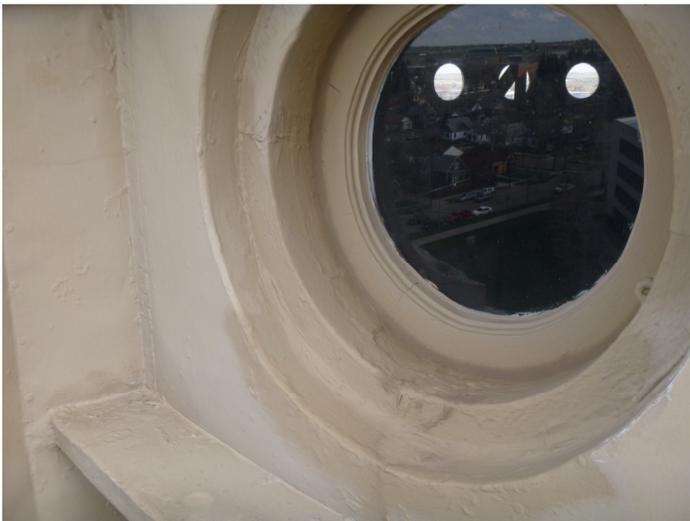
**22-99 SheetMetal\_Coating Coating Failed 2013-3**

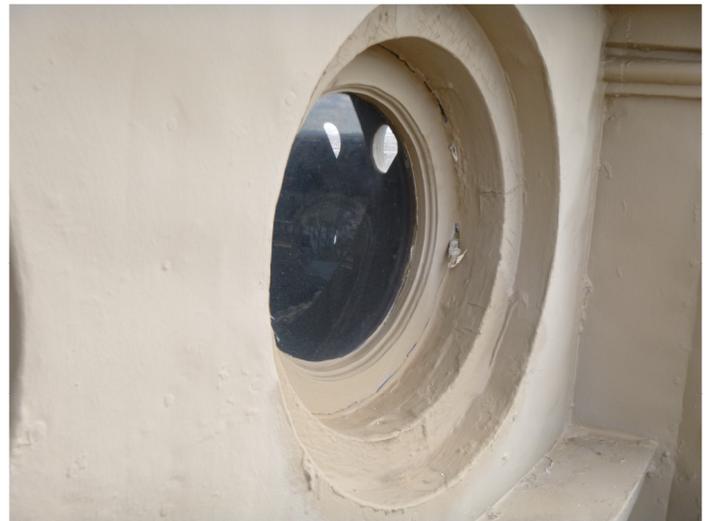
**22-99 SheetMetal\_Coating Coating Failed 2013-4**

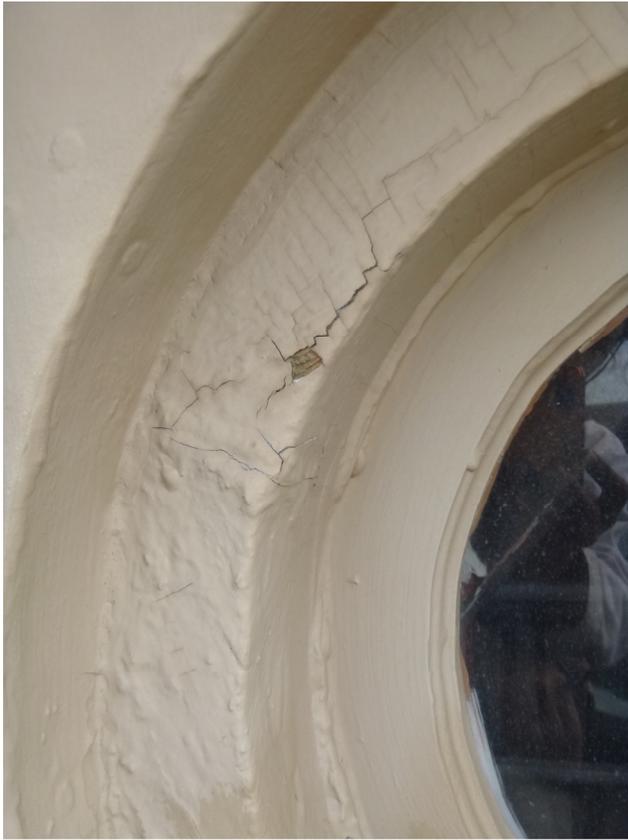
22-99 SheetMetal\_Coating Coating Failed 2013-5

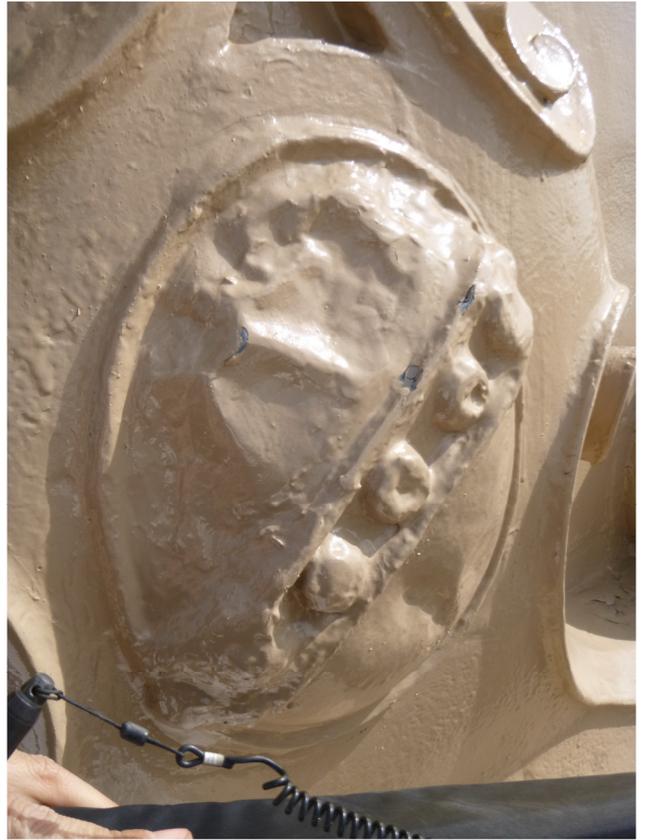
22-106 SheetMetal\_Damaged Dented 2013-1

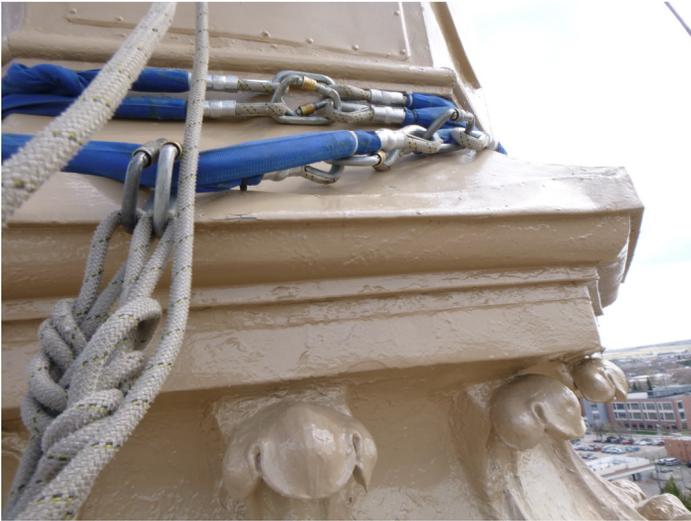
22-116 SheetMetal\_Note Hail damage 2013-1

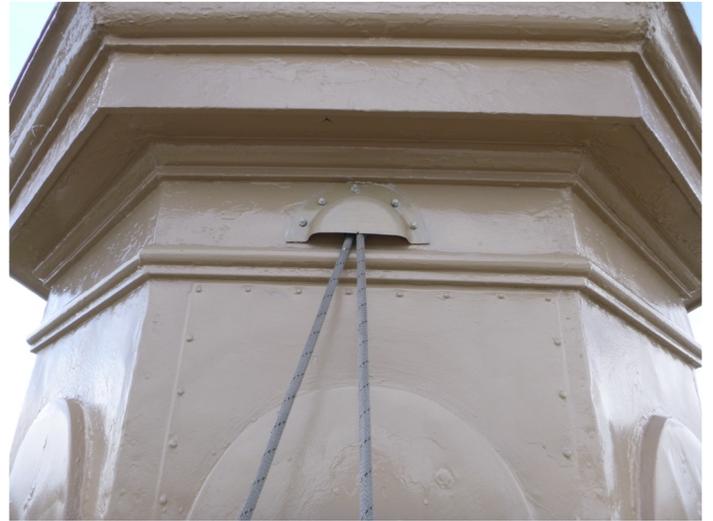
**22-124 SheetMetal\_Damaged Dented 2013-1**

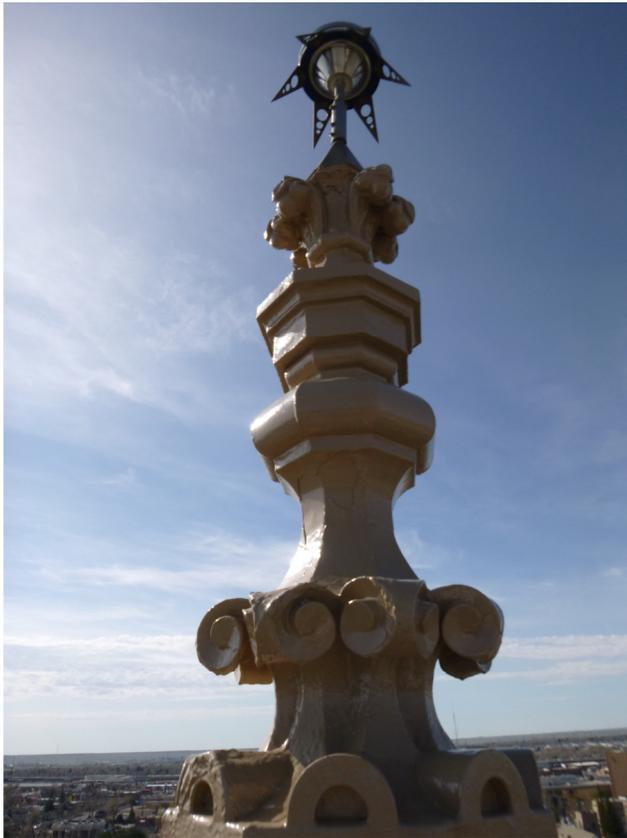
**22-127 SheetMetal\_Note Photo-rigging hole cowl 2013-1**

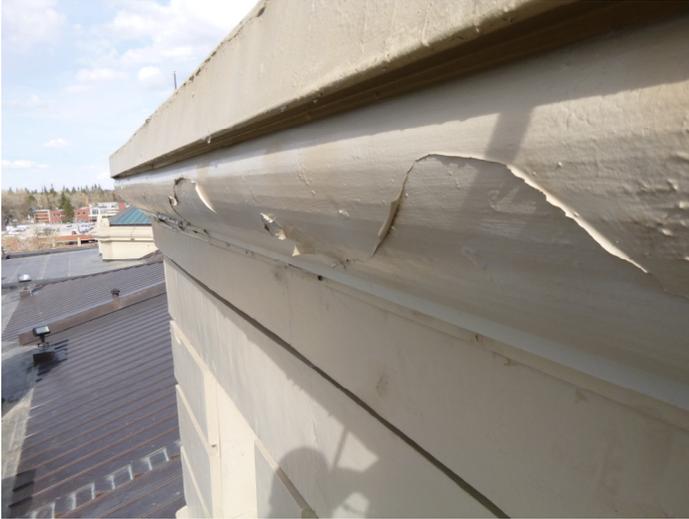
**23-61 SheetMetal\_Coating Coating Failed 2013-1**

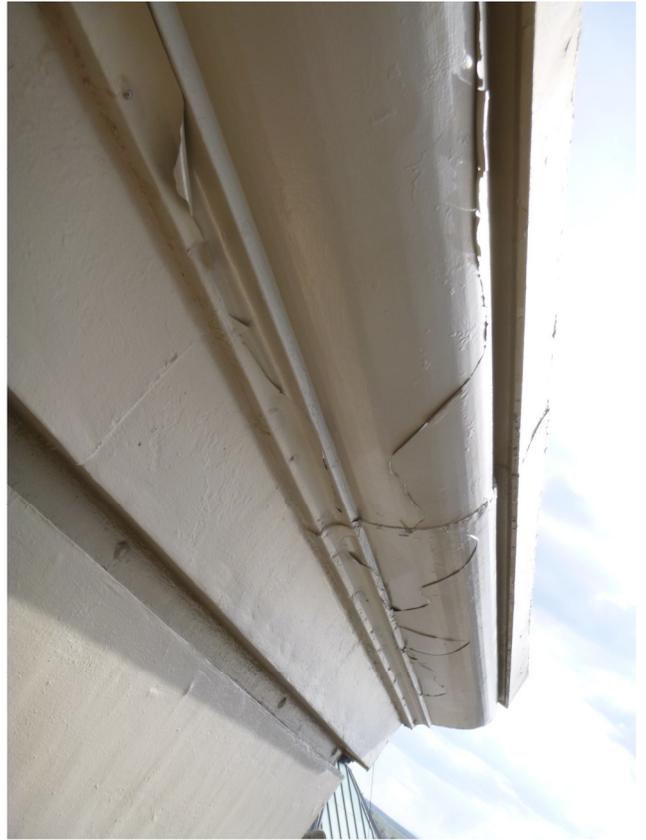
**23-61 SheetMetal\_Coating Coating Failed 2013-2**

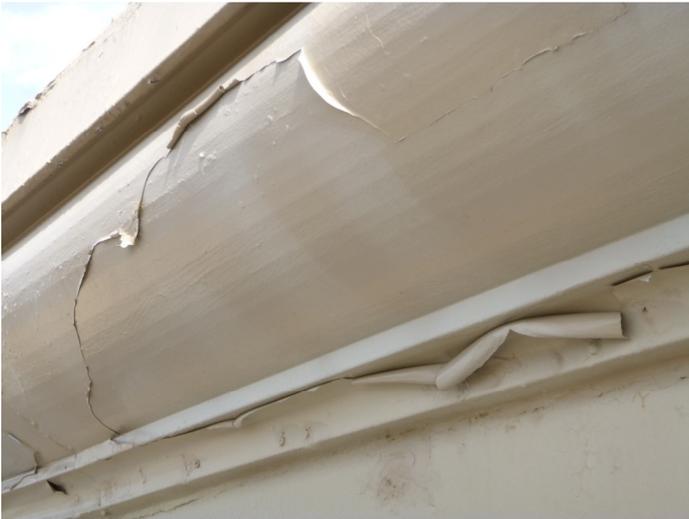
**23-61 SheetMetal\_Coating Coating Failed 2013-3**

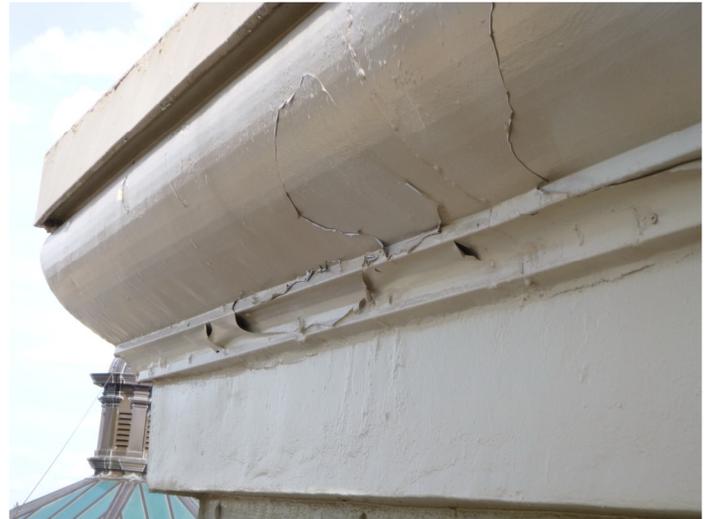
**23-61 SheetMetal\_Coating Coating Failed 2013-4**

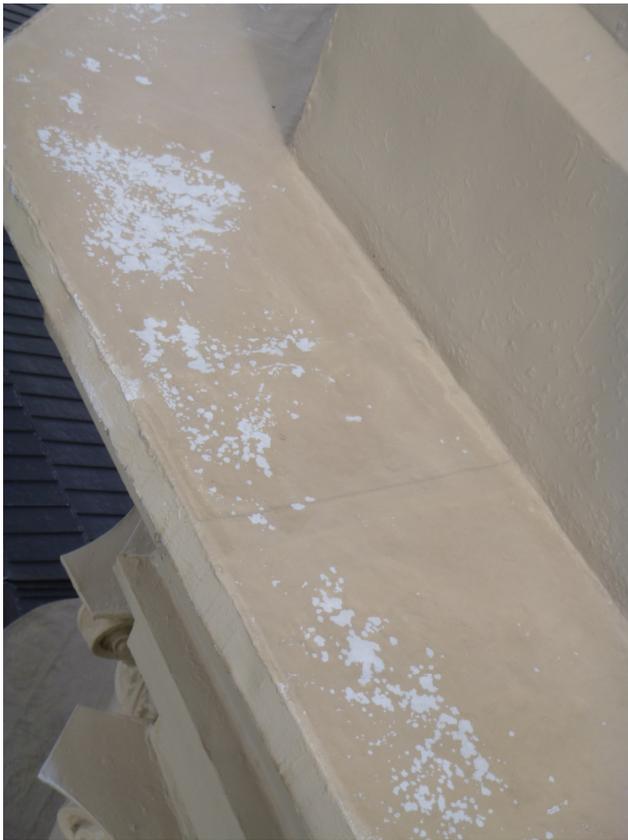
**23-61 SheetMetal\_Coating Coating Failed 2013-5**

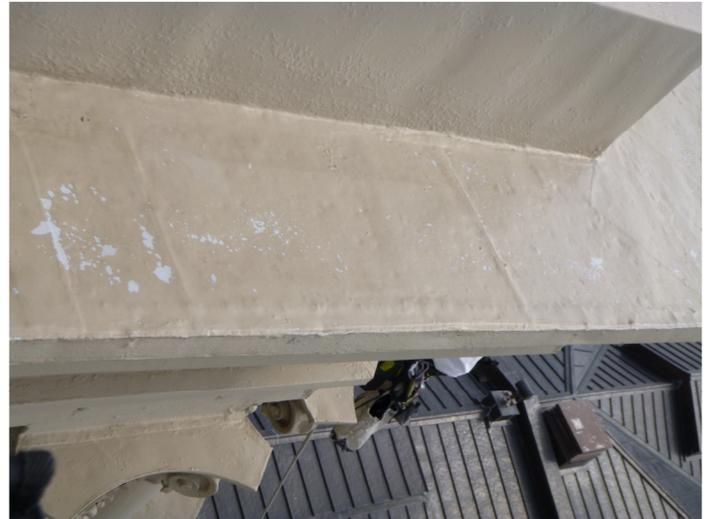
**23-92 SheetMetal\_Coating Coating Failed 2013-1**

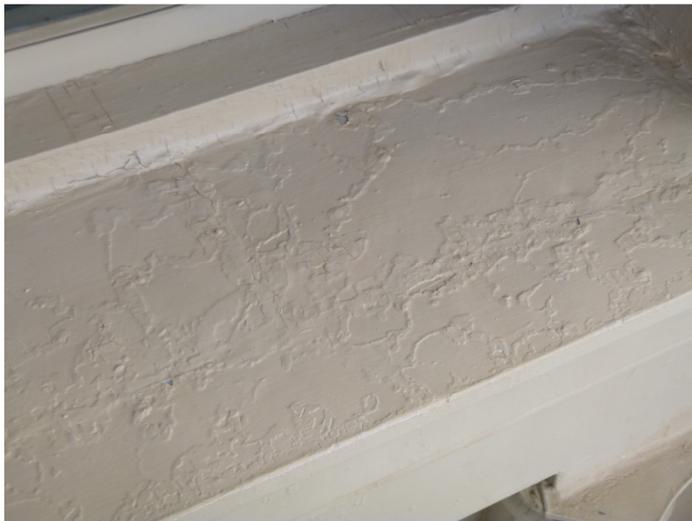
**23-92 SheetMetal\_Coating Coating Failed 2013-2**

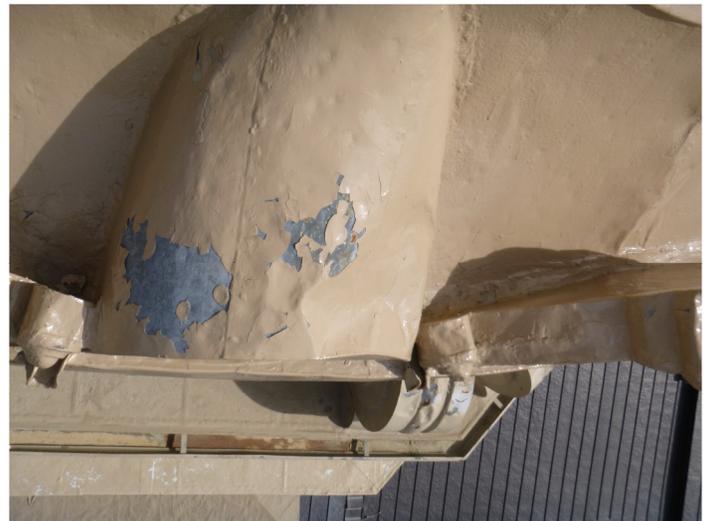
**23-92 SheetMetal\_Coating Coating Failed 2013-3**

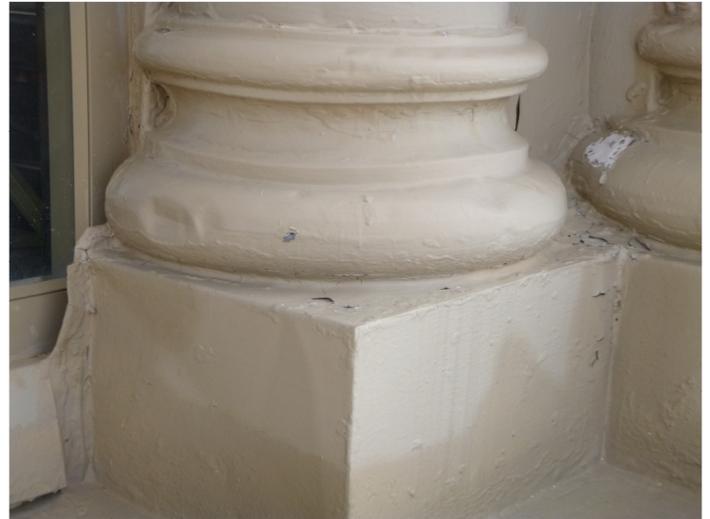
**23-120 SheetMetal\_Damaged Punctured 2013-1**

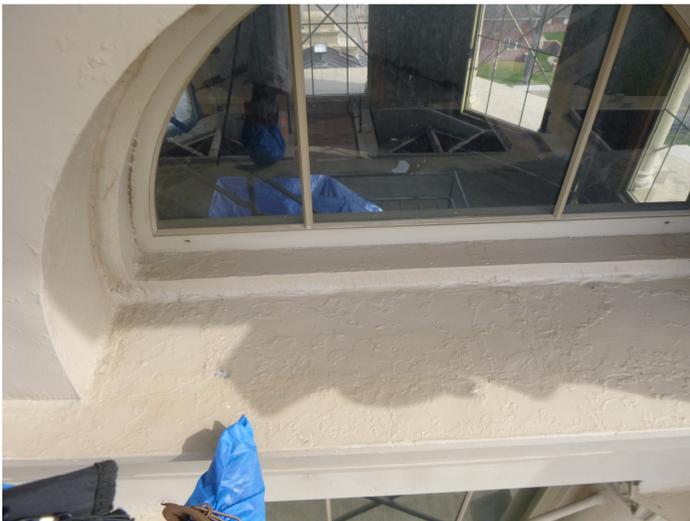
**24-74 SheetMetal\_Coating Coating Failed 2013-1**

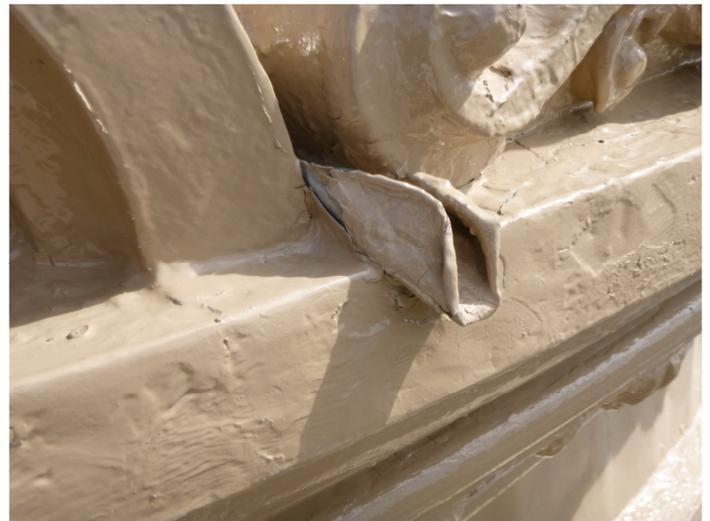
**24-84 SheetMetal\_Coating Coating Failed 2013-1**

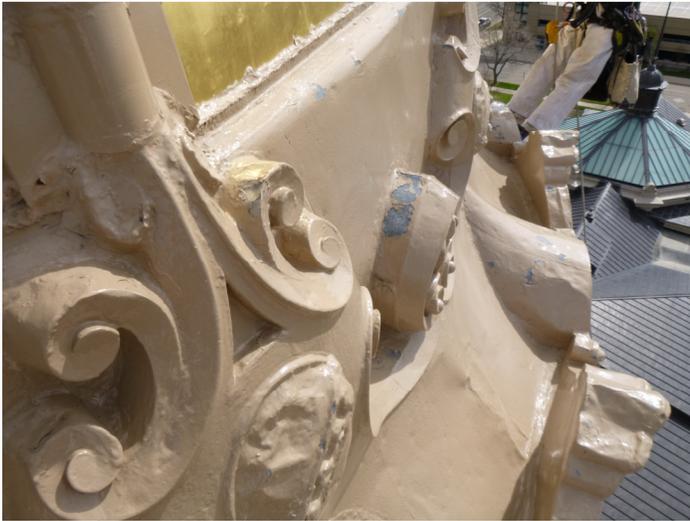
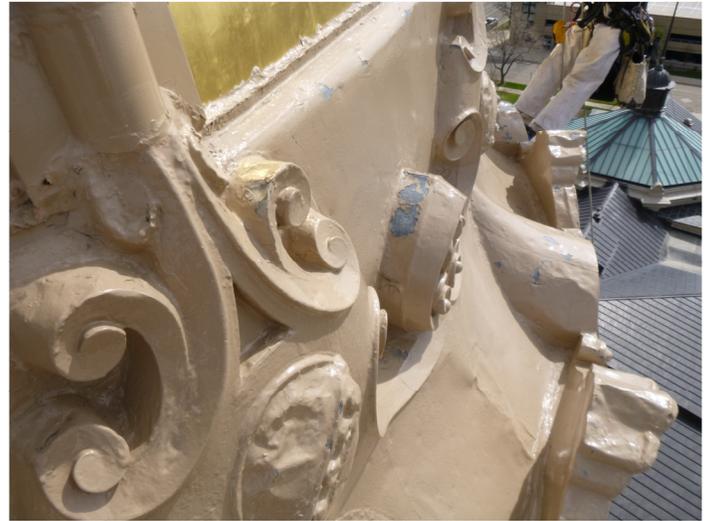
**24-104 SheetMetal\_Damaged Dented 2013-1**

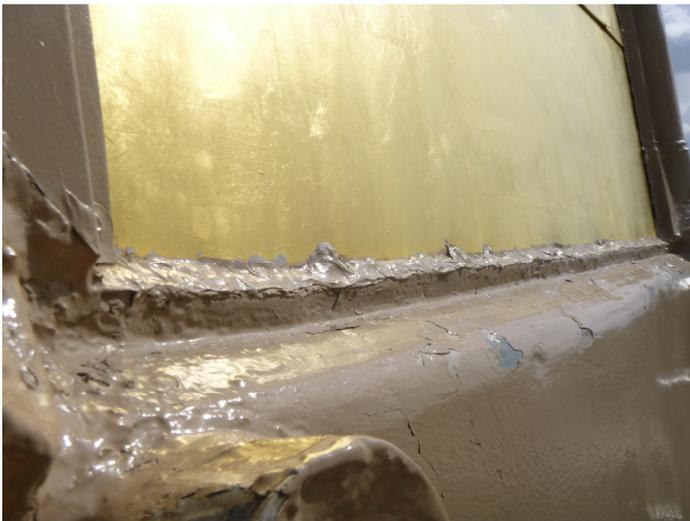
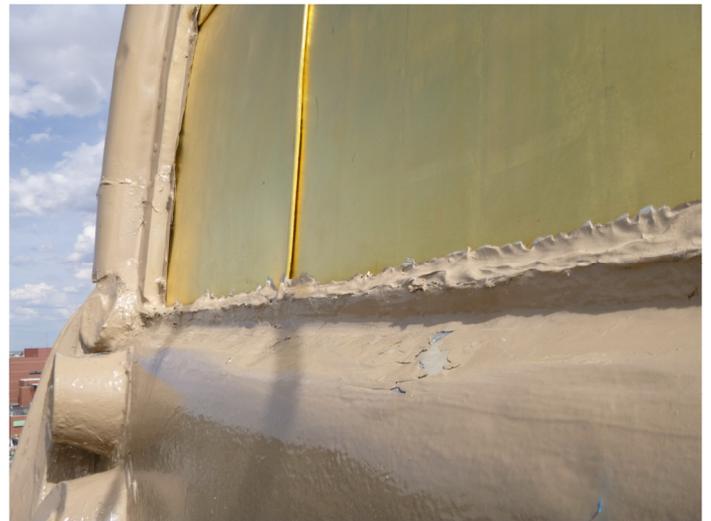
**24-107 SheetMetal\_Coating Coating Failed 2013-1**

**24-107 SheetMetal\_Coating Coating Failed 2013-2**

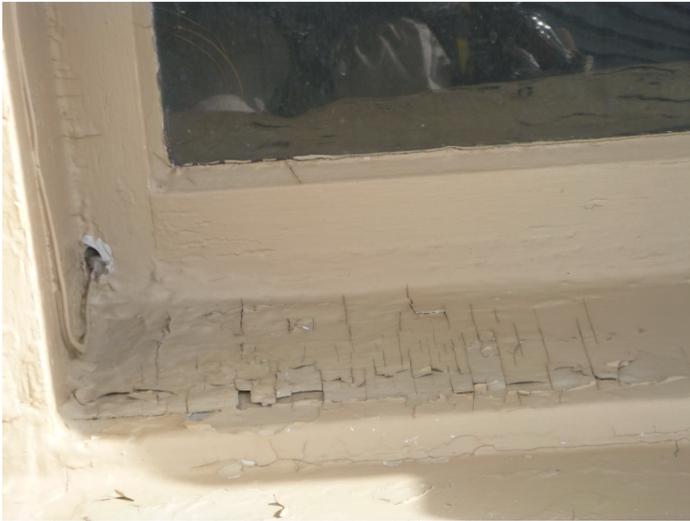
**24-108 SheetMetal\_Note Sealant (at all sections) 2013-1**

**24-108 SheetMetal\_Note Sealant (at all sections) 2013-2**
