# Report Narrative

## Wyoming State Capitol Dome Investigation Cheyenne, WY

Vertical Access LLC  
PO Box 4135, Ithaca, NY 14852  
Tel: 607 257 4049 / Fax: 607 257 2129

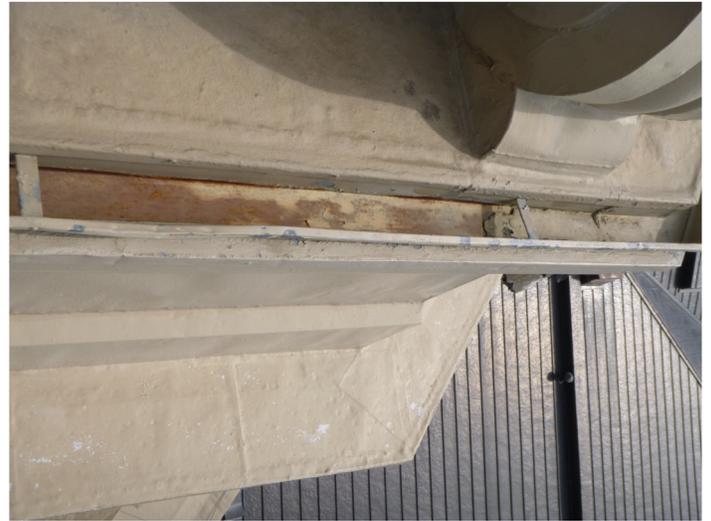
**25-56 Wood\_Coating Coating Failed 2013-1**

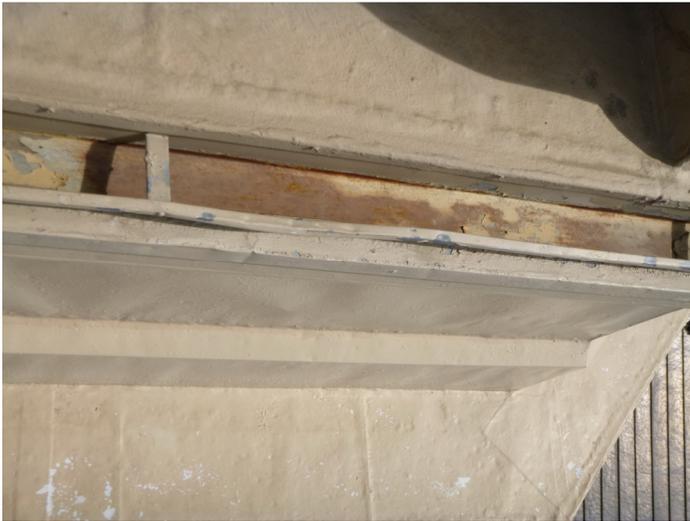
**25-95 SheetMetal\_Corrosion Surface 2013-1**

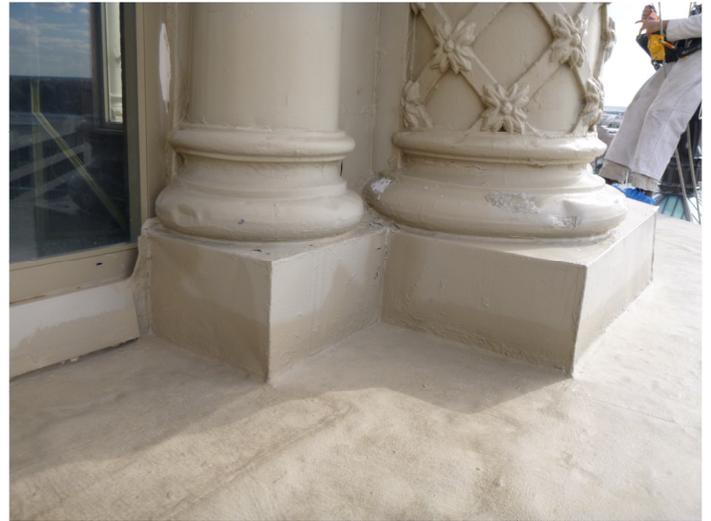
**25-95 SheetMetal\_Corrosion Surface 2013-2**

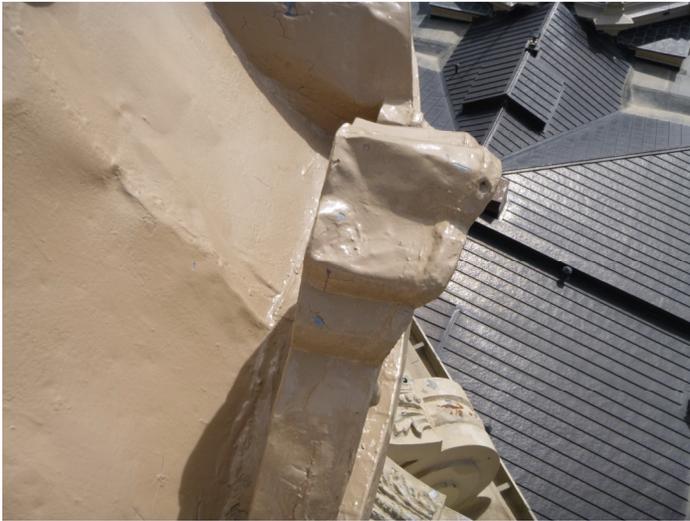
**26-75 SheetMetal\_Damaged Dented 2013-1**

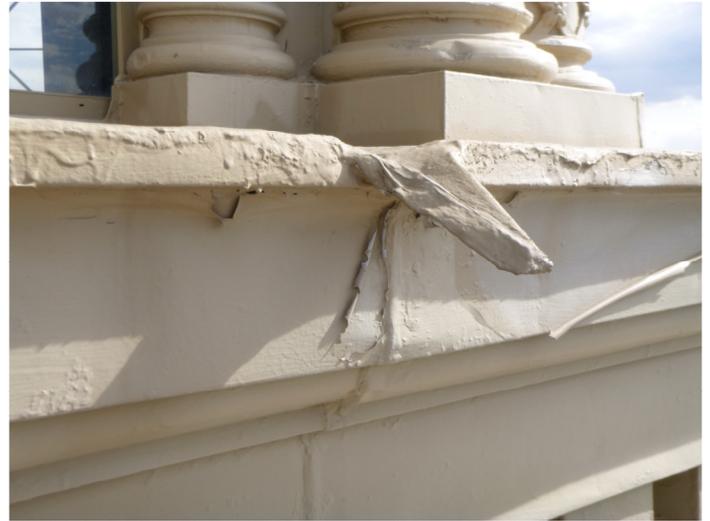
**26-105 SheetMetal\_Damaged Dented 2013-1**

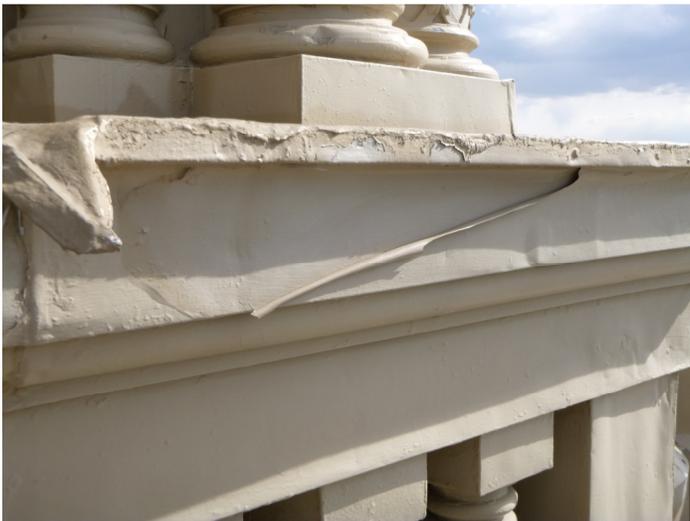
**27-73 SheetMetal\_Coating Coating Failed 2013-1**

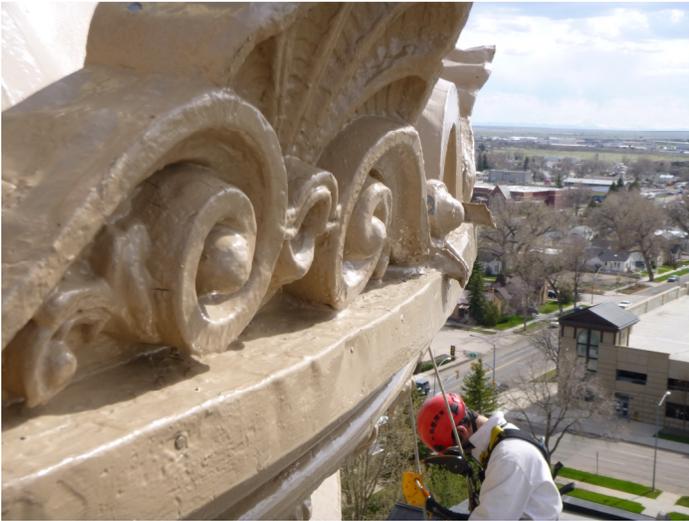
**27-97 SheetMetal\_Coating Coating Failed 2013-1**

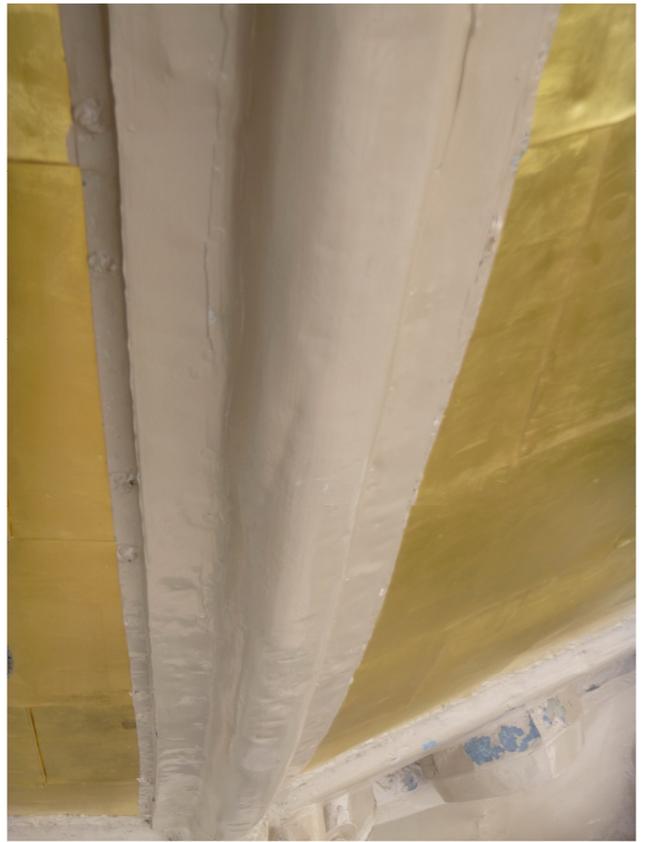
**27-104 SheetMetal\_Damaged Dented 2013-1**

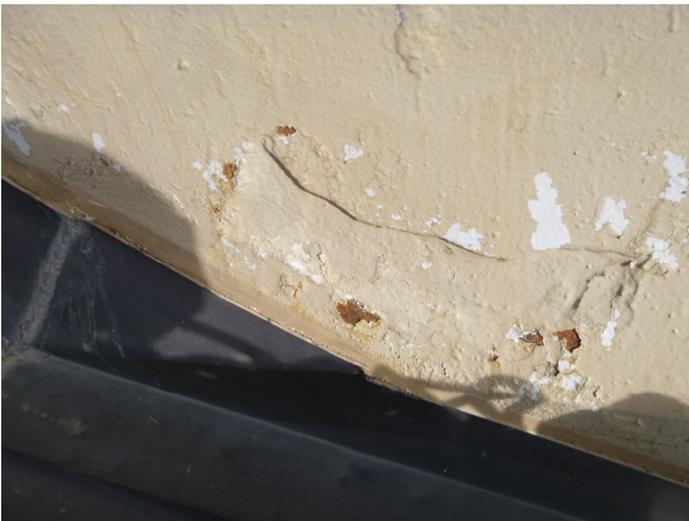
**27-110 SheetMetal\_Damaged Dented 2013-1**

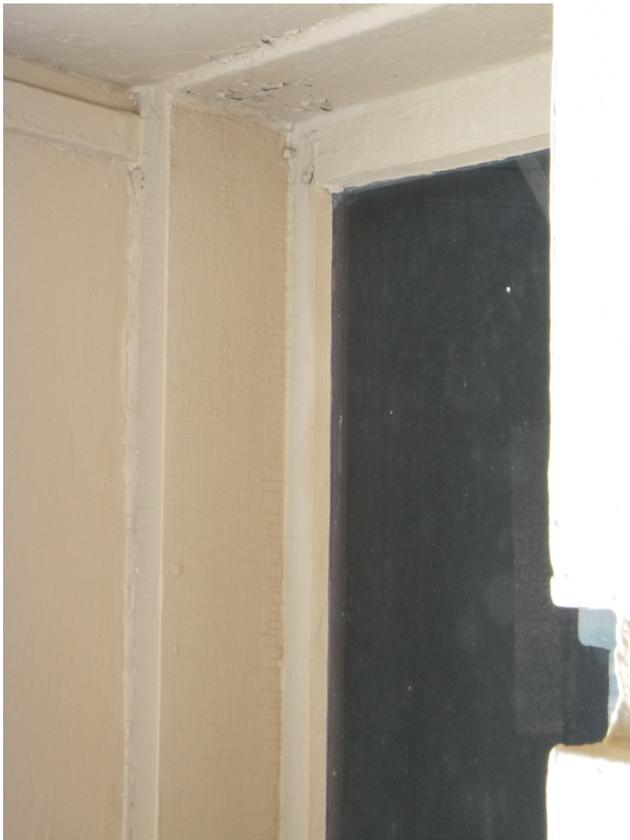
**28-96 SheetMetal\_Corrosion Surface 2013-1**

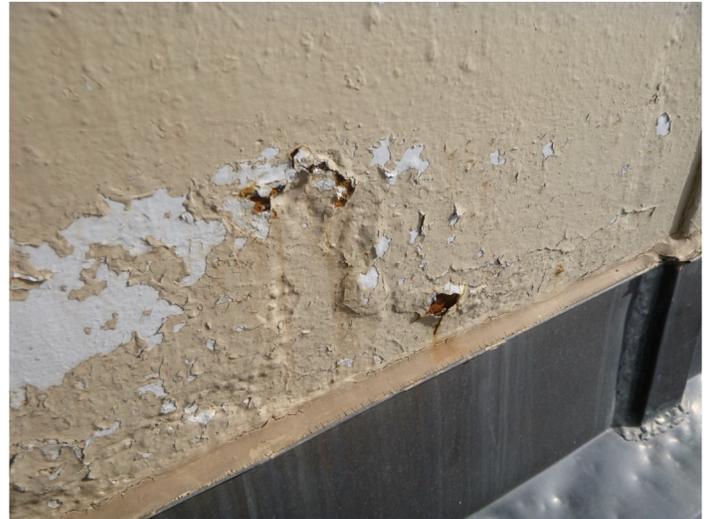
**30-56 Wood\_Coating Coating Failed 2013-1**

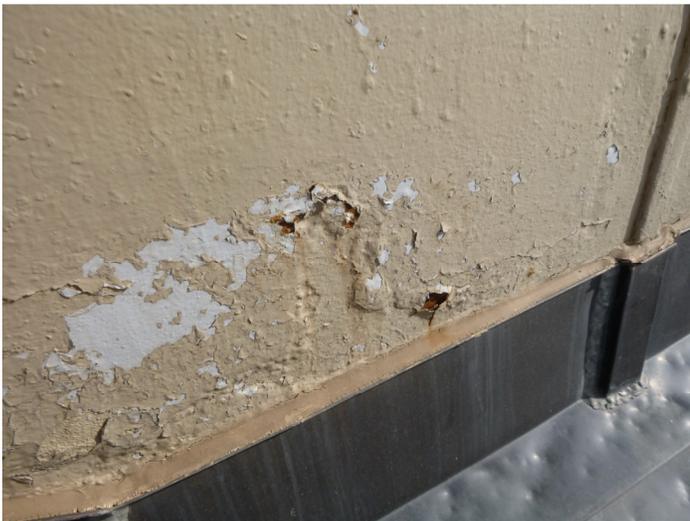
**33-50 ArchMetal\_Corrosion Surface 2013-1**

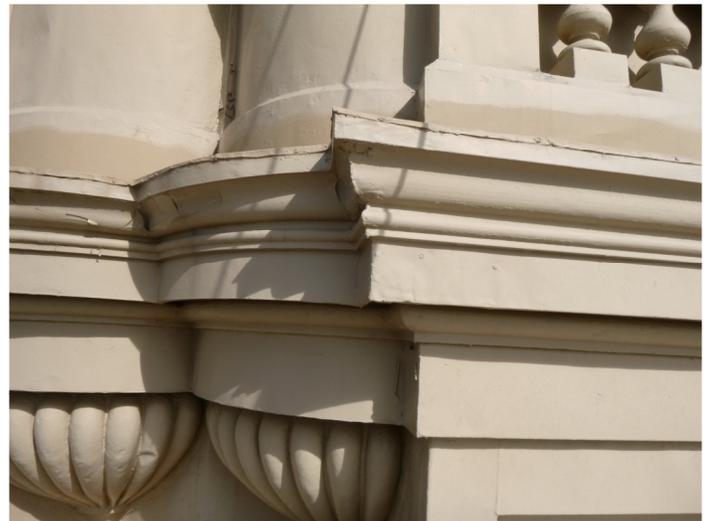
**33-51 ArchMetal\_Coating Coating Failed 2013-1**

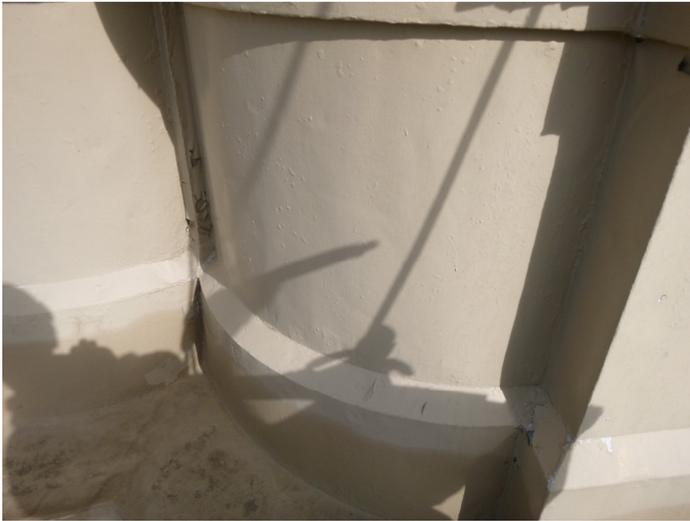
**89-68 SheetMetal\_Coating Coating Failed 2013-1**

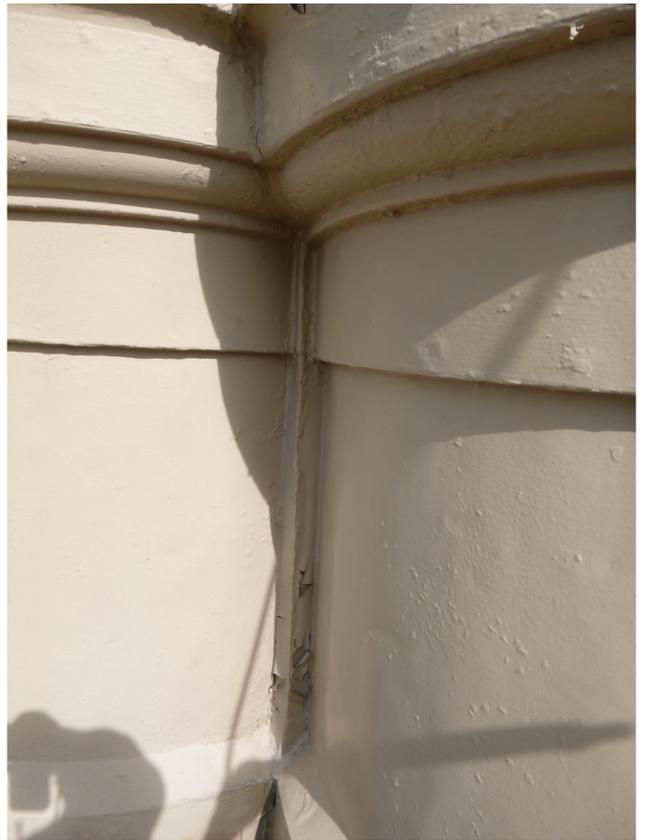
**89-70 SheetMetal\_Coating Coating Failed 2013-1**

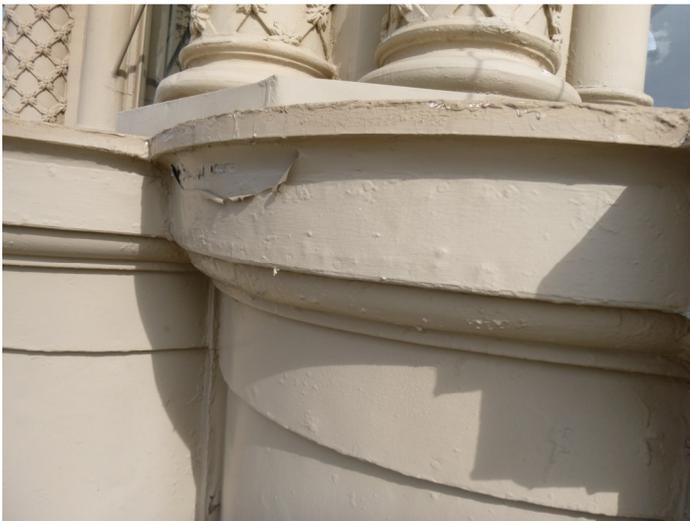
**89-71 SheetMetal\_Coating Coating Failed 2013-1**

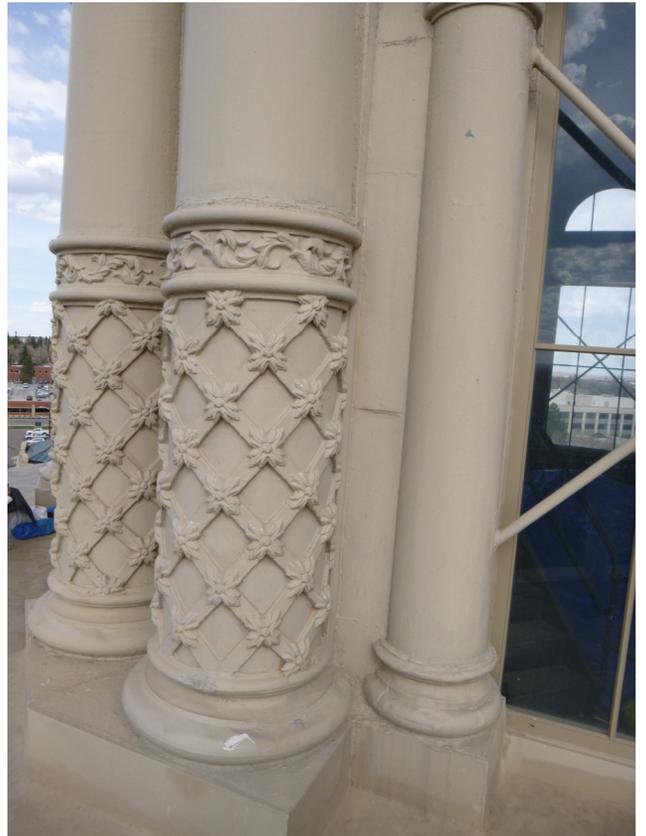
**89-73 SheetMetal\_Coating Coating Failed 2013-1**

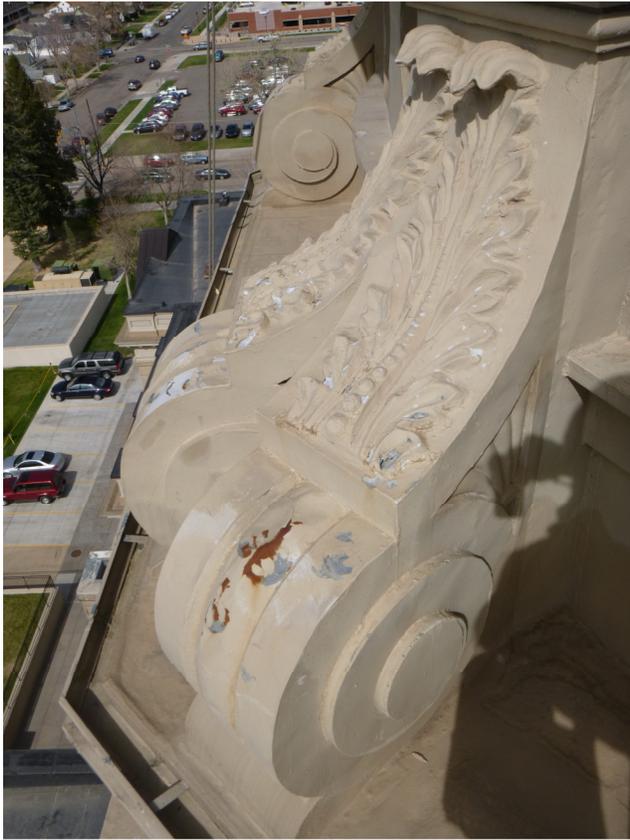
**90-77 SheetMetal\_Coating Coating Failed 2013-1**

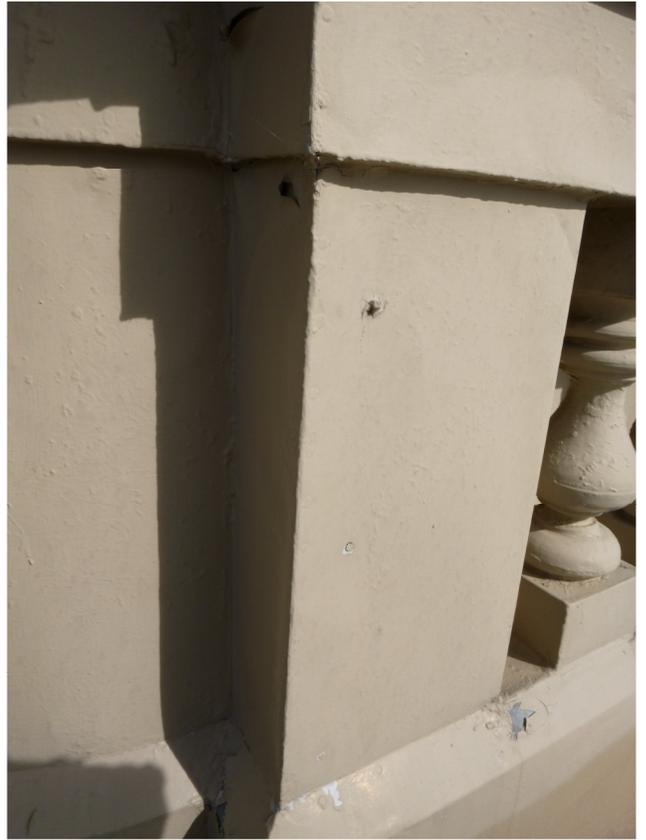
**90-99 SheetMetal\_Coating Coating Failed 2013-1**

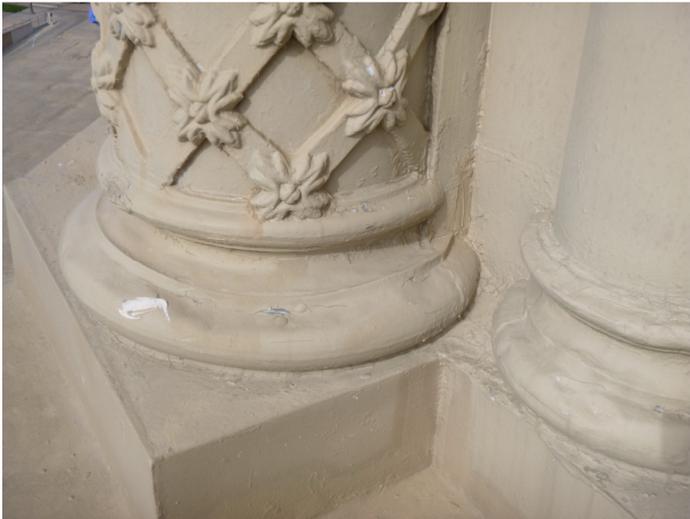
**91-71 SheetMetal\_Seam Fastener Failed 2013-1**

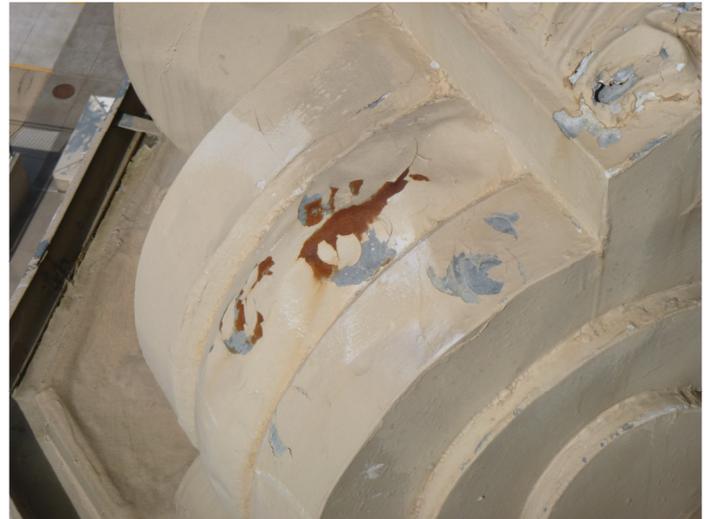
**91-74 SheetMetal\_Damaged Dented 2013-1**

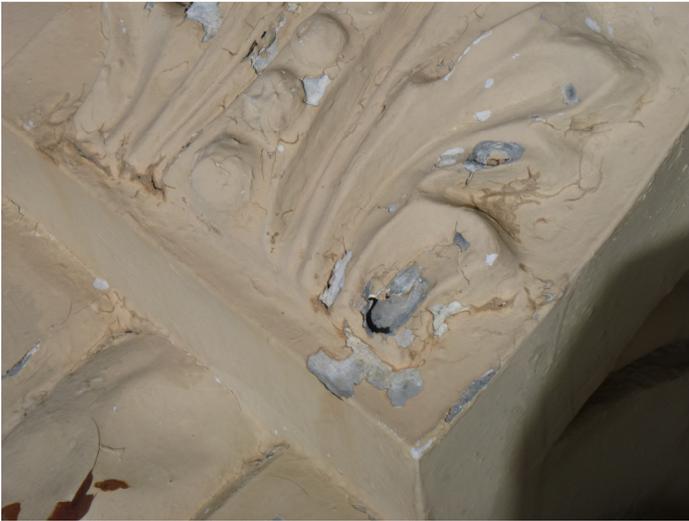
**91-97 SheetMetal\_Corrosion Surface 2013-1**

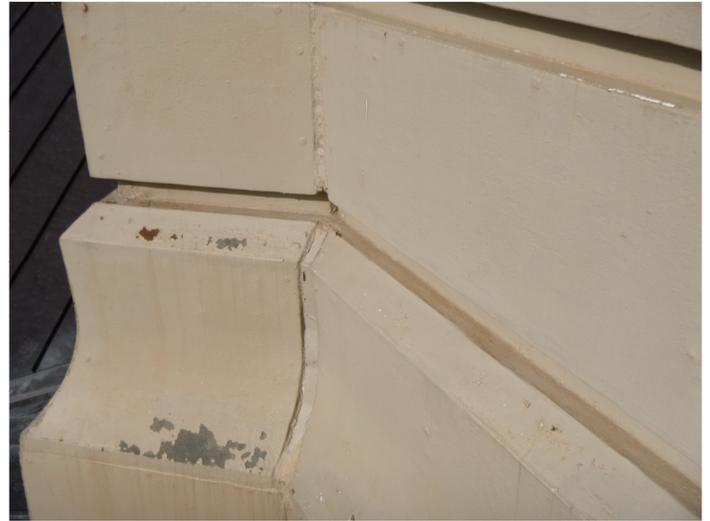
**91-99 SheetMetal\_Damaged Punctured 2013-1**

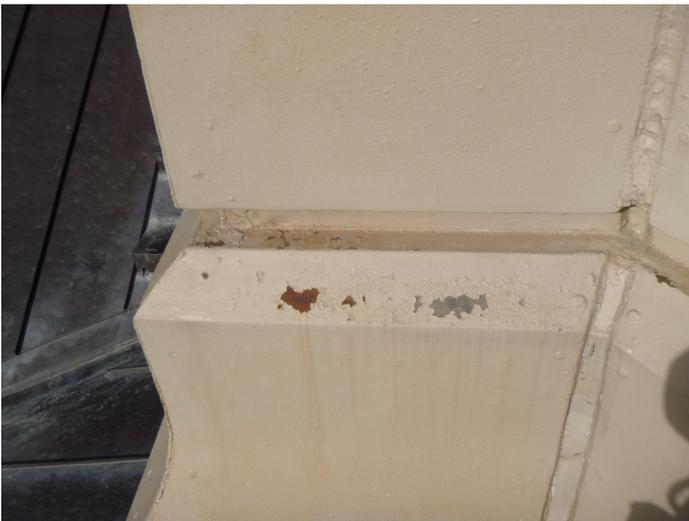
**92-52 ArchMetal\_Corrosion Surface 2013-1**

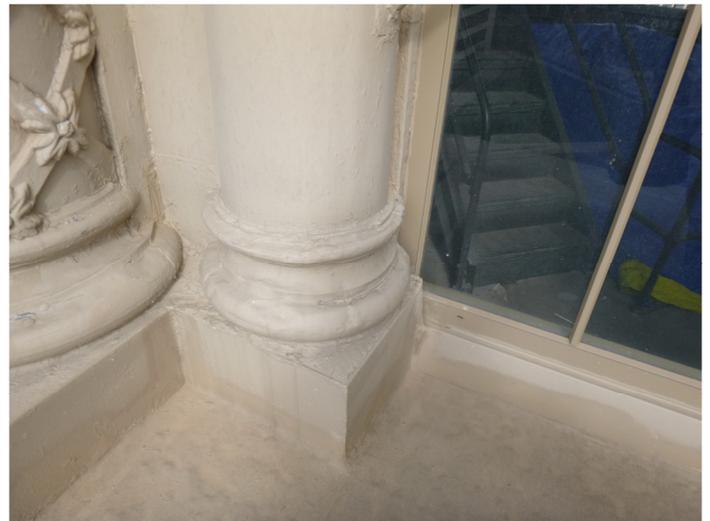
**92-52 ArchMetal\_Corrosion Surface 2013-2**

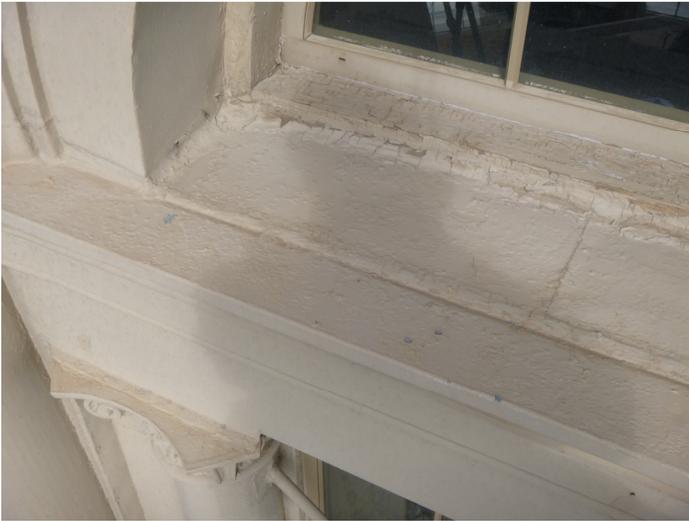
**92-75 SheetMetal\_Damaged Dented 2013-1**

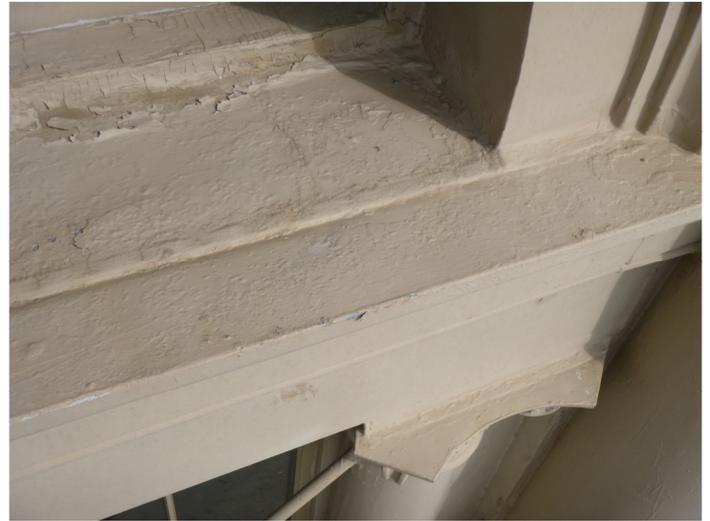
**92-83 SheetMetal\_Coating Coating Failed 2013-1**

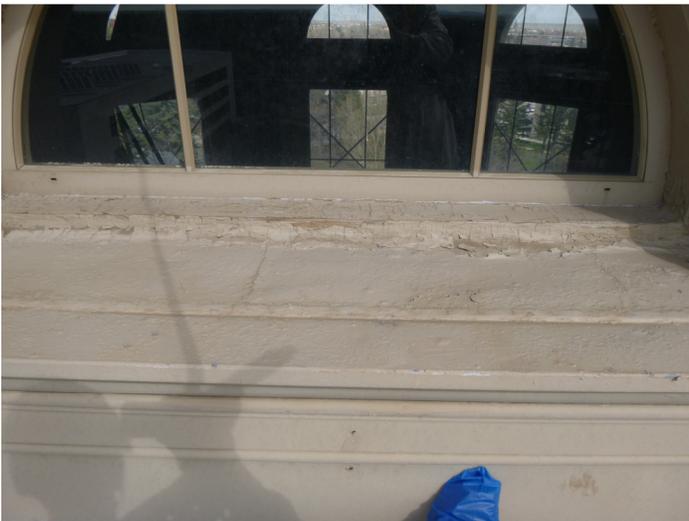
**92-83 SheetMetal\_Coating Coating Failed 2013-2**

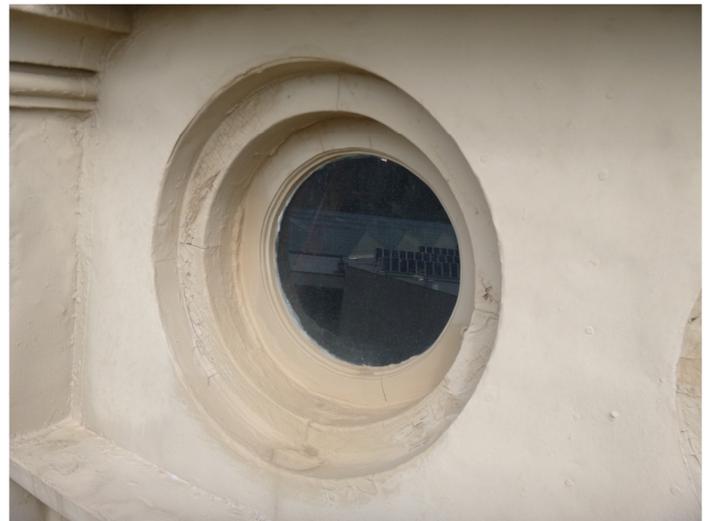
**92-83 SheetMetal\_Coating Coating Failed 2013-3**

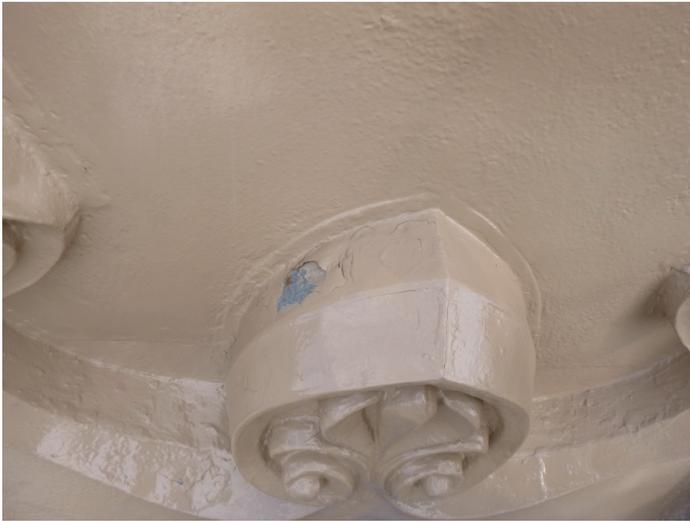
**92-98 Wood\_Coating Coating Failed 2013-1**

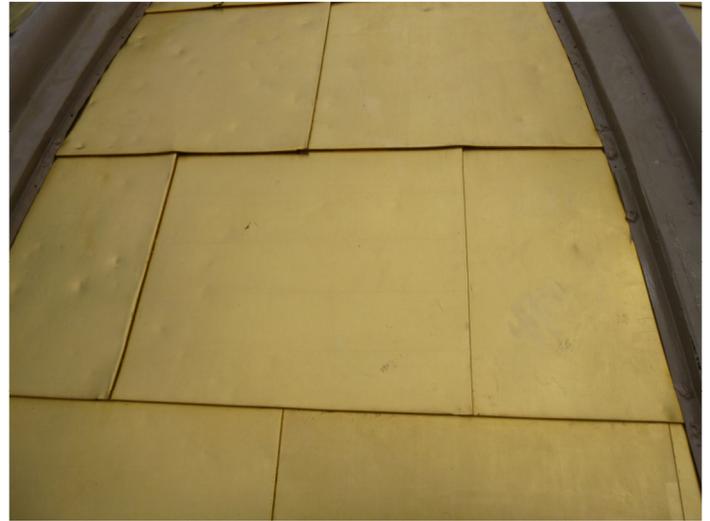
**92-105 SheetMetal\_Coating Coating Failed 2013-1**

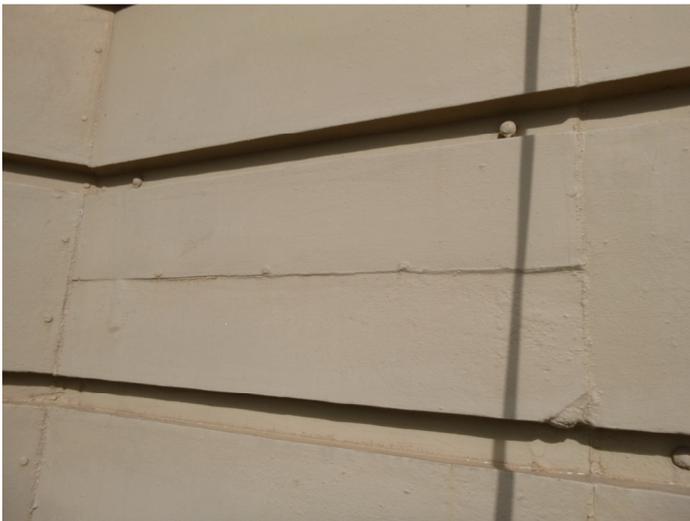
**92-115 SheetMetal\_Coating Coating Failed 2013-1**

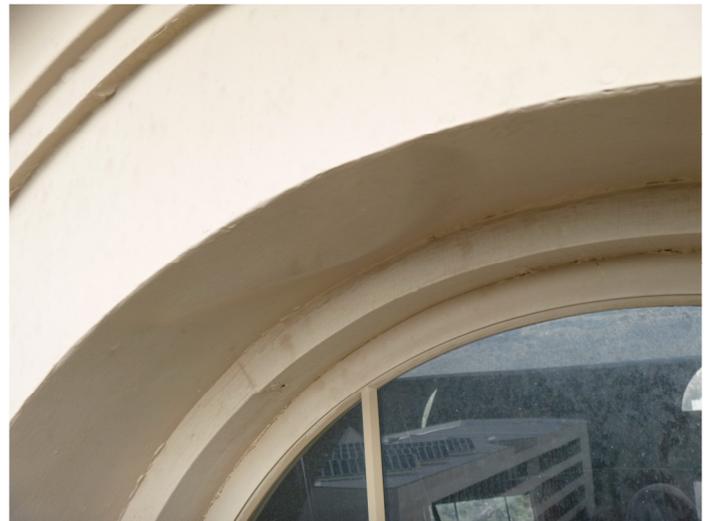
**93-58 ArchMetal\_Note Photo-joint 2013-1**

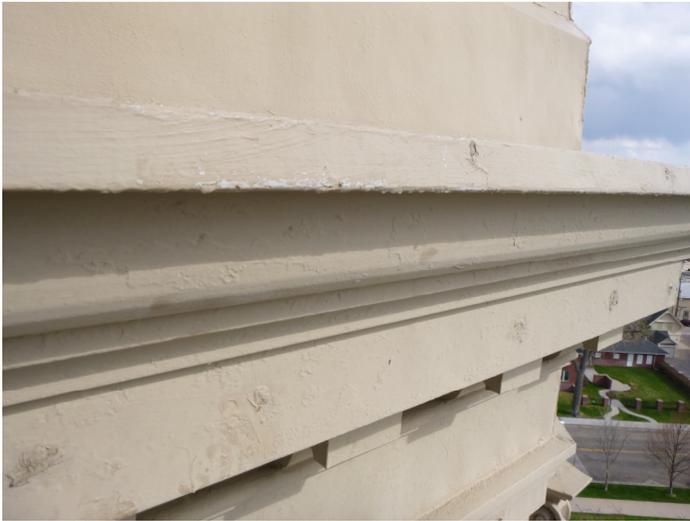
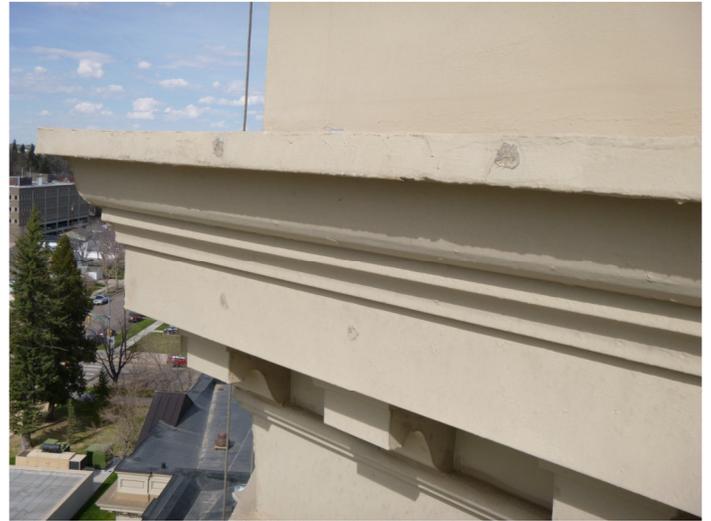
**93-86 SheetMetal\_Damaged Dented 2013-1**

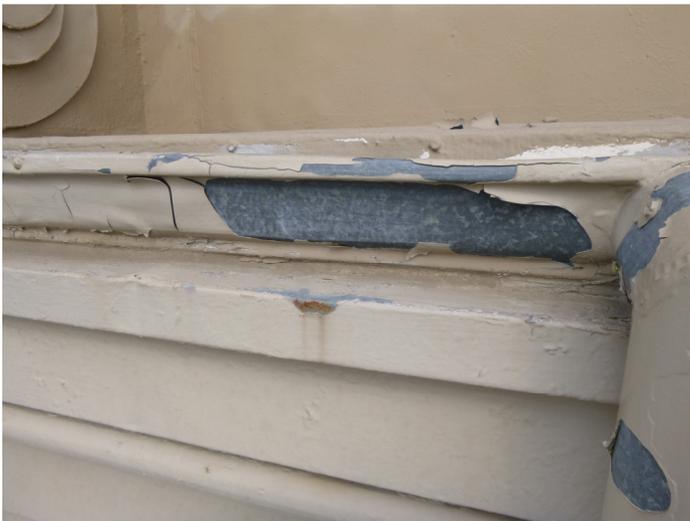
93-91 SheetMetal\_Note Photo-sealant at fasteners 2013-1

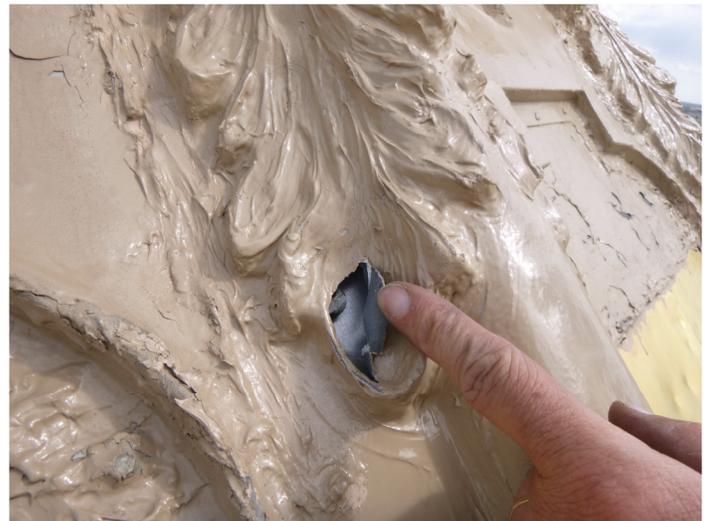
93-91 SheetMetal\_Note Photo-sealant at fasteners 2013-2

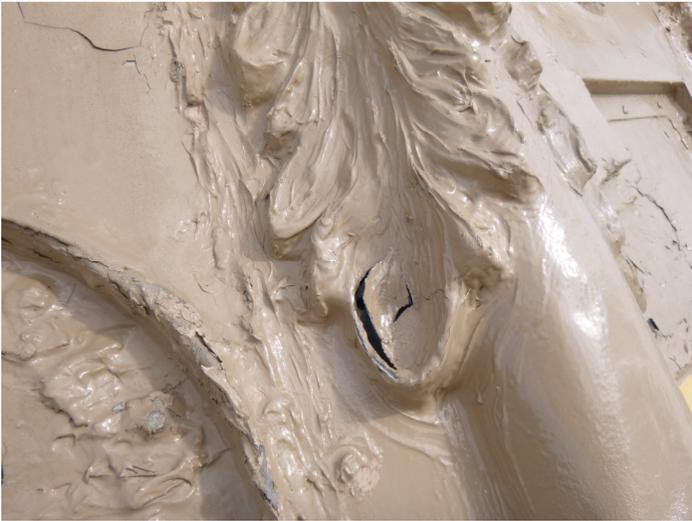
93-119 SheetMetal\_Damaged Punctured 2013-1

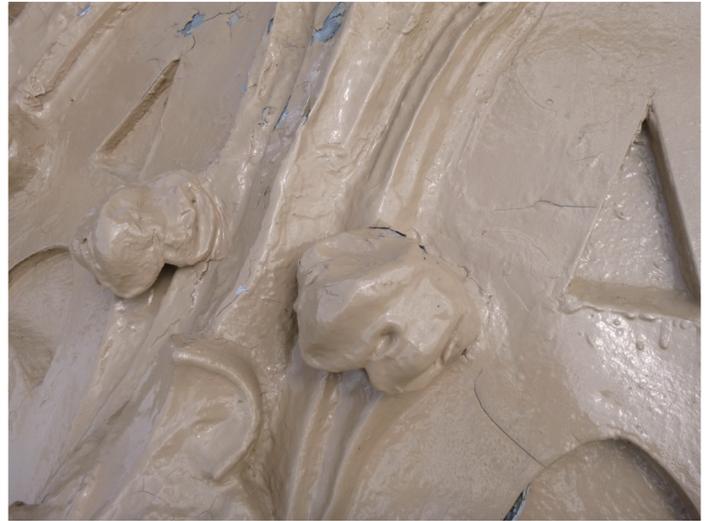
**93-119 SheetMetal\_Damaged Punctured 2013-2**

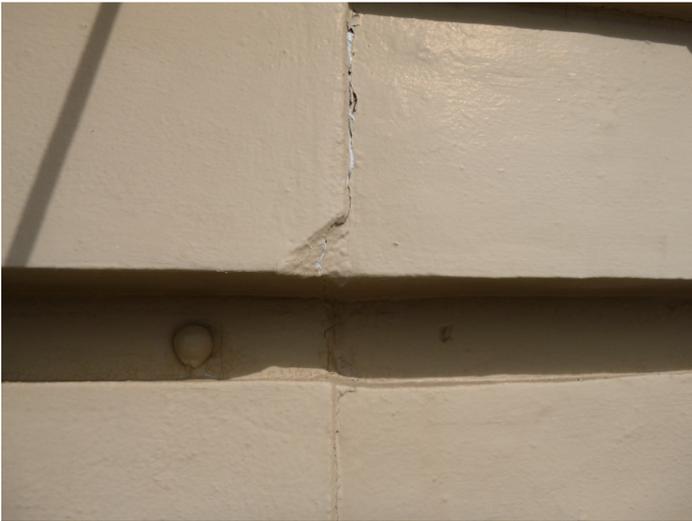
**93-120 SheetMetal\_Damaged Dented 2013-1**

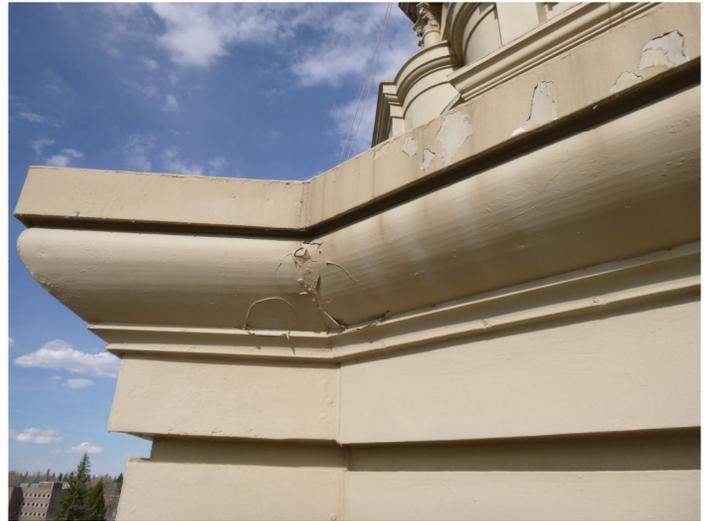
**94-59 ArchMetal\_Crack Crack 2013-1**

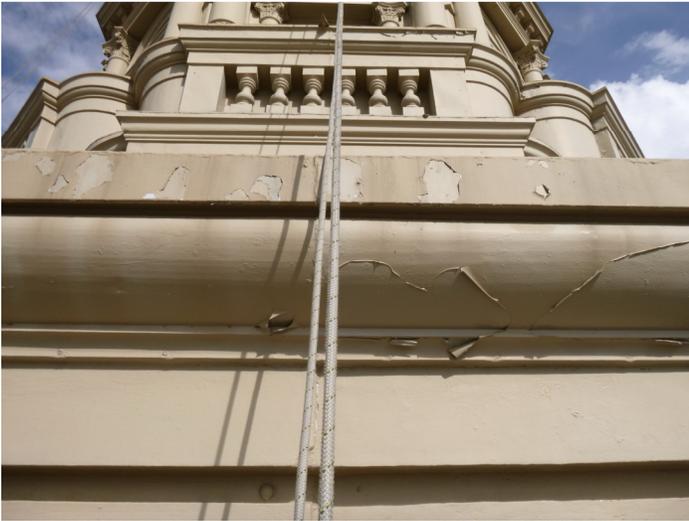
**94-61 SheetMetal\_Coating Coating Failed 2013-1**

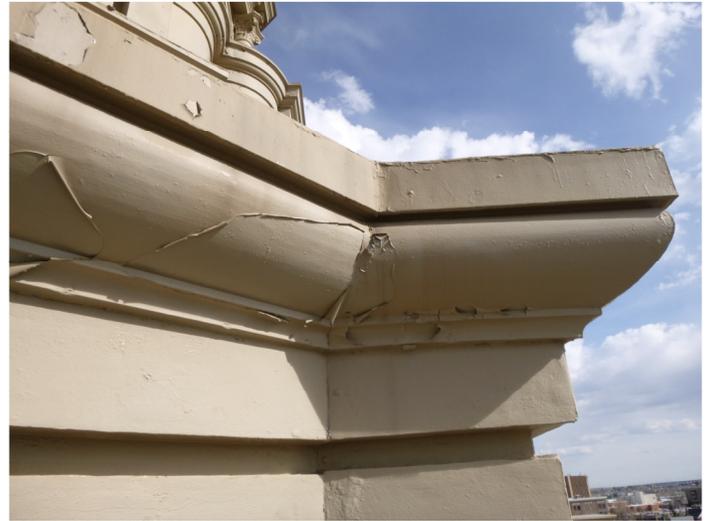
**94-61 SheetMetal\_Coating Coating Failed 2013-2**

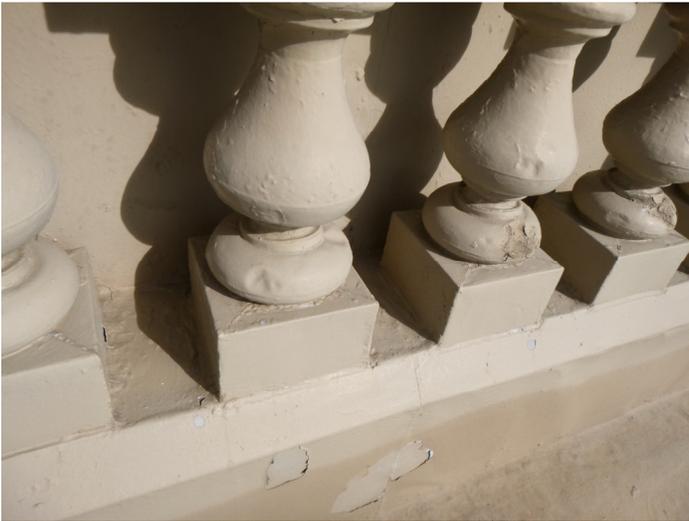
**94-61 SheetMetal\_Coating Coating Failed 2013-3**

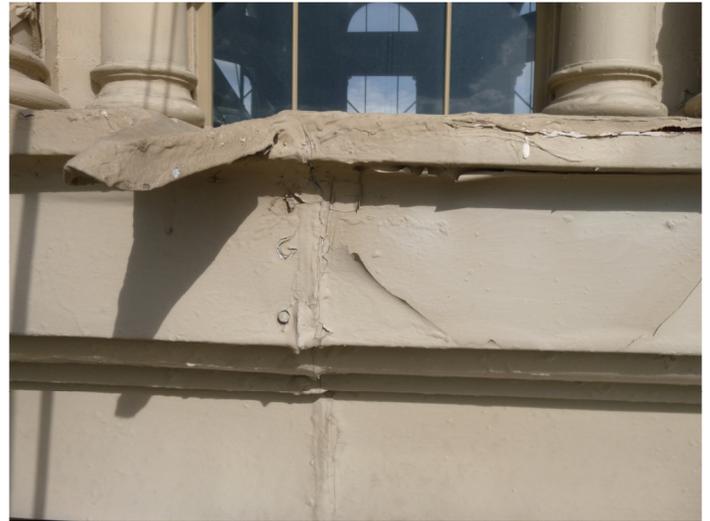
**94-70 SheetMetal\_Damaged Dented 2013-1**

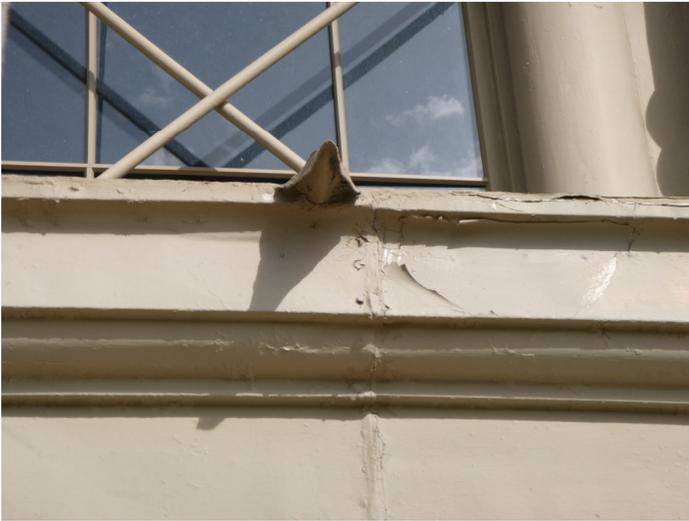
**94-73 SheetMetal\_Seam Fastener Failed 2013-1**

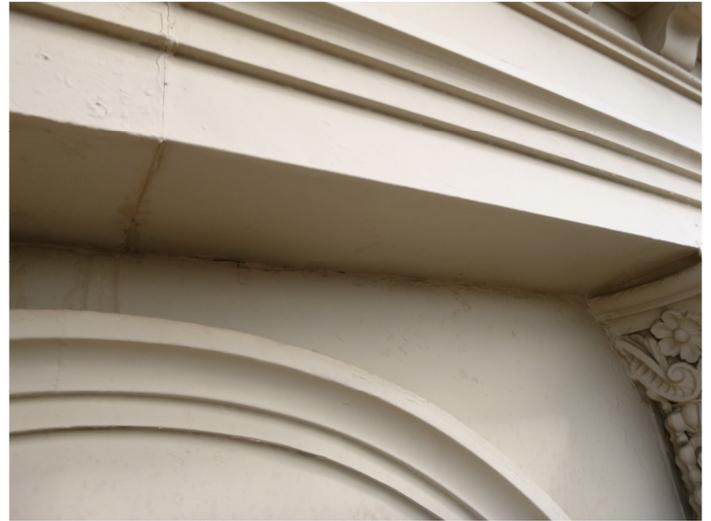
**94-74 SheetMetal\_Note Photo-scupper 2013-1**

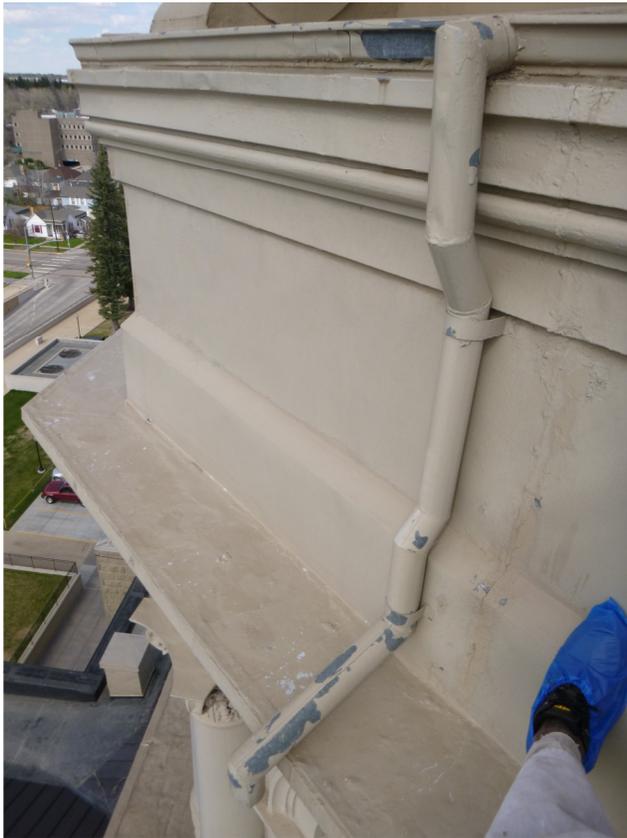
**94-87 SheetMetal\_Coating Coating Failed 2013-1**

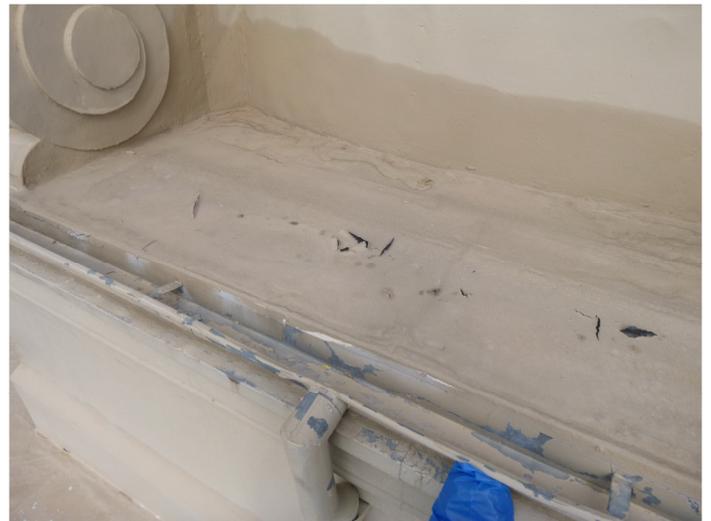
**94-93 SheetMetal\_Coating Coating Failed 2013-1**

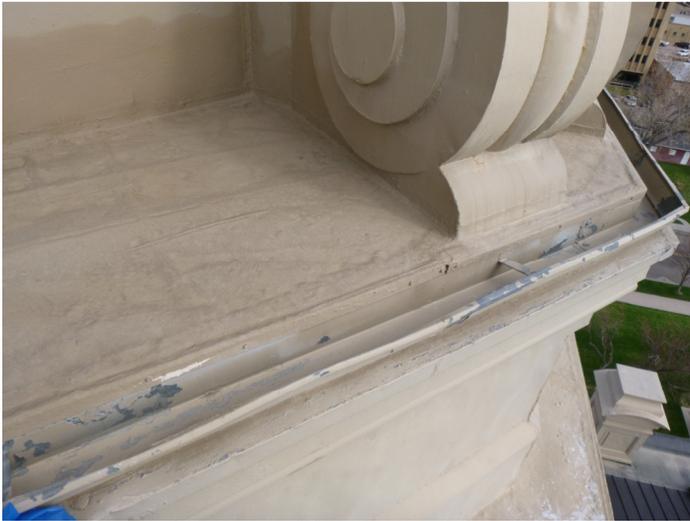
**94-96 SheetMetal\_Coating Coating Failed 2013-1**

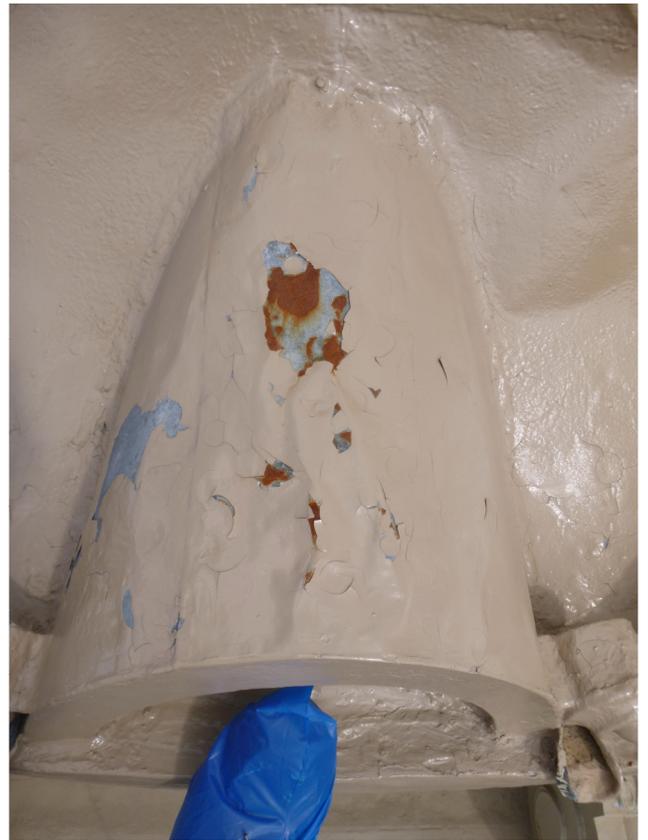
**94-96 SheetMetal\_Coating Coating Failed 2013-2**

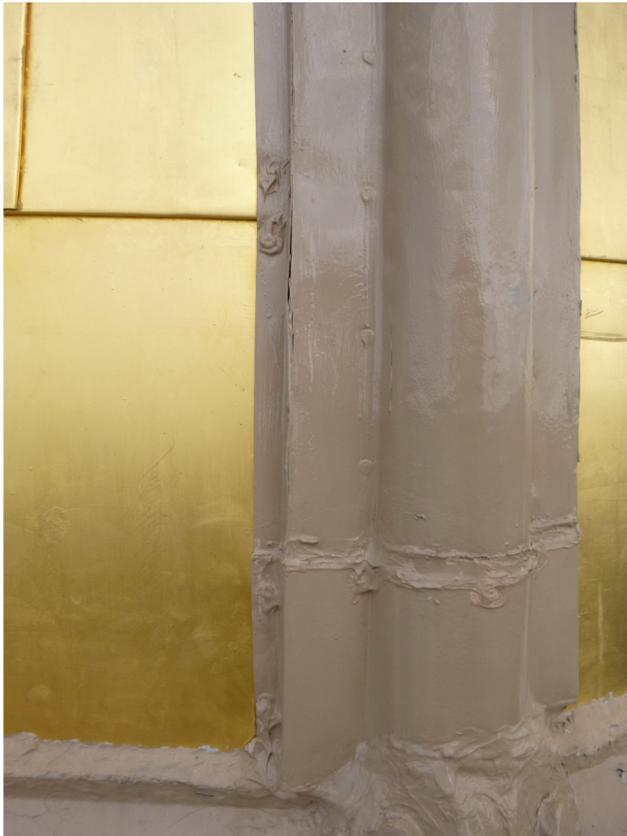
**94-104 SheetMetal\_Corrosion Surface 2013-1**

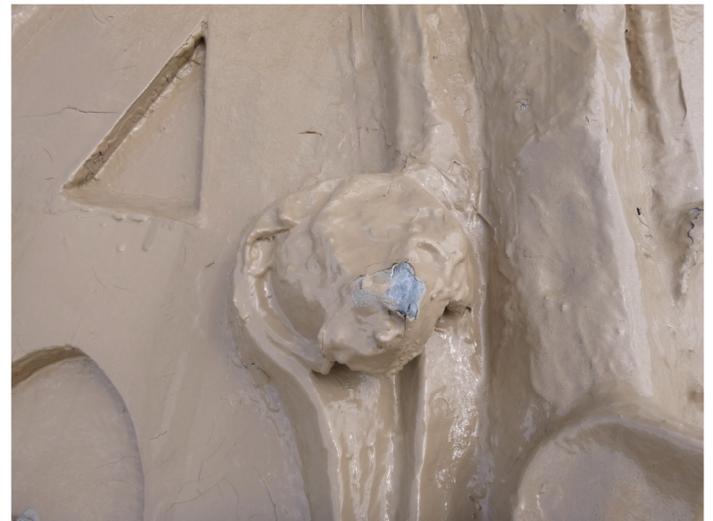
**94-110 SheetMetal\_Seam Solder Failed 2013-2**

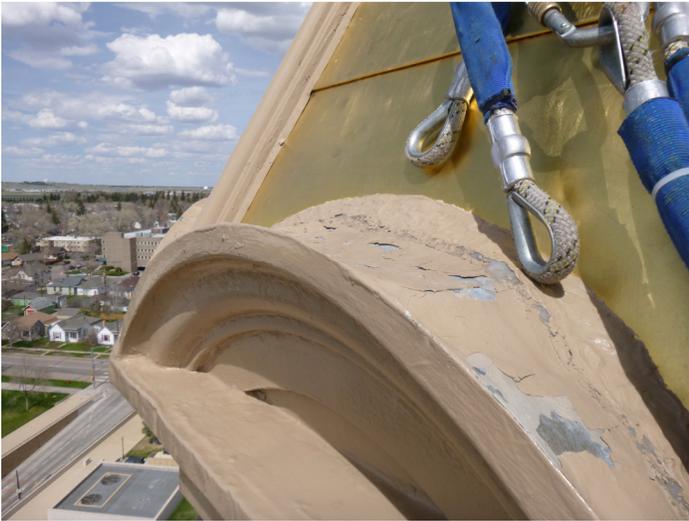
**94-120 SheetMetal\_Damaged Dented 2013-1**

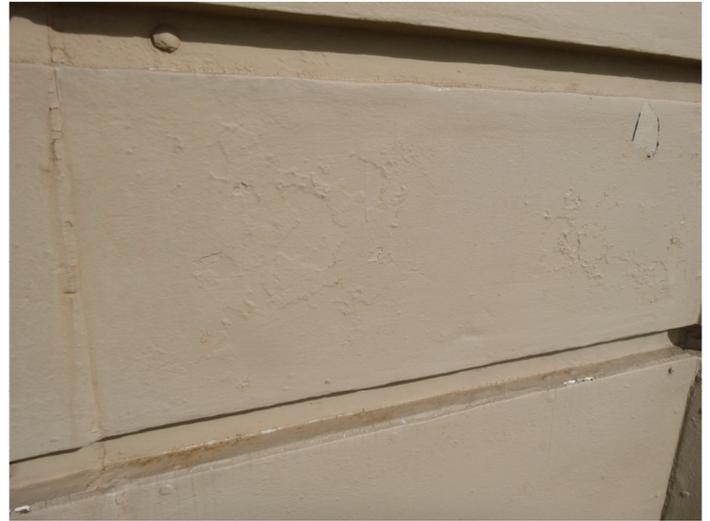
**94-130 SheetMetal\_Coating Coating Failed 2013-1**

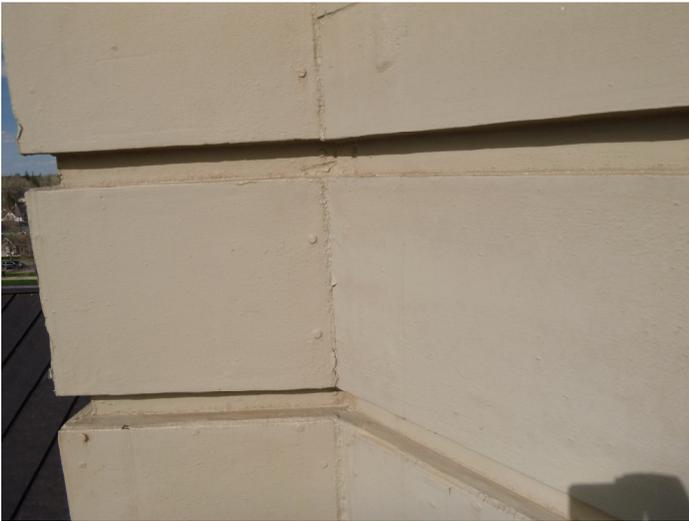
**95-55 ArchMetal\_Corrosion Surface 2013-1**

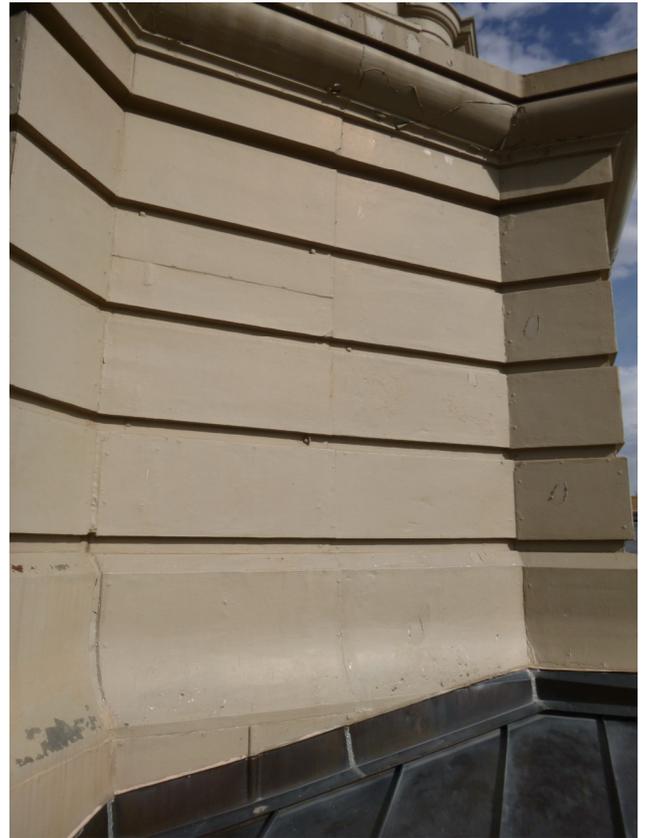
**95-55 ArchMetal\_Corrosion Surface 2013-2**
