# Report Narrative

## Wyoming State Capitol Dome Investigation Cheyenne, WY

Vertical Access LLC  
PO Box 4135, Ithaca, NY 14852  
Tel: 607 257 4049 / Fax: 607 257 2129

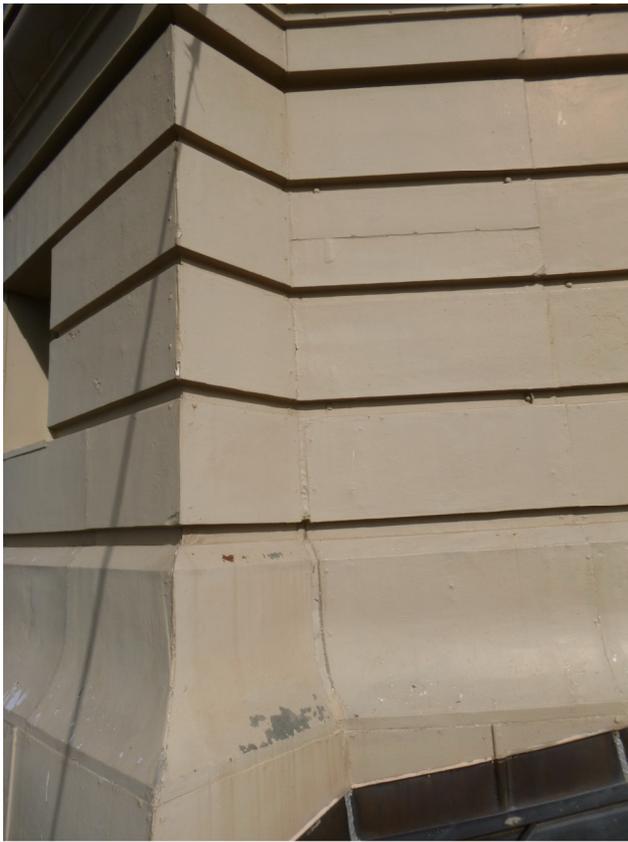
**95-59 ArchMetal\_Coating Coating Failed 2013-1**

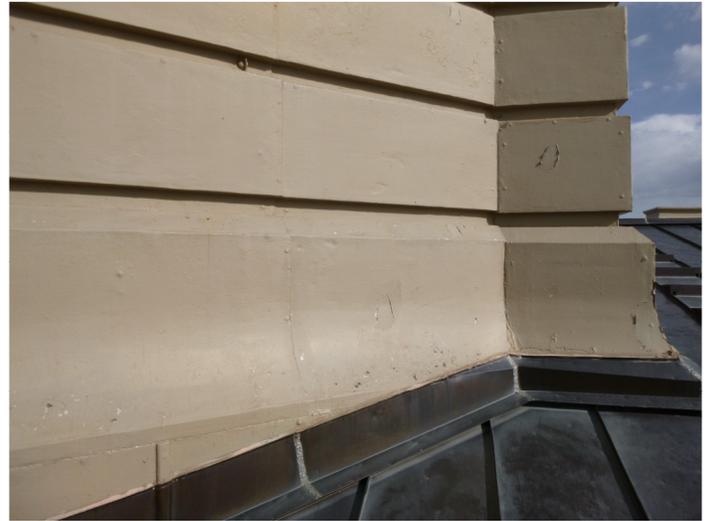
**95-59 ArchMetal\_Coating Coating Failed 2013-2**

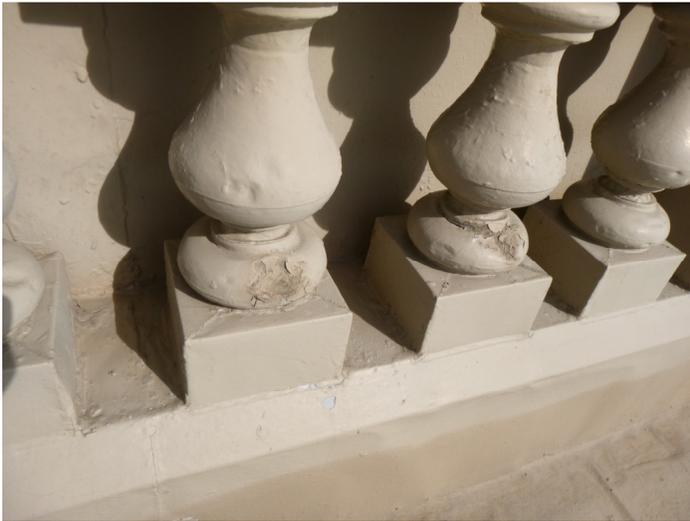
**95-59 ArchMetal\_Coating Coating Failed 2013-3**

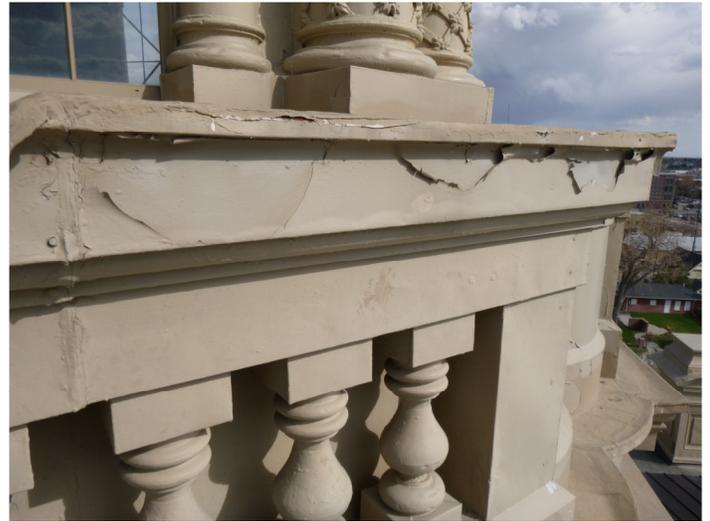
**95-71 SheetMetal\_Damaged Dented 2013-1**

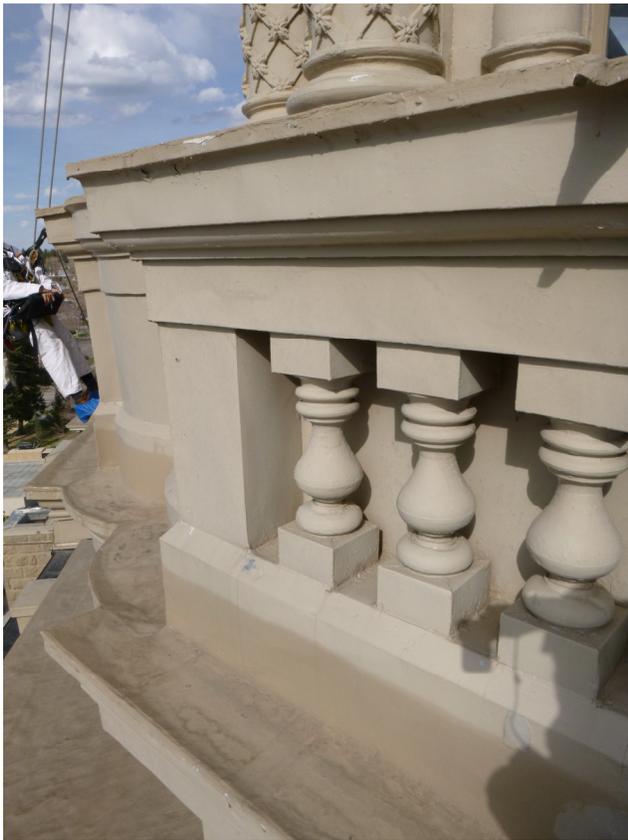
**95-73 SheetMetal\_Coating Coating Failed 2013-1**

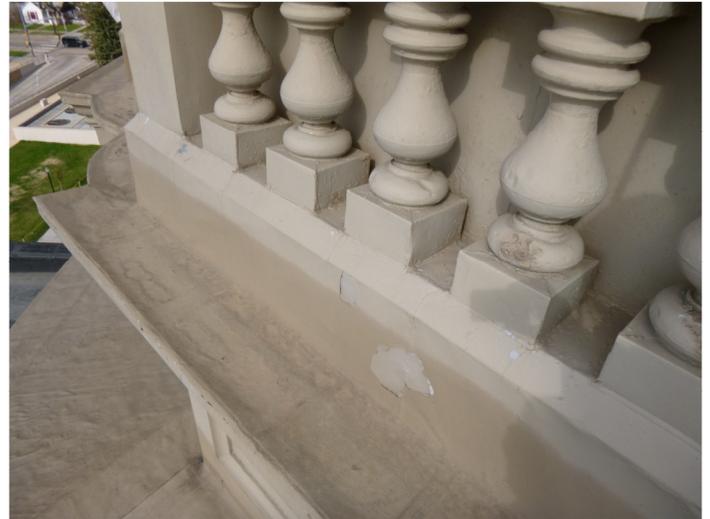
**95-73 SheetMetal\_Coating Coating Failed 2013-2**

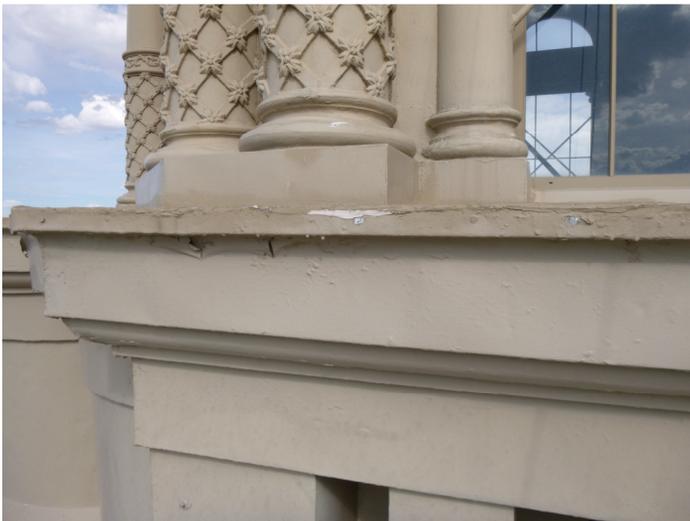
**95-73 SheetMetal\_Coating Coating Failed 2013-3**

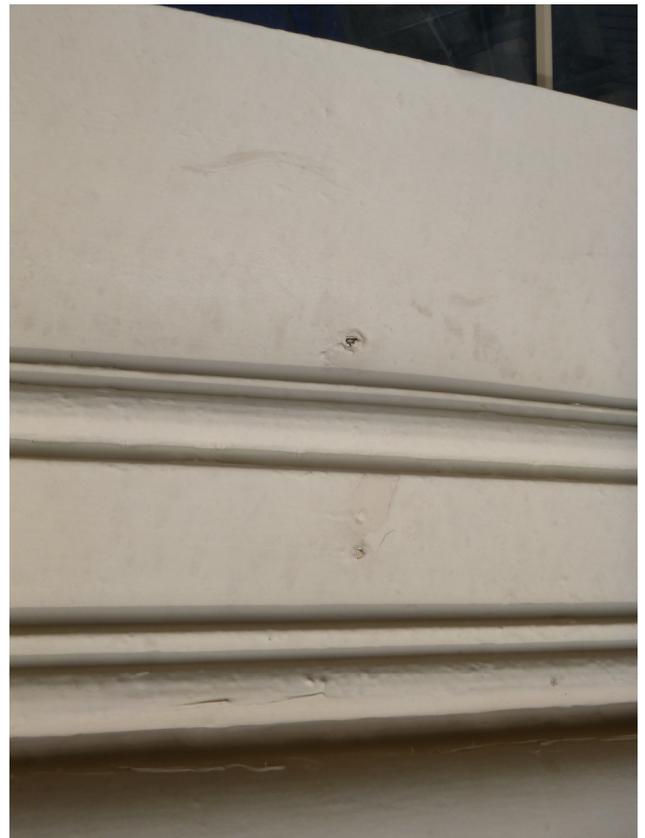
**95-73 SheetMetal\_Coating Coating Failed 2013-4**

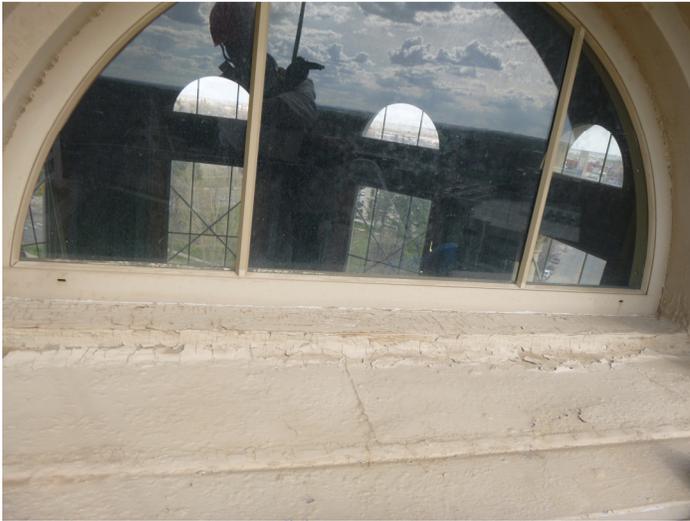
**95-82 SheetMetal\_Seam Fastener Failed 2013-1**

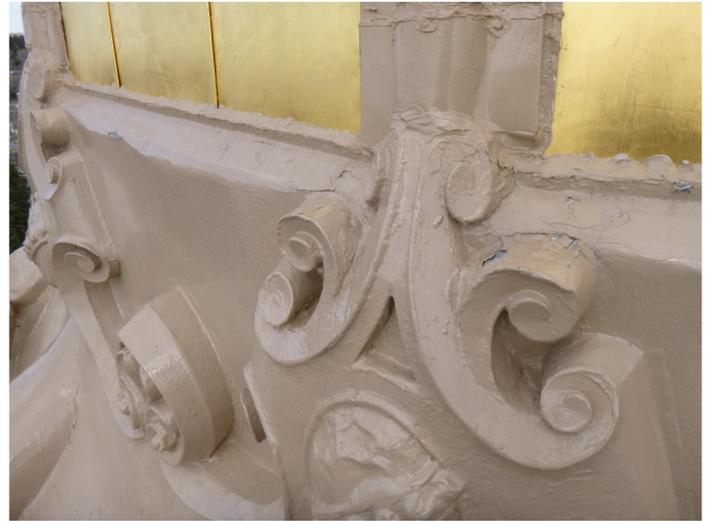
**95-84 Wood\_Deteriorated Weathered 2013-1**

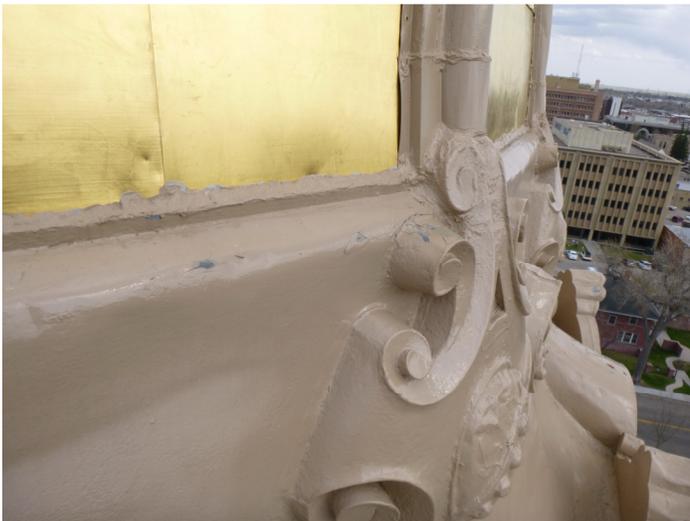
**95-107 SheetMetal\_Coating Coating Failed 2013-1**

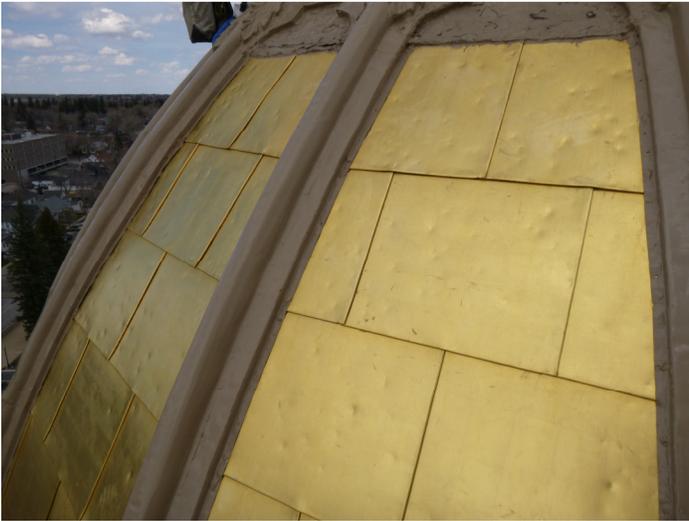
**95-115 SheetMetal\_Damaged Dented 2013-1**

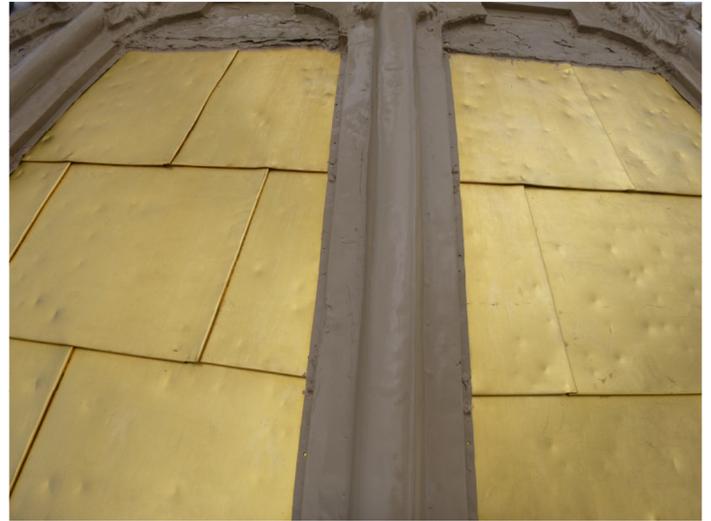
**95-115 SheetMetal\_Damaged Dented 2013-2**

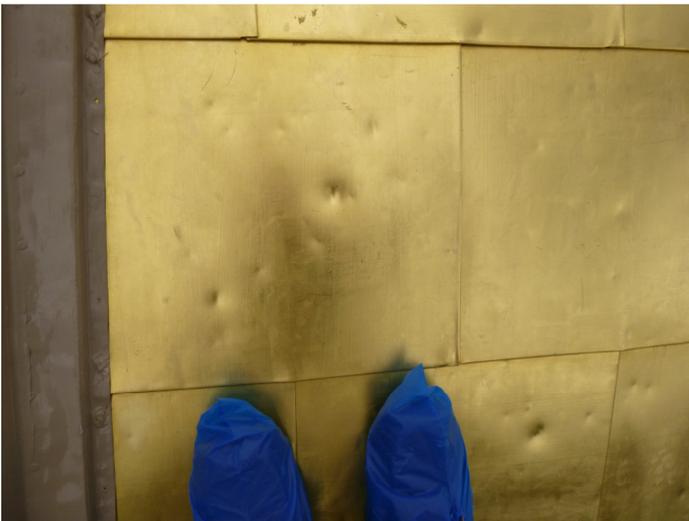
**95-115 SheetMetal\_Damaged Dented 2013-3**

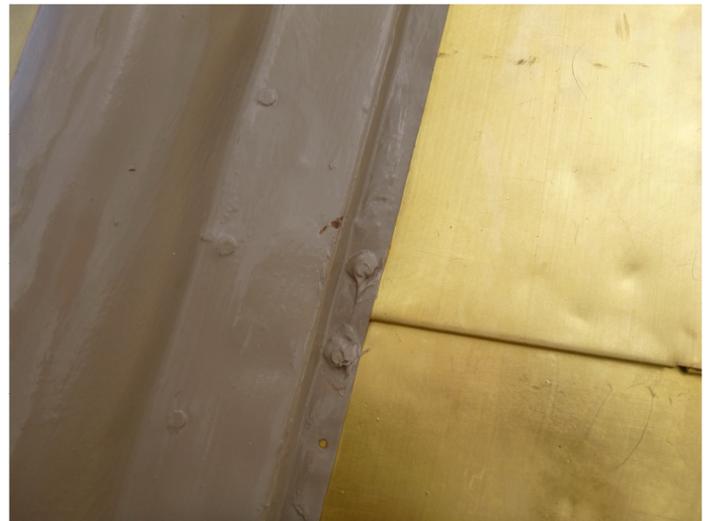
**95-115 SheetMetal\_Damaged Dented 2013-4**

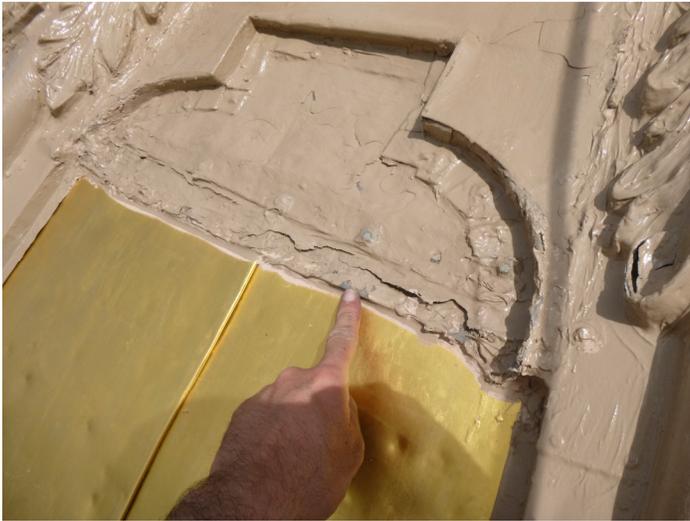
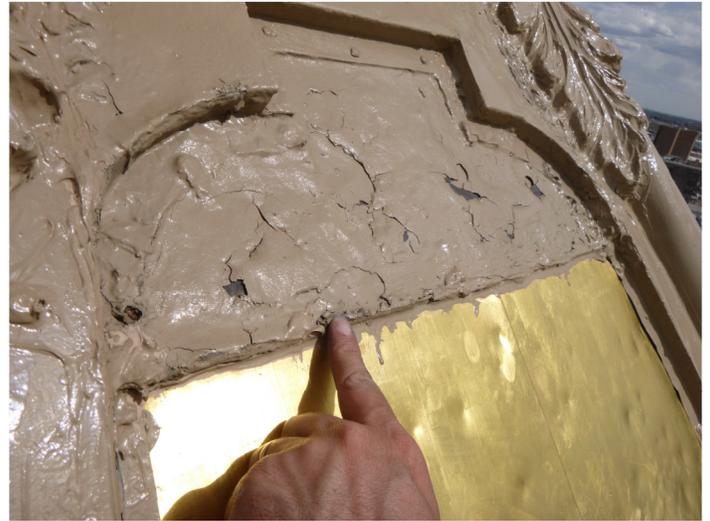
**95-116 SheetMetal\_Corrosion Surface 2013-2**

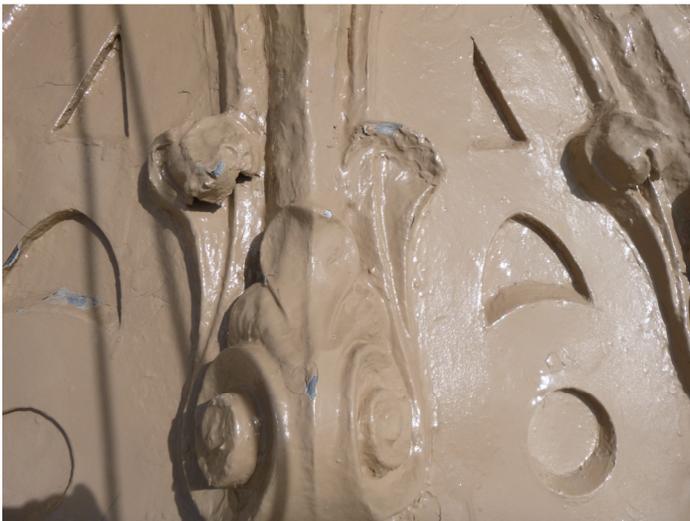
95-118 SheetMetal\_Note Photo-sealant joint 2013-6

95-118 SheetMetal\_Note Photo-sealant joint 2013-7

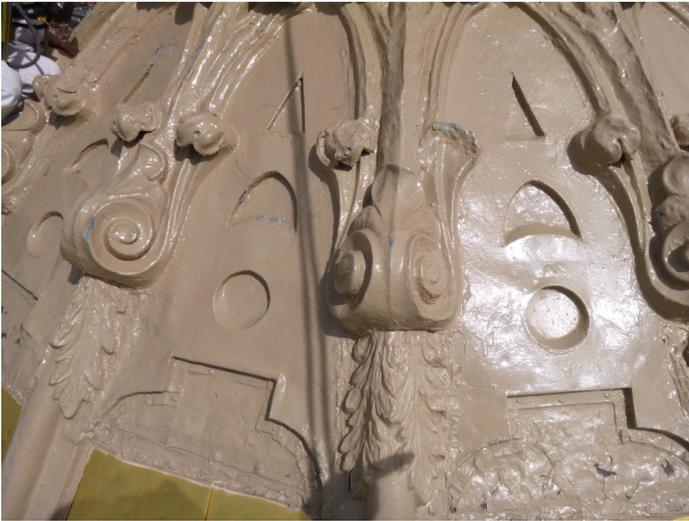
95-120 SheetMetal\_Coating Coating Failed 2013-1

95-120 SheetMetal\_Coating Coating Failed 2013-2

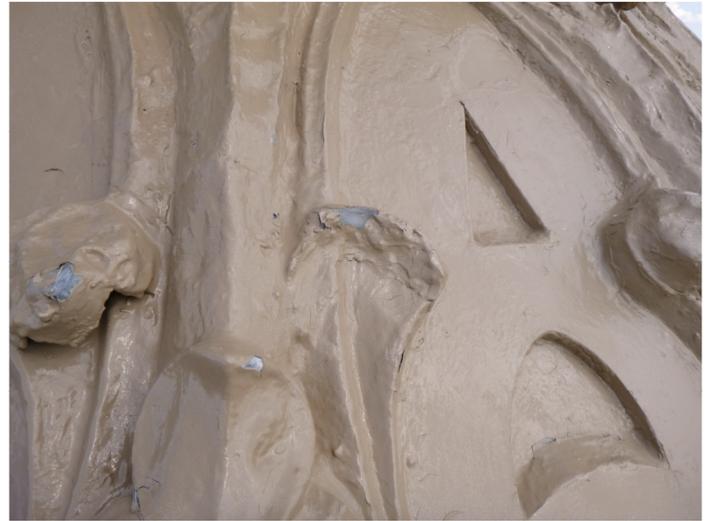
**95-120 SheetMetal\_Coating Coating Failed 2013-3**

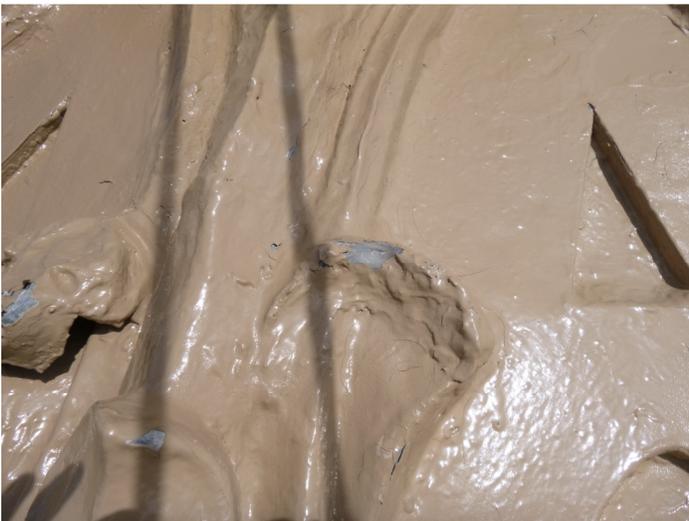
**95-120 SheetMetal\_Unsecured Missing 2013-1**

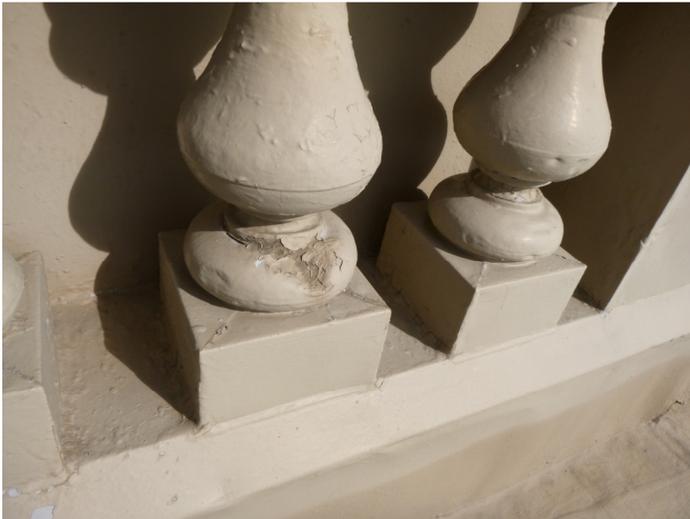
95-133 SheetMetal\_Note Photo-lantern roof and finial

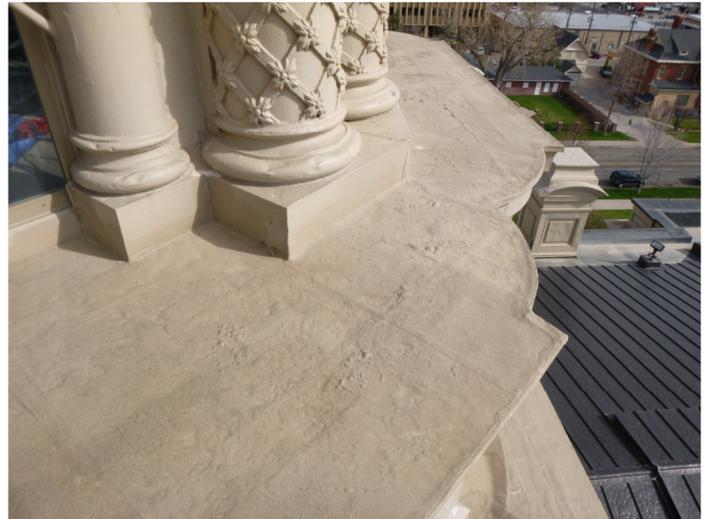
96-70 SheetMetal\_Damaged Dented 2013-1

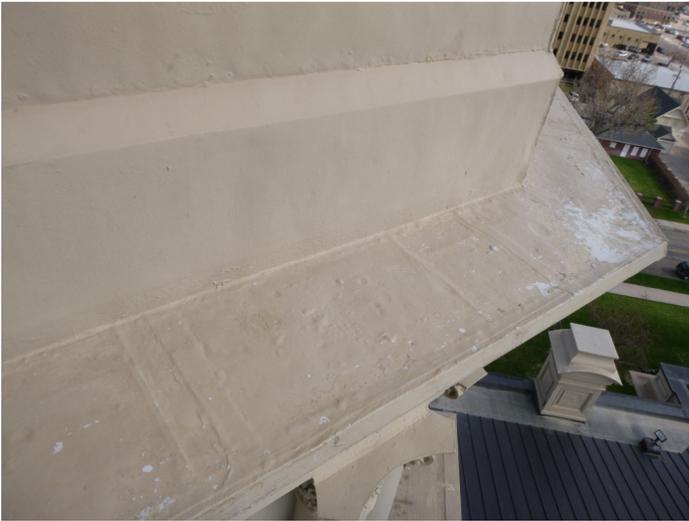
96-74 SheetMetal\_Coating Coating Failed 2013-1

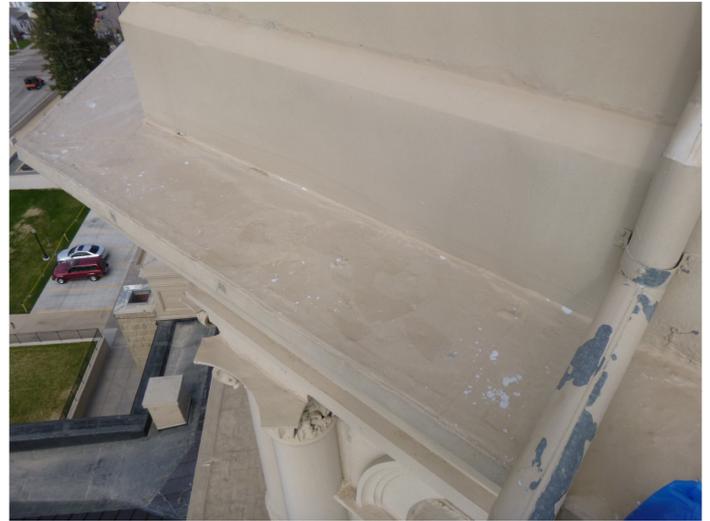
**96-91 SheetMetal\_Coating Coating Failed 2013-1**

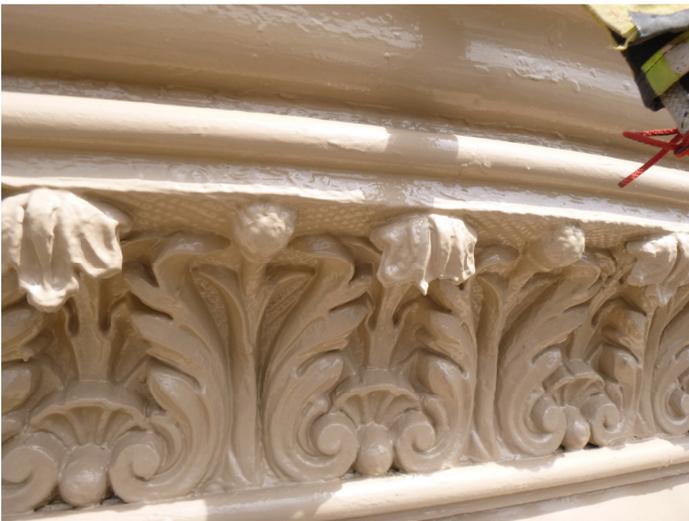
**96-91 SheetMetal\_Coating Coating Failed 2013-2**

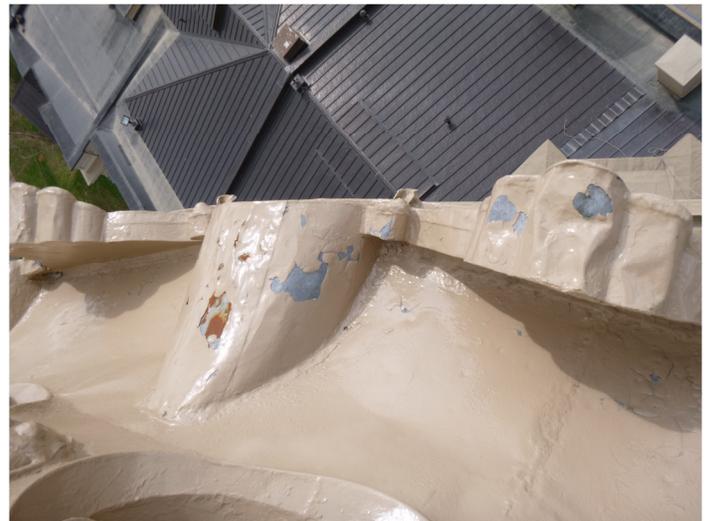
**96-102 SheetMetal\_Unsecured Missing 2013-1**

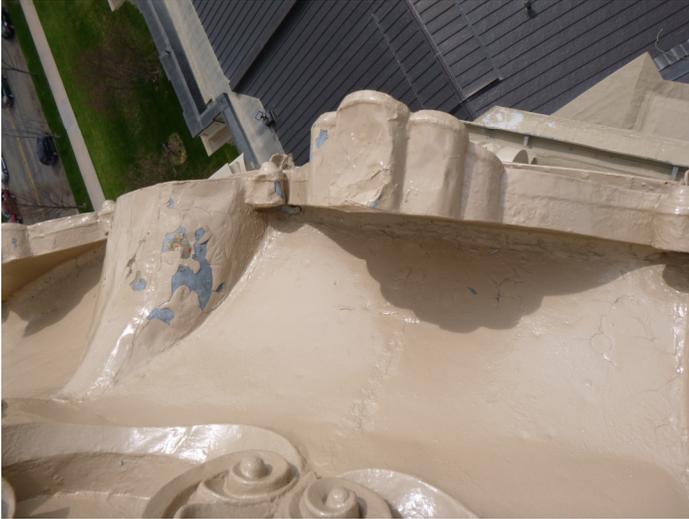
**96-104 SheetMetal\_Coating Coating Failed 2013-1**

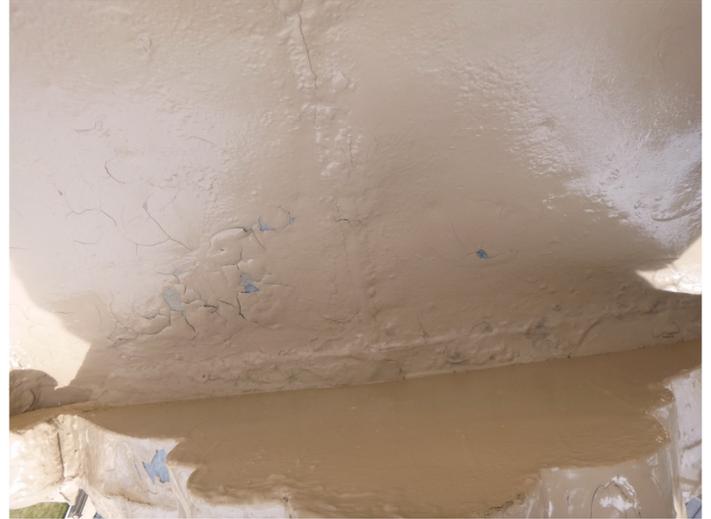
**96-104 SheetMetal\_Coating Coating Failed 2013-2**

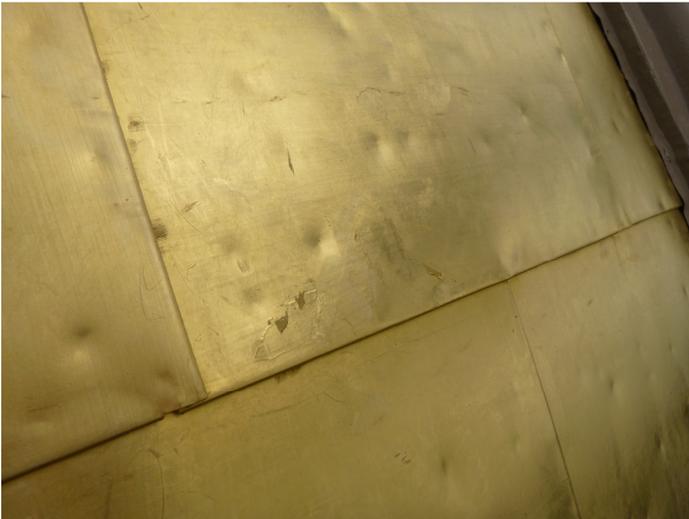
**96-104 SheetMetal\_Coating Coating Failed 2013-3**

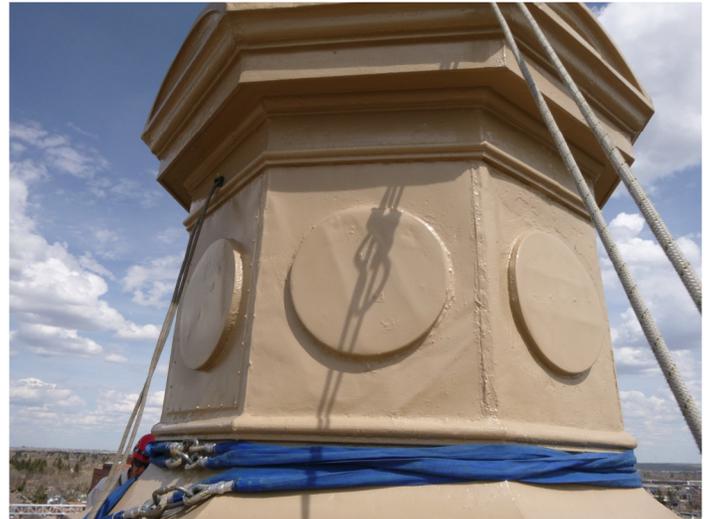
**96-117 SheetMetal\_Coating Coating Failed 2013-1**

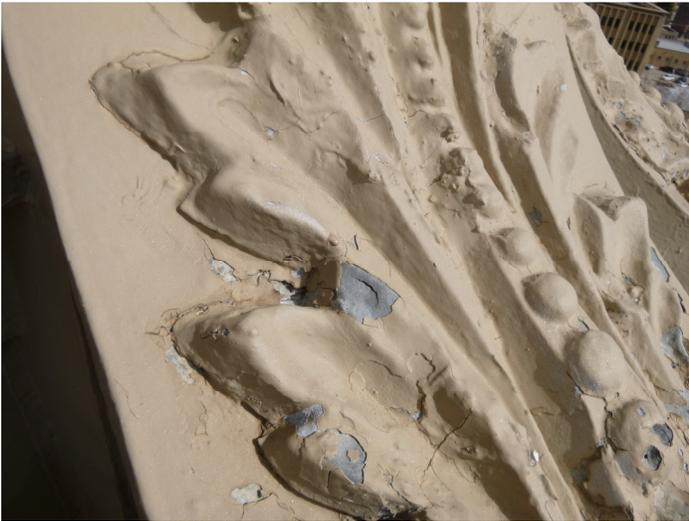
**97-75 SheetMetal\_Damaged Dented 2013-1**

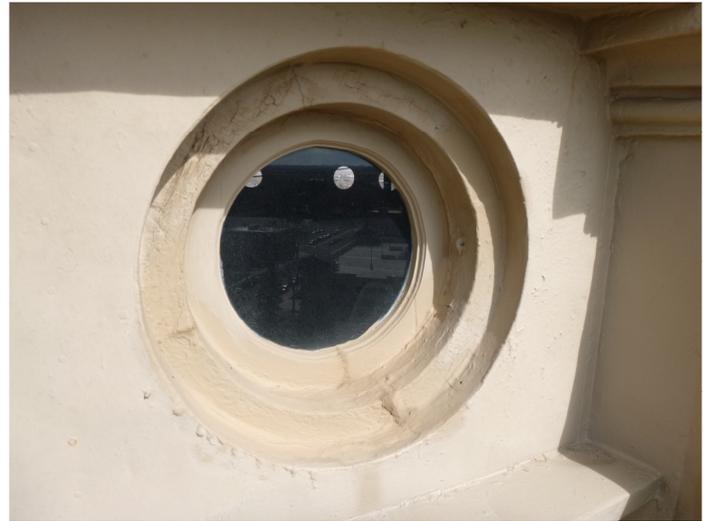
**97-99 SheetMetal\_Damaged Torn 2013-1**

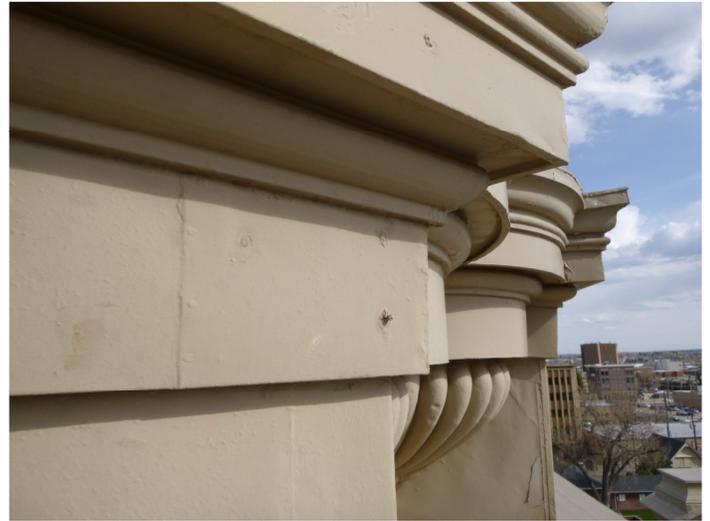
**97-106 SheetMetal\_Coating Coating Failed 2013-1**

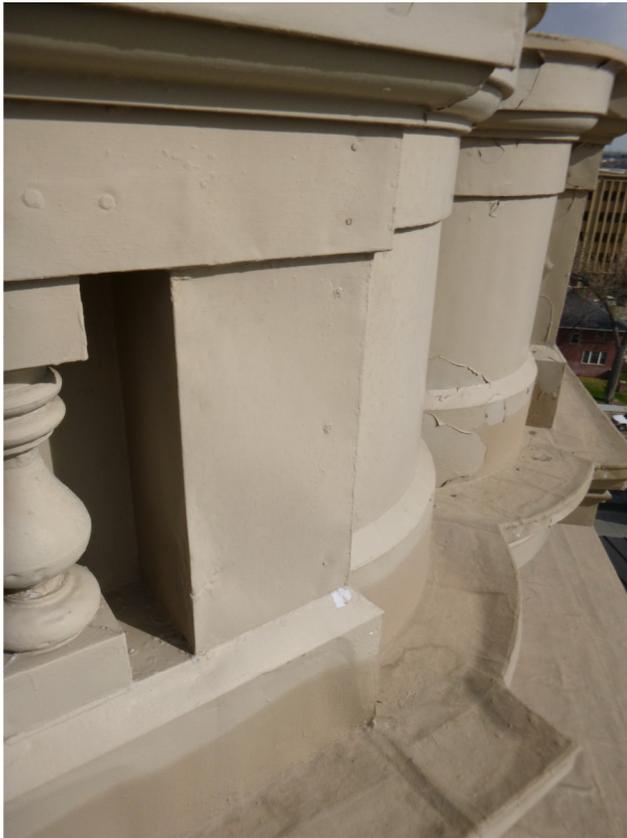
**98-67 SheetMetal\_Seam Fastener Failed 2013-1**

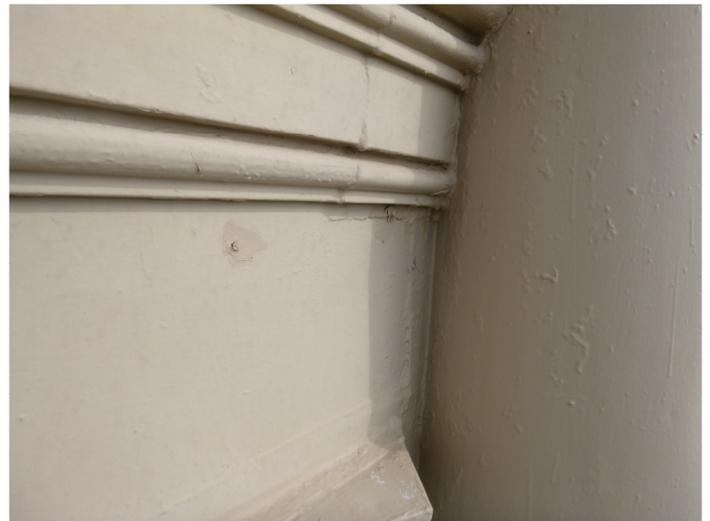
**98-71 SheetMetal\_Seam Fastener Failed 2013-1**

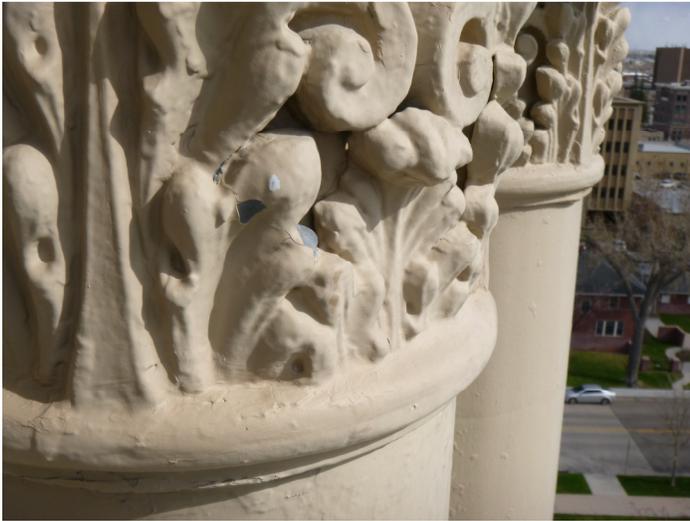
**98-82 SheetMetal\_Seam Fastener Failed 2013-1**

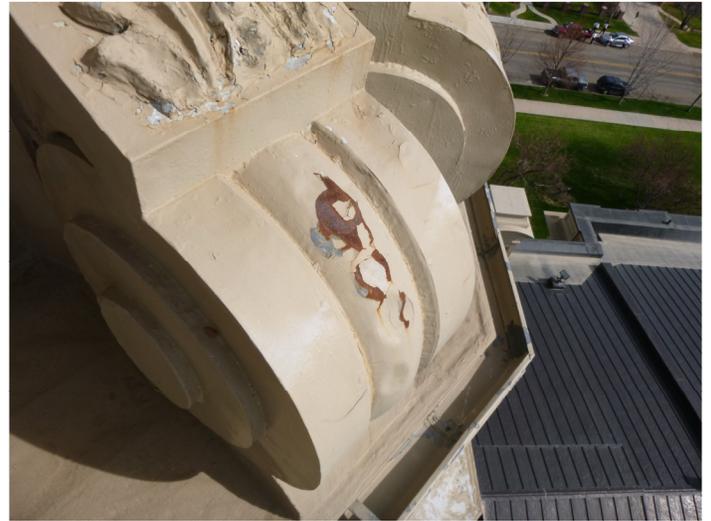
**98-87 SheetMetal\_Coating Coating Failed 2013-1**

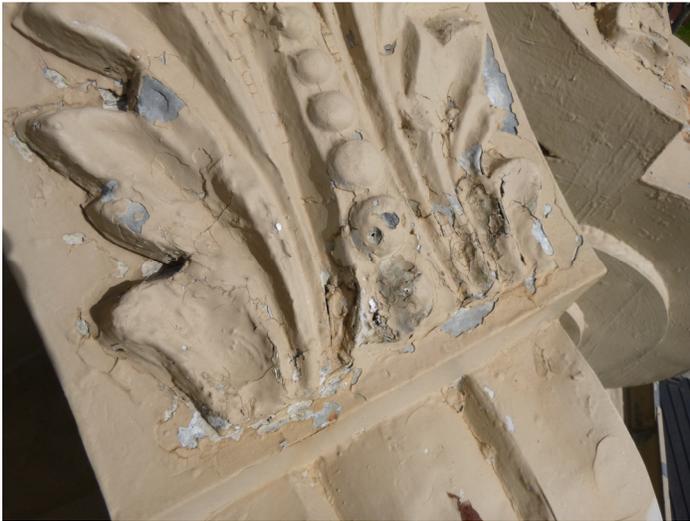
**98-97 SheetMetal\_Corrosion Surface 2013-1**

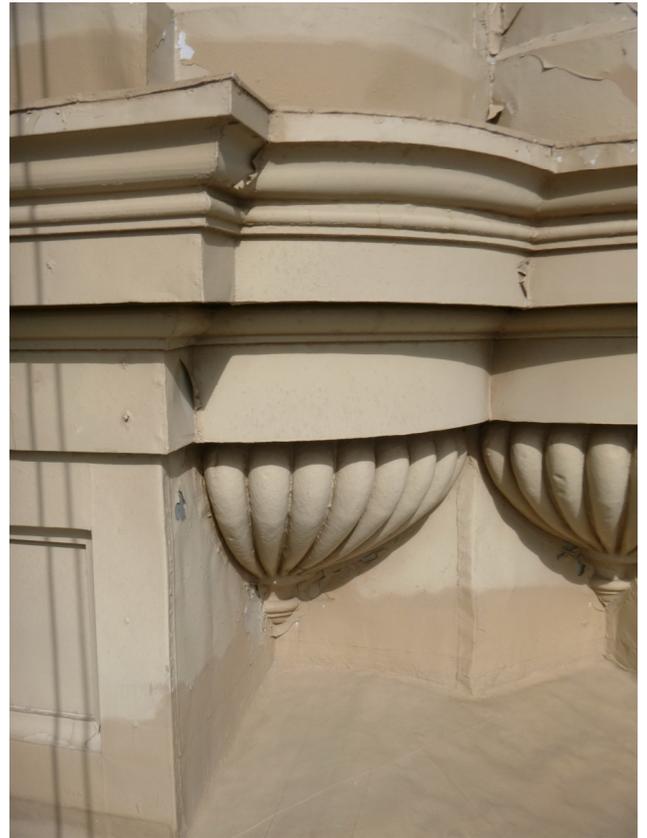
**98-98 SheetMetal\_Damaged Punctured 2013-1**

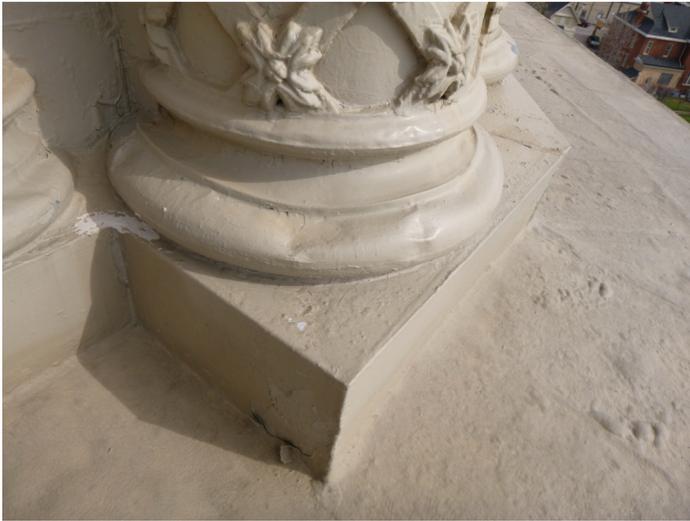
**99-66 SheetMetal\_Coating Coating Failed 2013-1**

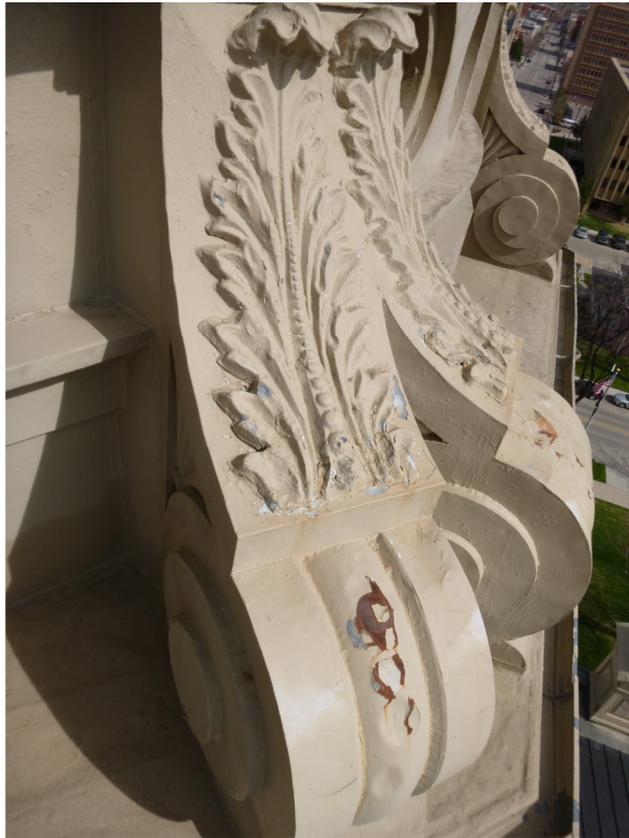
**99-77 SheetMetal\_Coating Coating Failed 2013-1**

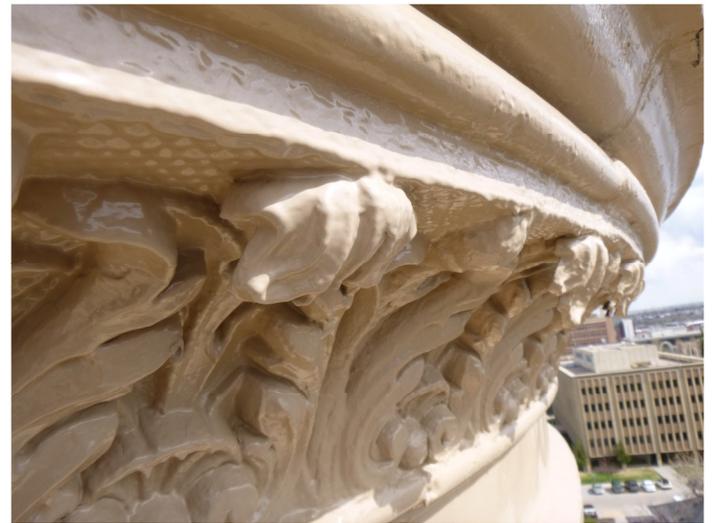
**99-99 SheetMetal\_Coating Coating Failed 2013-1**

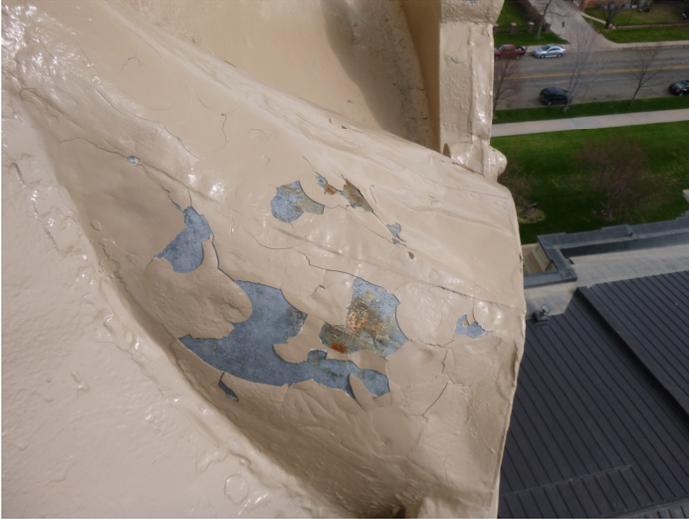
**99-102 SheetMetal\_Unsecured Missing 2013-1**

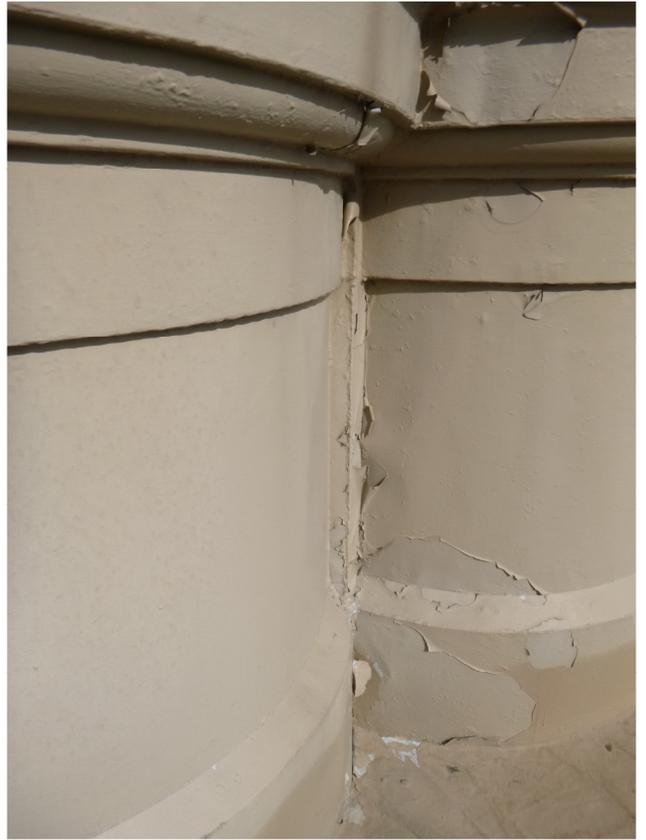
**99-105 SheetMetal\_Corrosion Surface 2013-1**

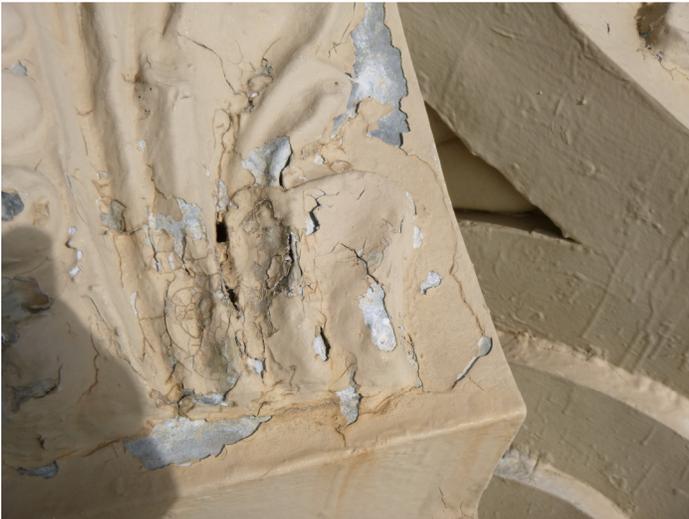
**100-71 SheetMetal\_Coating Coating Failed 2013-1**

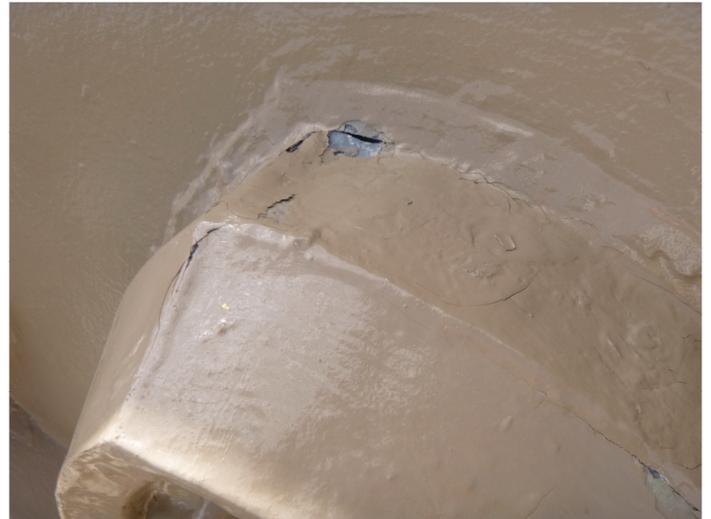
**100-99 SheetMetal\_Damaged Punctured 2013-1**

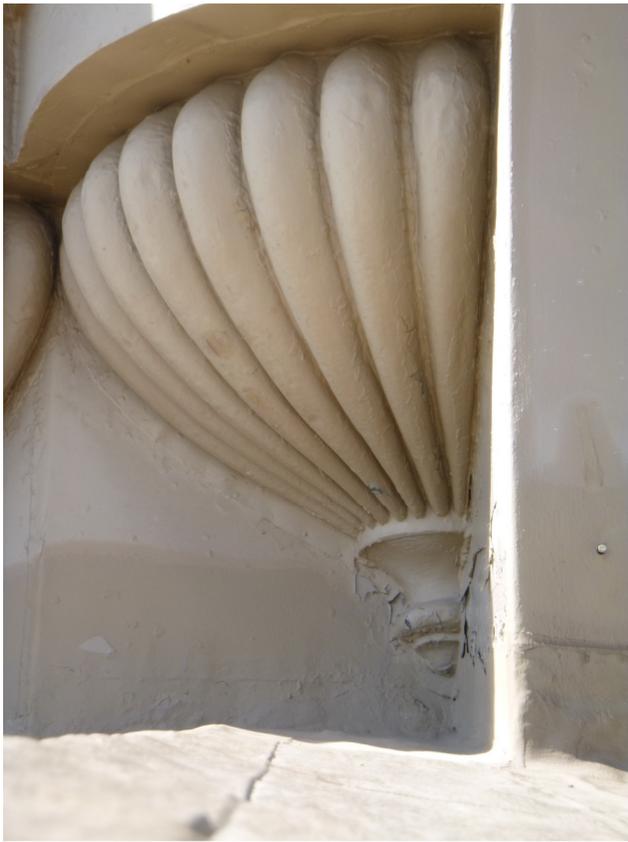
**167-106 SheetMetal\_Damaged Torn 2013-1**

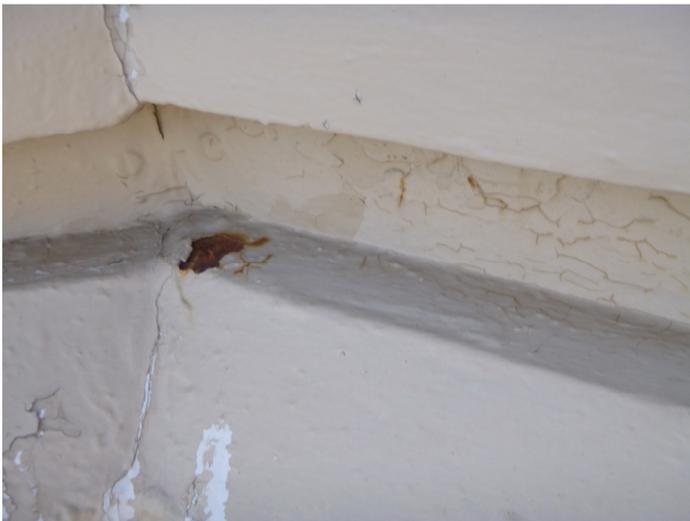
168-73 SheetMetal\_Note Photo-scupper 2013-1

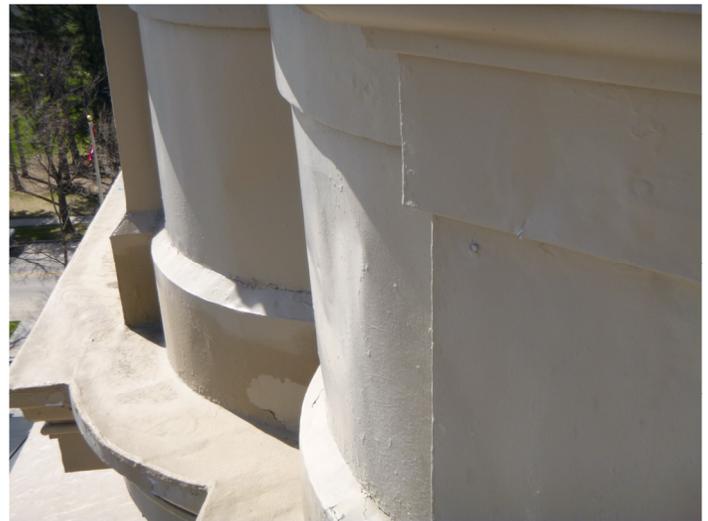
169-52 ArchMetal\_Corrosion Surface 2013-1

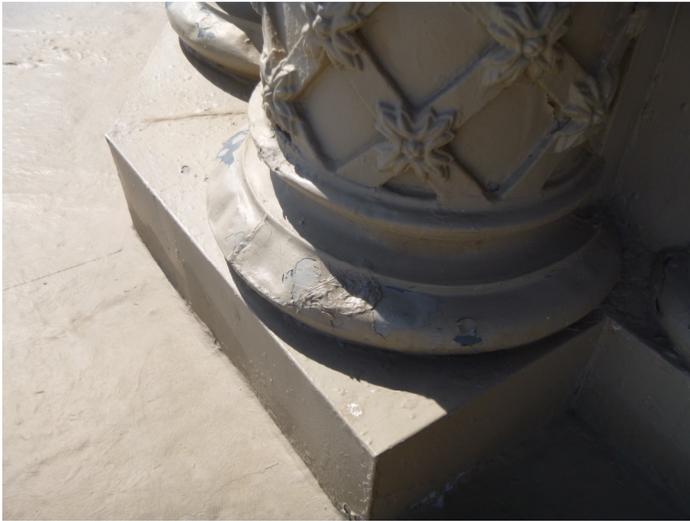
169-71 SheetMetal\_Damaged Dented 2013-1

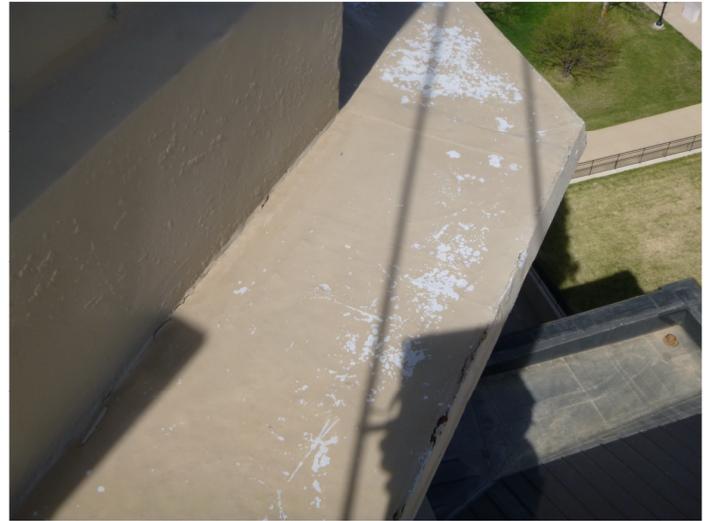
**169-74 SheetMetal\_Damaged Dented 2013-1**

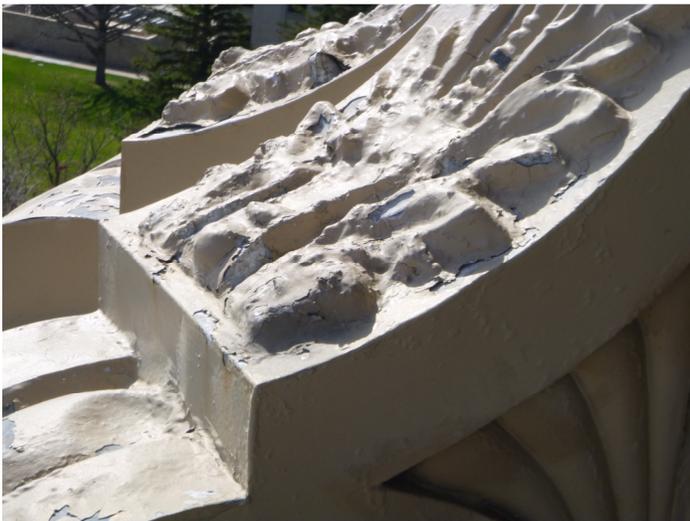
**169-91 SheetMetal\_Coating Coating Failed 2013-1**

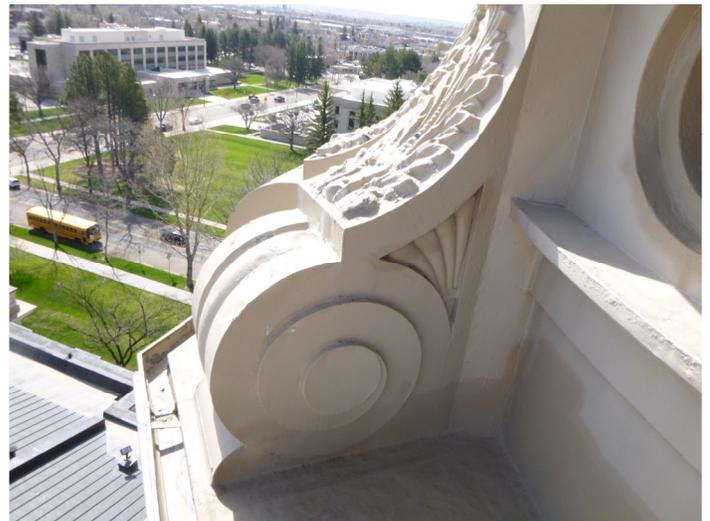
**169-98 SheetMetal\_Coating Coating Failed 2013-1**

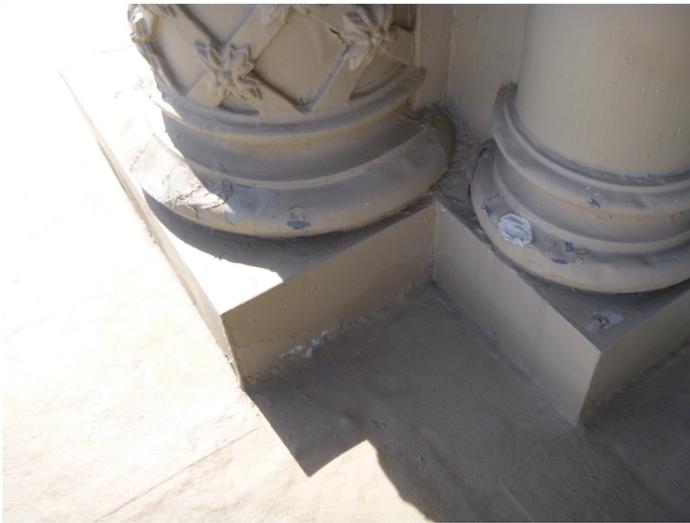
**169-98 SheetMetal\_Coating Coating Failed 2013-2**

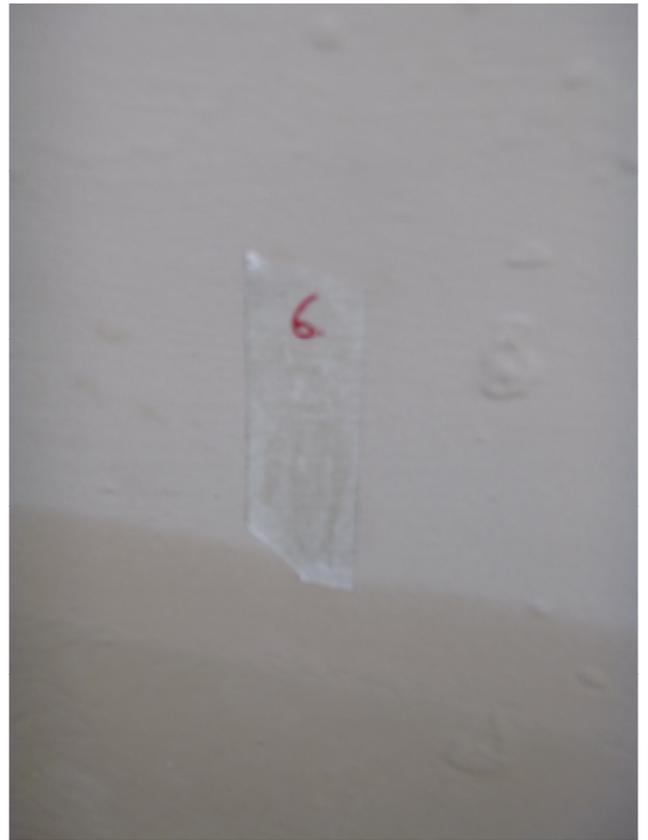
170-75 SheetMetal\_Coating Coating Failed 2013-1

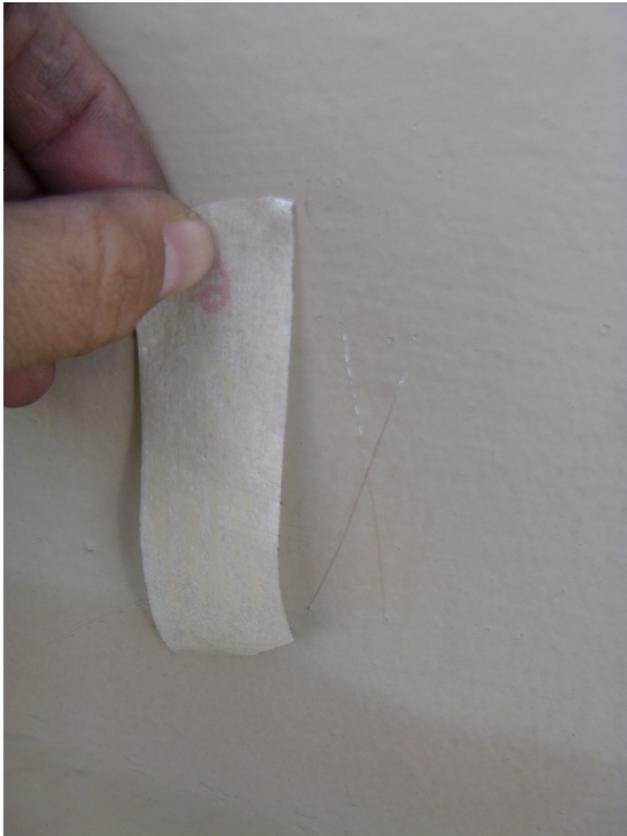
170-96 SheetMetal\_Note Photo-adhesion test6 2013-1
