# Report Narrative

## Wyoming State Capitol Dome Investigation Cheyenne, WY

Vertical Access LLC  
PO Box 4135, Ithaca, NY 14852  
Tel: 607 257 4049 / Fax: 607 257 2129

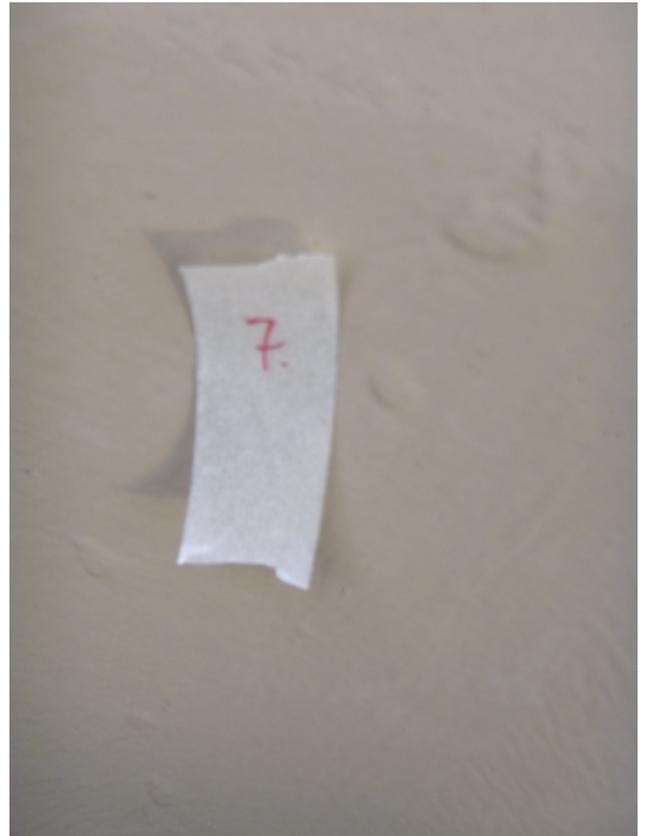
170-96 SheetMetal\_Note Photo-adhesion test6 2013-2

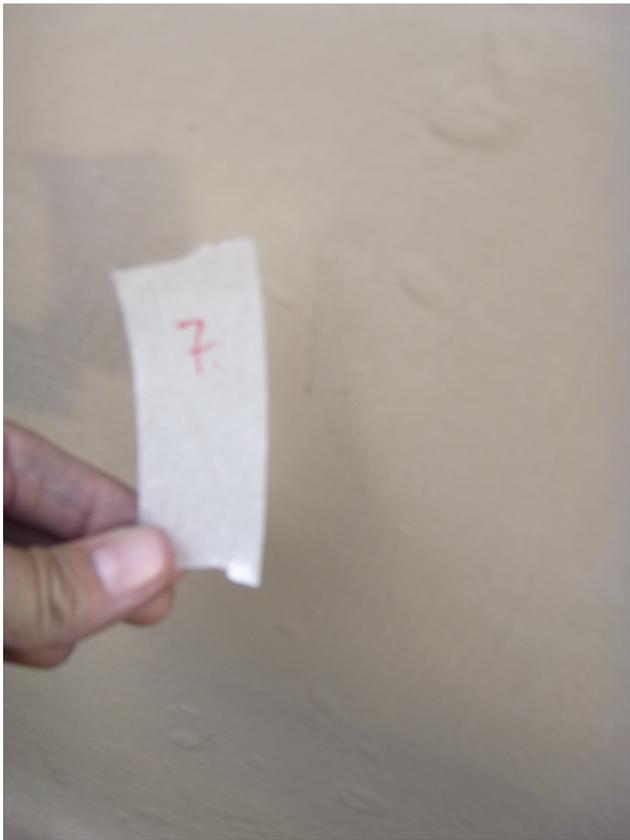
170-96 SheetMetal\_Note Photo-adhesion test7 2013-1

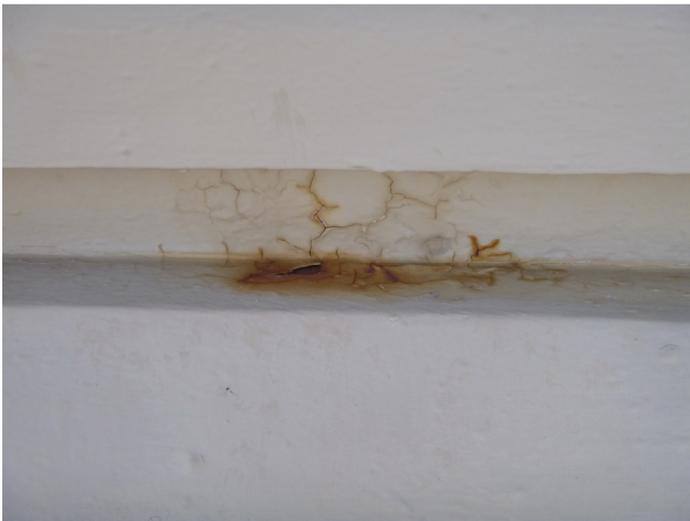
170-96 SheetMetal\_Note Photo-adhesion test7 2013-3

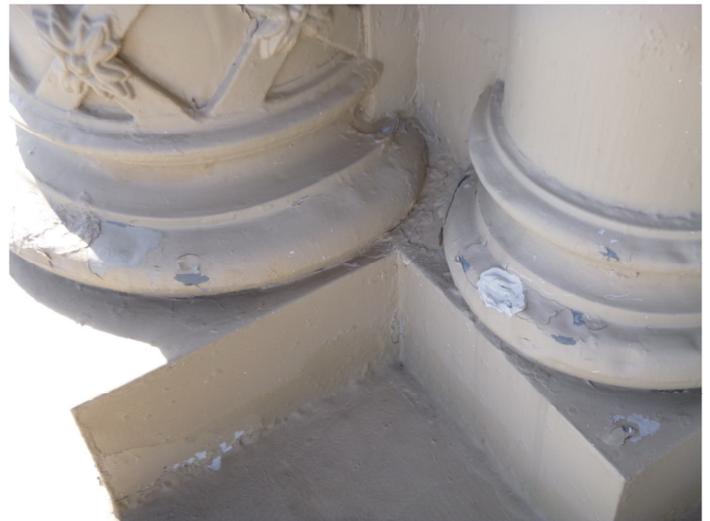
171-53 ArchMetal\_Corrosion Surface 2013-1

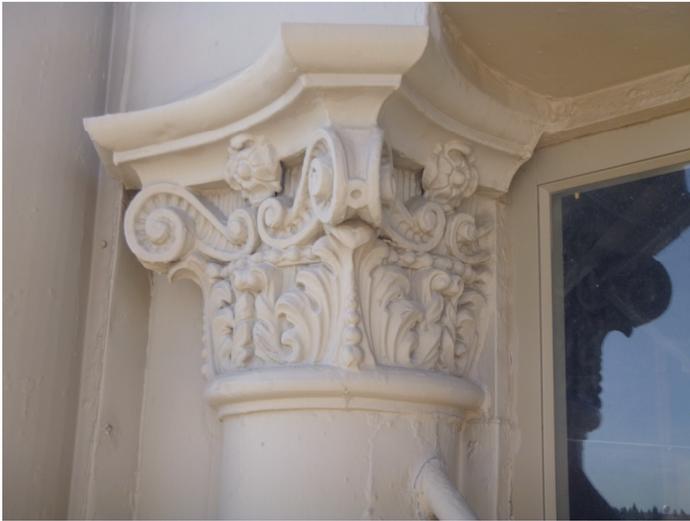
171-74 SheetMetal\_Note Photo-sealant 2013-1

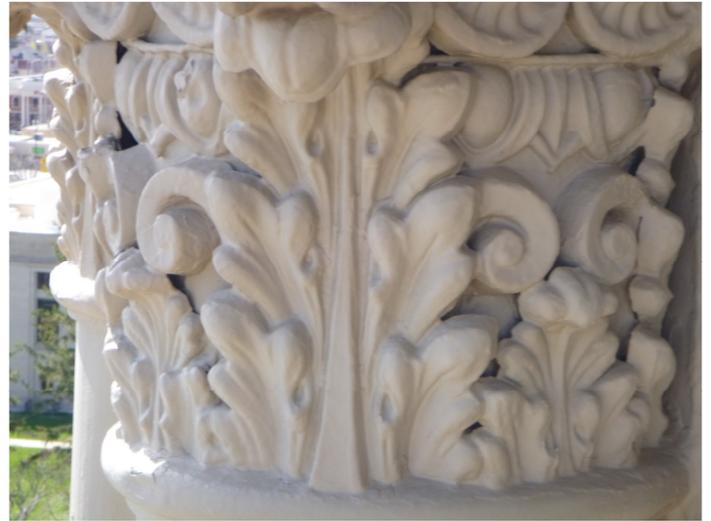
**171-81 SheetMetal\_Note Photo-capital 2013-1**

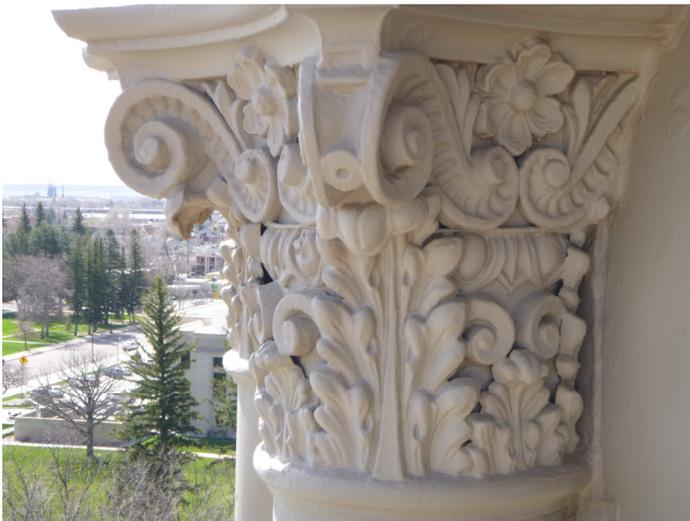
**171-87 SheetMetal\_Note Photo-capital 2013-2**

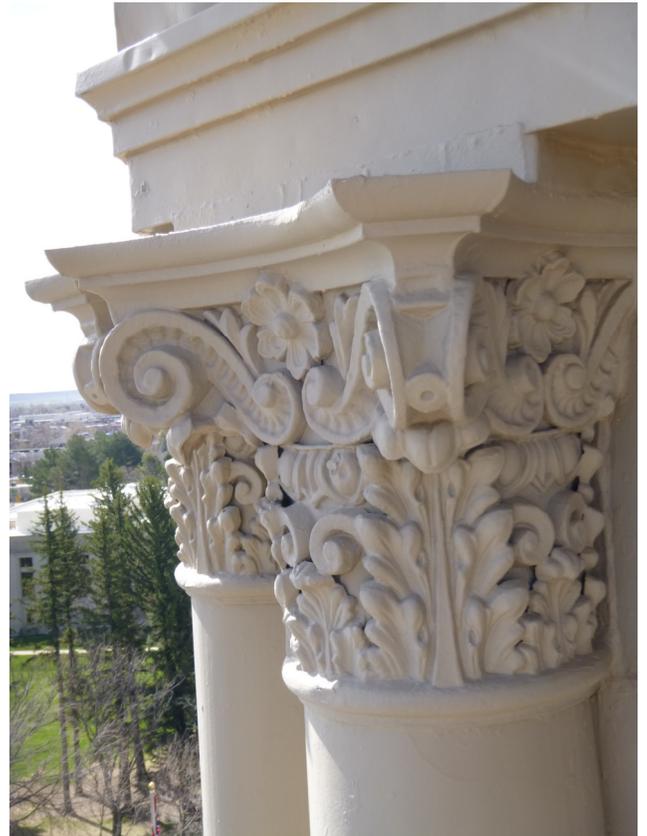
**171-87 SheetMetal\_Note Photo-capital 2013-3**

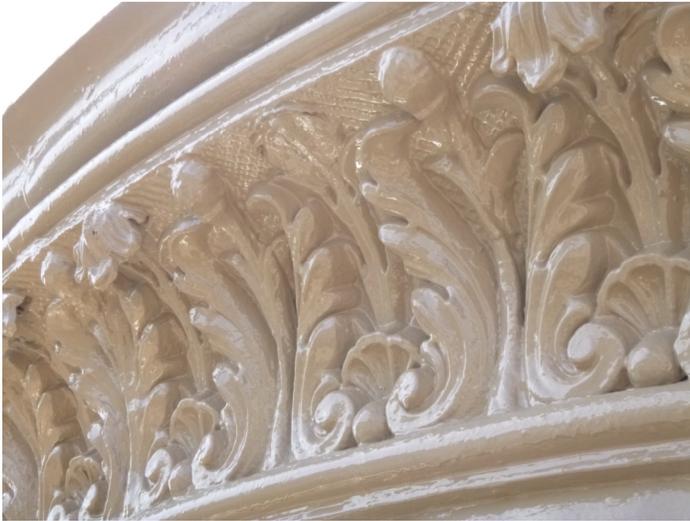
**171-87 SheetMetal\_Note Photo-capital 2013-4**

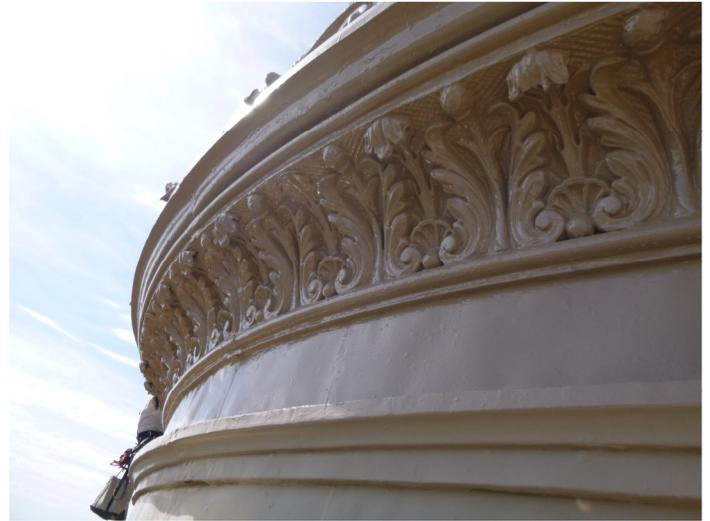
171-102 SheetMetal\_Unsecured Missing 2013-1

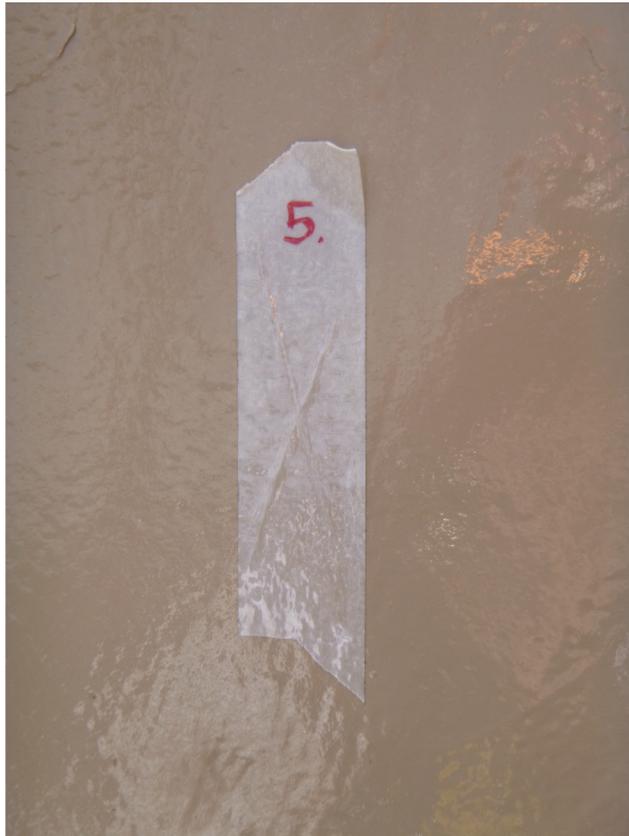
171-102 SheetMetal\_Unsecured Missing 2013-2

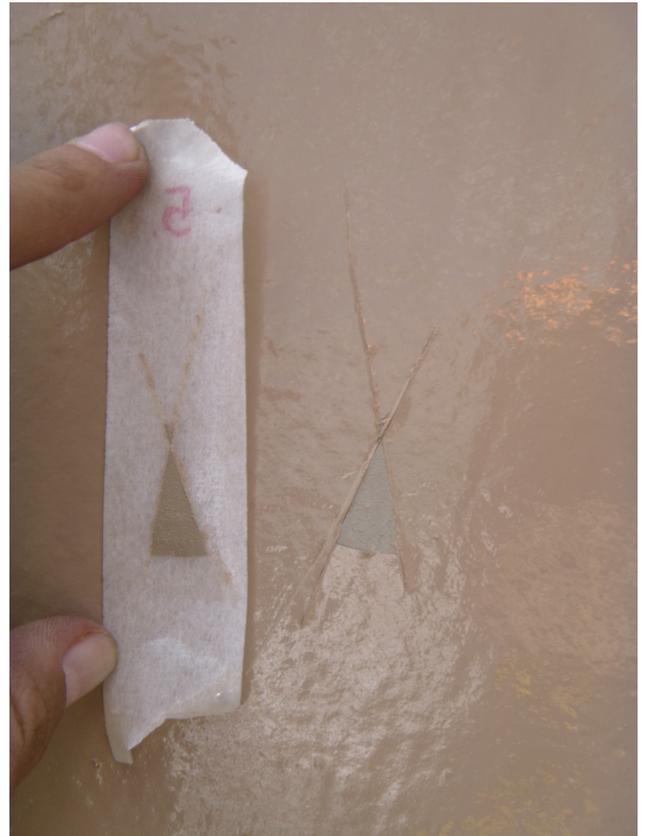
171-107 SheetMetal\_Note Photo-adhesion test 5 2013-1

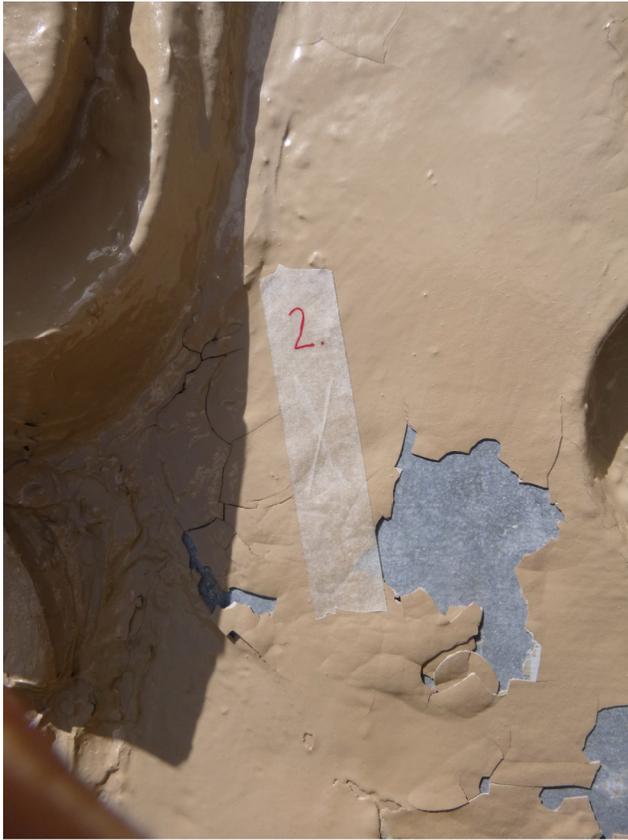
171-107 SheetMetal\_Note Photo-adhesion test 5 2013-2

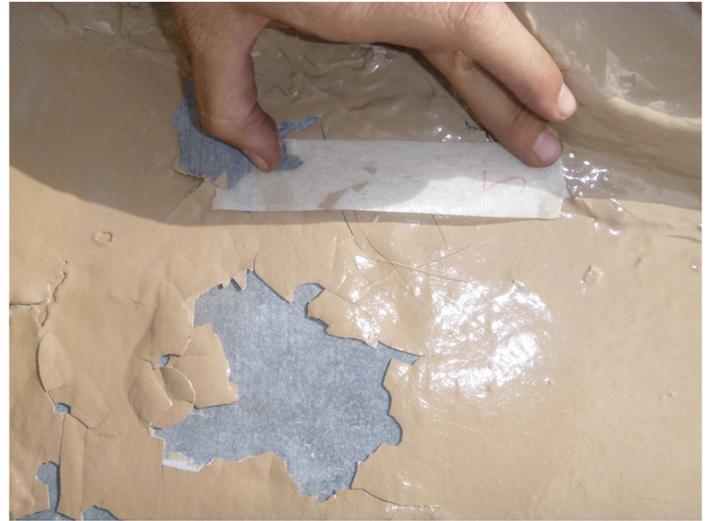
171-118 SheetMetal\_Note Photo-adhesion test2 2013-1

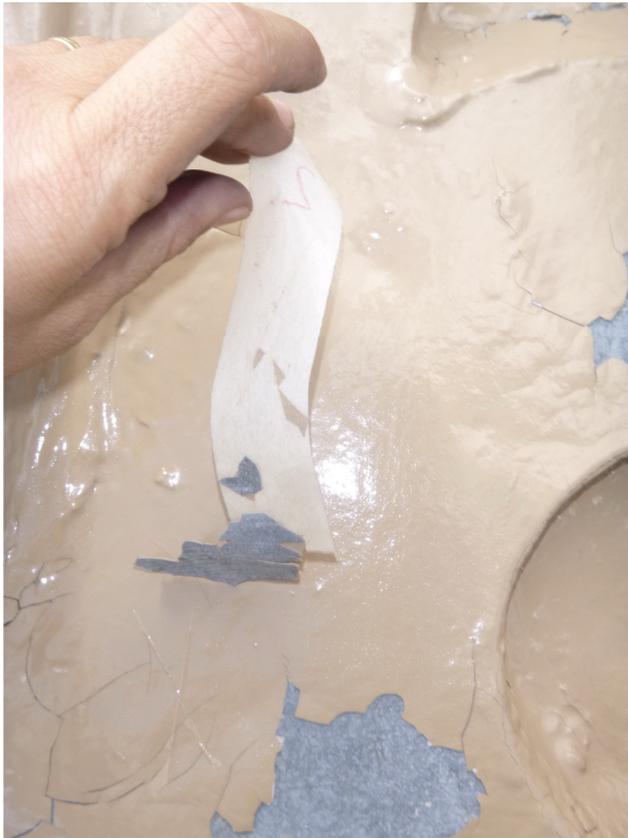
171-118 SheetMetal\_Note Photo-adhesion test2 2013-2

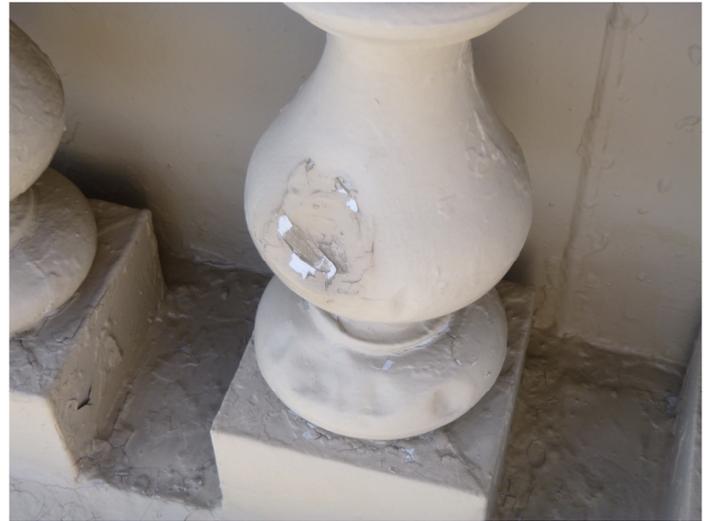
171-118 SheetMetal\_Note Photo-adhesion test2 2013-3

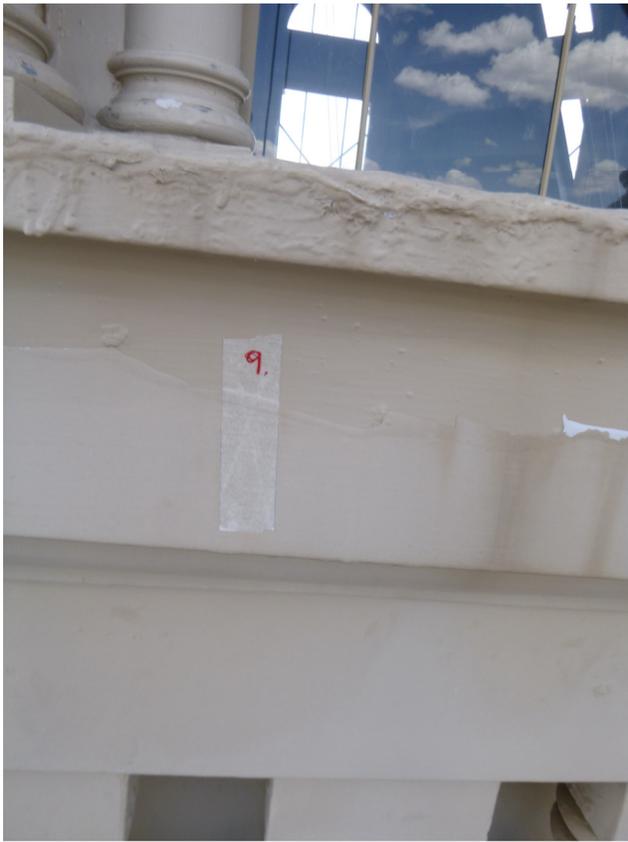
172-71 SheetMetal\_Damaged Dented 2013-1

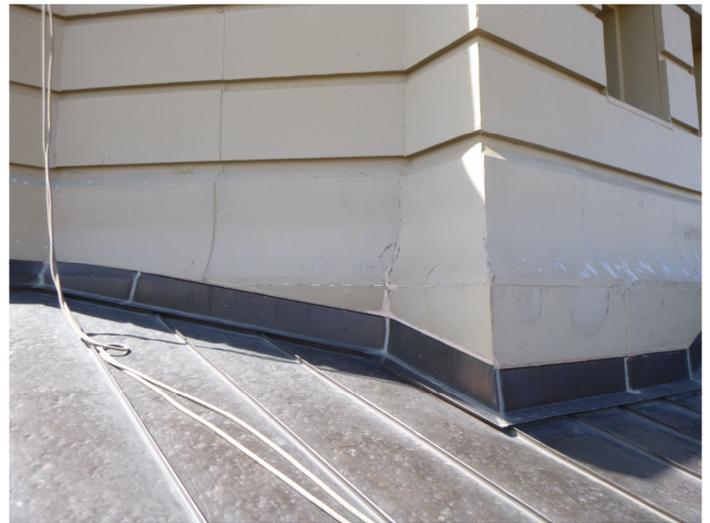
172-117 SheetMetal\_Note Photo-hail damage 2013-1

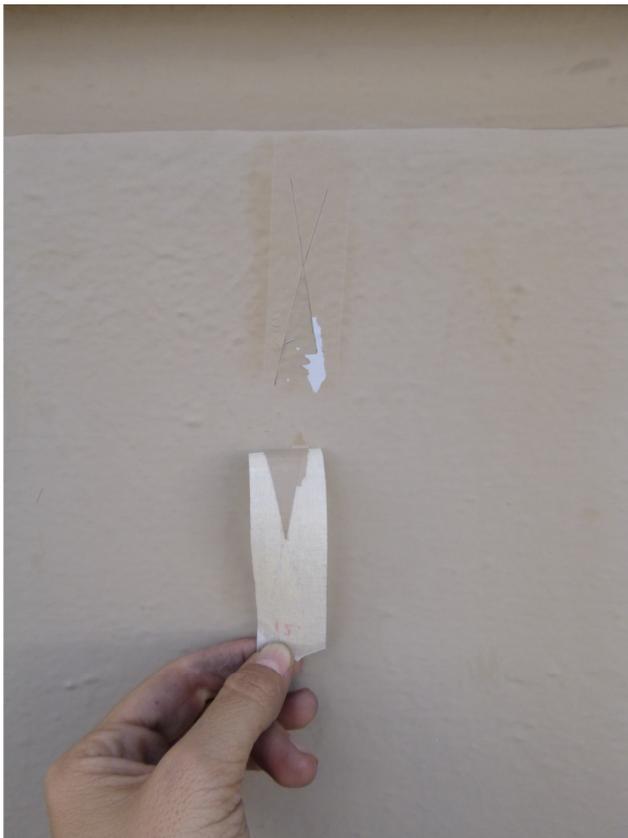
173-57 SheetMetal\_Note Photo-adhesion test 12 2013-2

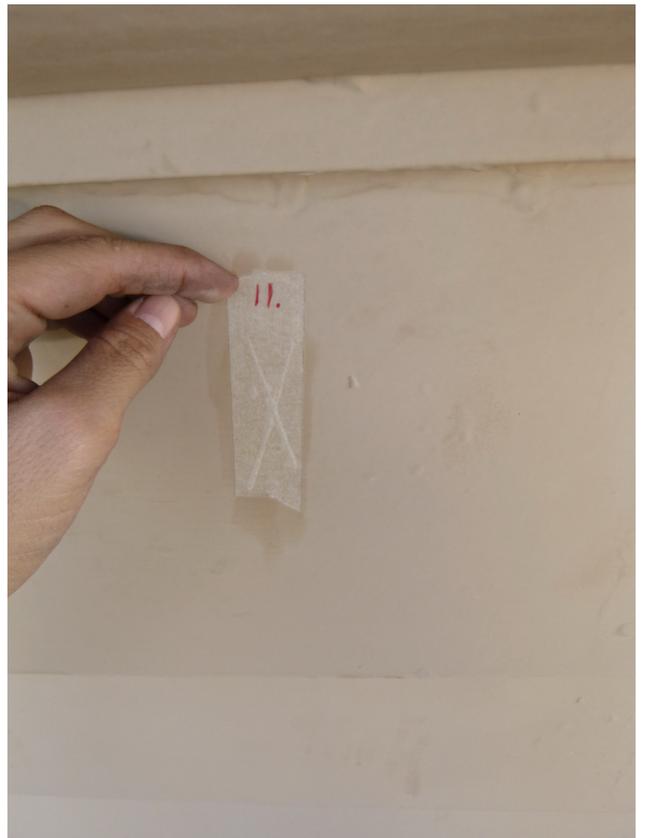
173-57 SheetMetal\_Note Photo-adhesion test 12 2013-3

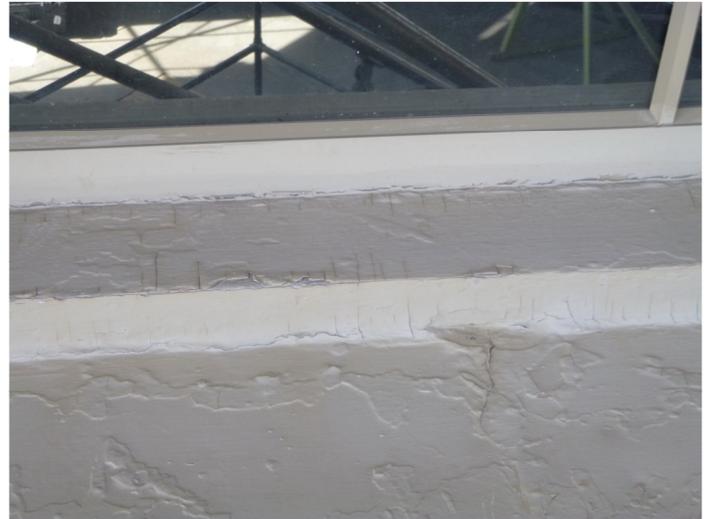
**173-66 SheetMetal\_Note Photo-adhesion test 11 2013-2**

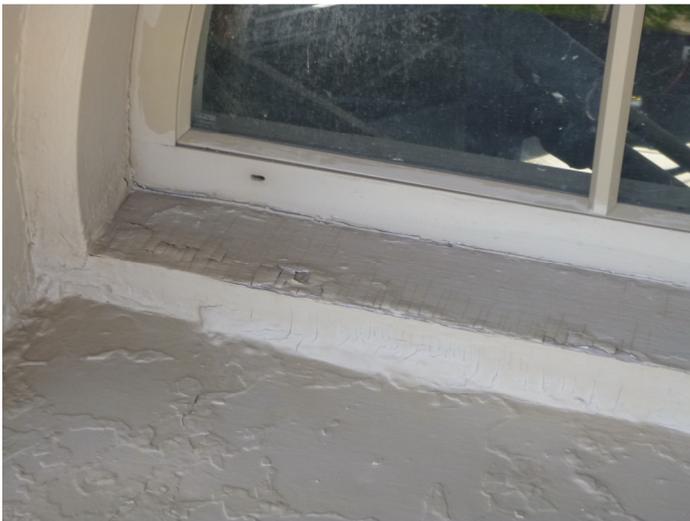
**173-84 Wood\_Coating Coating Failed 2013-1**

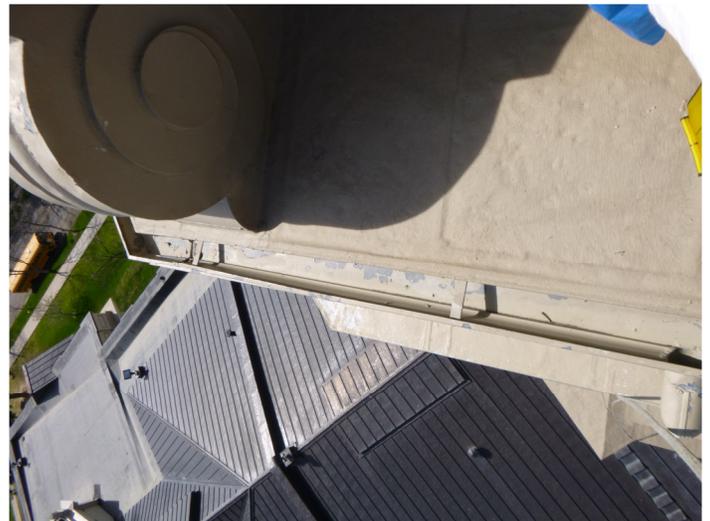
**173-84 Wood\_Coating Coating Failed 2013-2**

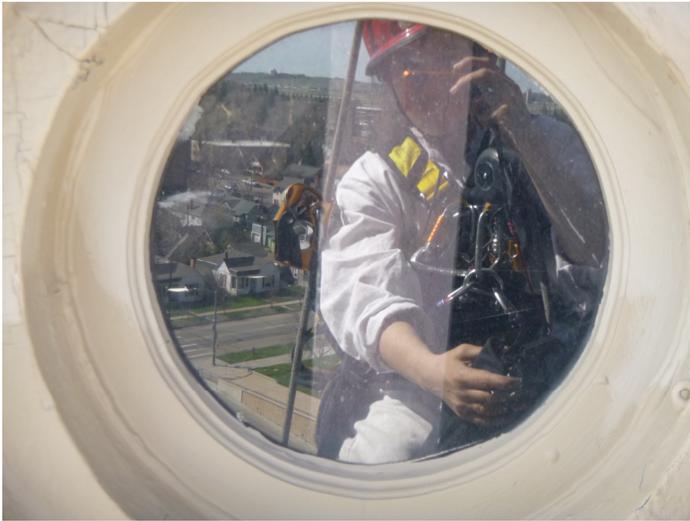
**173-96 SheetMetal\_Note Photo-gutter 2013-1**

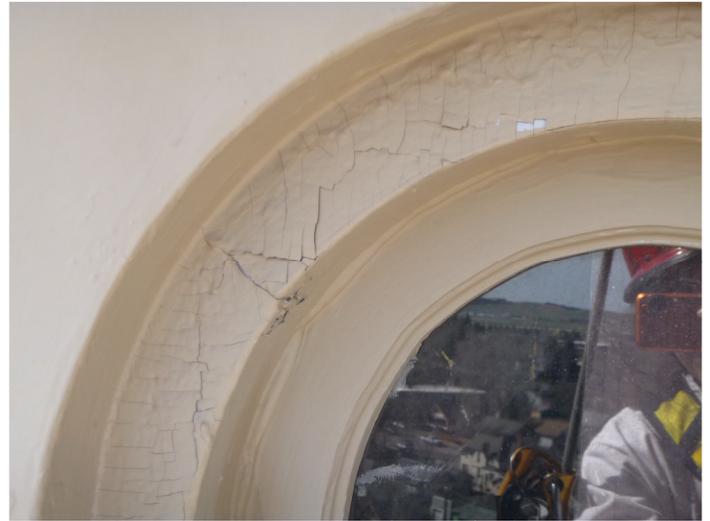
**173-99 Wood\_Coating Coating Failed 2013-1**

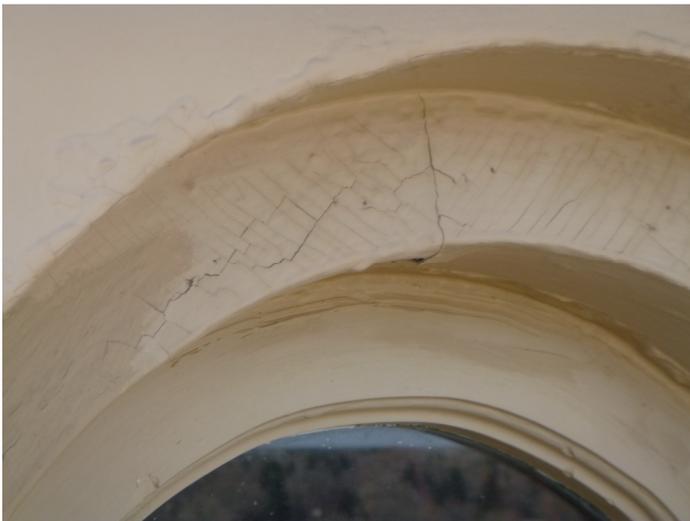
**173-99 Wood\_Coating Coating Failed 2013-2**

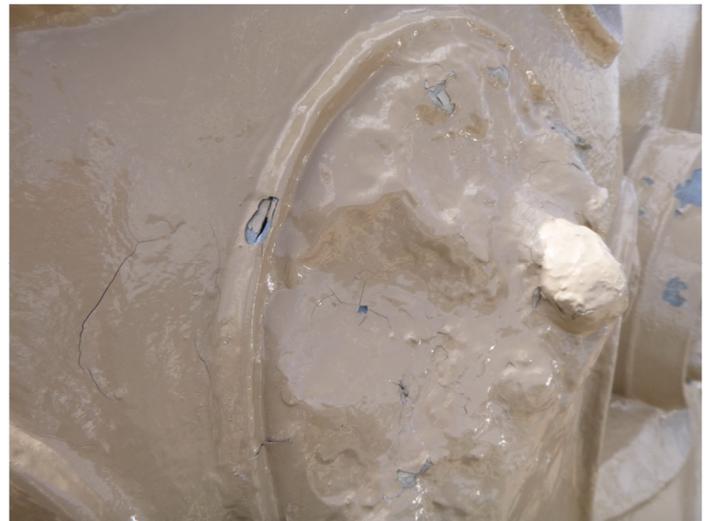
**173-99 Wood\_Coating Coating Failed 2013-3**

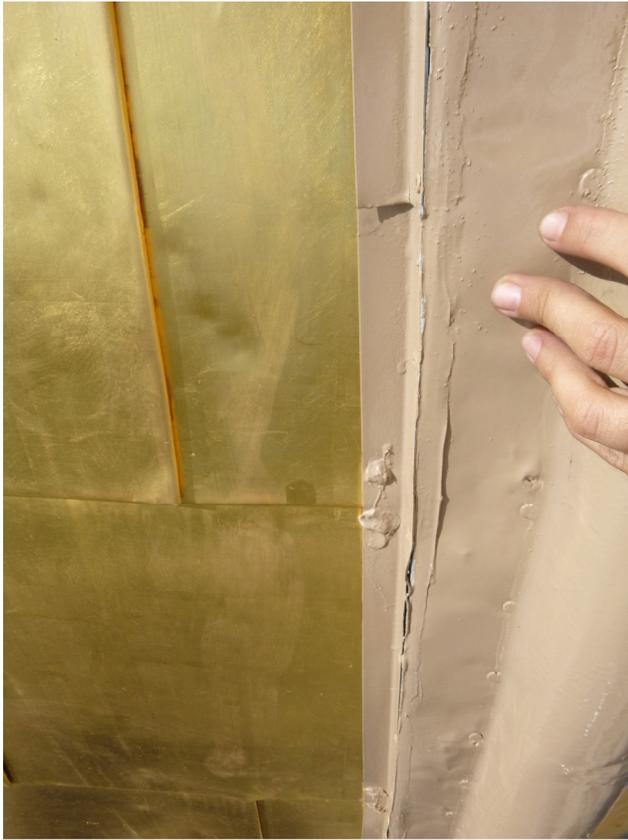
**173-106 SheetMetal\_Damaged Torn 2013-1**

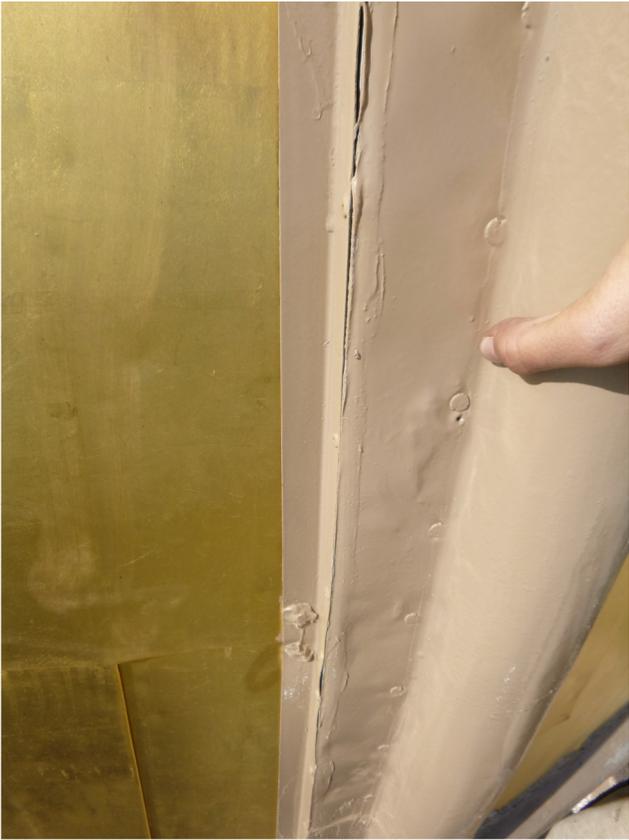
**173-108 SheetMetal\_Seam Sealant Failed 2013-1**

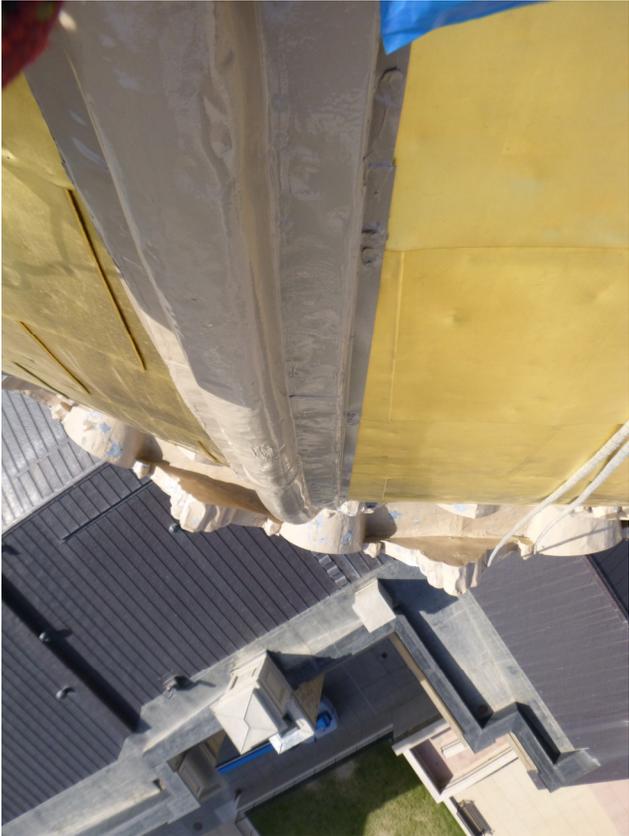
**173-111 SheetMetal\_Damaged Dented 2013-1**

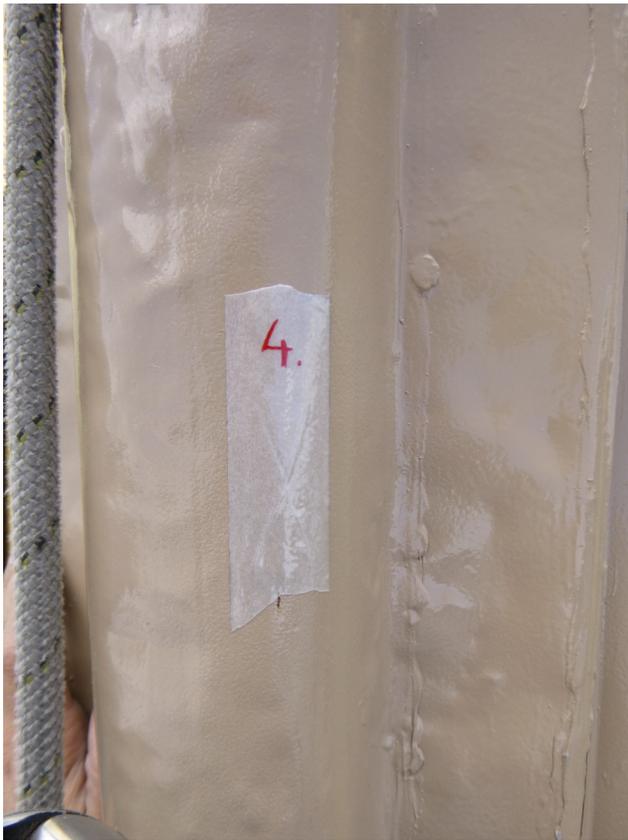
**173-111 SheetMetal\_Damaged Dented 2013-2**

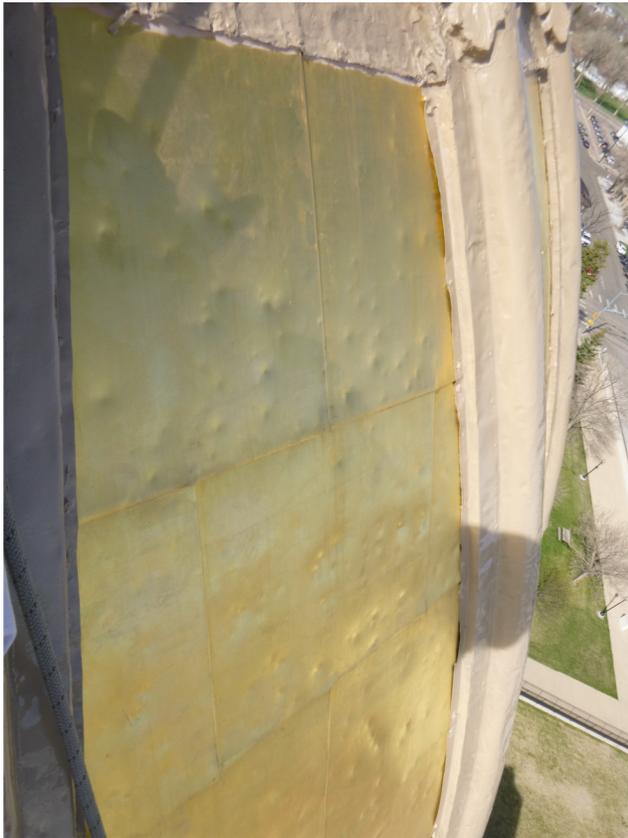
173-114 SheetMetal\_Note Photo-adhesion test 4 2013-2

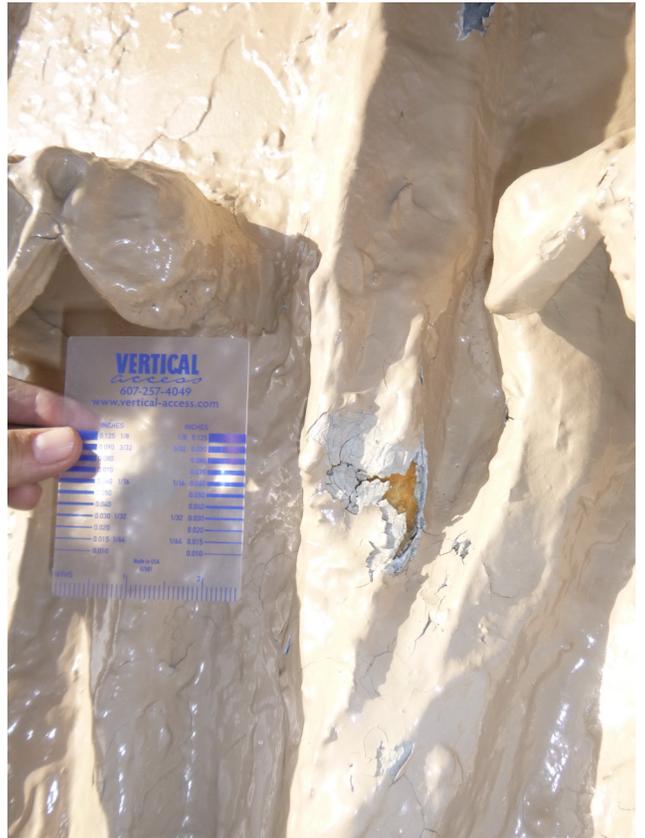
173-116 SheetMetal\_Damaged Dented 2013-1

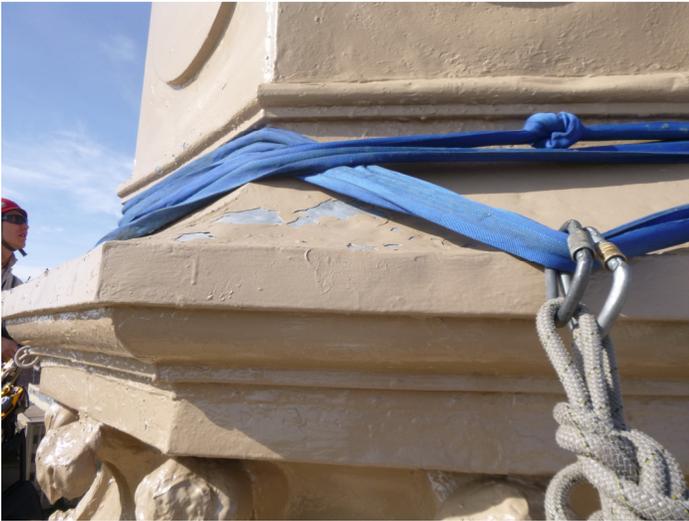
173-120 SheetMetal\_Damaged Punctured 2013-1

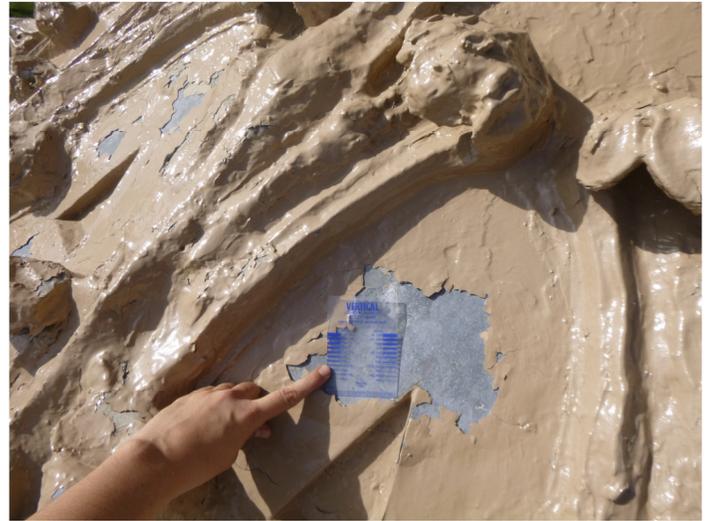
173-121 SheetMetal\_Coating Coating Failed 2013-1

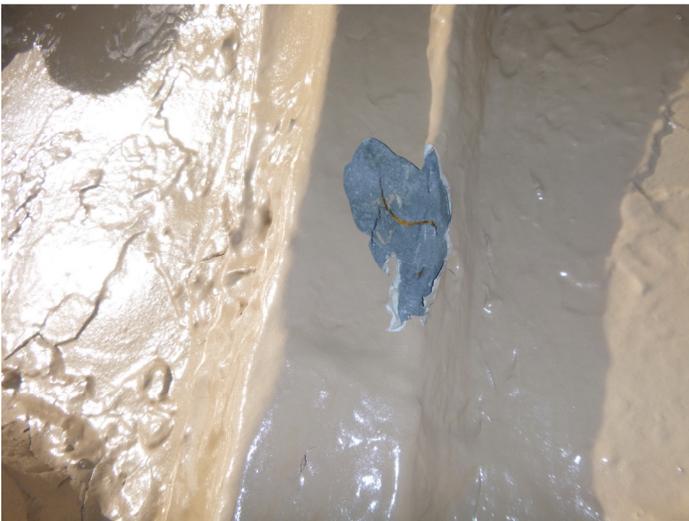
173-121 SheetMetal\_Coating Coating Failed 2013-2

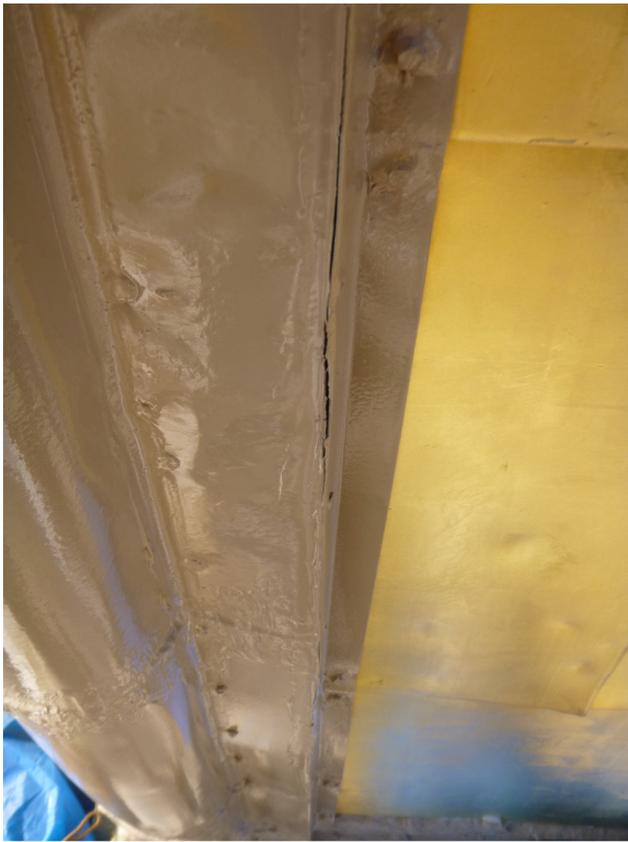
174-92 SheetMetal\_Note Photo-downspout 2013-1

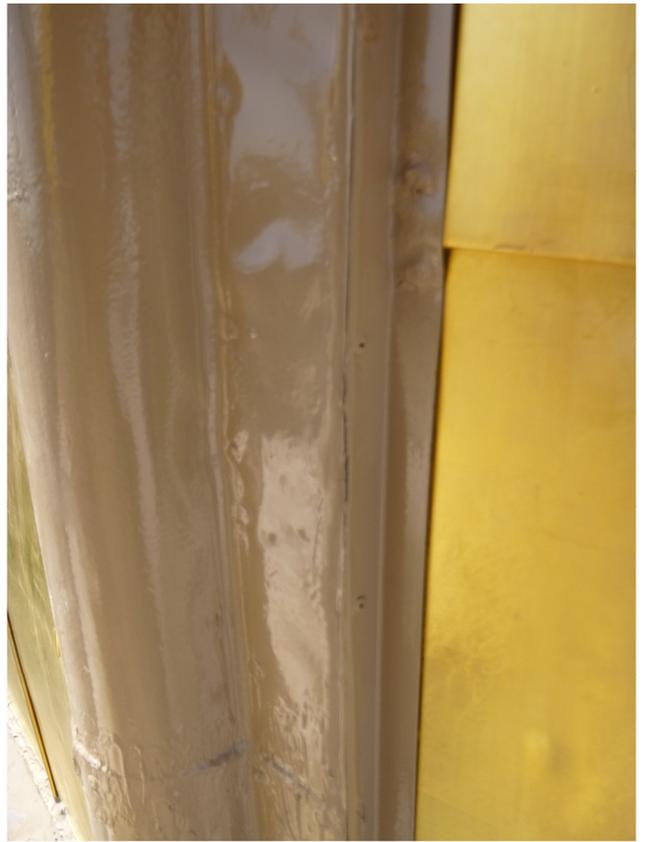
174-108 SheetMetal\_Seam Sealant Failed 2013-1

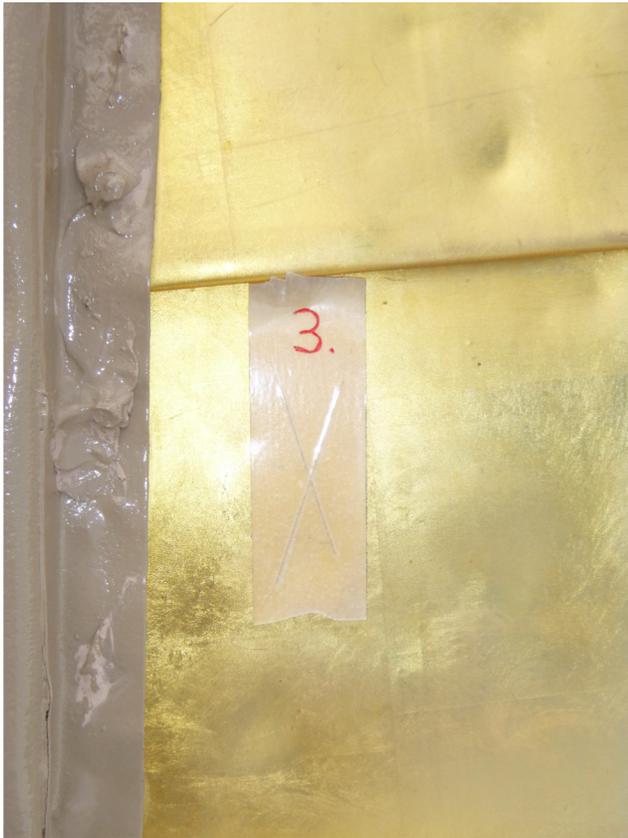
174-108 SheetMetal\_Seam Sealant Failed 2013-2

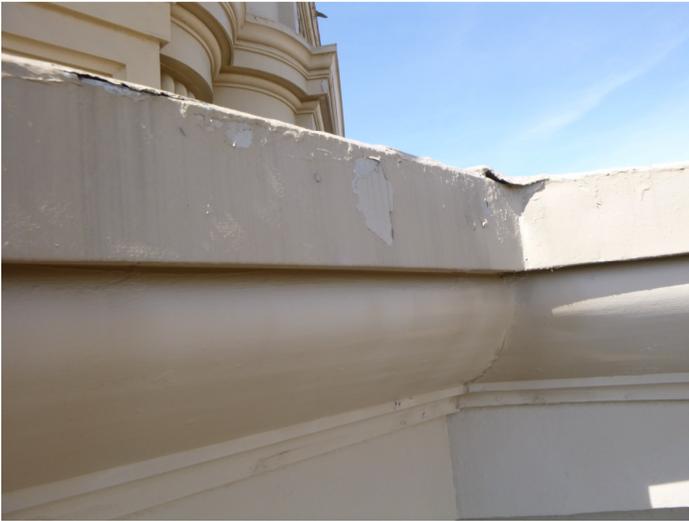
174-117 SheetMetal\_Note Photo-adhesion test 3 2013-2

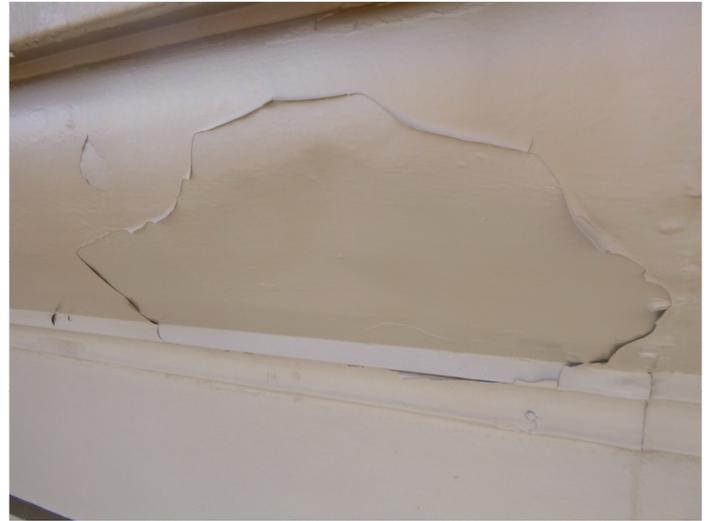
**175-63 SheetMetal\_Coating Coating Failed 2013-1**

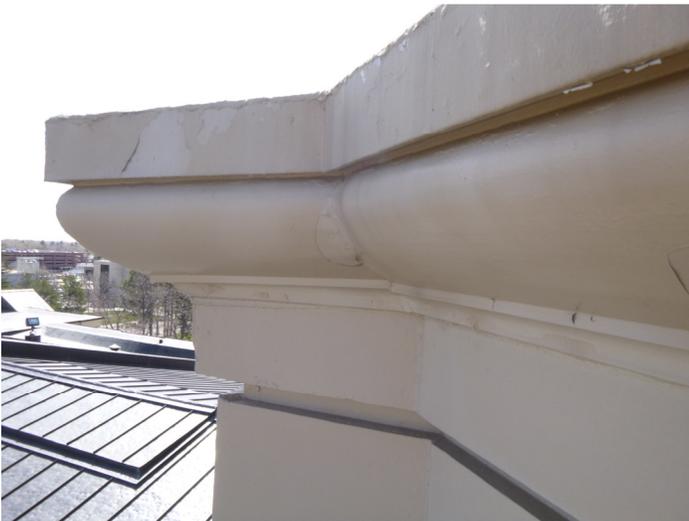
**175-63 SheetMetal\_Coating Coating Failed 2013-2**

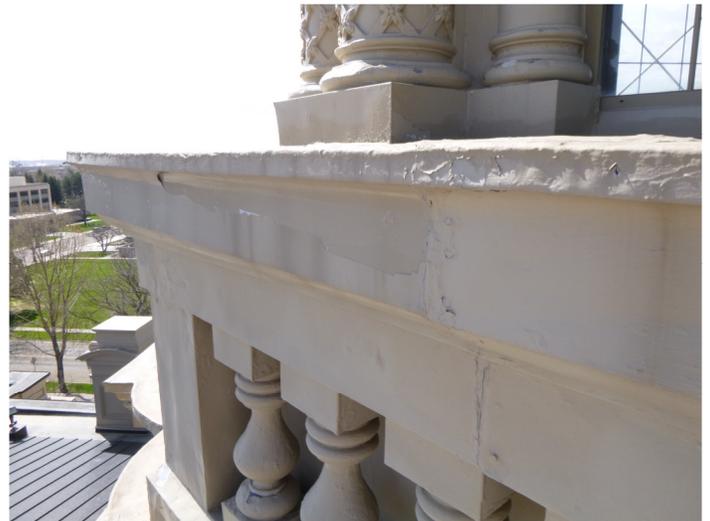
**175-63 SheetMetal\_Coating Coating Failed 2013-3**

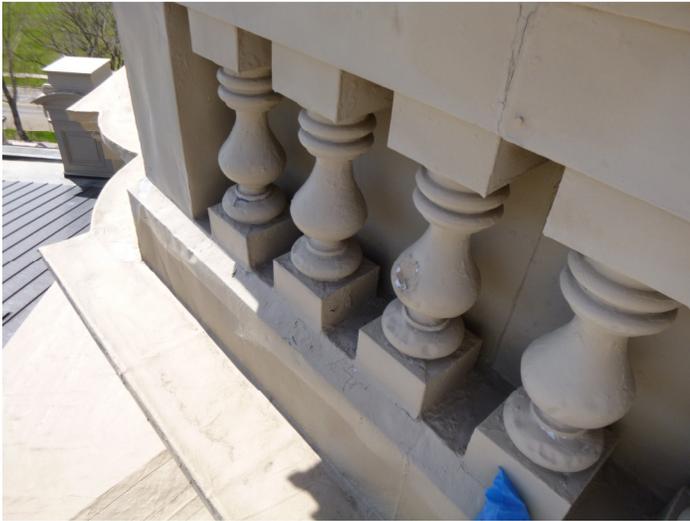
**175-69 SheetMetal\_Coating Coating Failed 2013-1**

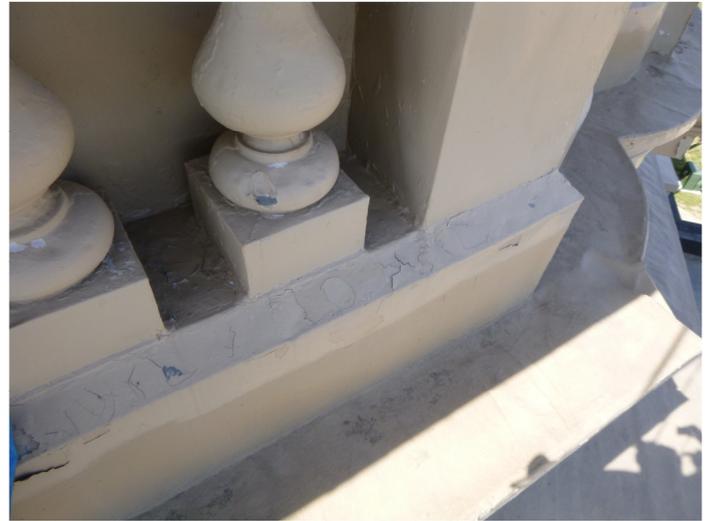
175-69 SheetMetal\_Coating Coating Failed 2013-2

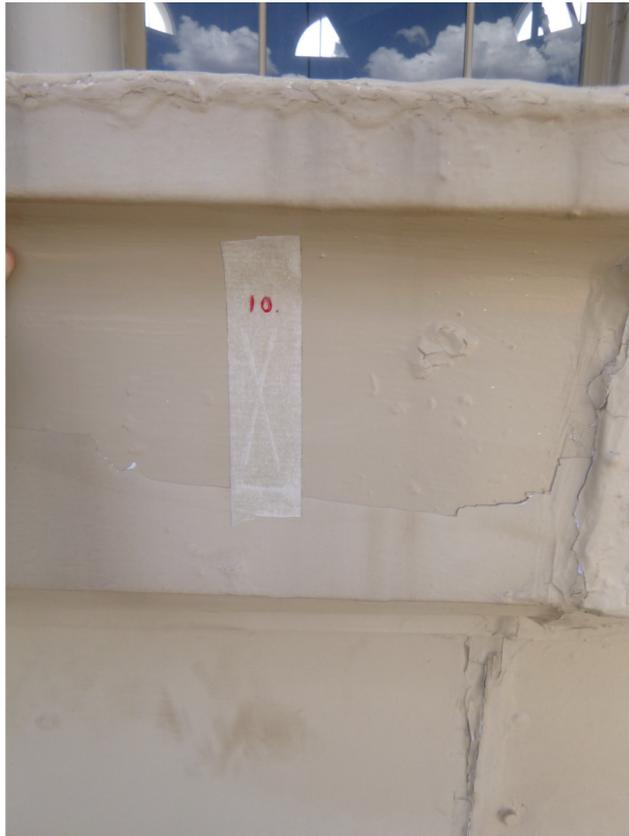
175-69 SheetMetal\_Coating Coating Failed 2013-3

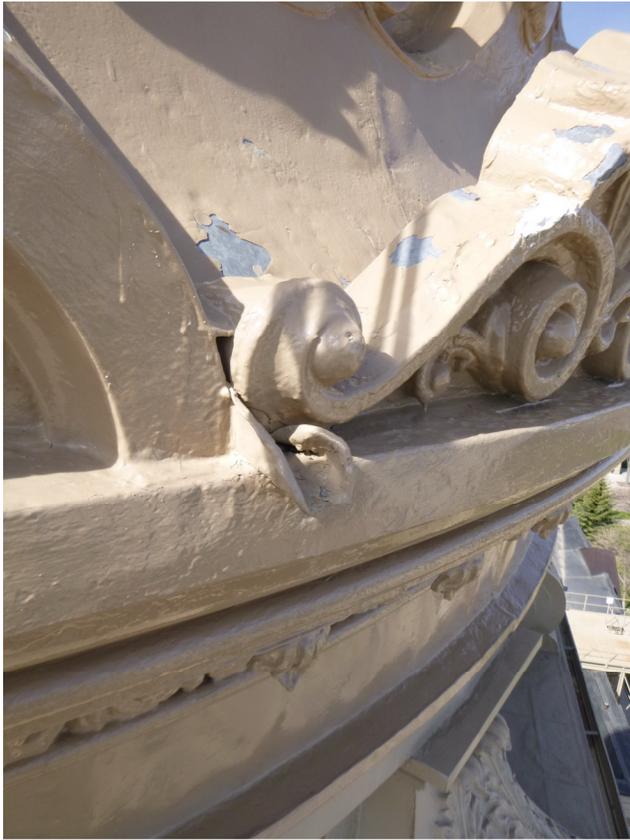
175-74 SheetMetal\_Note Photo-adhesion test 10 2013-2

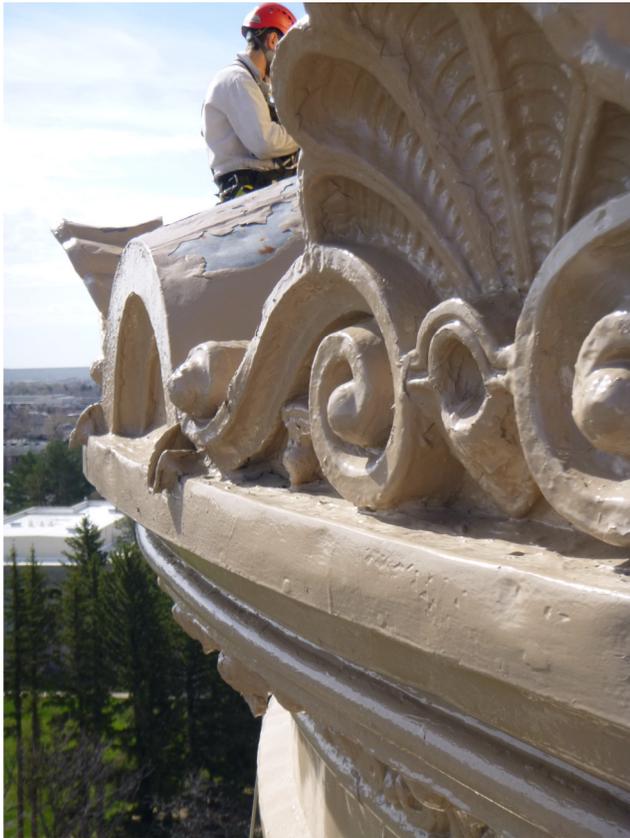
175-103 SheetMetal\_Note Photo-scupper both sides of

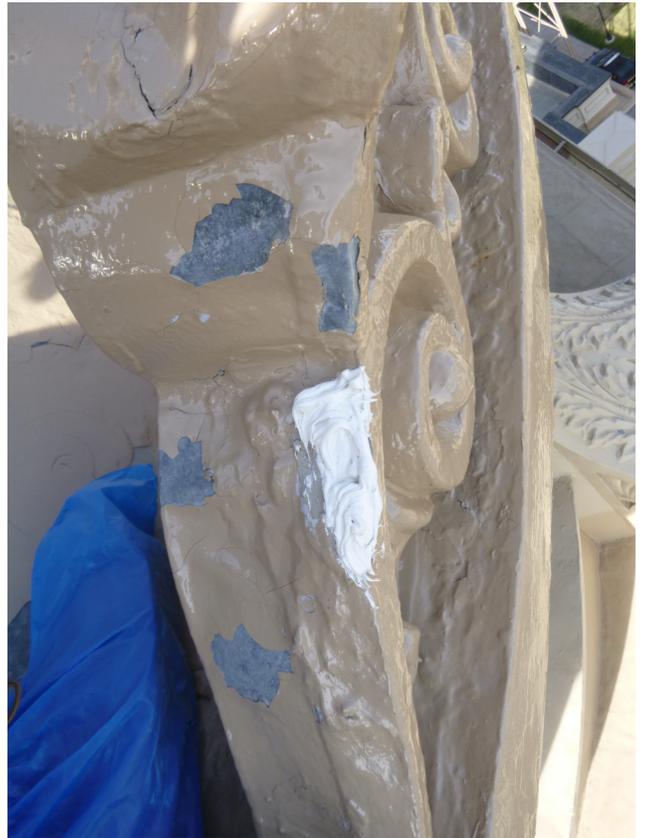
175-103 SheetMetal\_Note Photo-scupper both sides of

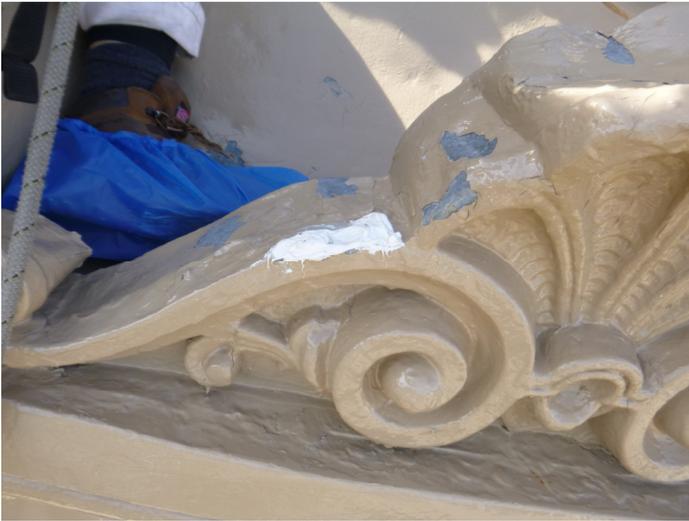
175-105 SheetMetal\_Note Photo-silicone 2013-1

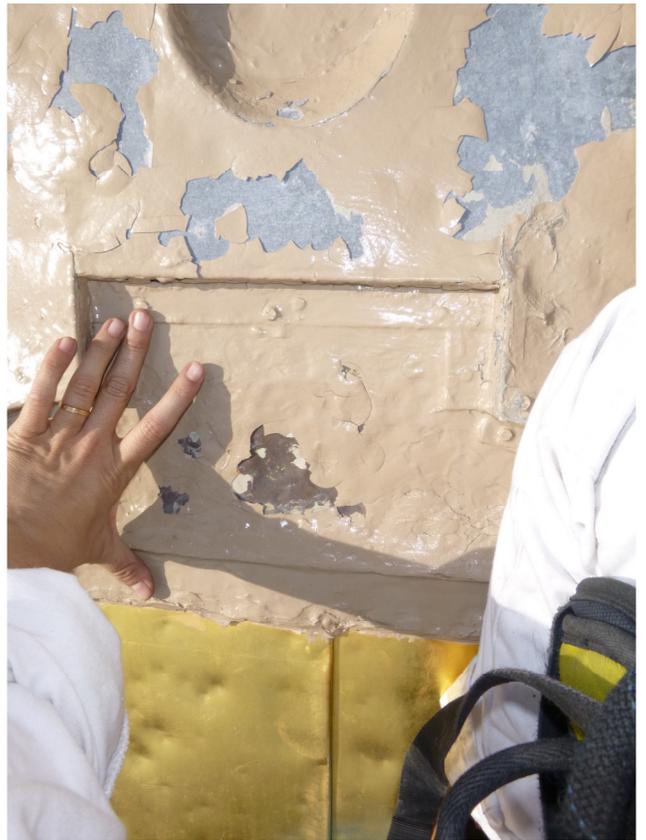
175-105 SheetMetal\_Note Photo-silicone 2013-2
