# Report Narrative

## Wyoming State Capitol Dome Investigation Cheyenne, WY

Vertical Access LLC  
PO Box 4135, Ithaca, NY 14852  
Tel: 607 257 4049 / Fax: 607 257 2129

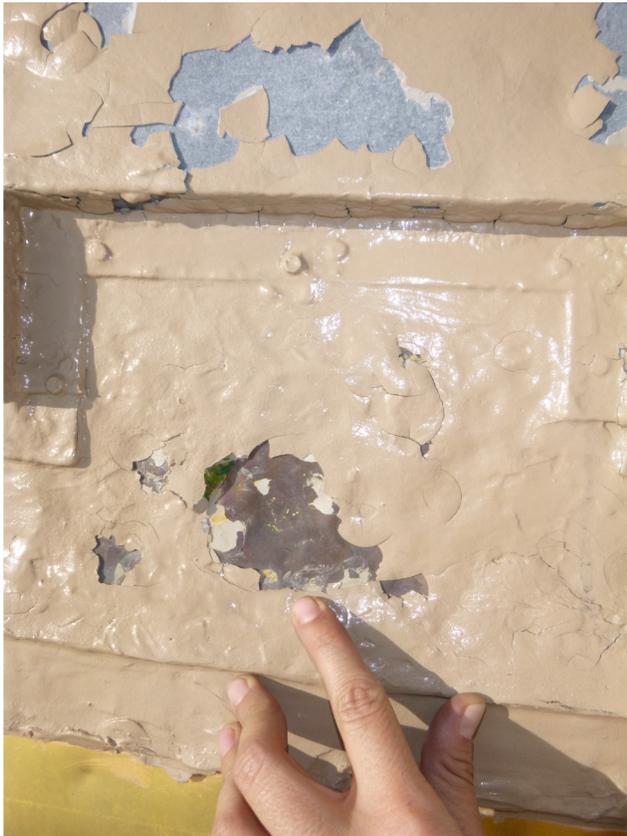
175-119 SheetMetal\_Note Photo-traces of gilding at

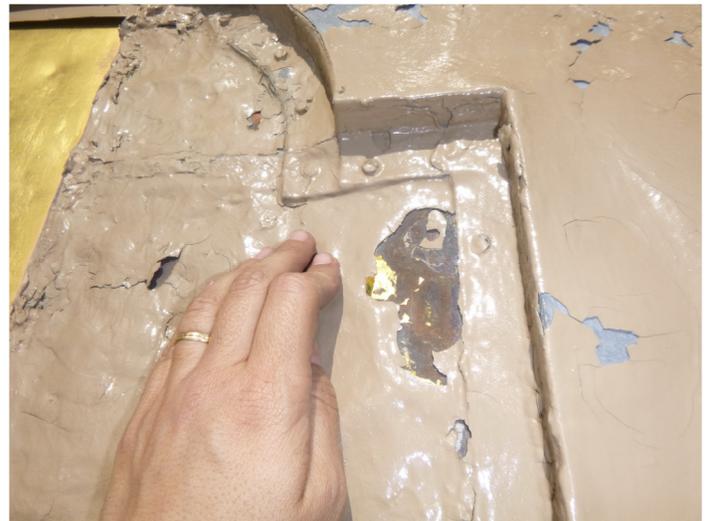
175-119 SheetMetal\_Note Photo-traces of gilding at

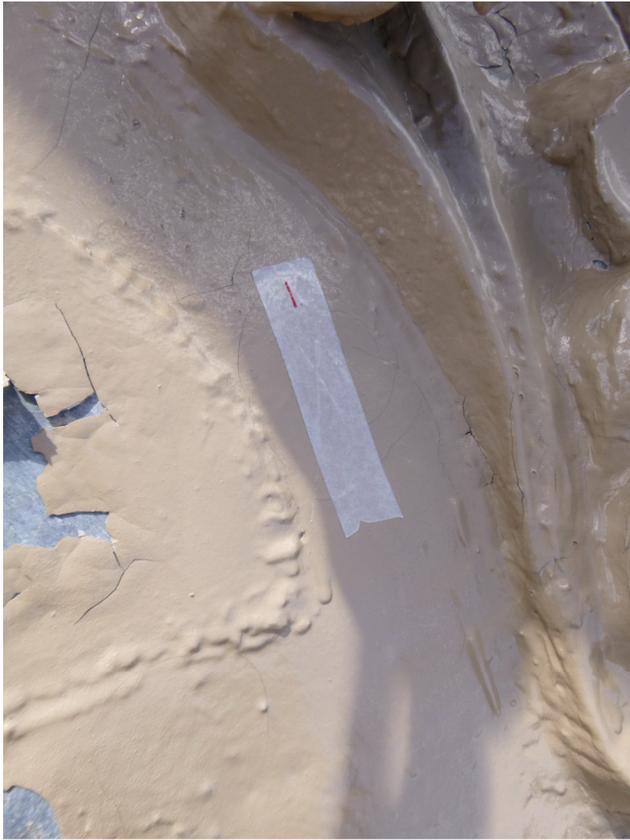
175-119 SheetMetal\_Note Photo-traces of gilding at

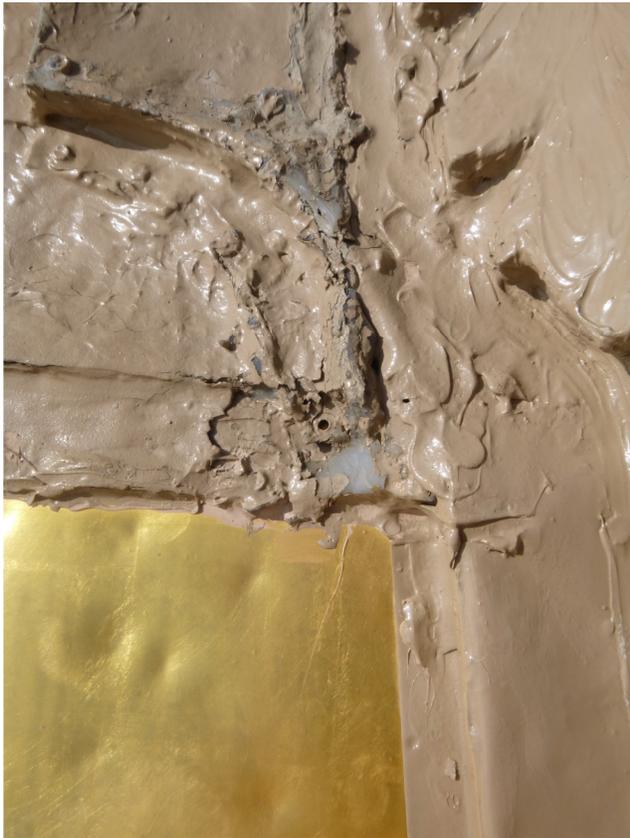
175-120 SheetMetal\_Note Photo-adhesion test1 2013-2

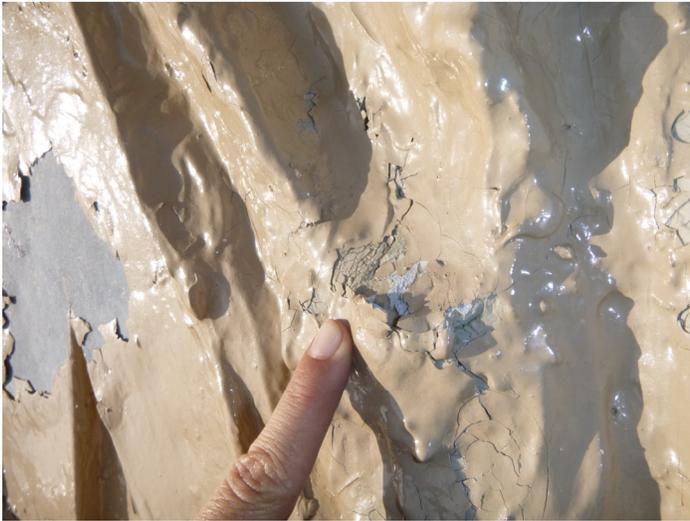
175-122 SheetMetal\_Note Photo-coating over damaged

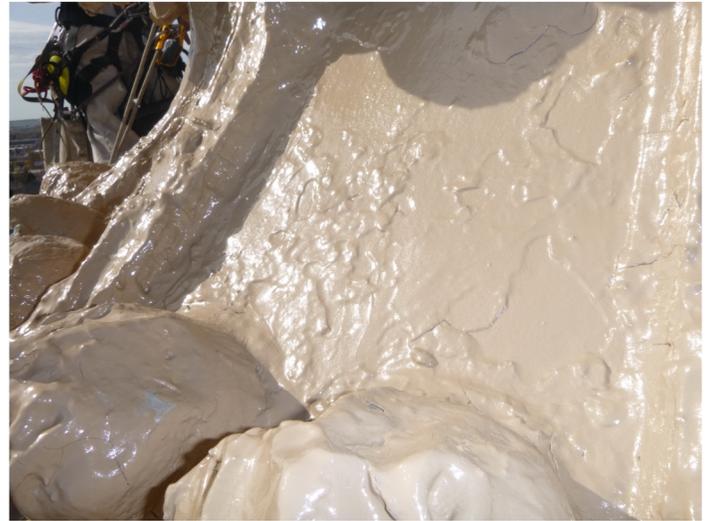
175-122 SheetMetal\_Note Photo-coating over damaged

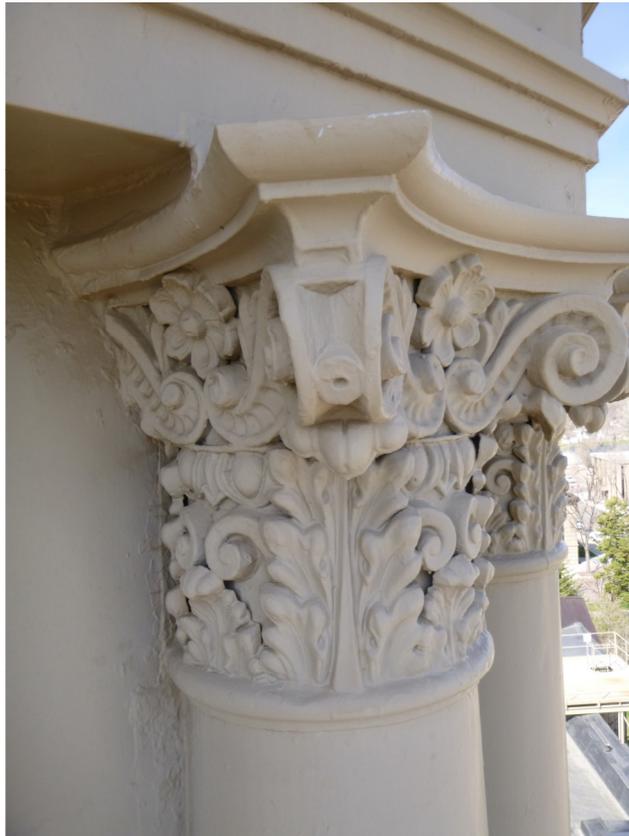
175-122 SheetMetal\_Note Photo-coating over damaged

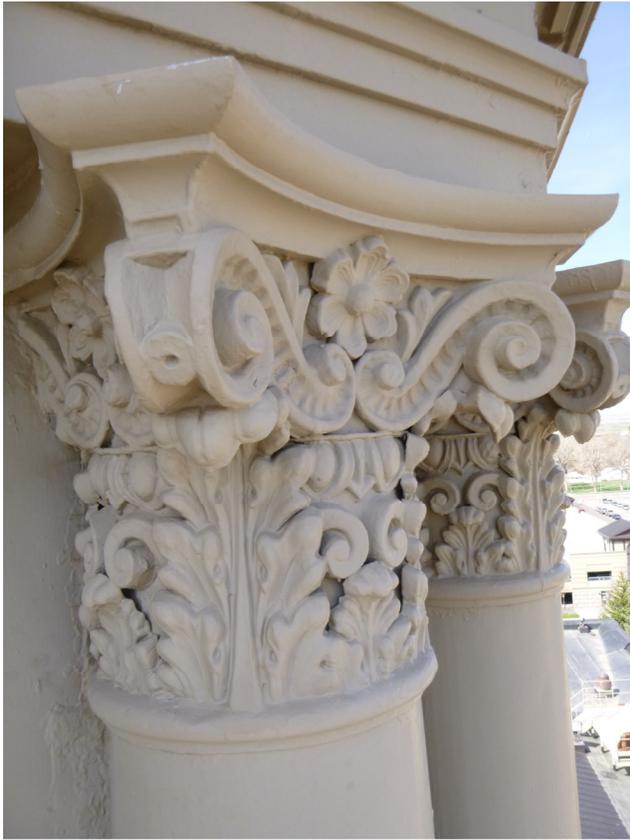
176-87 SheetMetal\_Note Photo-capital 2013-2

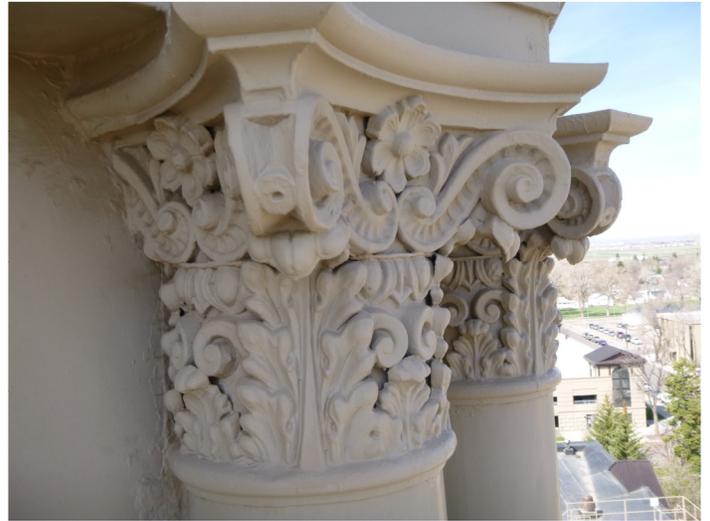
**176-87 SheetMetal\_Note Photo-capital 2013-3**

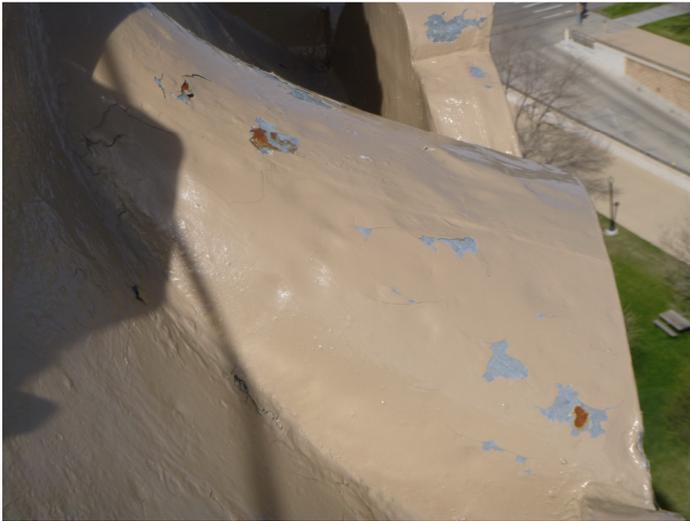
**176-87 SheetMetal\_Note Photo-capital 2013-4**

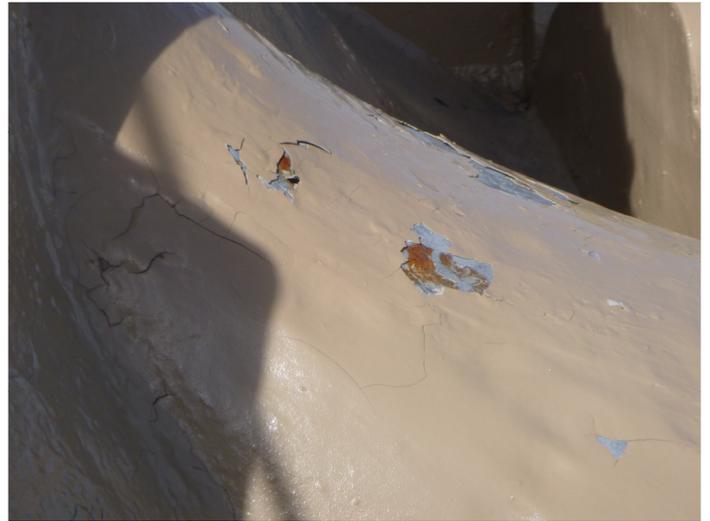
**176-106 SheetMetal\_Corrosion Surface 2013-1**

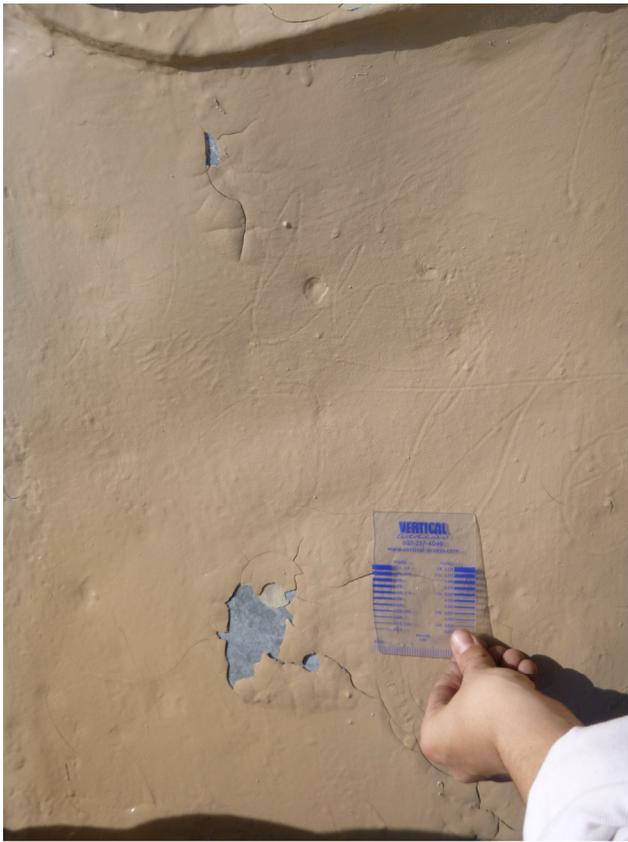
**176-106 SheetMetal\_Corrosion Surface 2013-2**

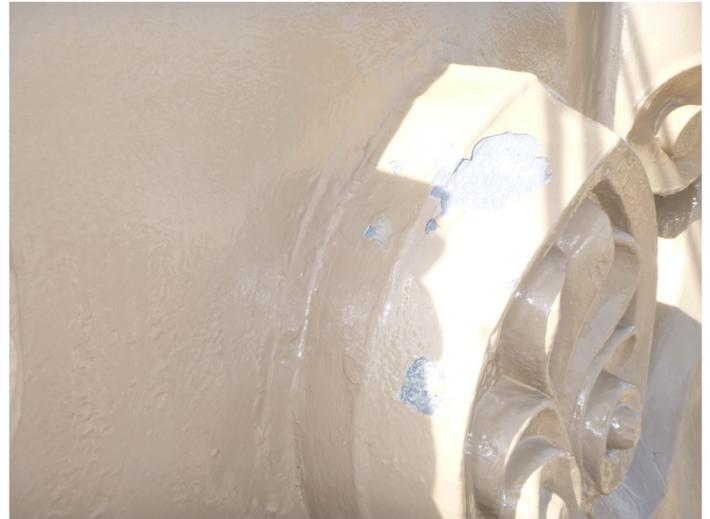
**176-107 SheetMetal\_Coating Coating Failed 2013-1**

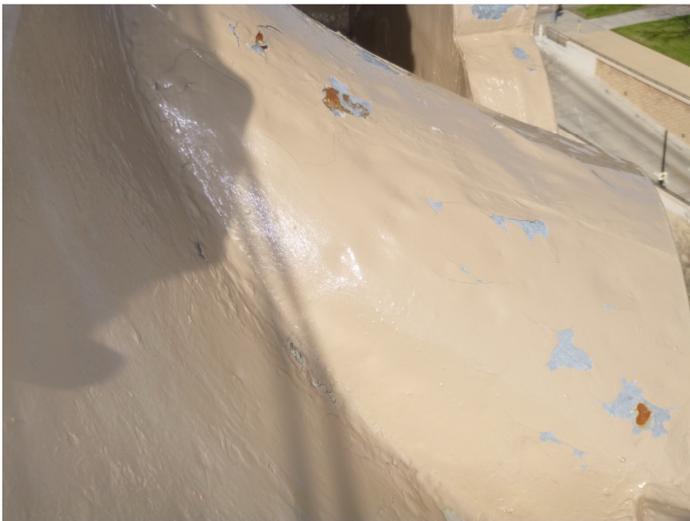
**176-107 SheetMetal\_Coating Coating Failed 2013-2**

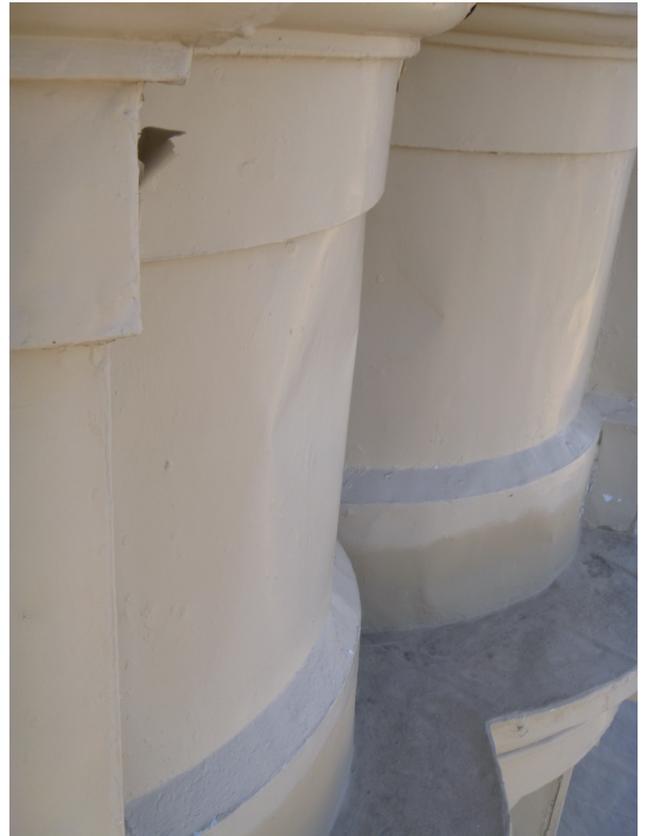
**176-107 SheetMetal\_Coating Coating Failed 2013-3**

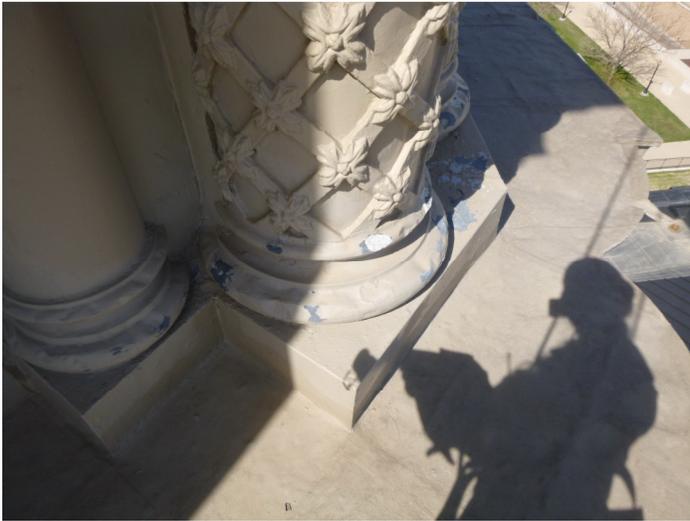
**177-71 SheetMetal\_Damaged Dented 2013-1**

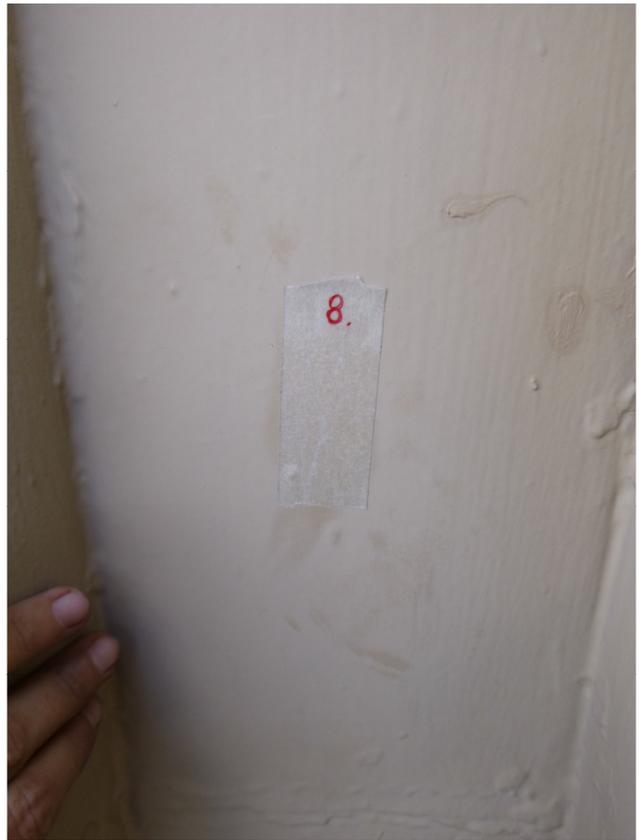
177-74 SheetMetal\_Coating Coating Failed 2013-1

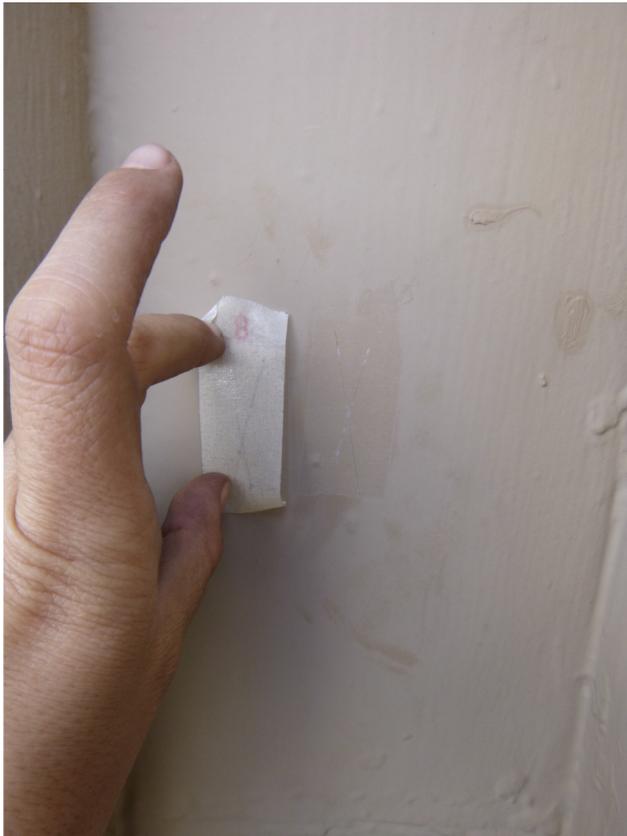
177-75 SheetMetal\_Note Photo-adhesion test 8 2013-1

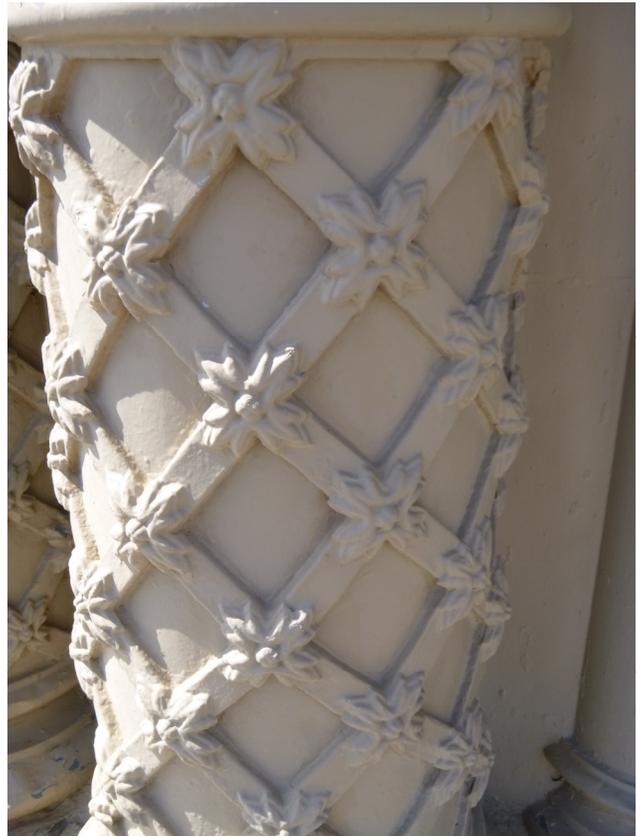
177-75 SheetMetal\_Note Photo-adhesion test 8 2013-2

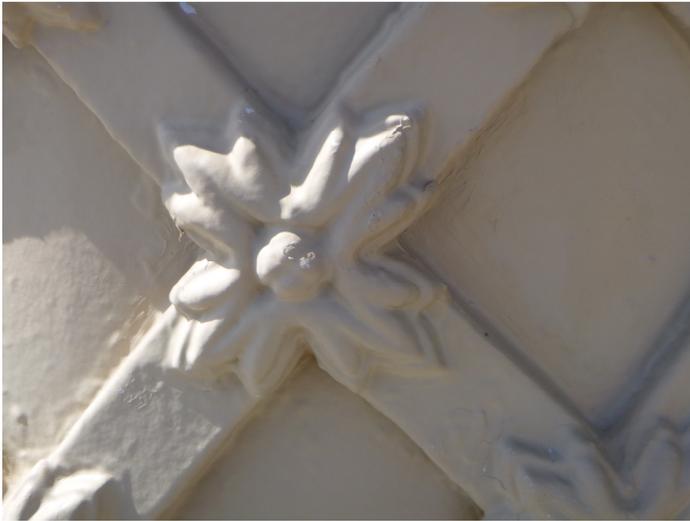
177-77 SheetMetal\_Note Photo-detail ornament 2013-1

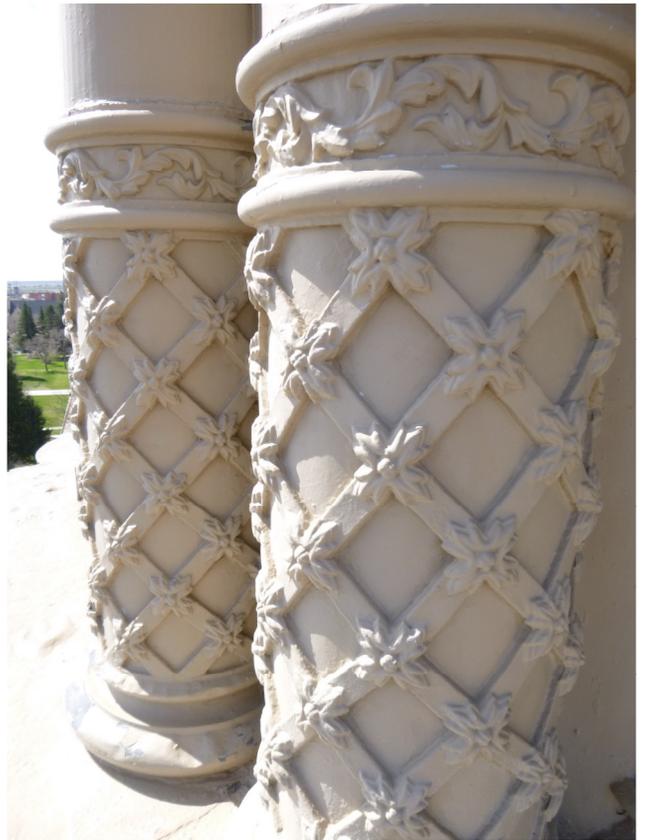
177-77 SheetMetal\_Note Photo-detail ornament 2013-2

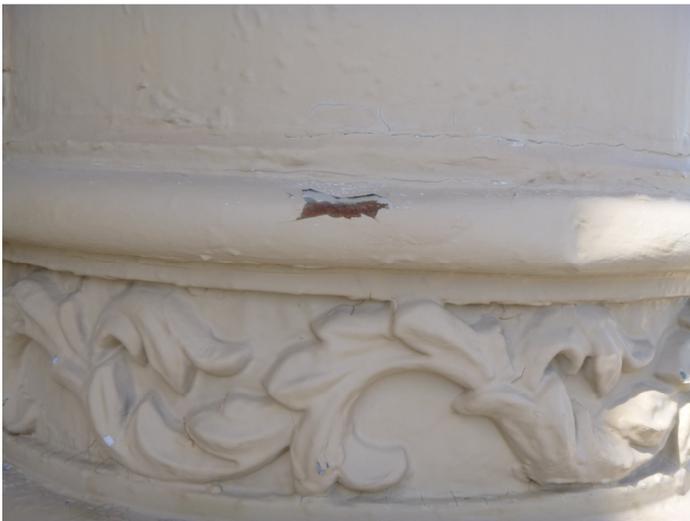
177-77 SheetMetal\_Note Photo-detail ornament 2013-3

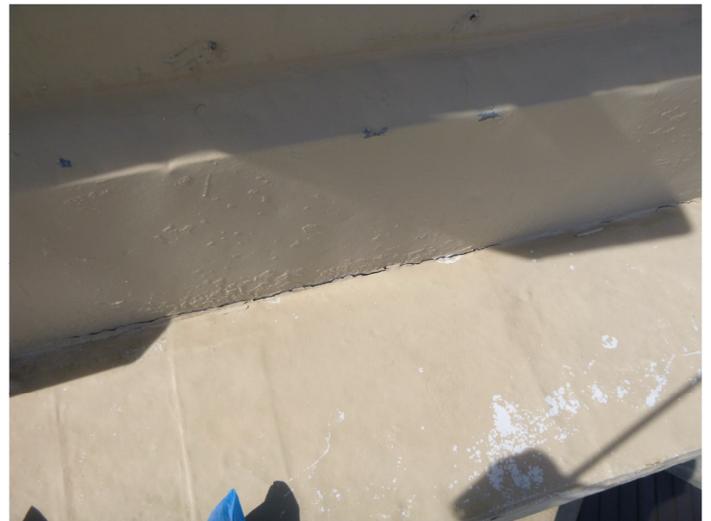
177-79 SheetMetal\_Corrosion Surface 2013-1

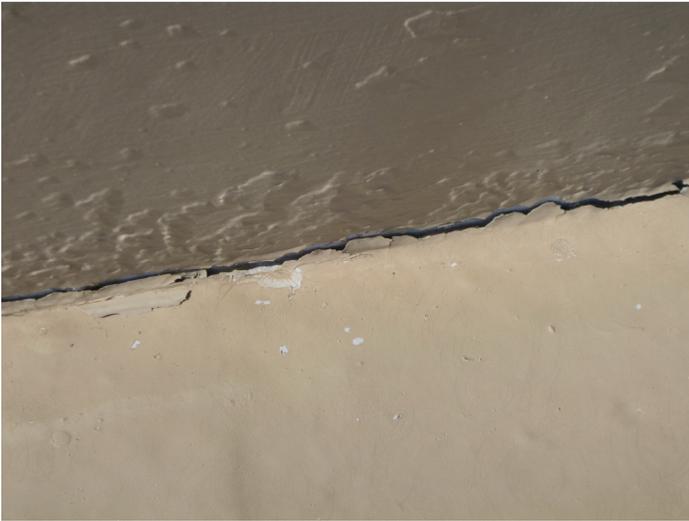
177-91 SheetMetal\_Seam Sealant Failed 2013-1

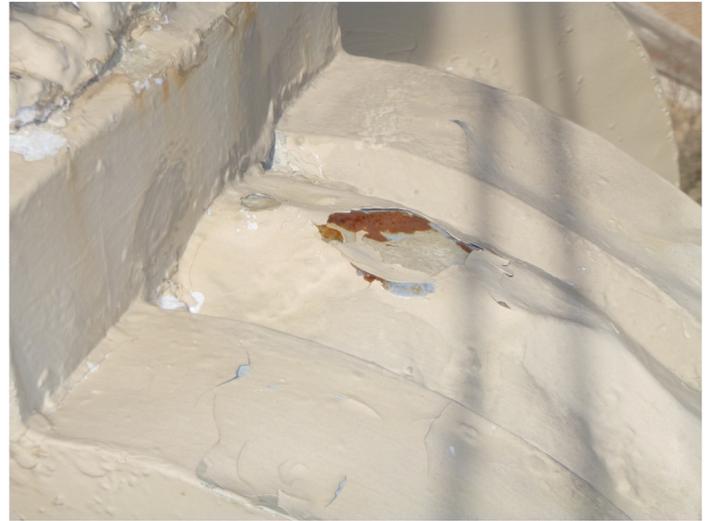
**177-91 SheetMetal\_Seam Sealant Failed 2013-2**

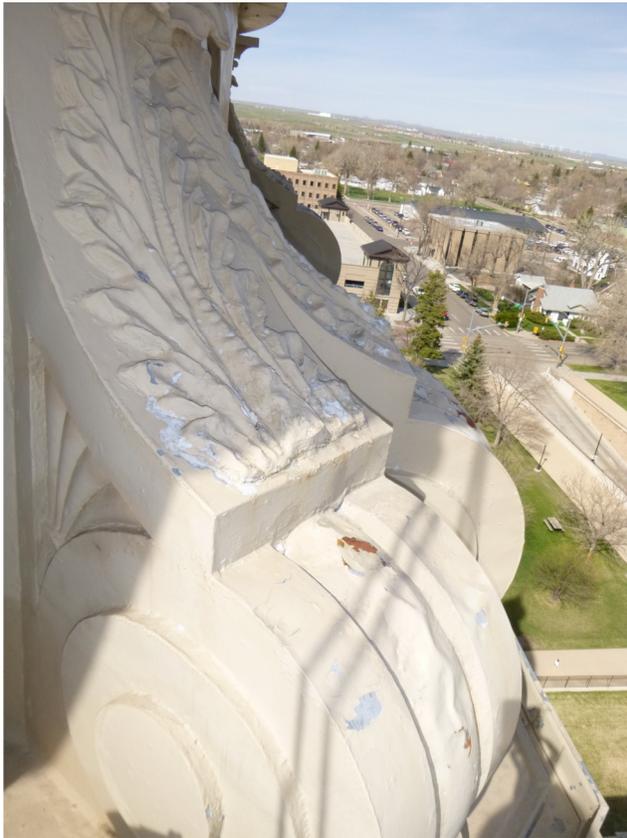
**177-97 SheetMetal\_Corrosion Surface 2013-1**

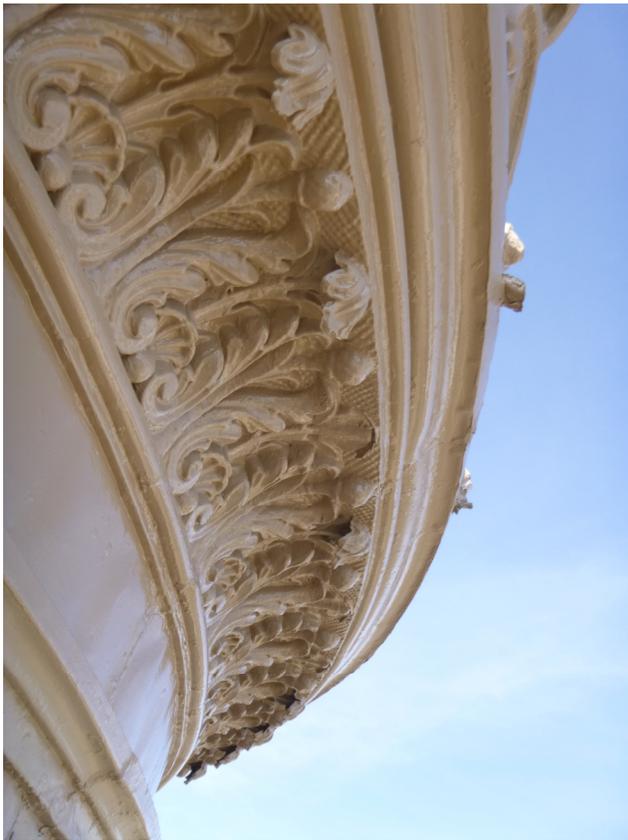
**178-102 SheetMetal\_Unsecured Missing 2013-1**

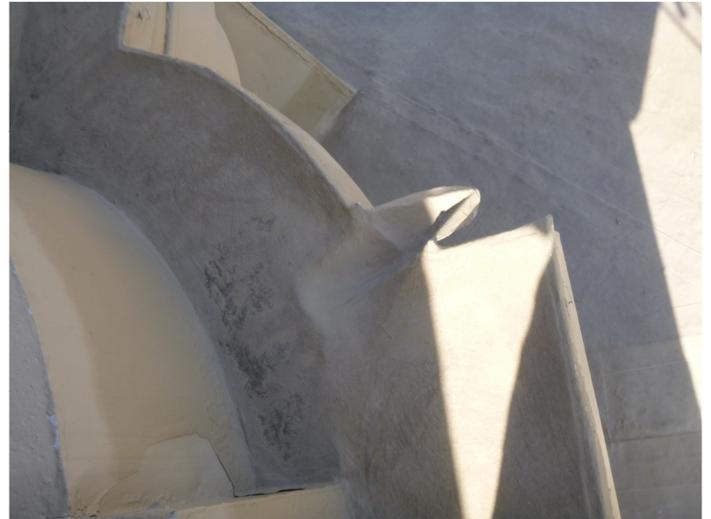
**179-69 SheetMetal\_Note Photo-scupper 2013-1**

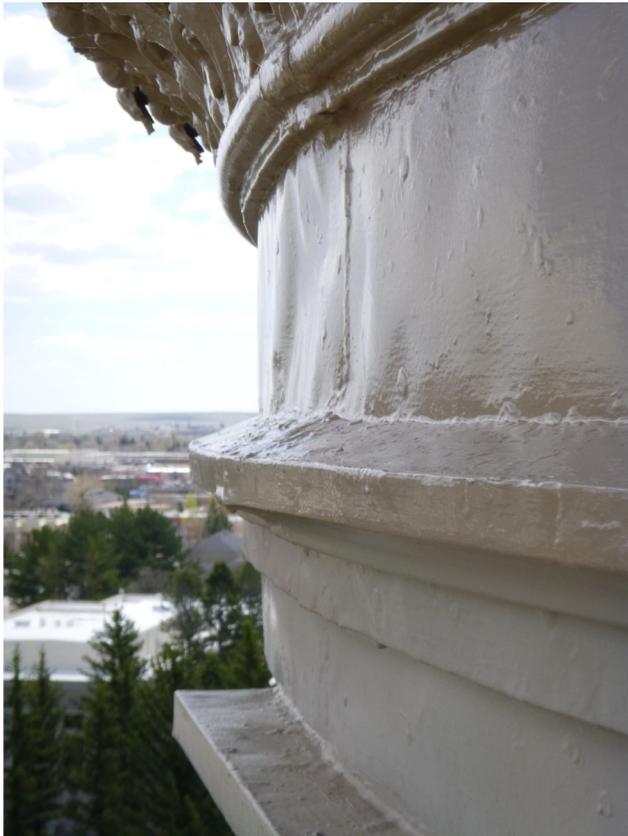
**185-100 SheetMetal\_Note Photo-matte coating 2013-1**

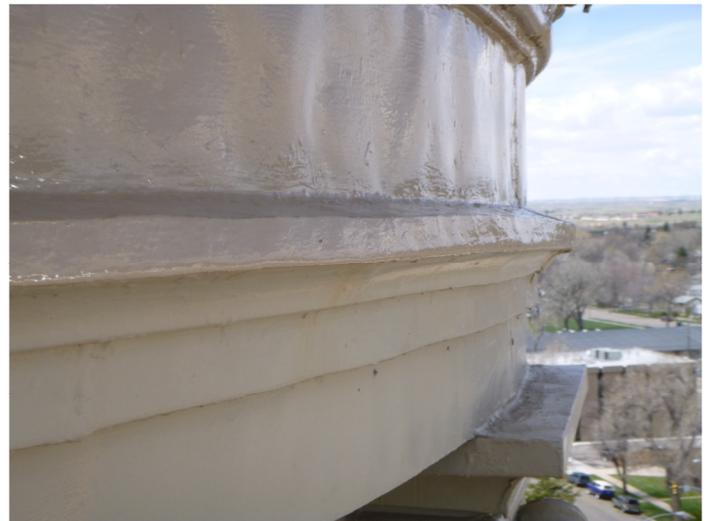
**185-102 SheetMetal\_Note Photo-glossy coating 2013-1**

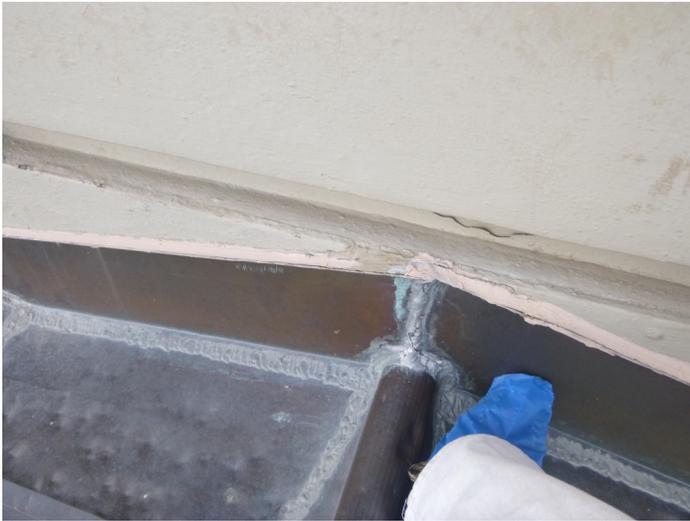
**236-53 SheetMetal\_Seam Sealant Failed 2013-1**

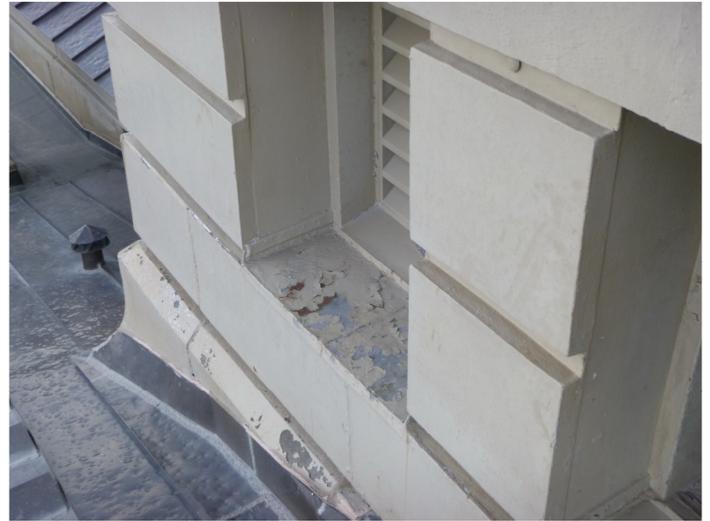
**238-56 SheetMetal\_Corrosion Surface 2013-1**

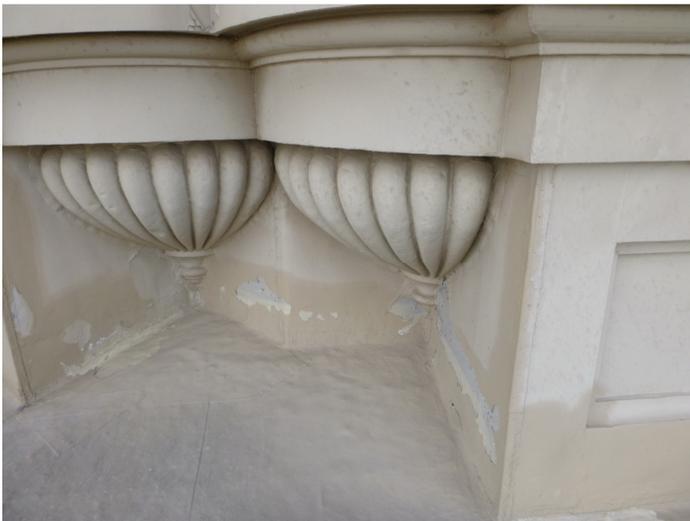
**240-66 SheetMetal\_Coating Coating Failed 2013-1**

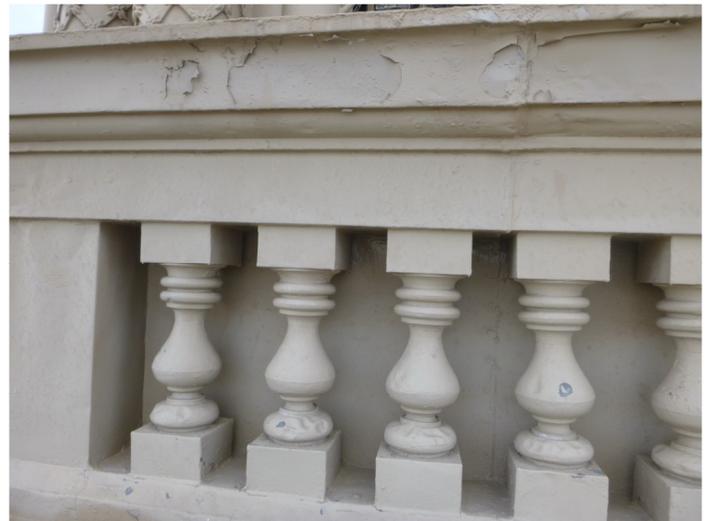
**240-73 SheetMetal\_Coating Coating Failed 2013-1**

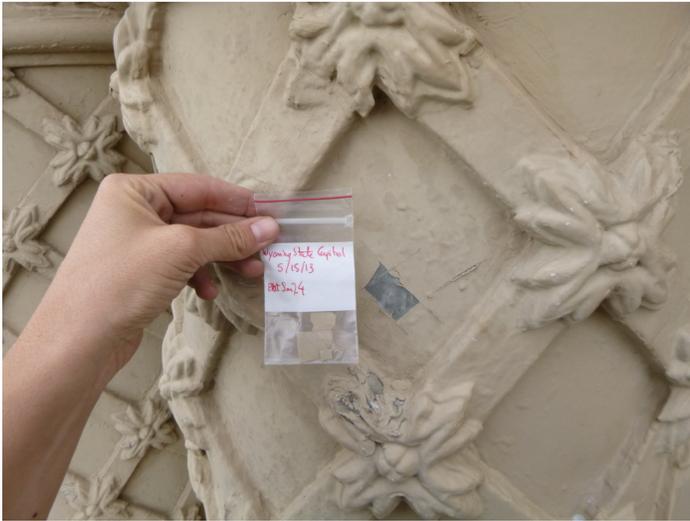
241-76 SheetMetal\_Note PntSm 24 2013-1

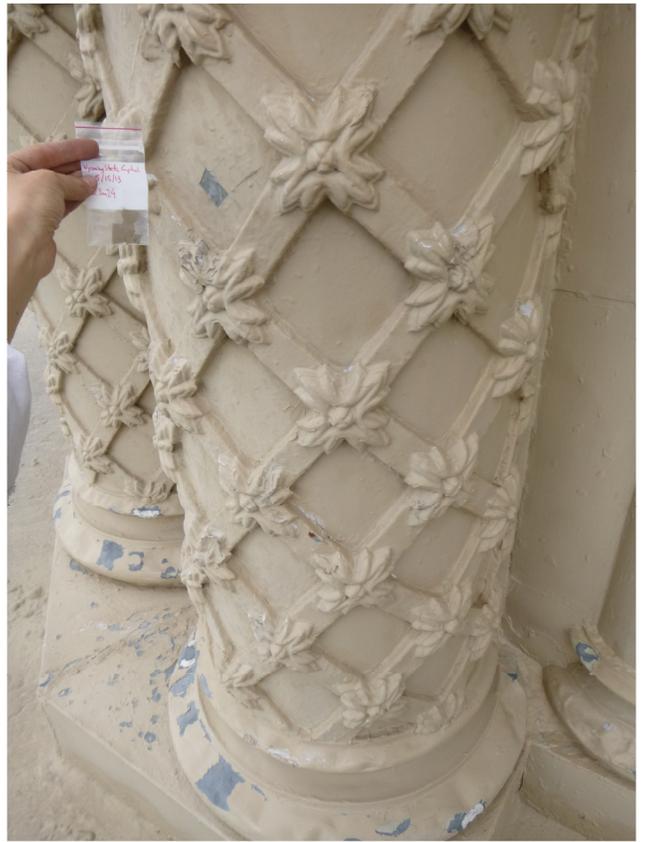
241-76 SheetMetal\_Note PntSm 24 2013-2

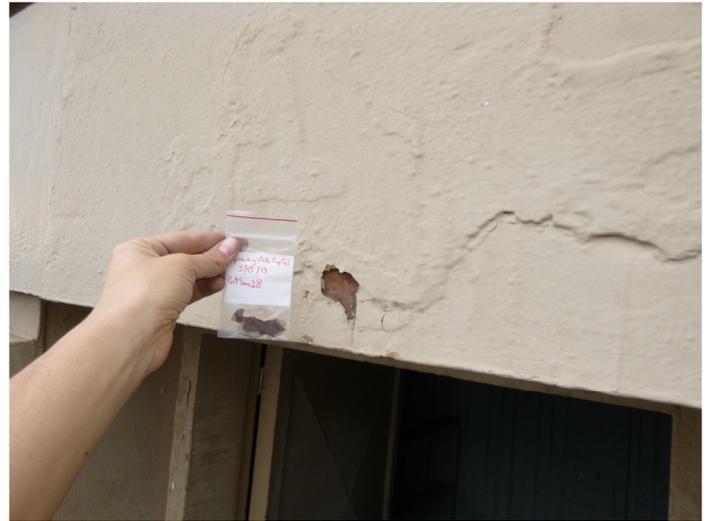
242-60 ArchMetal\_Note PntSm 28 2013-1

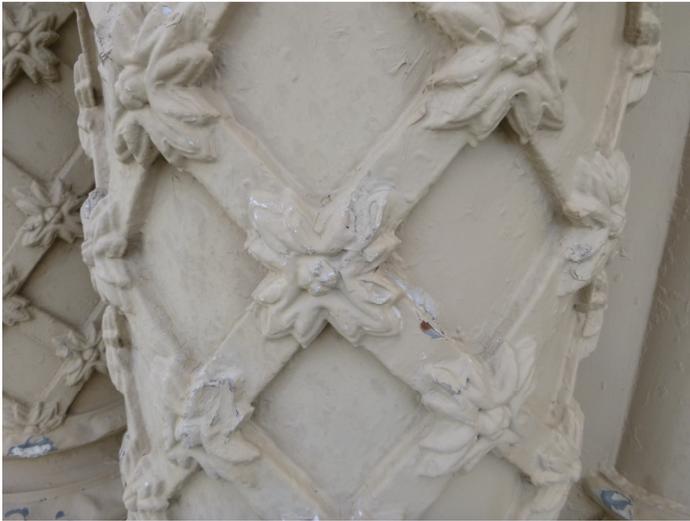
**242-78 SheetMetal\_Repair Patch Failed 2013-1**

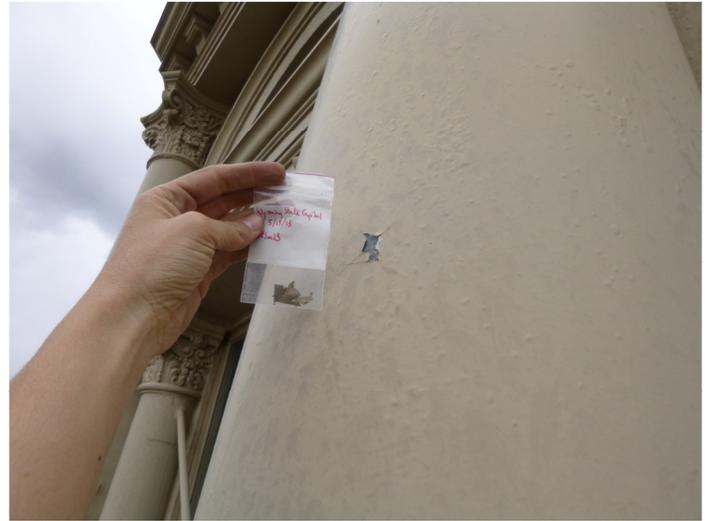
**242-80 SheetMetal\_Note PntSm 23 2013-1**

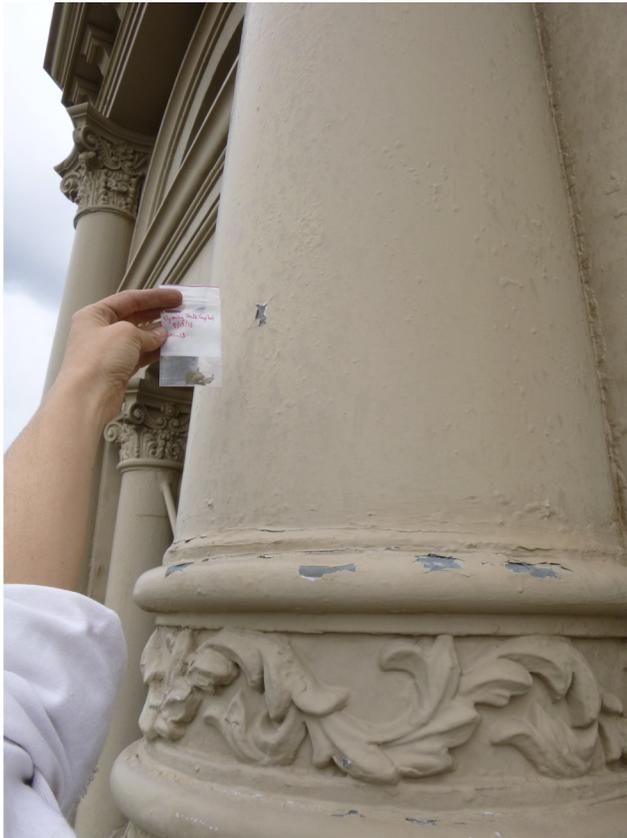
**242-80 SheetMetal\_Note PntSm 23 2013-2**

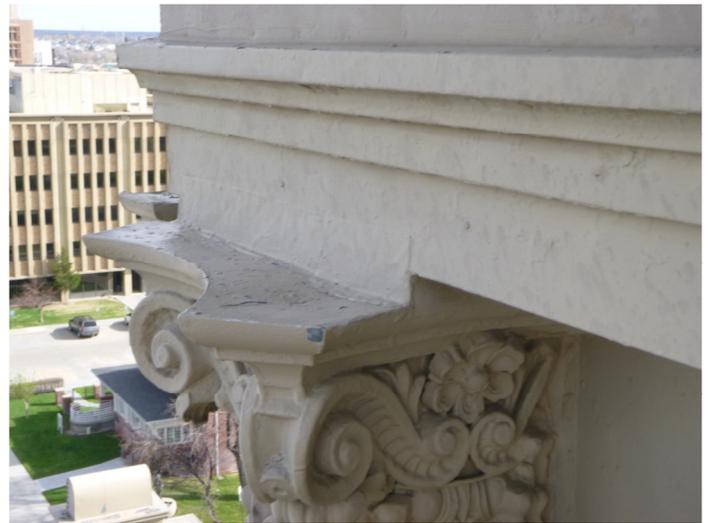
**242-88 SheetMetal\_Coating Coating Failed 2013-1**

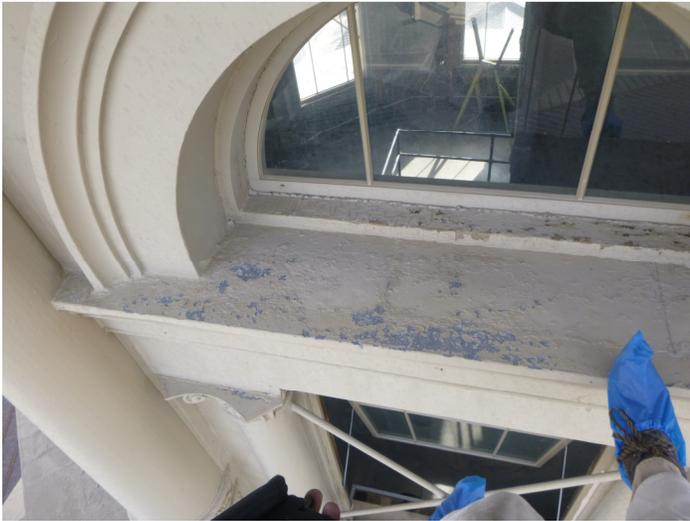
**242-88 SheetMetal\_Coating Coating Failed 2013-2**

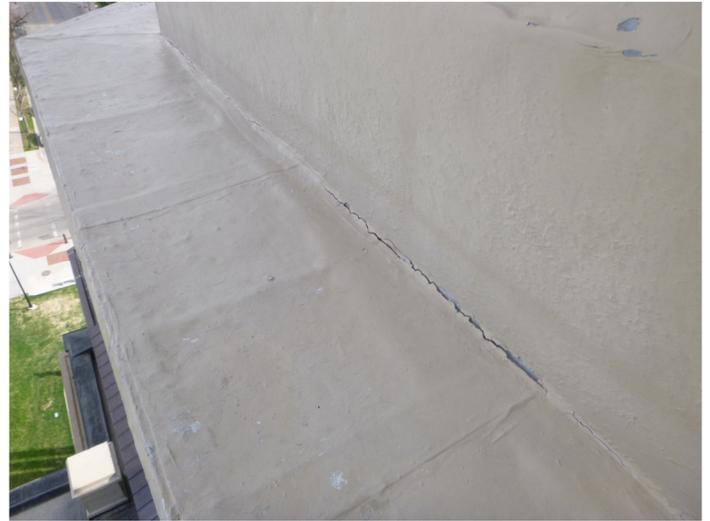
**242-92 SheetMetal\_Coating Coating Sound 2013-1**

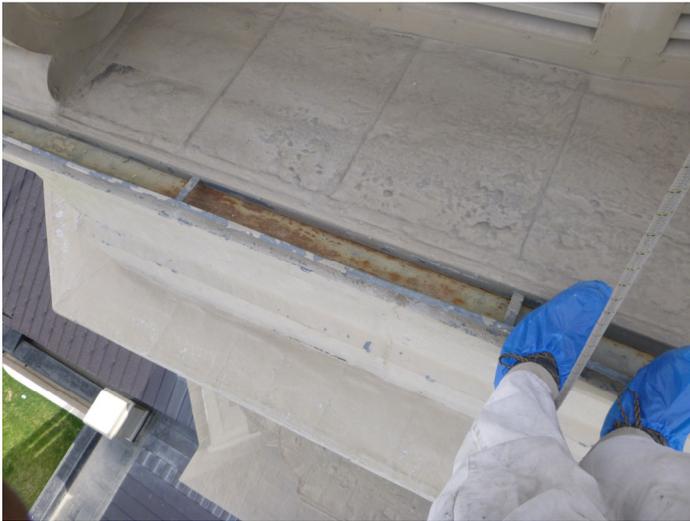
**242-94 SheetMetal\_Corrosion Surface 2013-1**

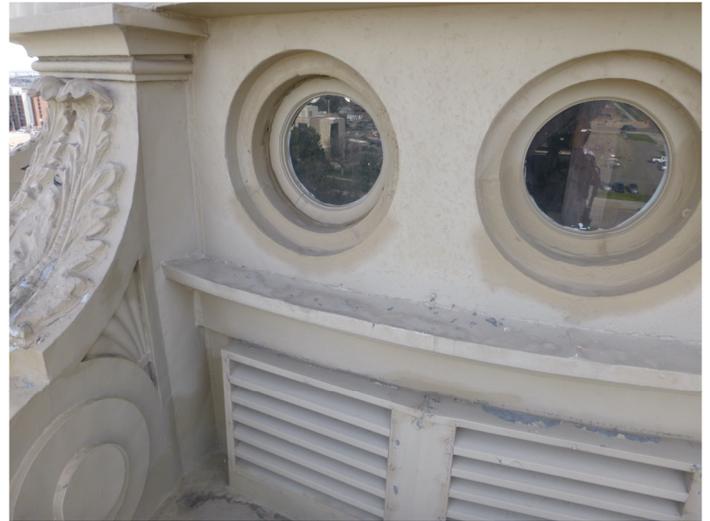
**242-100 SheetMetal\_Coating Coating Failed 2013-1**

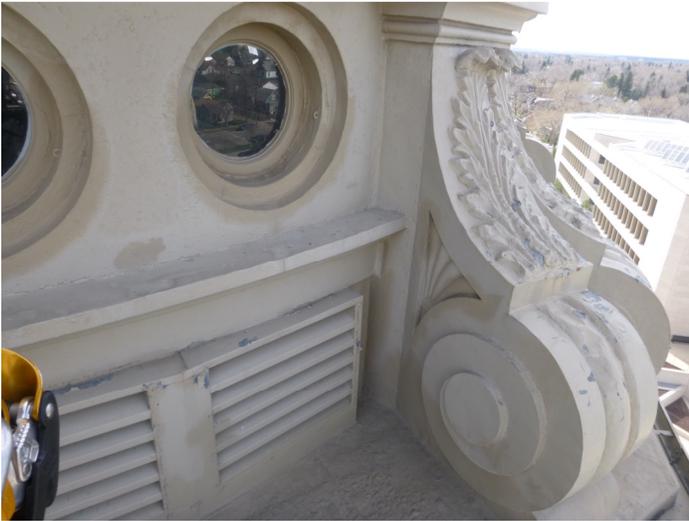
**242-100 SheetMetal\_Coating Coating Failed 2013-2**

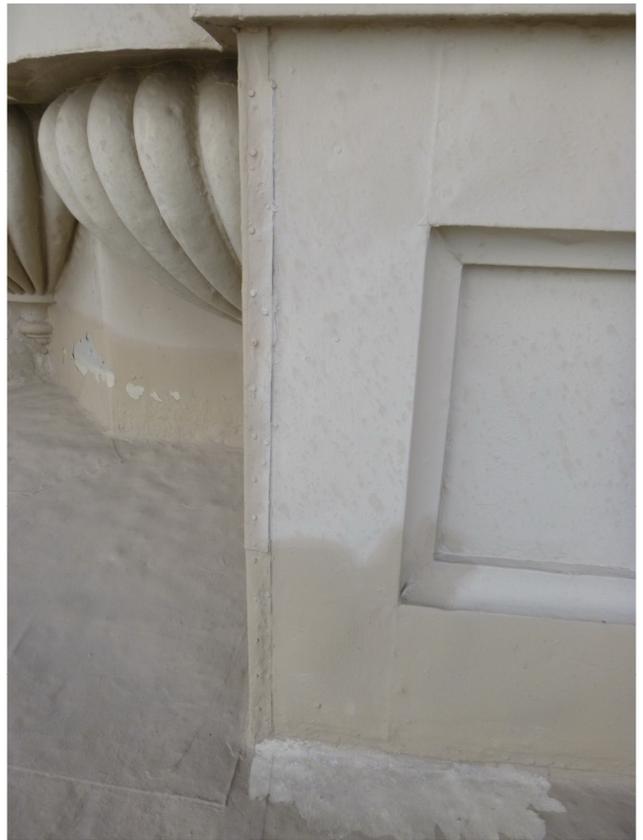
**243-67 SheetMetal\_Seam Sealant Failed 2013-1**

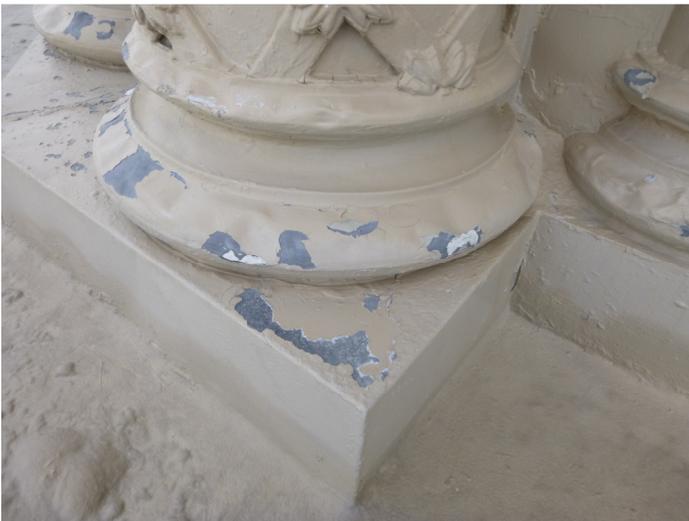
**243-74 SheetMetal\_Repair Patch Failed 2013-1**

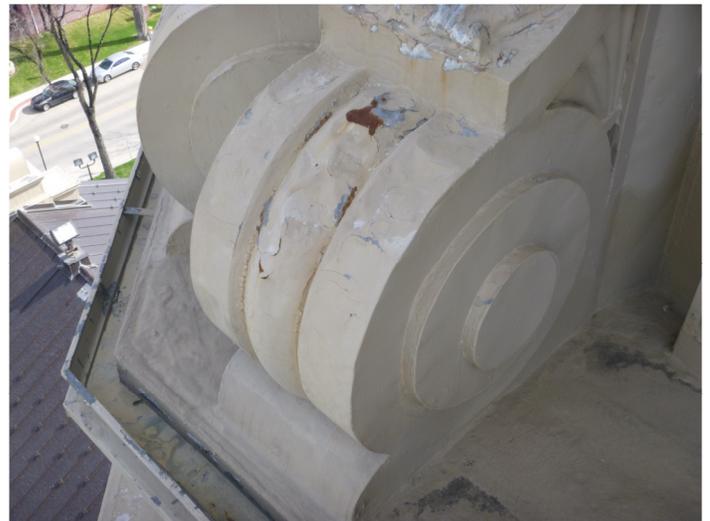
**243-96 SheetMetal\_Corrosion Surface 2013-1**

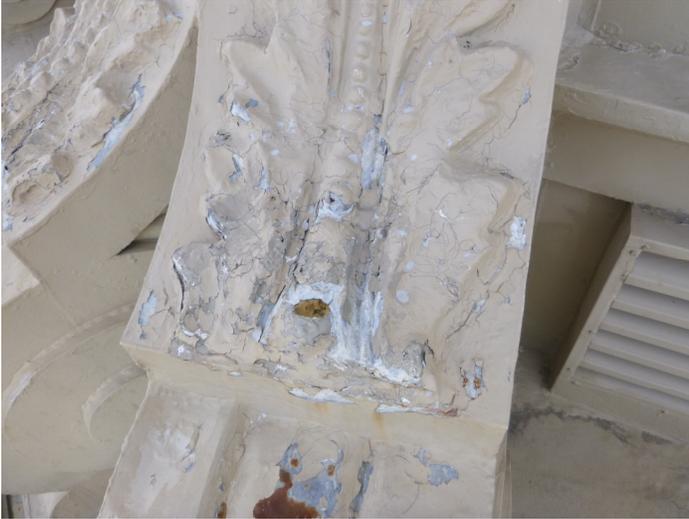
**243-98 SheetMetal\_Damaged Punctured 2013-1**

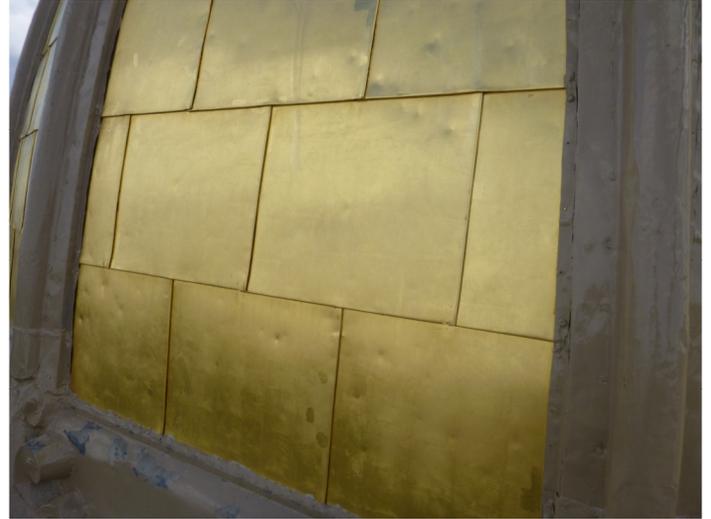
**243-112 SheetMetal\_Damaged Dented 2013-1**

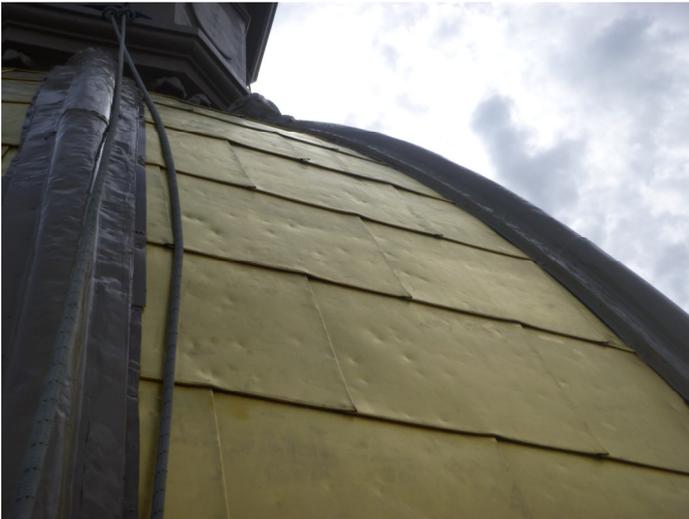
**243-112 SheetMetal\_Damaged Dented 2013-2**

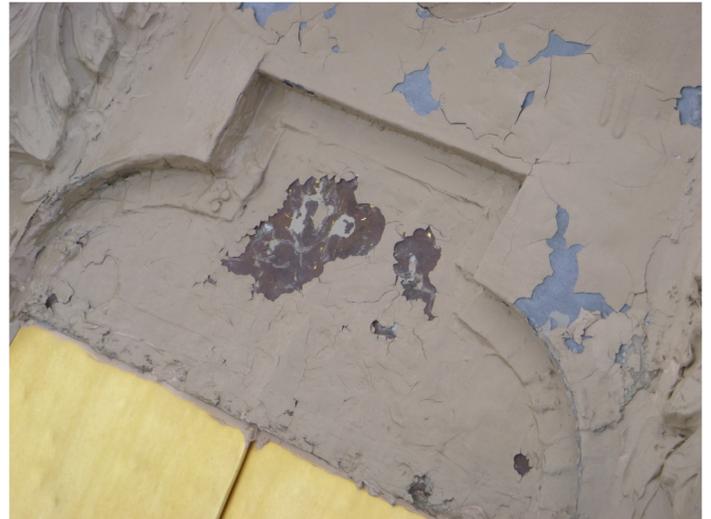
**243-118 SheetMetal\_Corrosion Surface 2013-1**

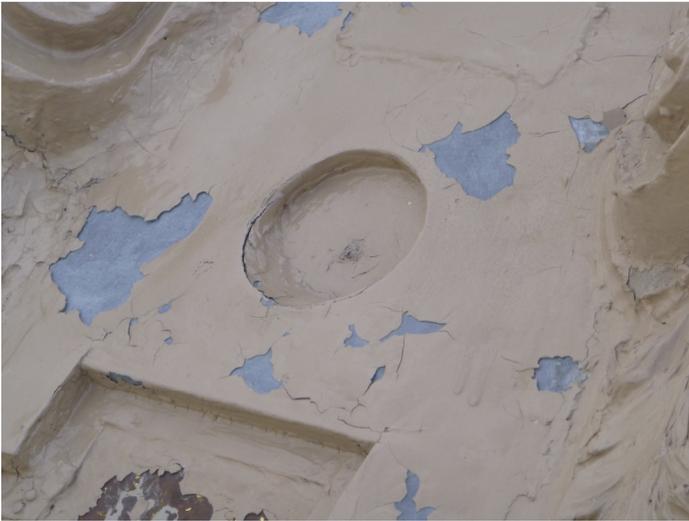
**243-120 SheetMetal\_Damaged Torn 2013-1**
