# Report Narrative

## Wyoming State Capitol Dome Investigation Cheyenne, WY

Vertical Access LLC  
PO Box 4135, Ithaca, NY 14852  
Tel: 607 257 4049 / Fax: 607 257 2129

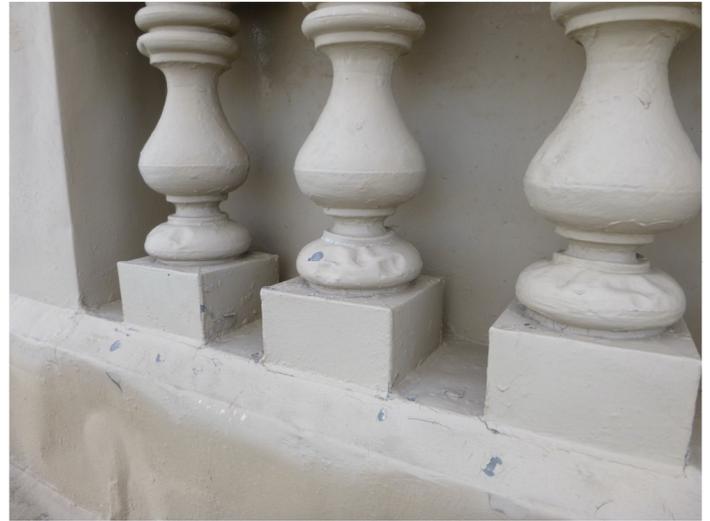
**244-70 SheetMetal\_Damaged Torn 2013-1**

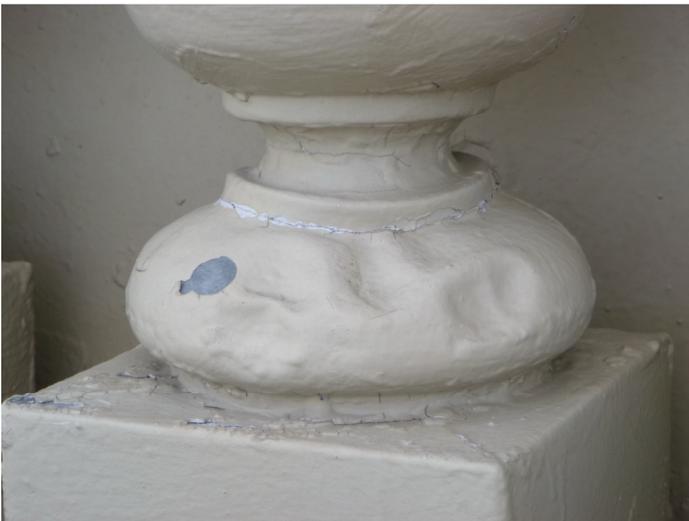
**244-70 SheetMetal\_Damaged Torn 2013-2**

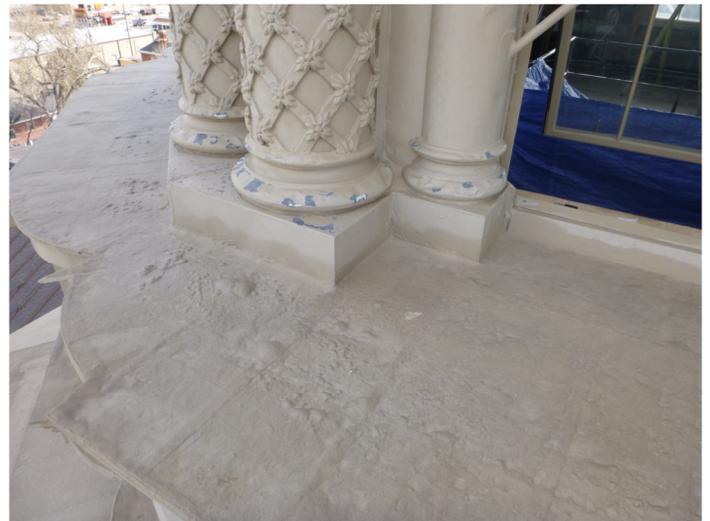
**244-75 SheetMetal\_Coating Coating Failed 2013-1**

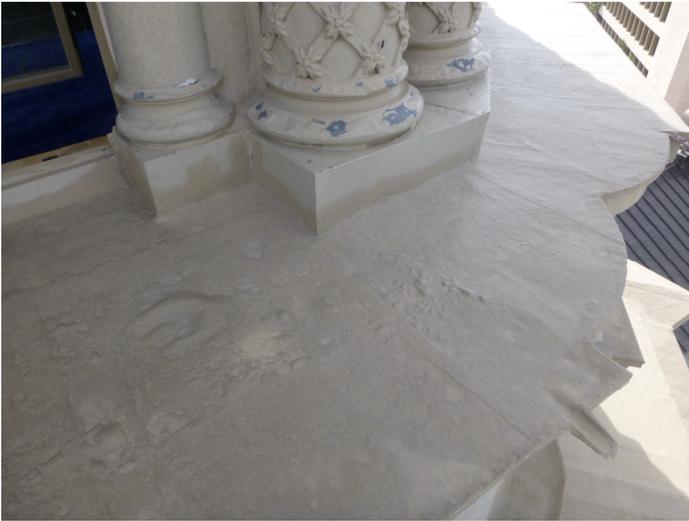
**244-75 SheetMetal\_Coating Coating Failed 2013-2**

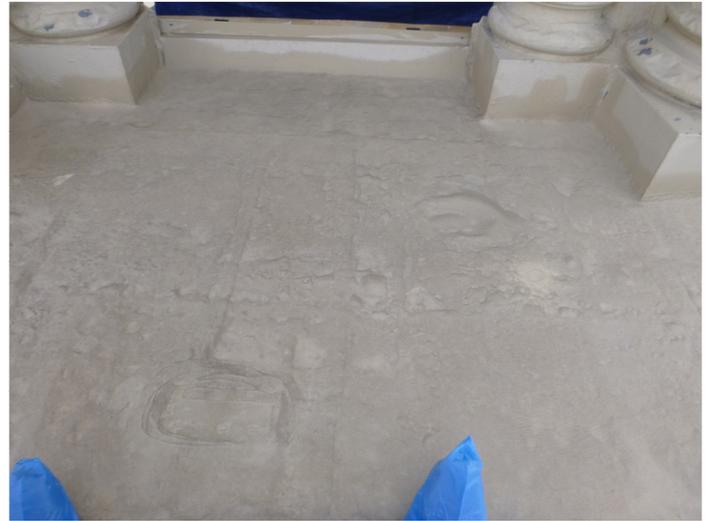
**244-75 SheetMetal\_Coating Coating Failed 2013-3**

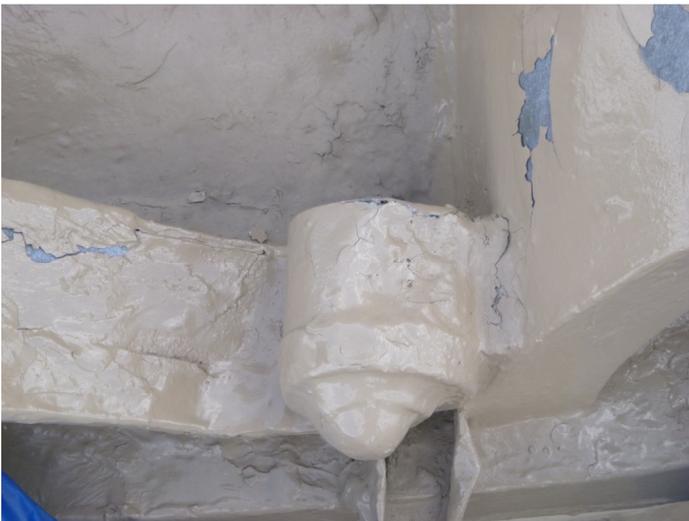
**244-105 SheetMetal\_Damaged Torn 2013-1**

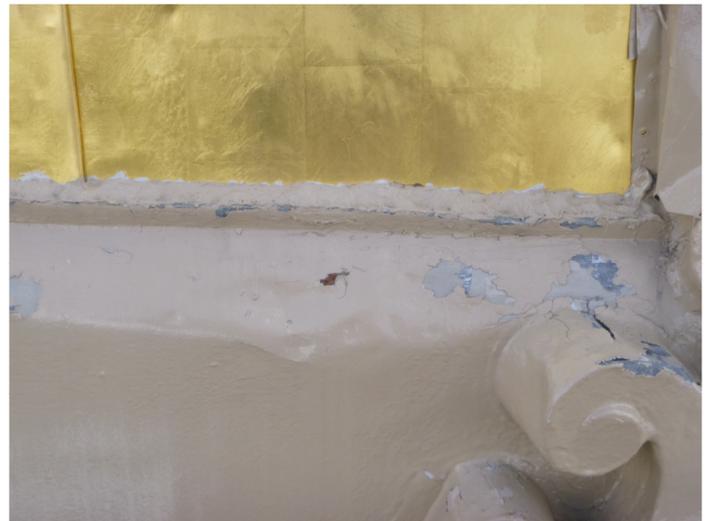
**244-108 SheetMetal\_Corrosion Surface 2013-1**

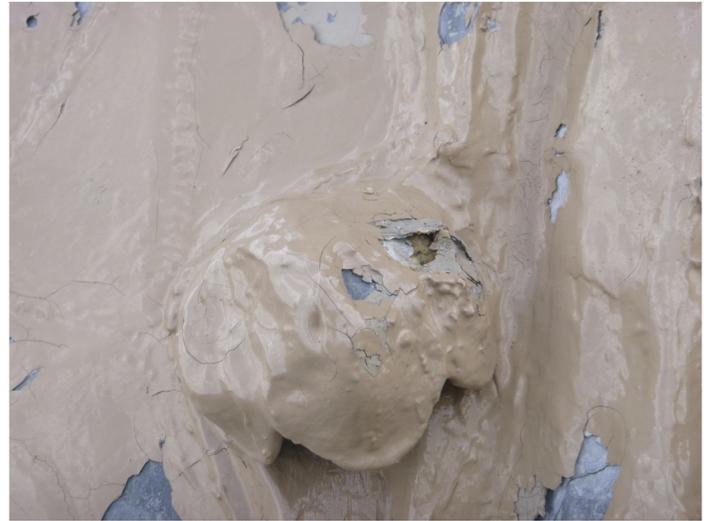
**244-121 SheetMetal\_Damaged Punctured 2013-1**

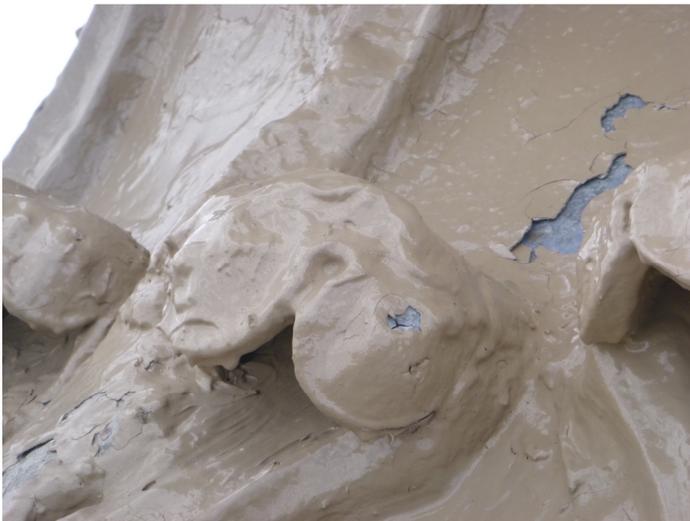
**244-122 SheetMetal\_Damaged Punctured 2013-1**

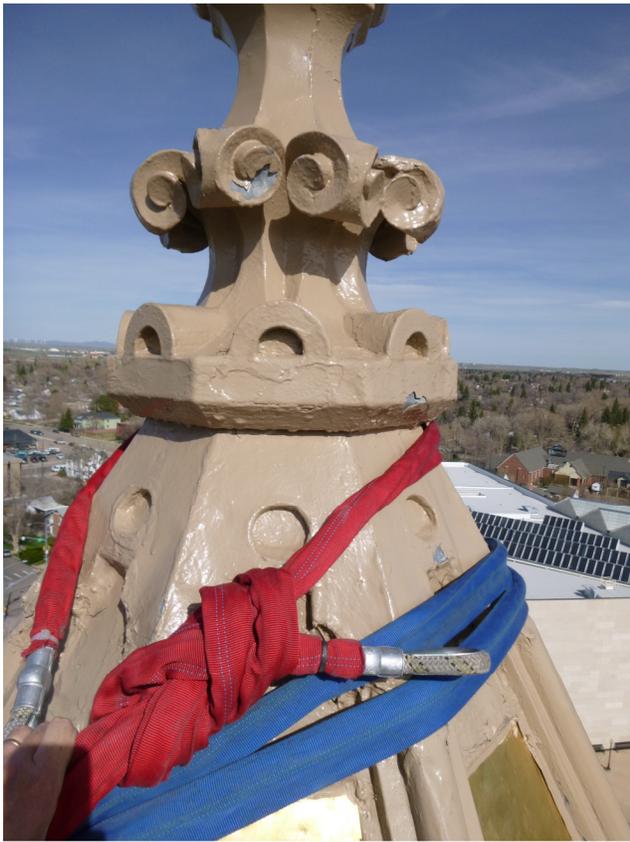
244-137 SheetMetal\_Coating Coating Failed 2013-1

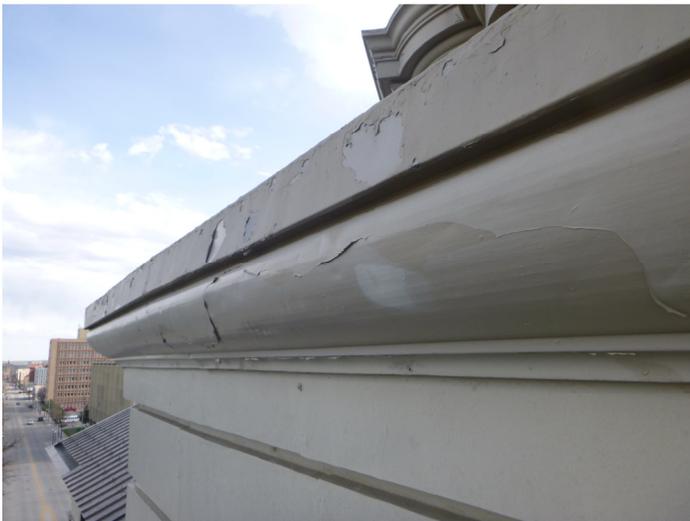
244-137 SheetMetal\_Coating Coating Failed 2013-2

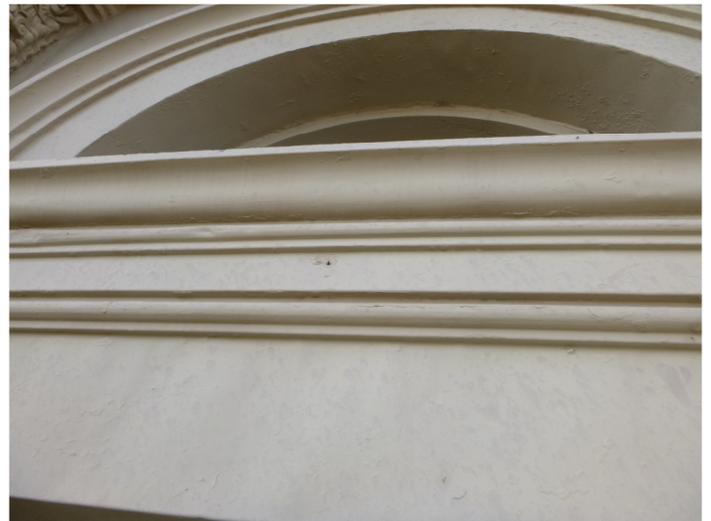
245-61 SheetMetal\_Coating Coating Failed 2013-1

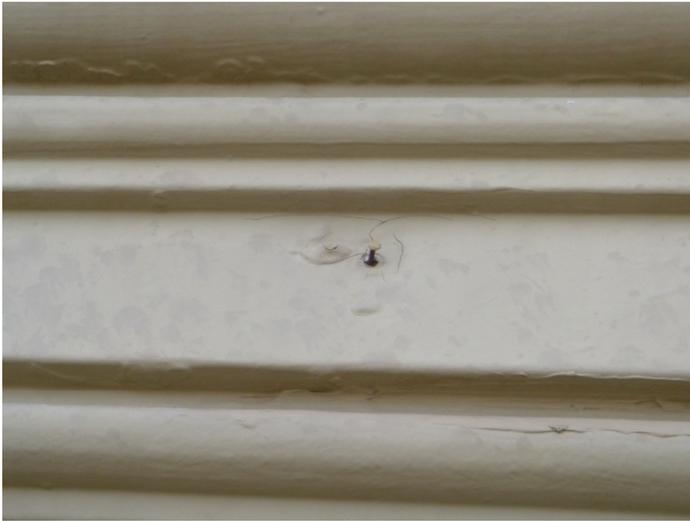
245-82 SheetMetal\_Seam Fastener Failed 2013-1

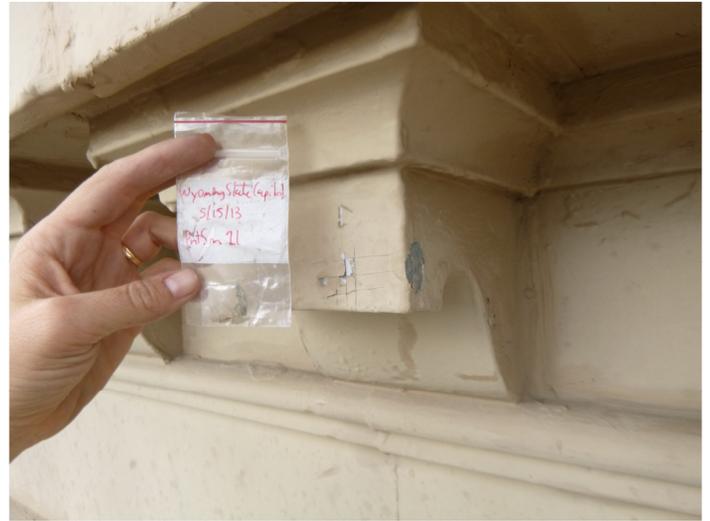
**245-82 SheetMetal\_Seam Fastener Failed 2013-2**

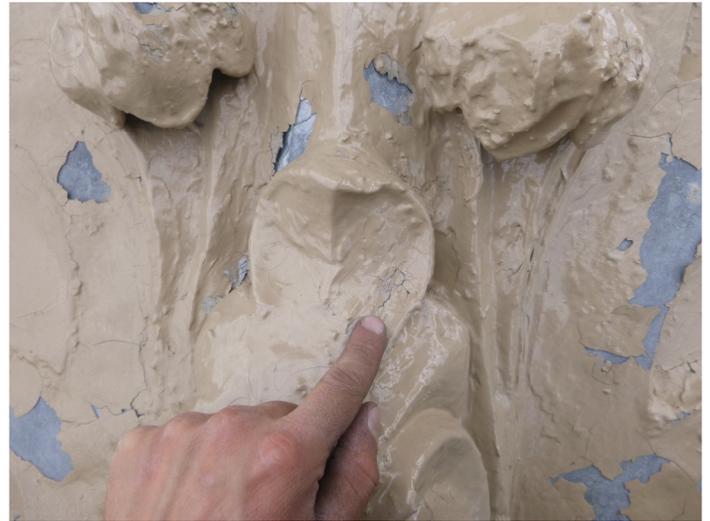
**245-111 SheetMetal\_Damaged Torn 2013-1**

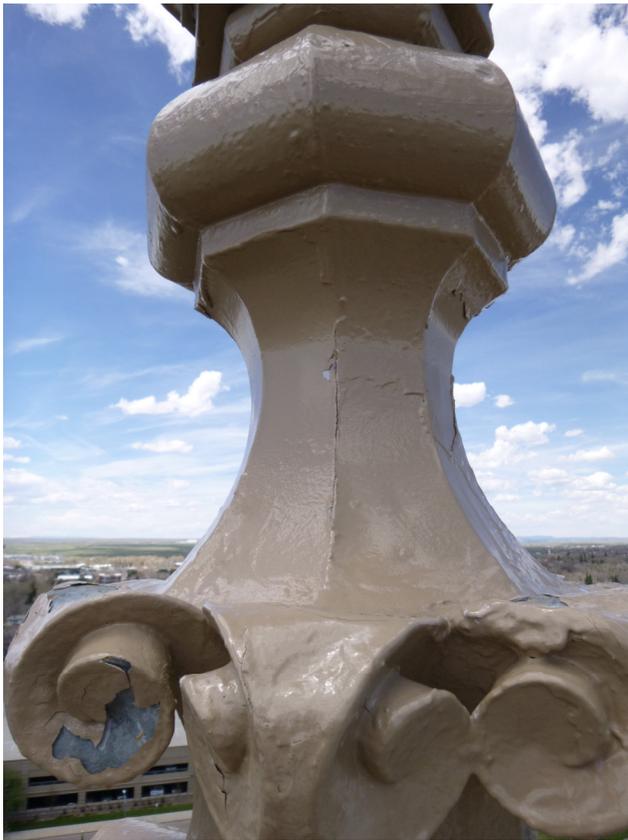
**245-119 SheetMetal\_Damaged Punctured 2013-1**

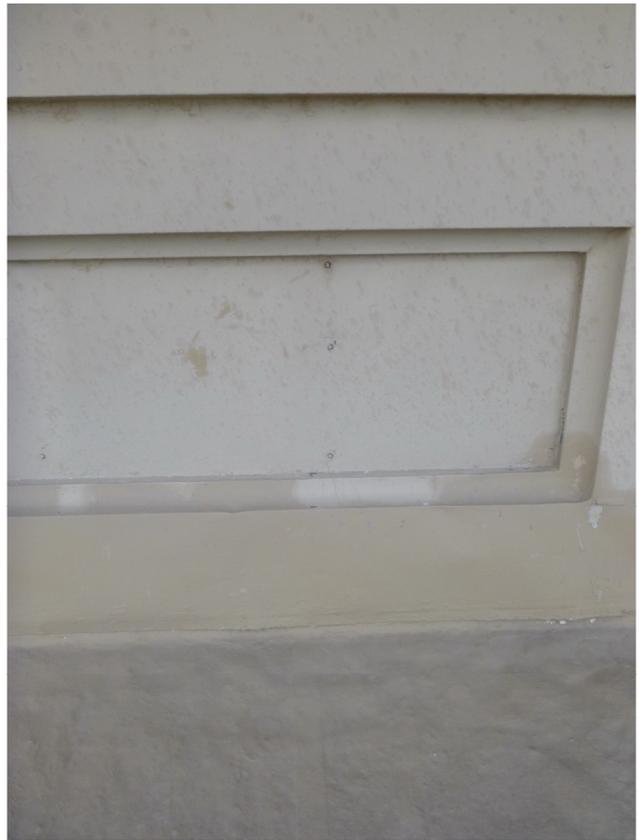
**245-136 SheetMetal\_Seam Solder Failed 2013-1**

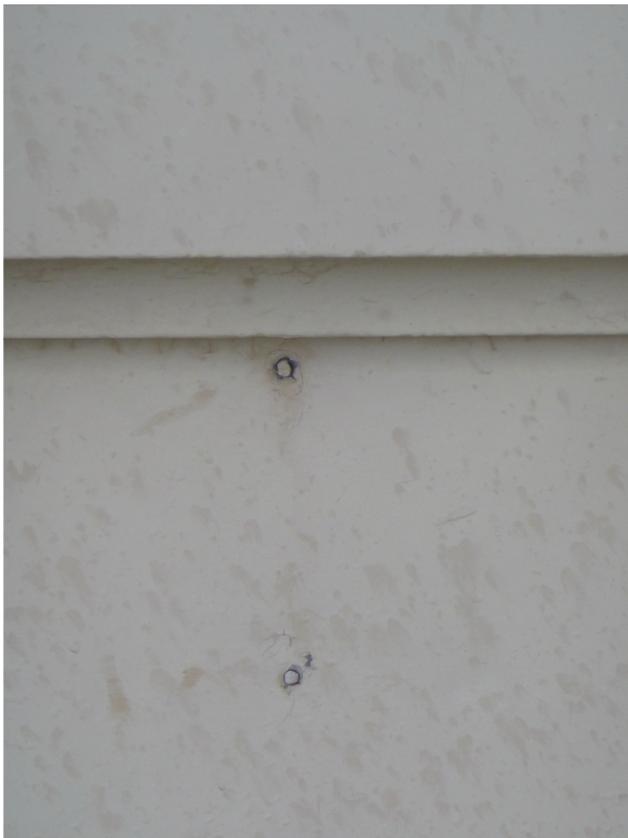
**246-65 SheetMetal\_Seam Fastener Failed 2013-1**

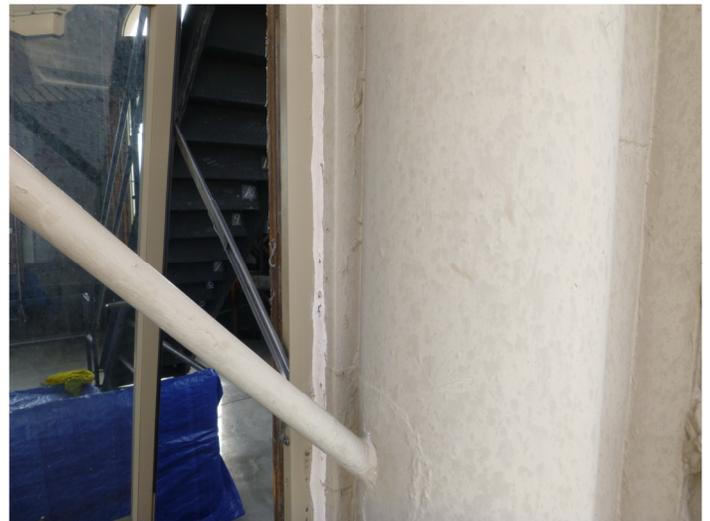
**246-65 SheetMetal\_Seam Fastener Failed 2013-2**

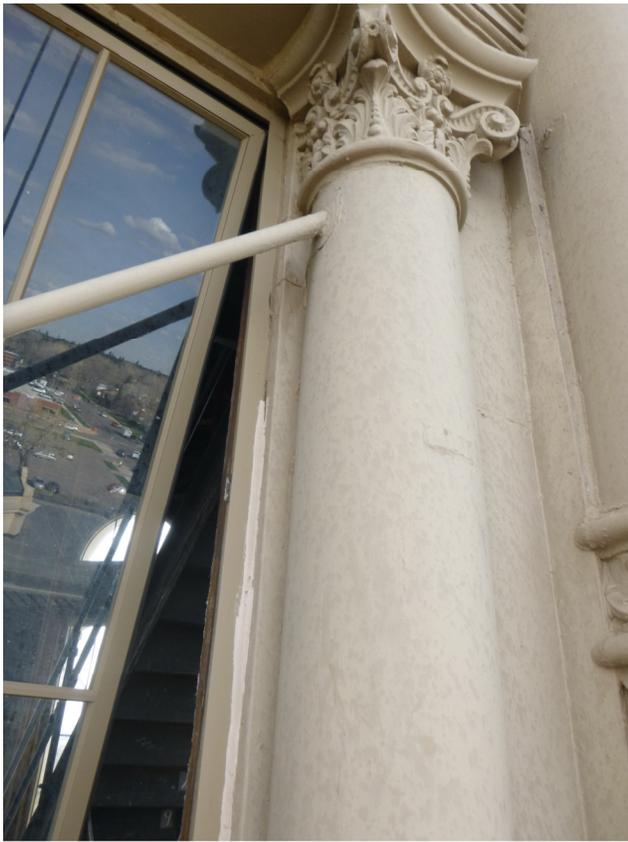
**246-80 SheetMetal\_Seam Sealant Failed 2013-1**

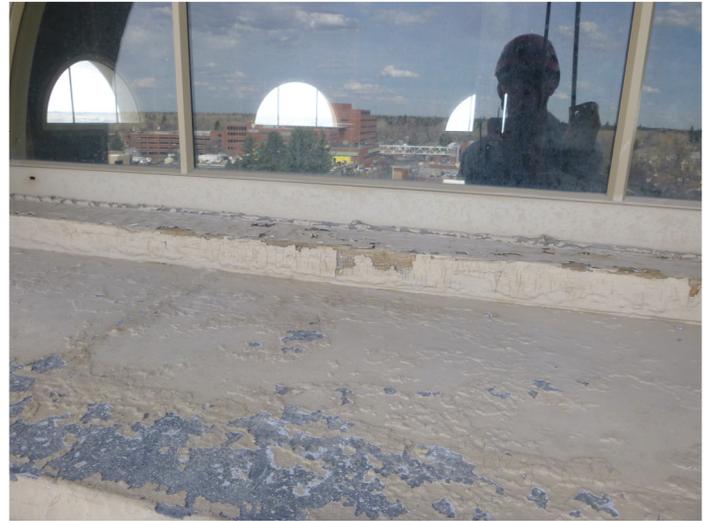
**246-80 SheetMetal\_Seam Sealant Failed 2013-2**

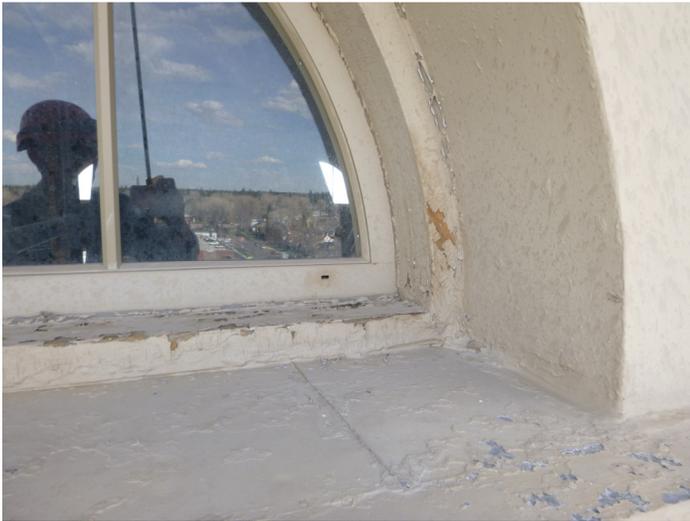
**246-83 Wood\_Crack Checking 2013-1**

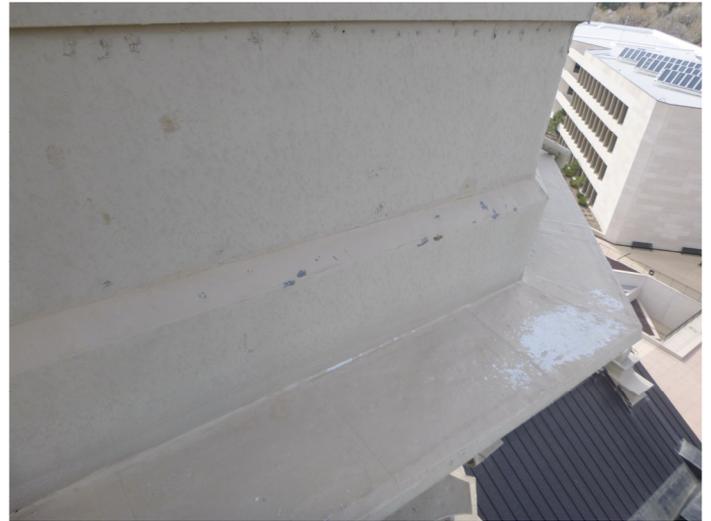
**246-83 Wood\_Crack Checking 2013-2**

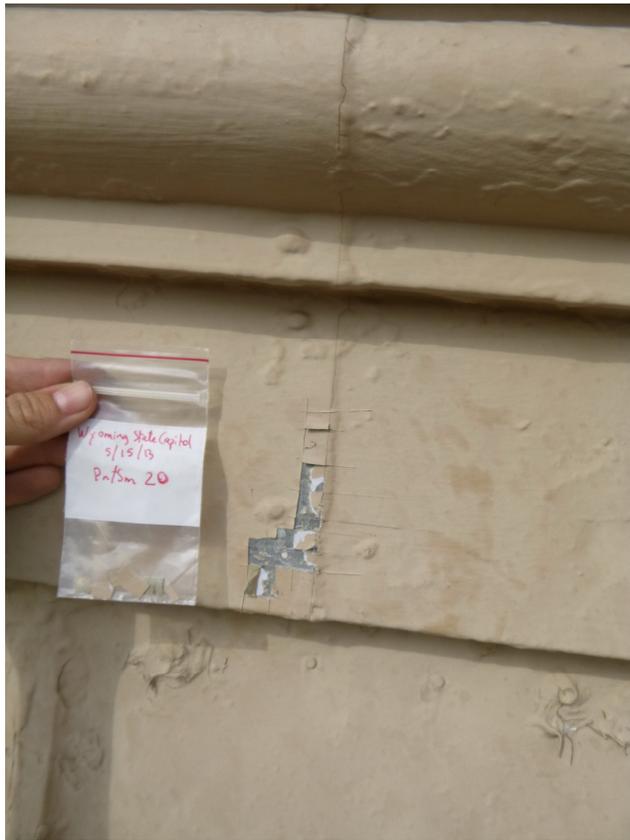
**246-93 SheetMetal\_Coating Coating Failed 2013-1**

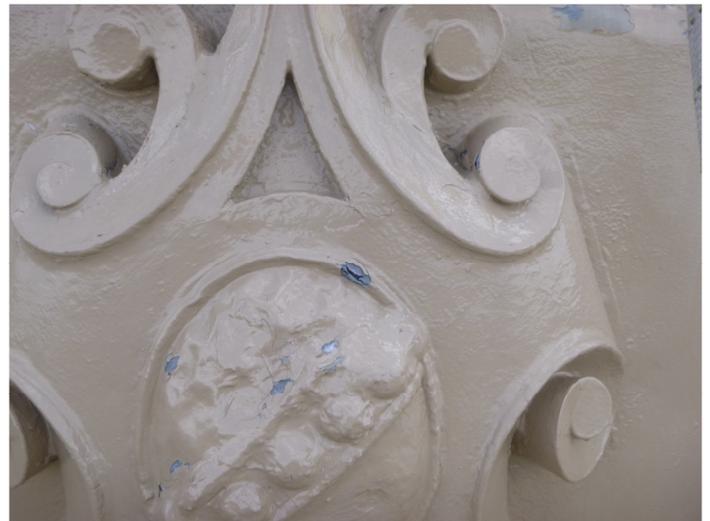
**246-105 SheetMetal\_Corrosion Surface 2013-1**

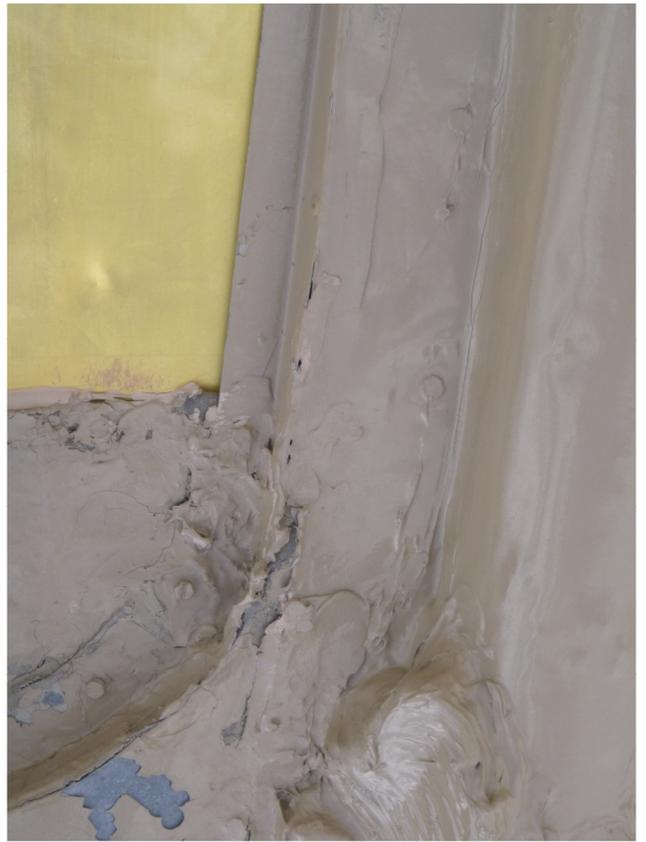
**246-114 SheetMetal\_Seam Fastener Failed 2013-1**

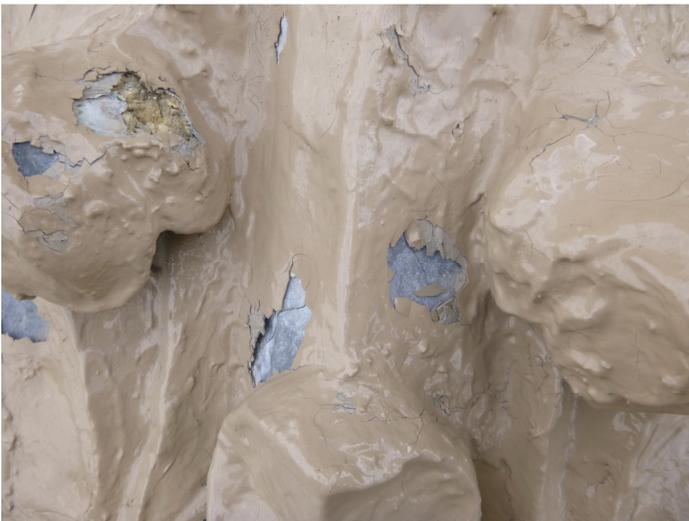
**246-117 SheetMetal\_Damaged Torn 2013-1**

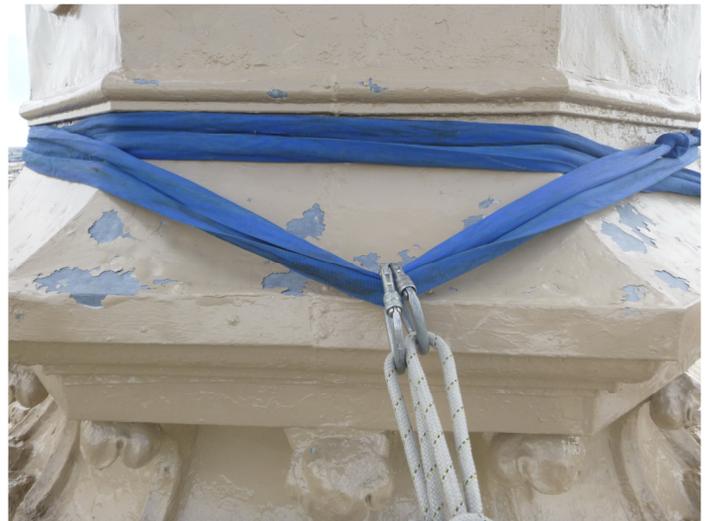
**246-121 SheetMetal\_Damaged Torn 2013-1**

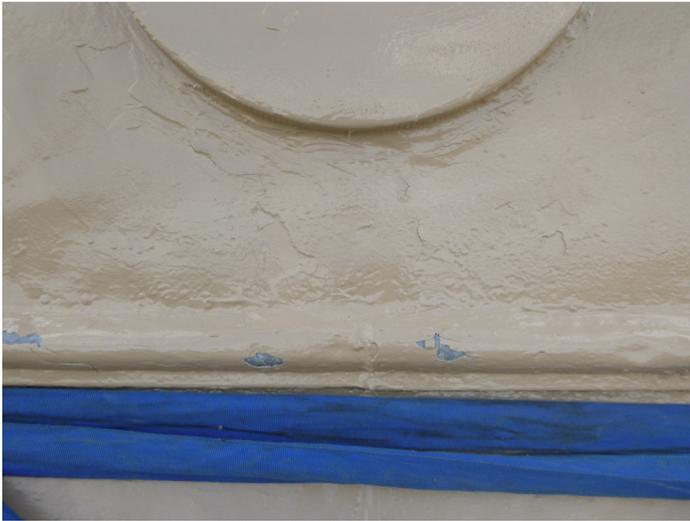
**246-124 SheetMetal\_Coating Coating Failed 2013-1**

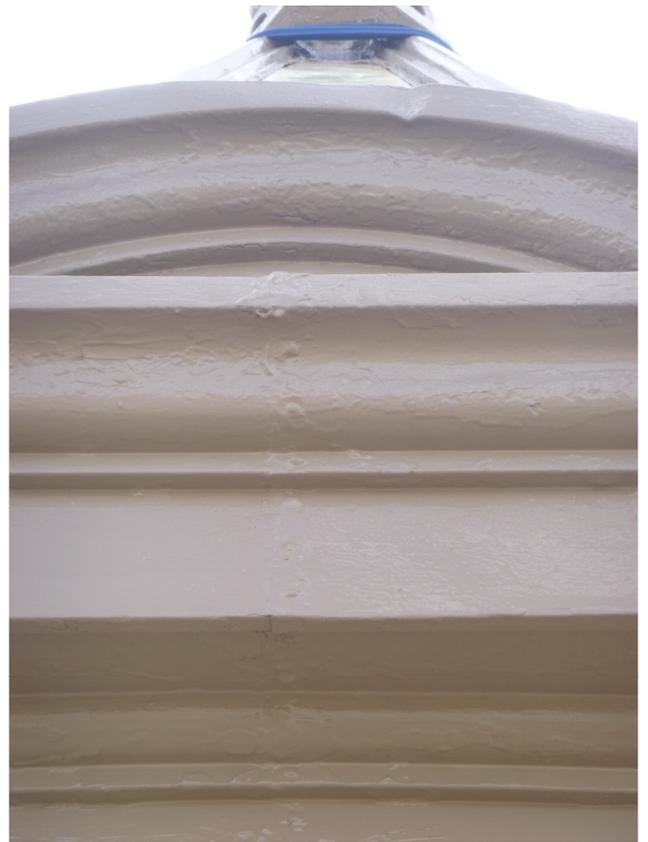
246-124 SheetMetal\_Coating Coating Failed 2013-2

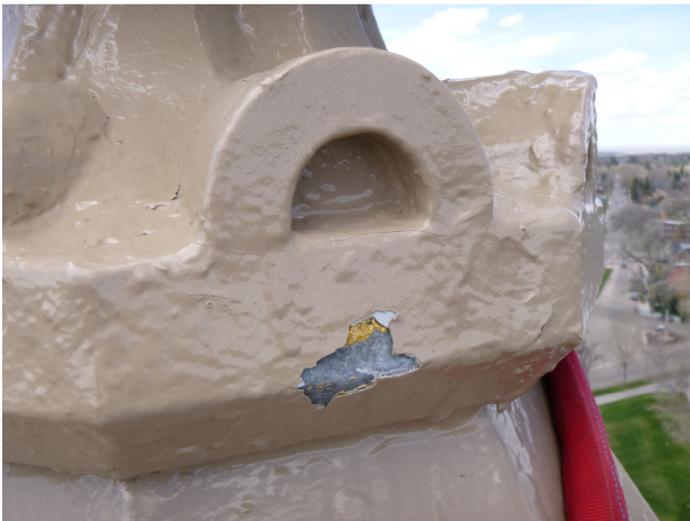
246-128 SheetMetal\_Coating Coating Failed 2013-1

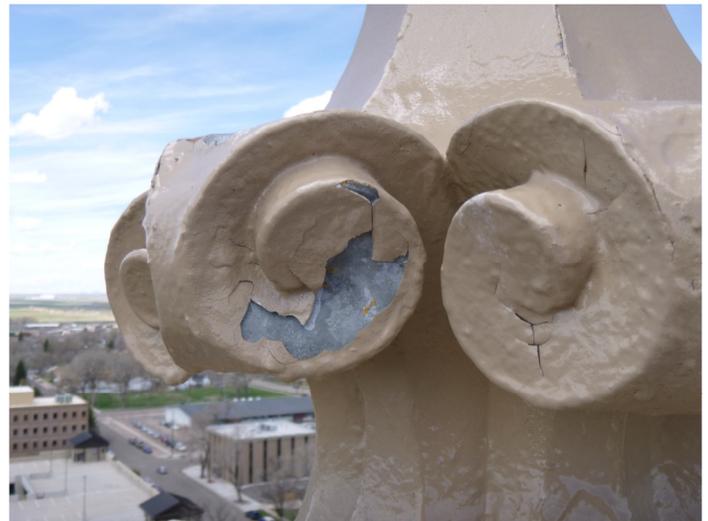
246-135 SheetMetal\_Note Photo-traces of gilding 2013-1

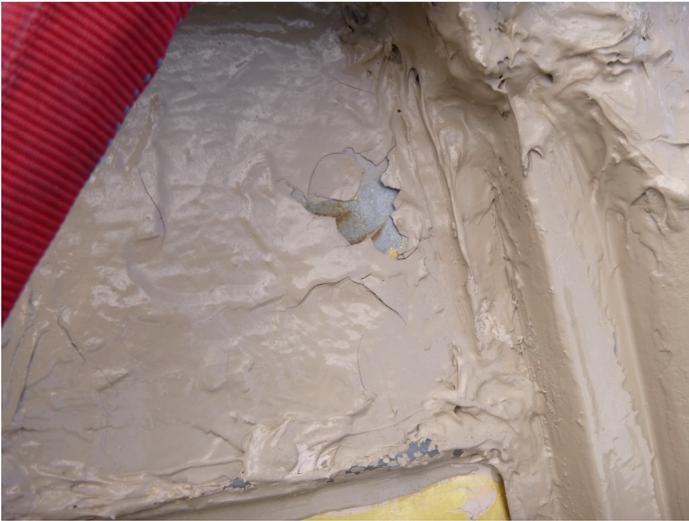
246-135 SheetMetal\_Note Photo-traces of gilding 2013-2

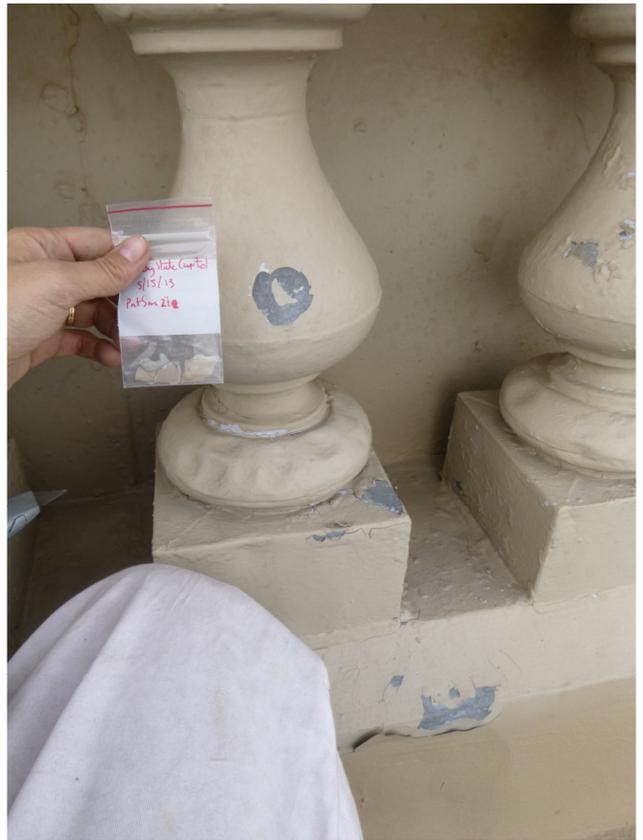
246-135 SheetMetal\_Note Photo-traces of gilding 2013-3

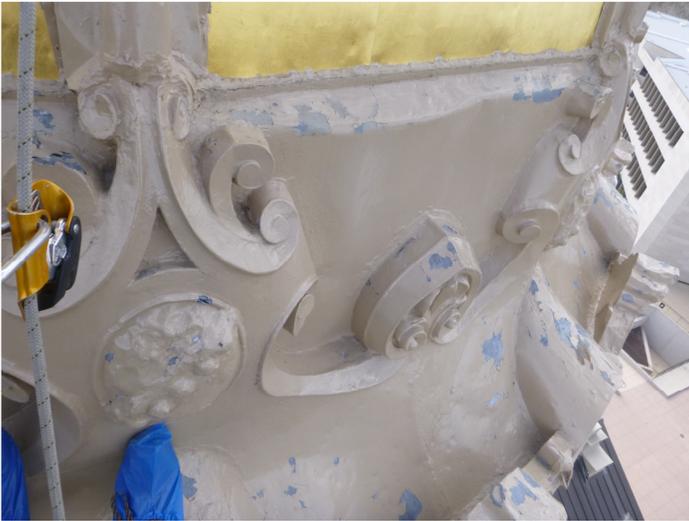
247-103 SheetMetal\_Note Misc condition 2013-1

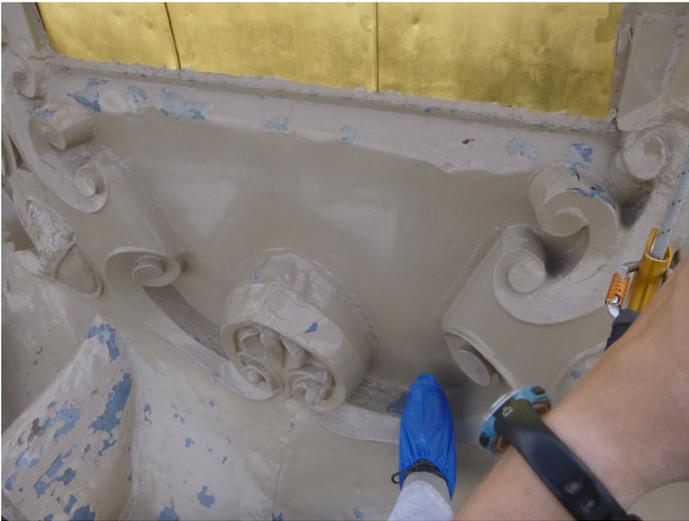
247-108 SheetMetal\_Coating Coating Failed 2013-1

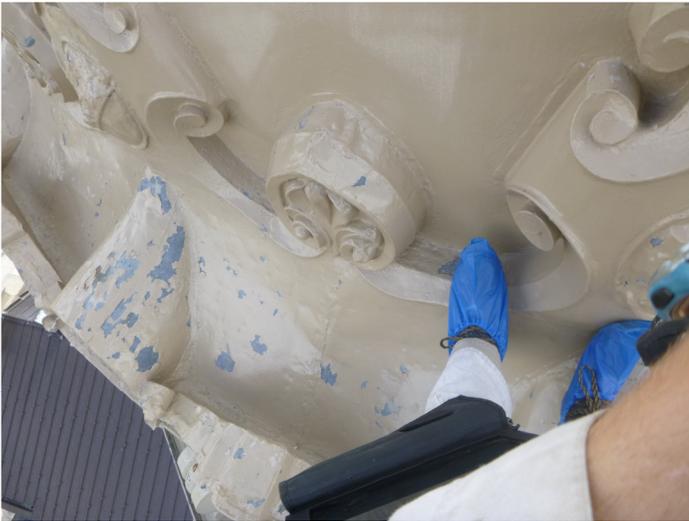
247-108 SheetMetal\_Coating Coating Failed 2013-2

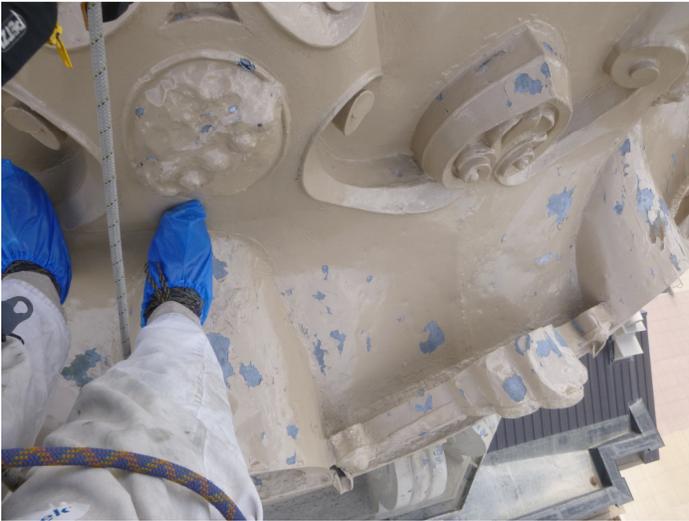
247-108 SheetMetal\_Coating Coating Failed 2013-3

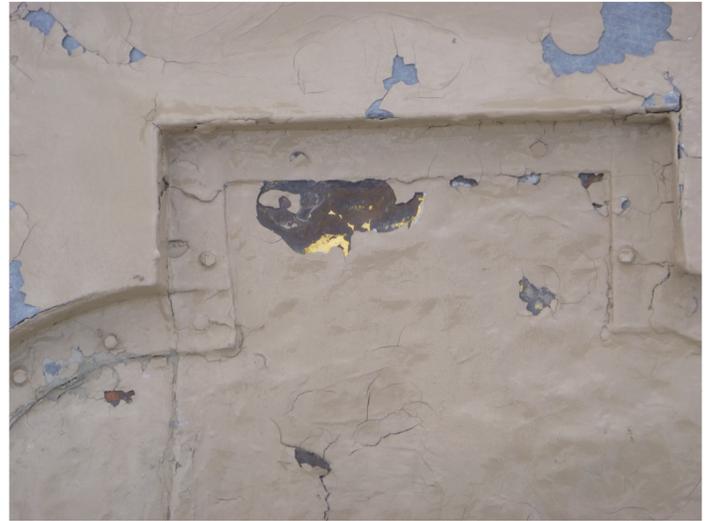
247-108 SheetMetal\_Coating Coating Failed 2013-4

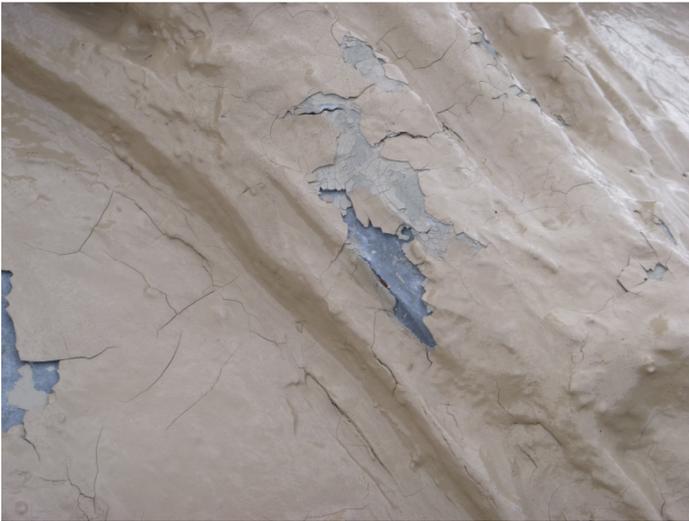
247-118 SheetMetal\_Corrosion Surface 2013-1

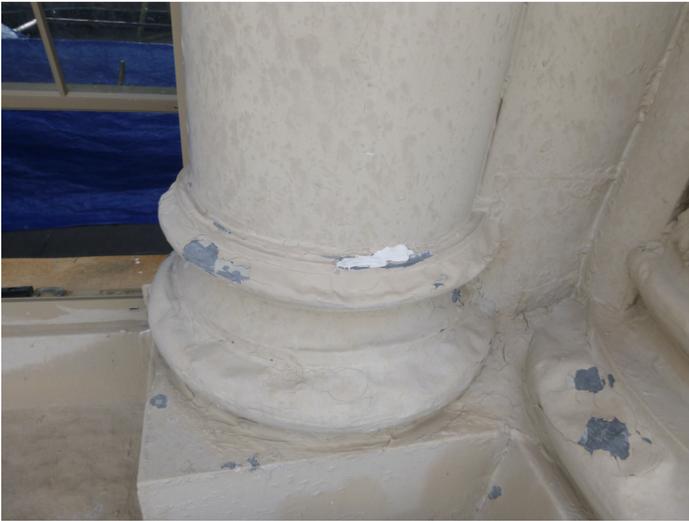
247-131 SheetMetal\_Coating Coating Failed 2013-1

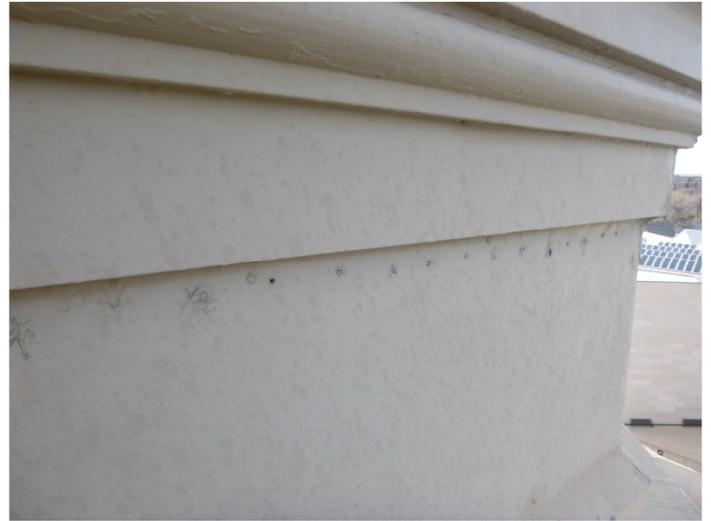
**248-74 SheetMetal\_Repair Patch Failed 2013-1**

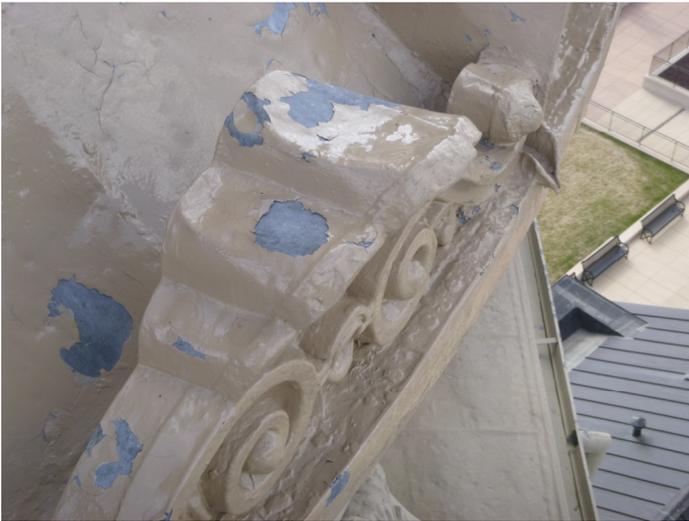
**248-93 SheetMetal\_Seam Fastener Failed 2013-1**

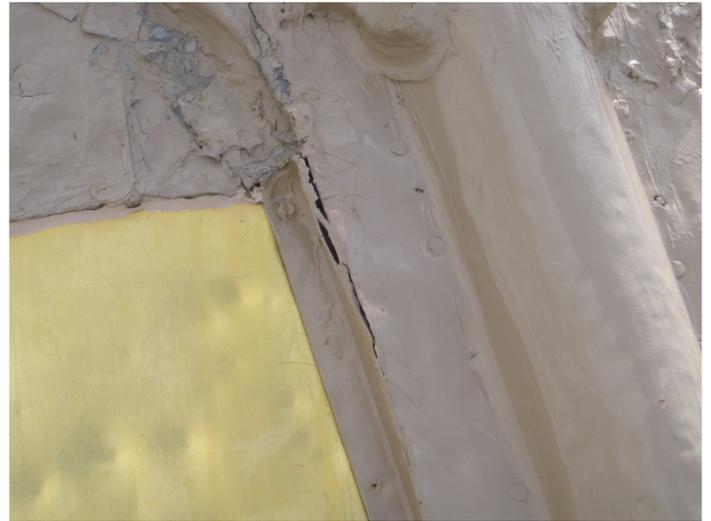
**248-104 SheetMetal\_Damaged Dented 2013-1**

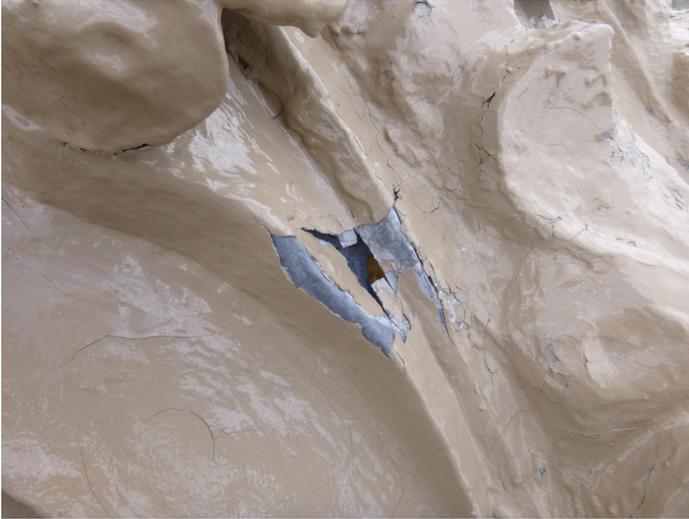
**248-117 SheetMetal\_Damaged Torn 2013-1**

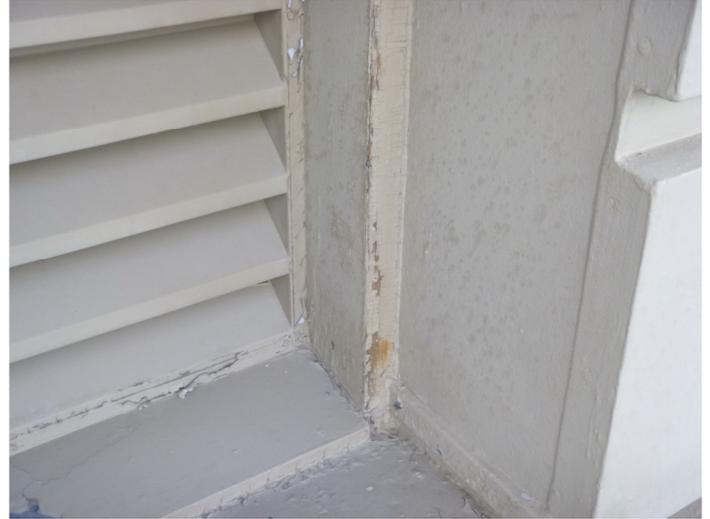
**248-121 SheetMetal\_Damaged Torn 2013-1**

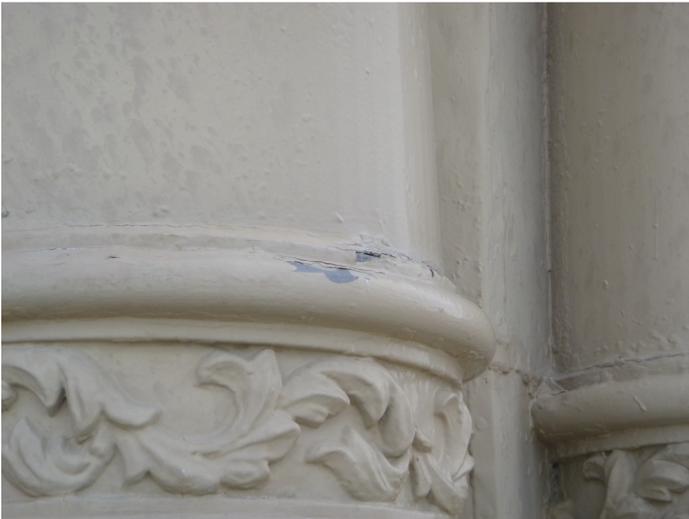
**249-56 Wood\_Crack Checking 2013-1**

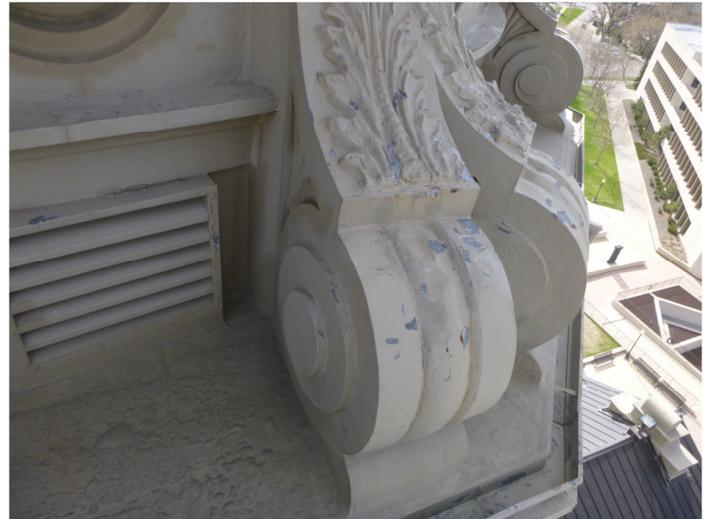
**249-79 SheetMetal\_Damaged Torn 2013-1**

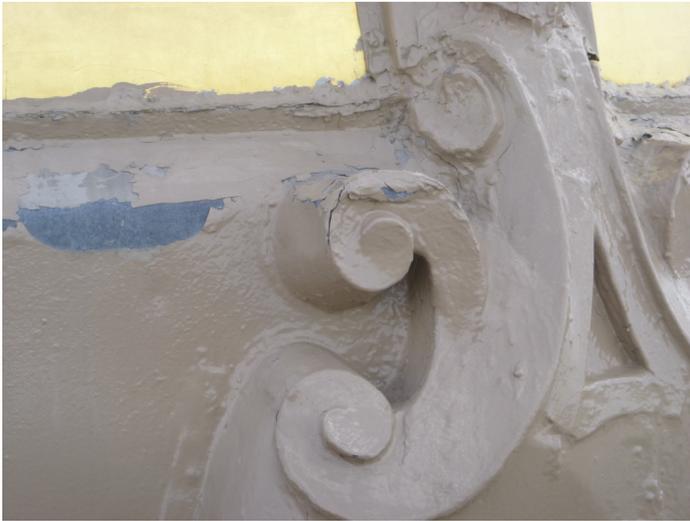
**249-97 SheetMetal\_Corrosion Surface 2013-1**

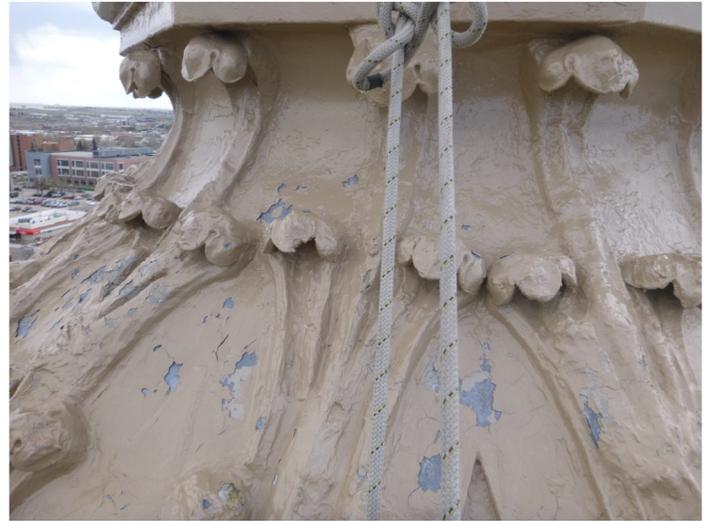
249-107 SheetMetal\_Damaged Torn 2013-1

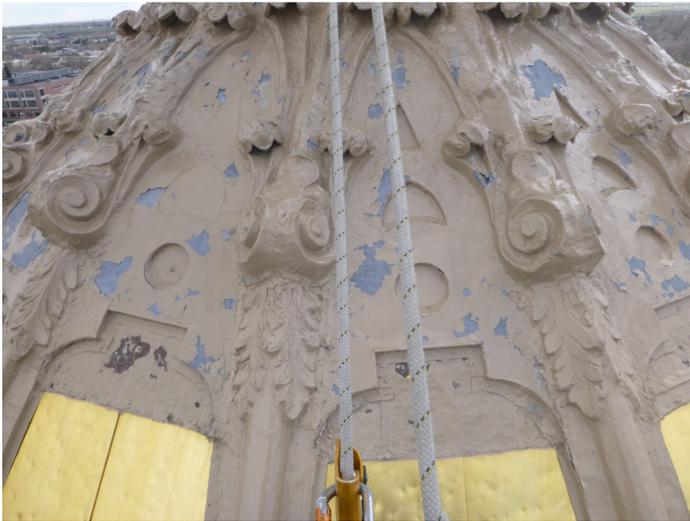
249-119 SheetMetal\_Coating Coating Failed 2013-1

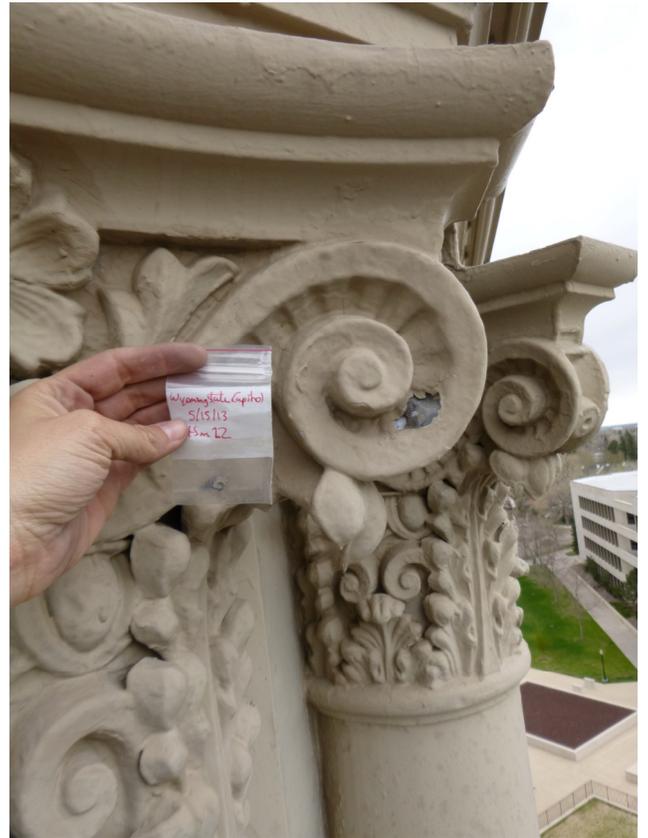
249-119 SheetMetal\_Coating Coating Failed 2013-2

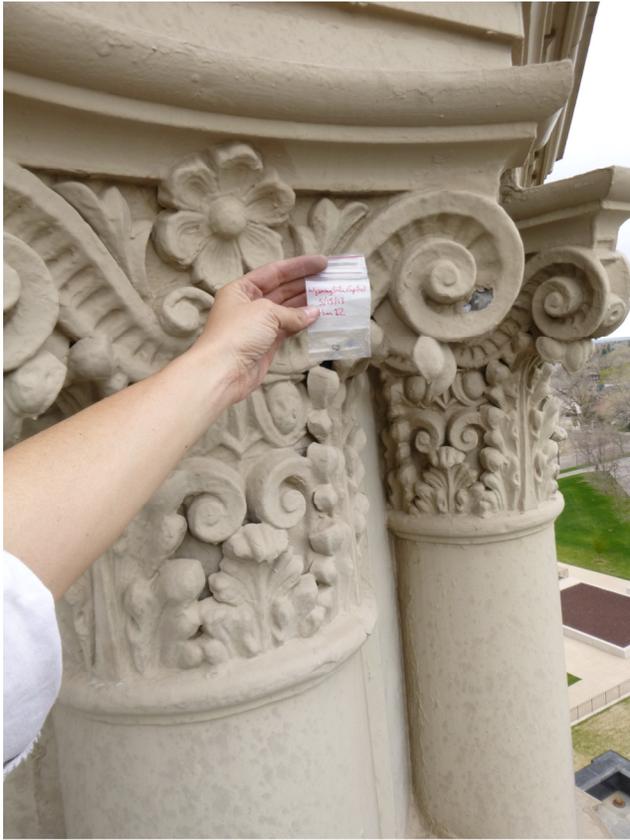
250-87 SheetMetal\_Note PntSm 22 2013-1

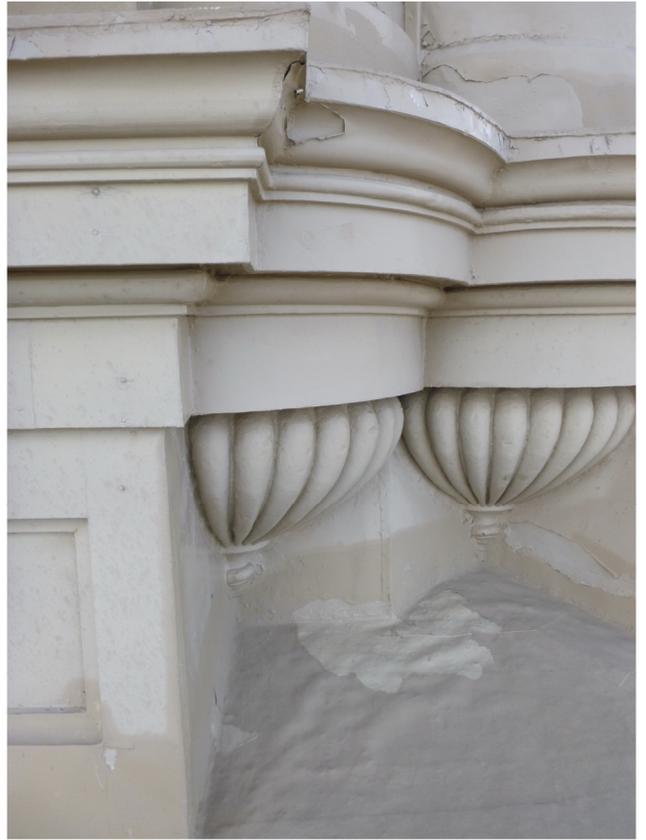
**250-87 SheetMetal\_Note PntSm 22 2013-2**

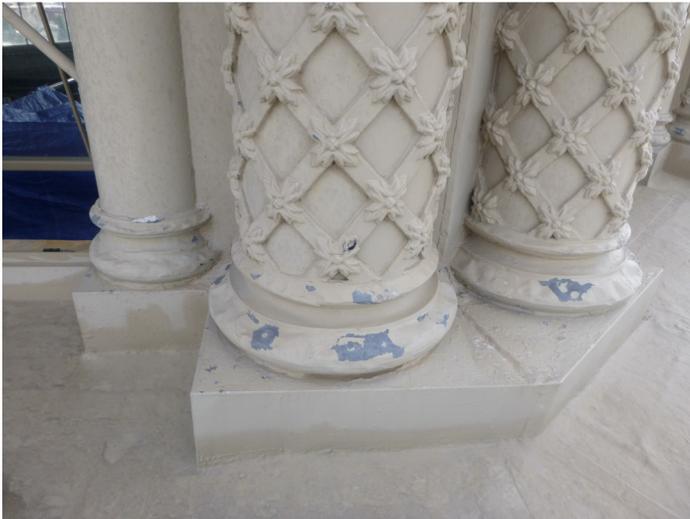
**251-66 SheetMetal\_Coating Coating Failed 2013-1**

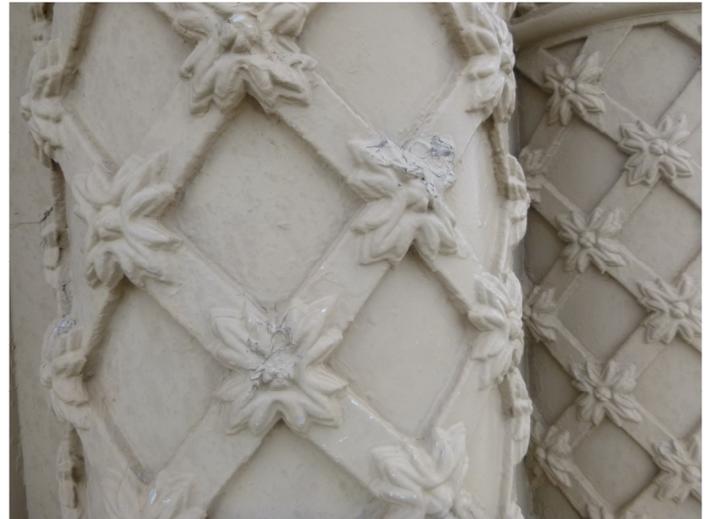
**251-75 SheetMetal\_Damaged Punctured 2013-1**
