# Report Narrative

## Wyoming State Capitol Dome Investigation Cheyenne, WY

Vertical Access LLC  
PO Box 4135, Ithaca, NY 14852  
Tel: 607 257 4049 / Fax: 607 257 2129

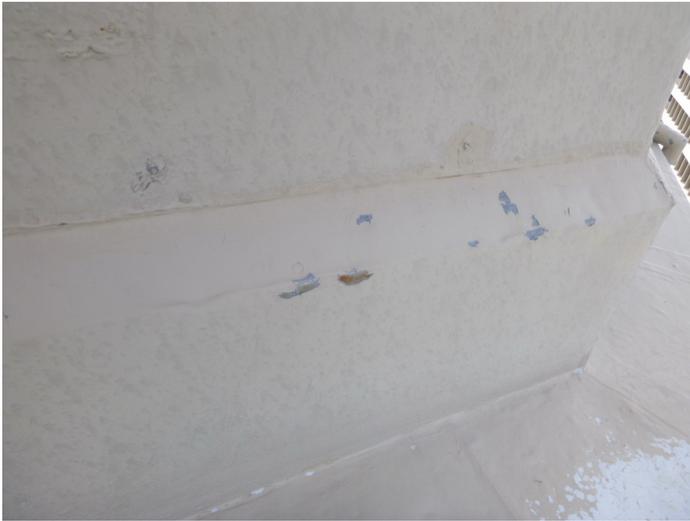
**251-77 SheetMetal\_Repair Patch Failed 2013-1**

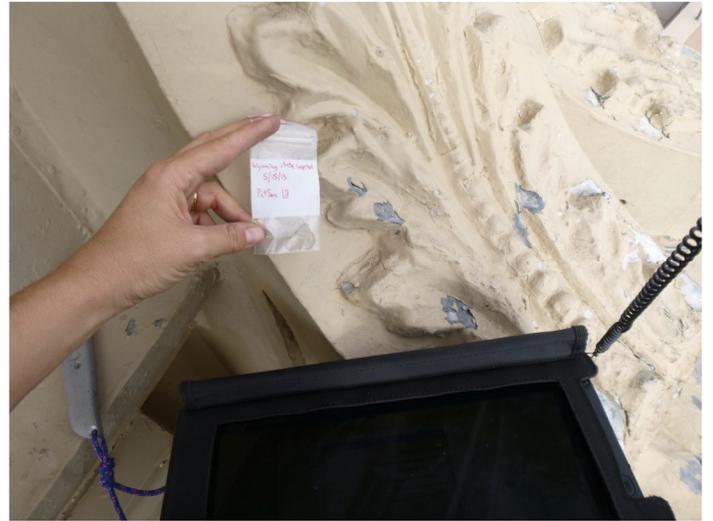
**251-93 SheetMetal\_Corrosion Surface 2013-1**

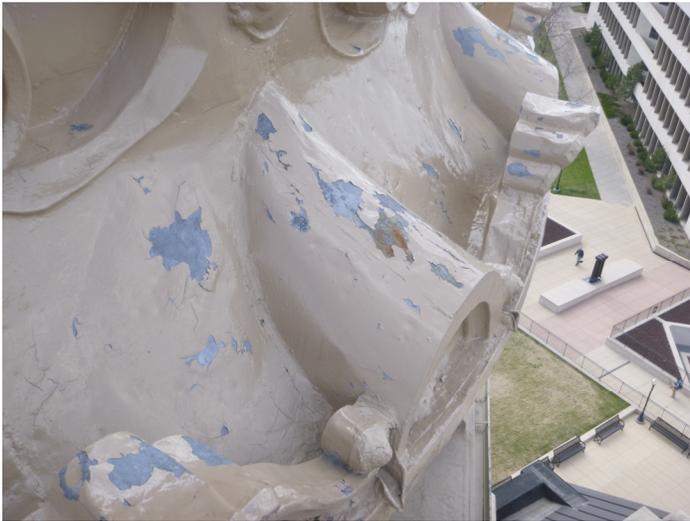
**251-99 SheetMetal\_Note PntSm 18 2013-1**

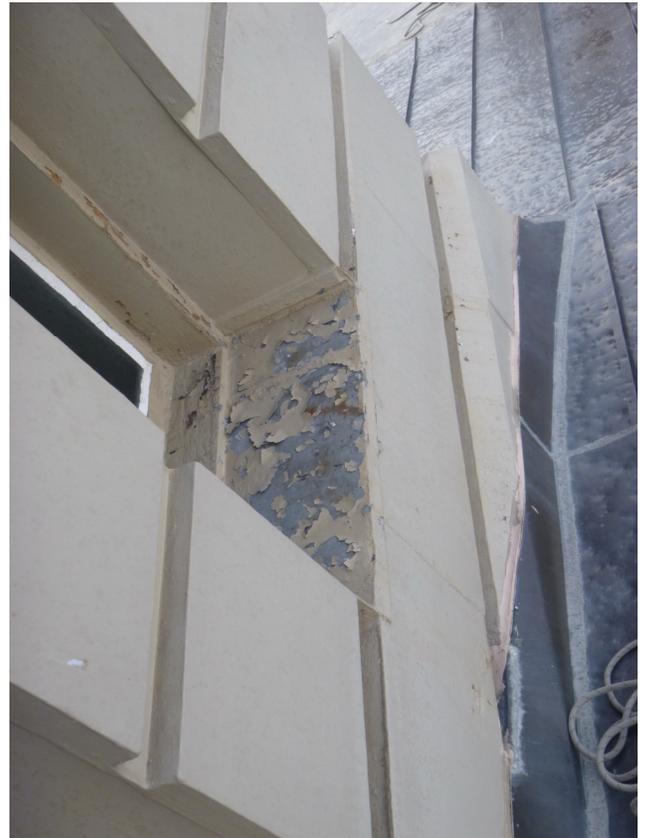
**252-105 SheetMetal\_Corrosion Surface 2013-1**

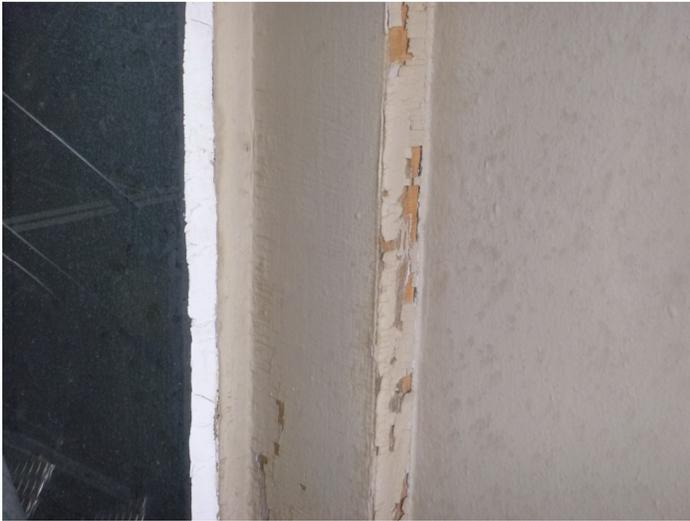
**254-55 SheetMetal\_Corrosion Surface 2013-1**

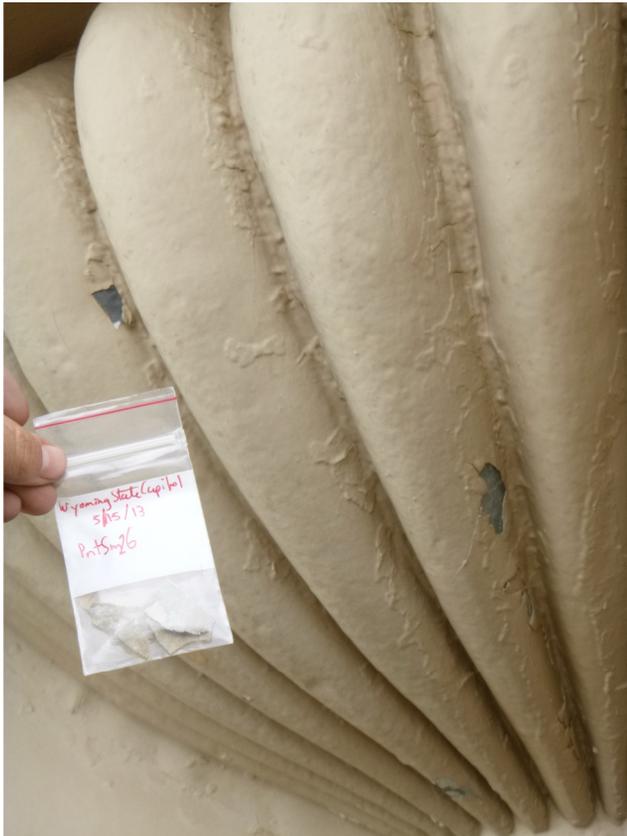
254-67 SheetMetal\_Note PntSm 26 2013-1

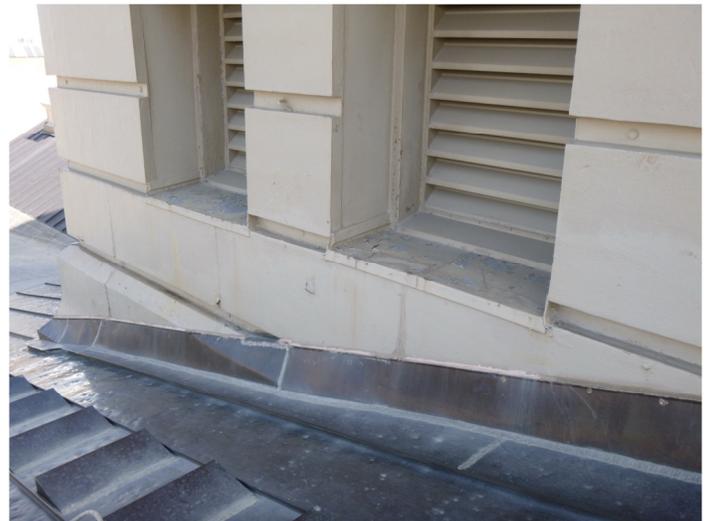
254-67 SheetMetal\_Note PntSm 26 2013-2

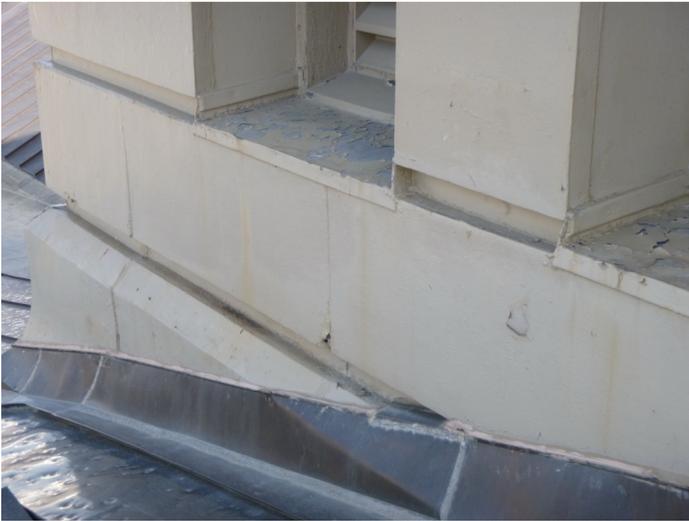
309-54 ArchMetal\_Coating Coating Failed 2013-1

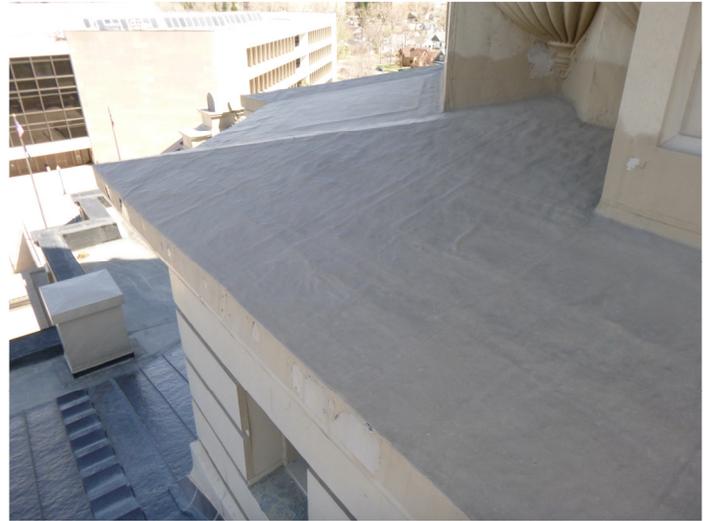
**309-54 ArchMetal\_Coating Coating Failed 2013-2**

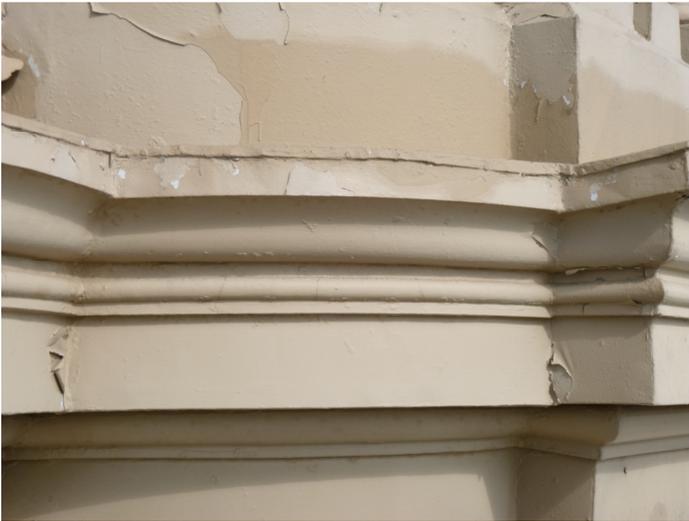
**311-63 SheetMetal\_Coating Coating Failed 2013-1**

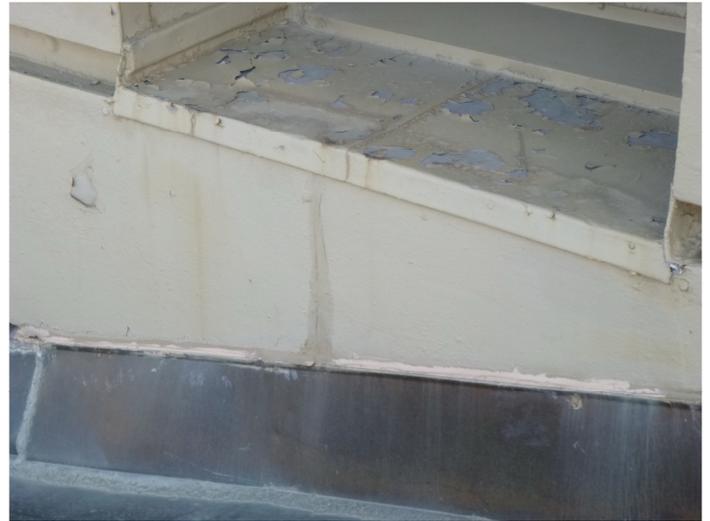
**312-68 SheetMetal\_Coating Coating Failed 2013-1**

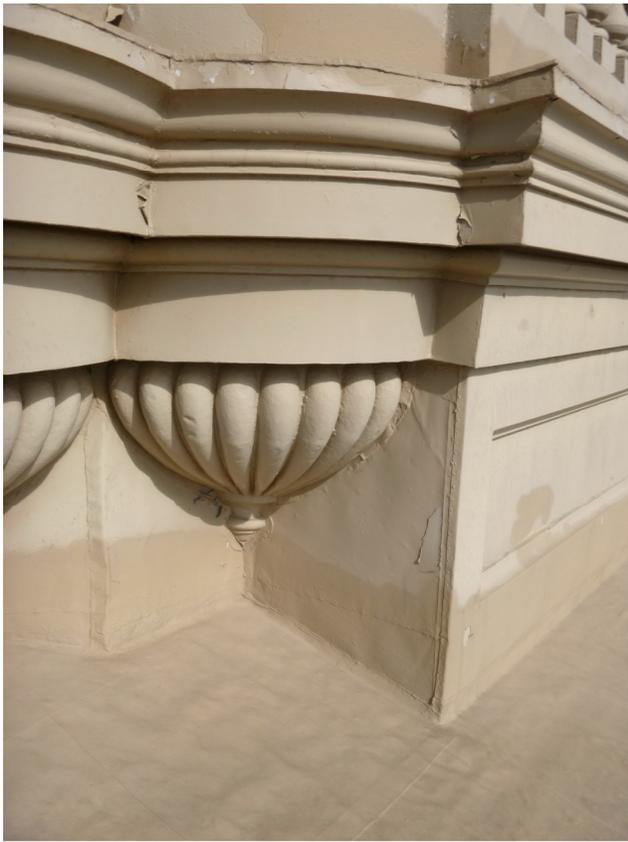
**313-53 ArchMetal\_Crack Repair sound 2013-1**

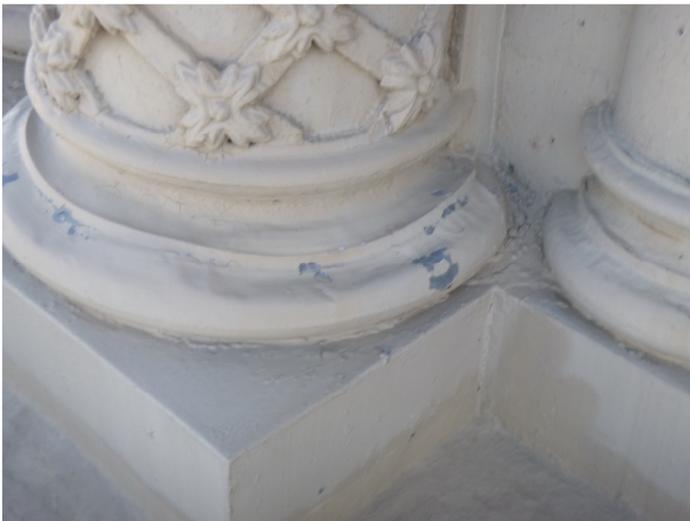
313-71 SheetMetal\_Coating Coating Failed 2013-1

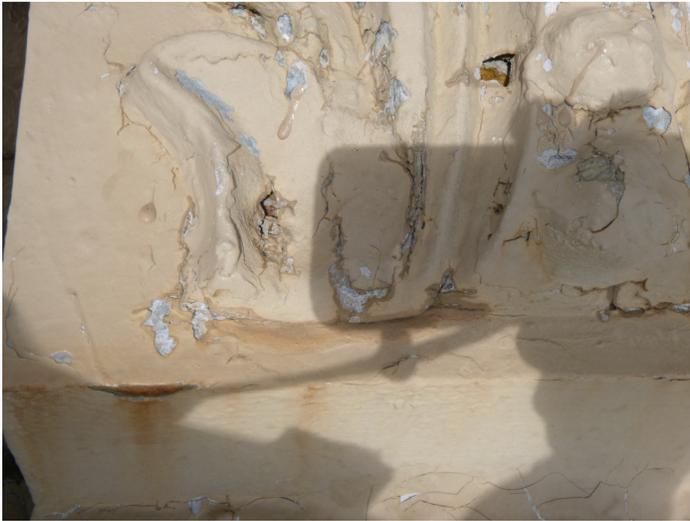
314-77 SheetMetal\_Coating Coating Failed 2013-1

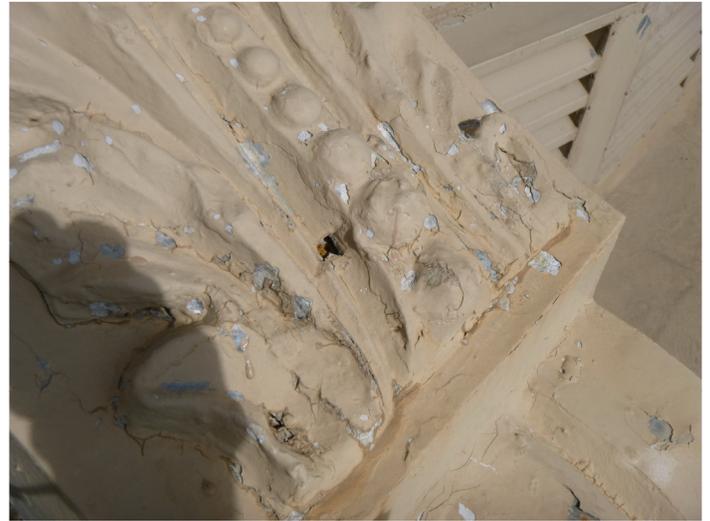
**314-98 SheetMetal\_Damaged Punctured 2013-1**

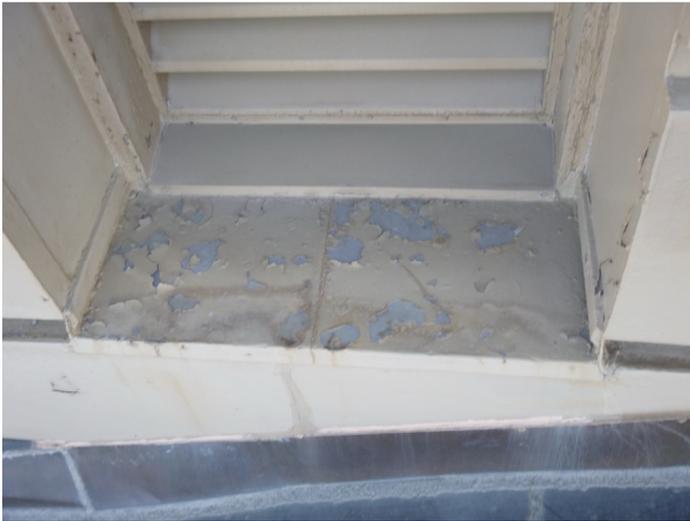
**314-99 SheetMetal\_Damaged Punctured 2013-1**

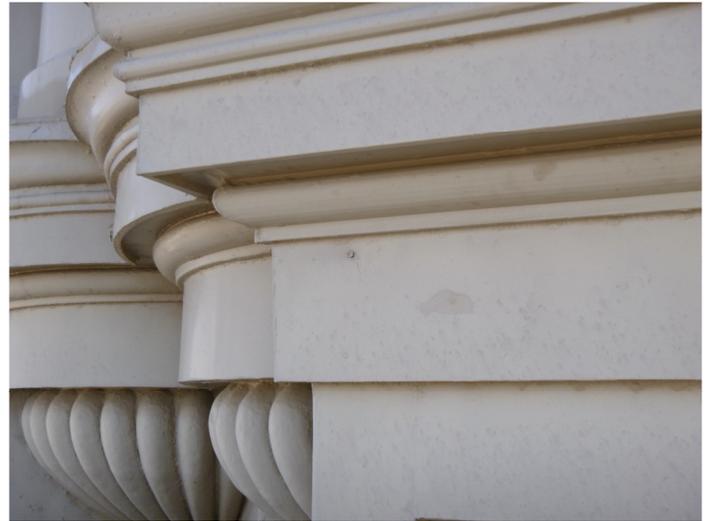
**315-56 SheetMetal\_Coating Coating Failed 2013-1**

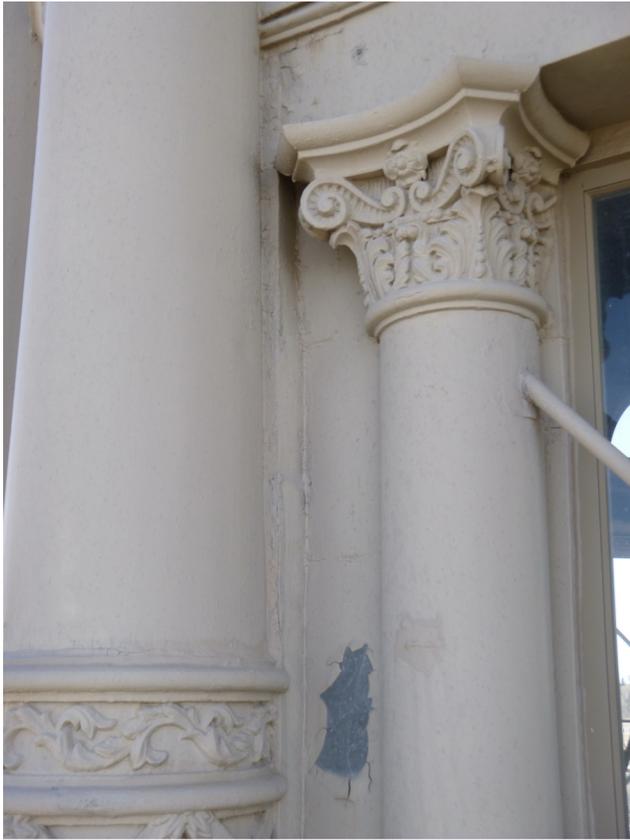
**315-67 SheetMetal\_Seam Fastener Failed 2013-1**

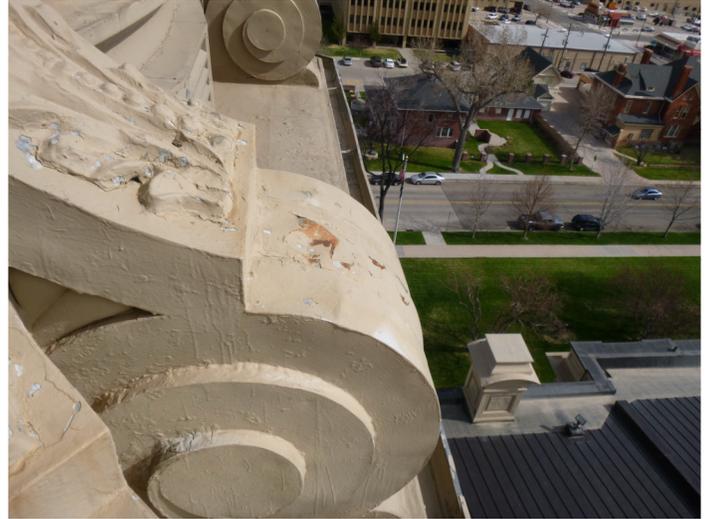
**315-80 SheetMetal\_Coating Coating Failed 2013-1**

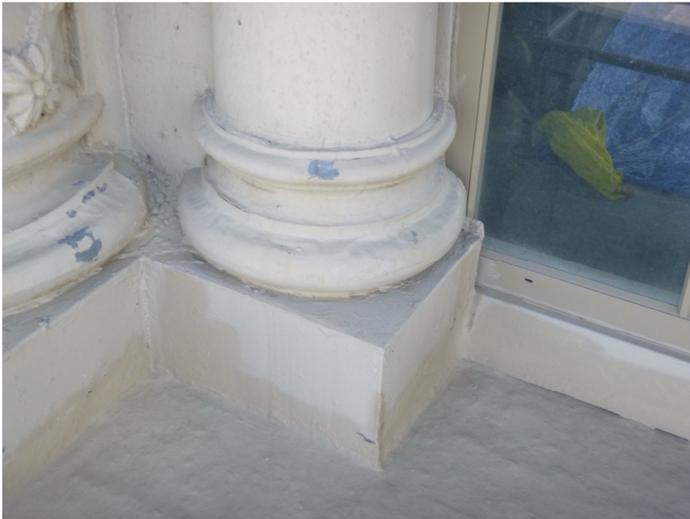
**315-97 SheetMetal\_Damaged Dented 2013-1**

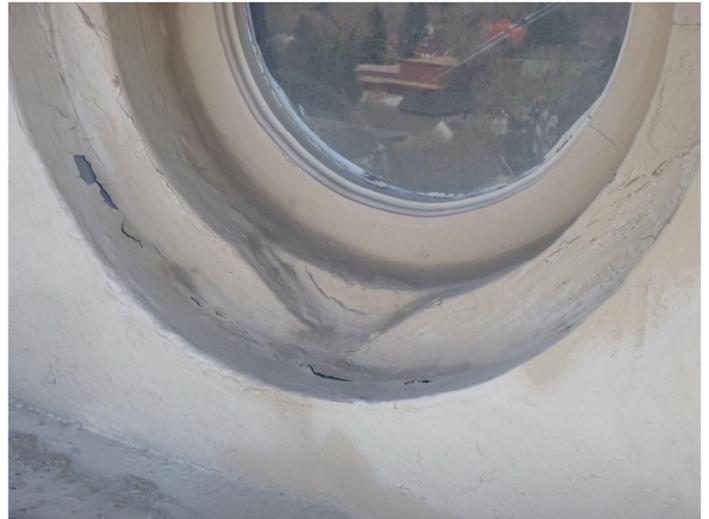
**316-74 SheetMetal\_Coating Coating Failed 2013-1**

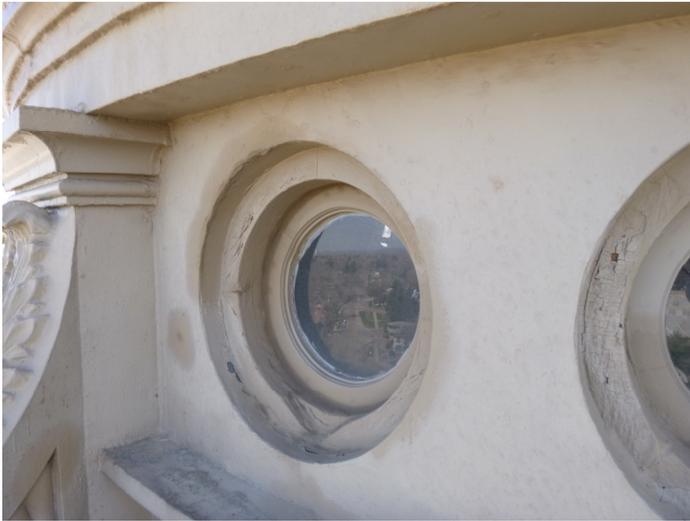
**316-99 Wood\_Unsecured Missing 2013-1**

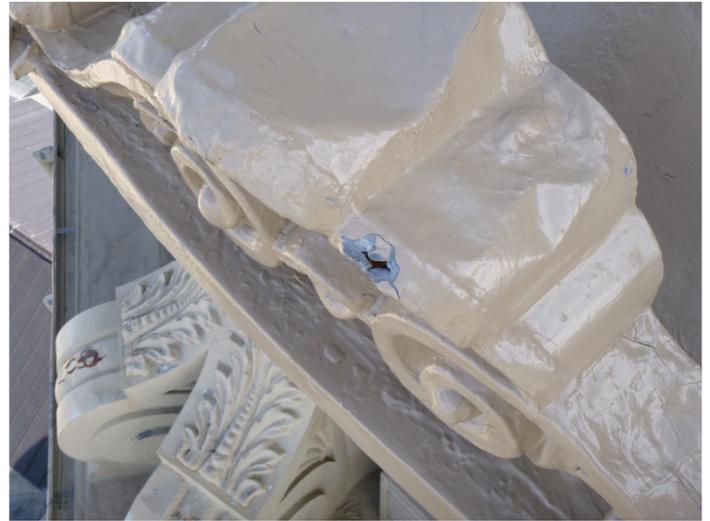
**316-100 Wood\_Coating Coating Failed 2013-1**

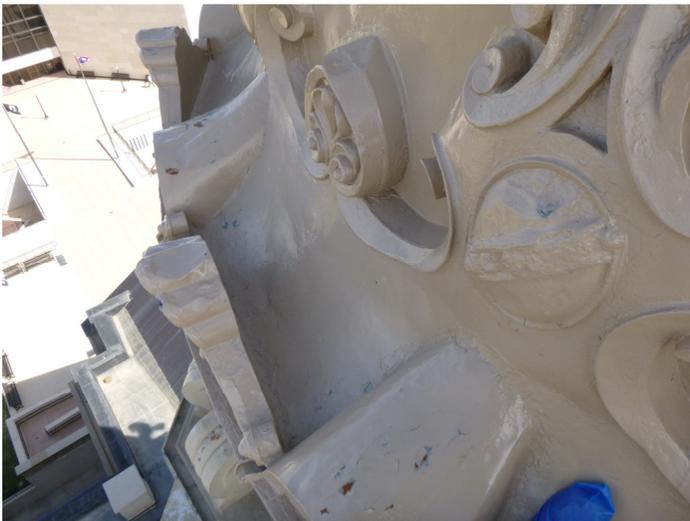
**316-105 SheetMetal\_Damaged Torn 2013-1**

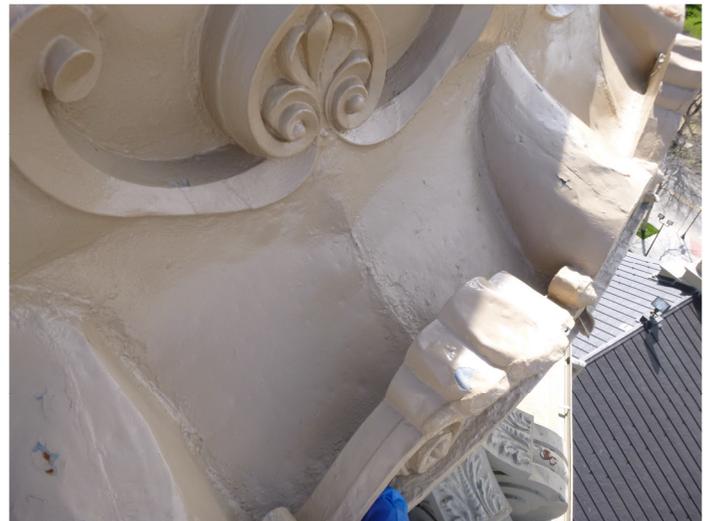
**316-106 SheetMetal\_Coating Coating Failed 2013-1**

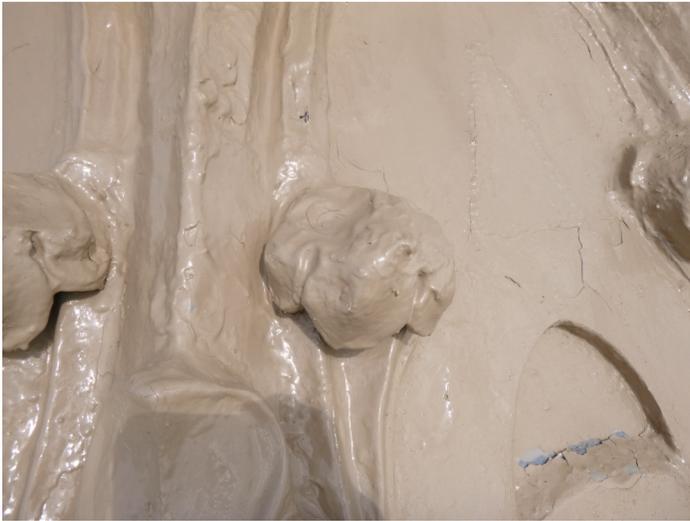
**316-106 SheetMetal\_Coating Coating Failed 2013-2**

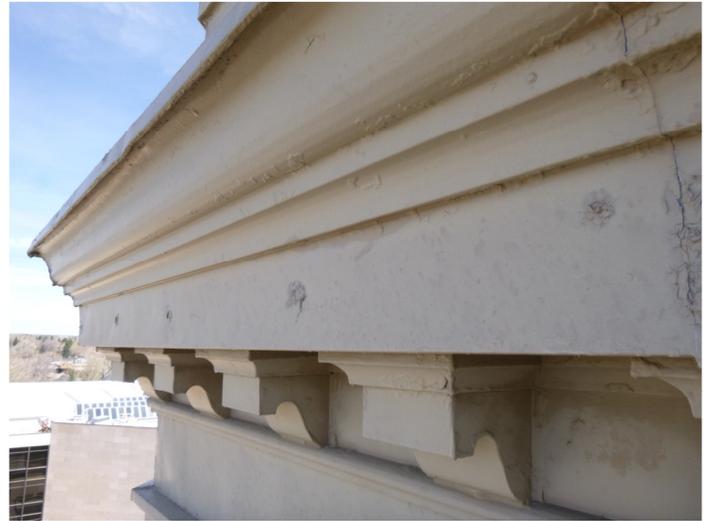
**316-120 SheetMetal\_Damaged Dented 2013-1**

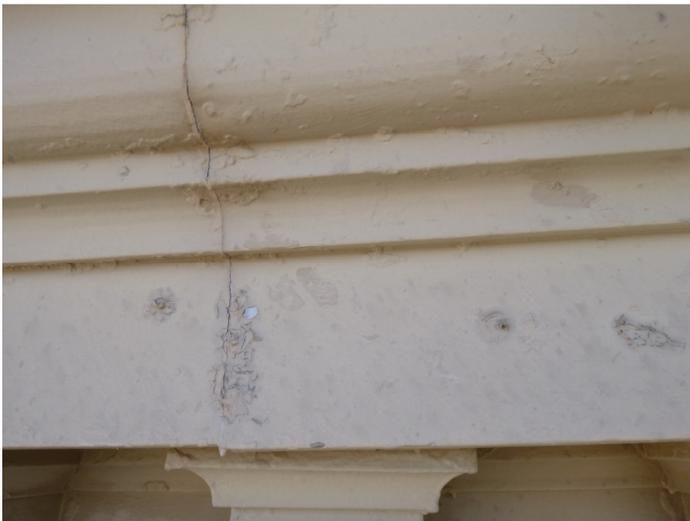
**317-90 SheetMetal\_Coating Coating Failed 2013-1**

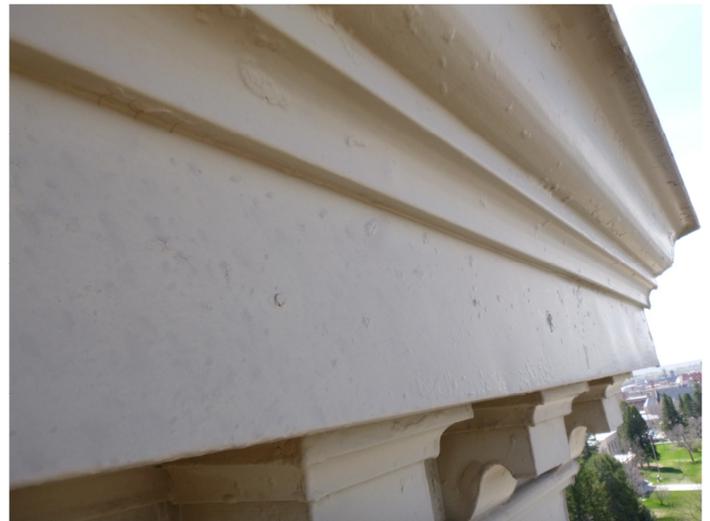
**317-90 SheetMetal\_Coating Coating Failed 2013-2**

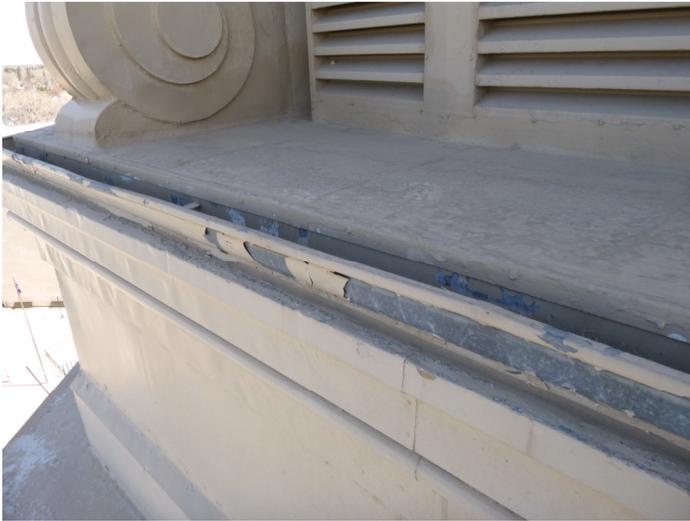
**317-90 SheetMetal\_Coating Coating Failed 2013-3**

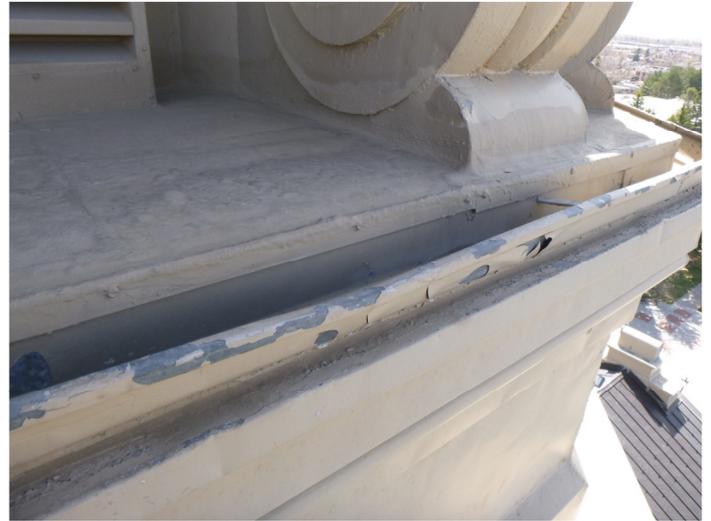
**317-96 SheetMetal\_Coating Coating Sound 2013-1**

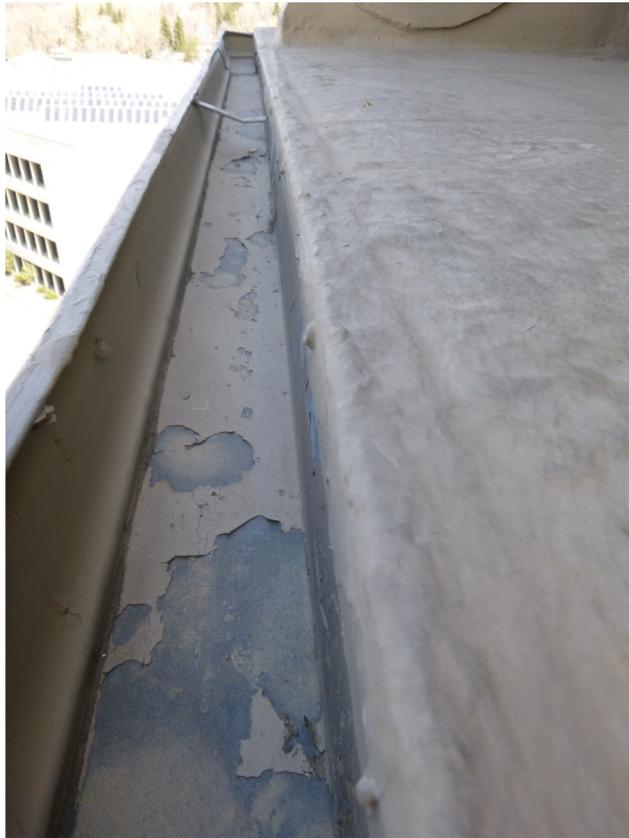
**317-96 SheetMetal\_Coating Coating Sound 2013-2**

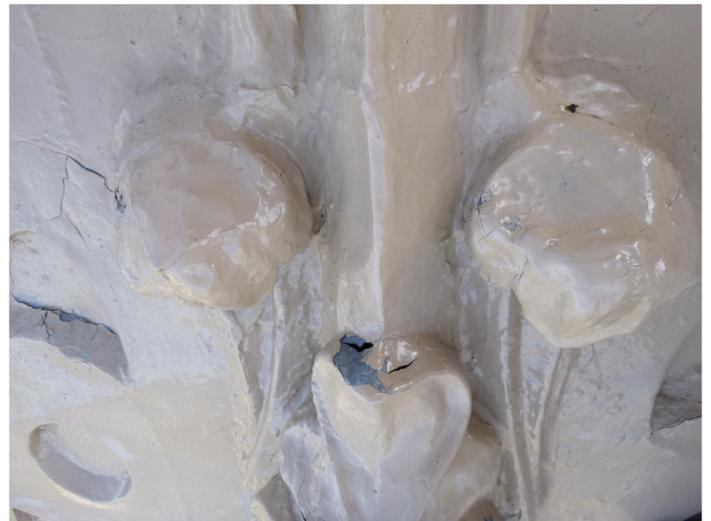
**317-96 SheetMetal\_Coating Coating Sound 2013-3**

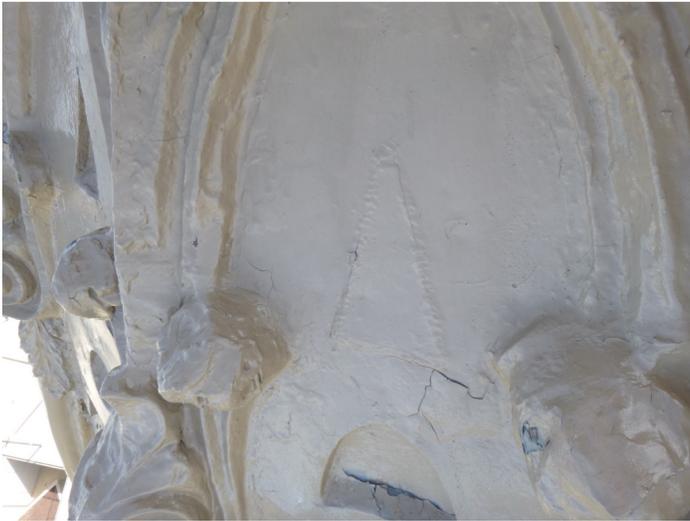
**317-120 SheetMetal\_Damaged Punctured 2013-1**

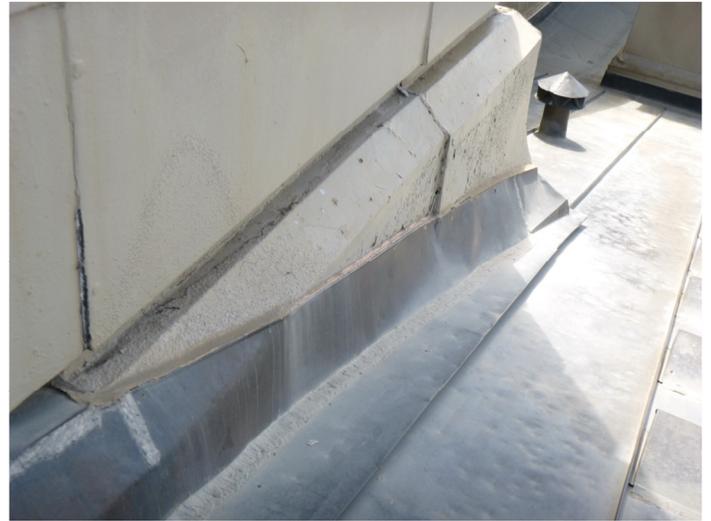
**317-121 SheetMetal\_Repair Patch Sound 2013-1**

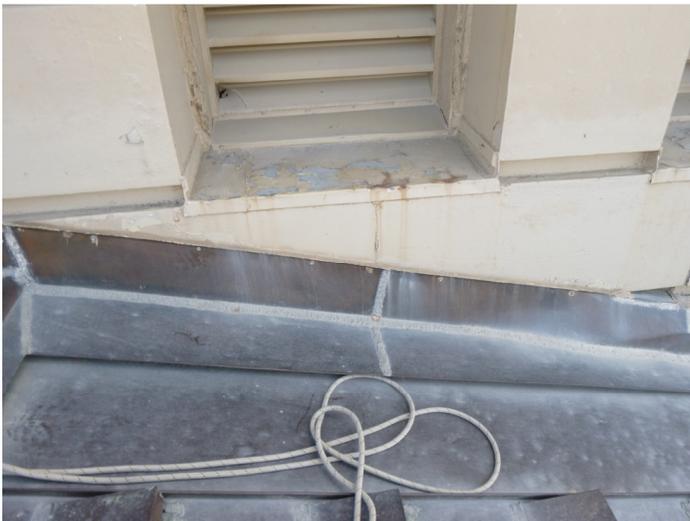
**318-54 SheetMetal\_Seam Sealant Failed 2013-1**

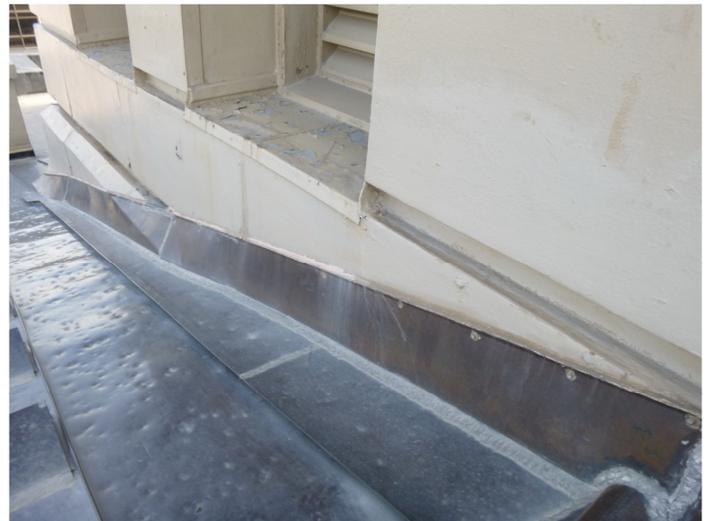
**318-54 SheetMetal\_Seam Sealant Failed 2013-2**

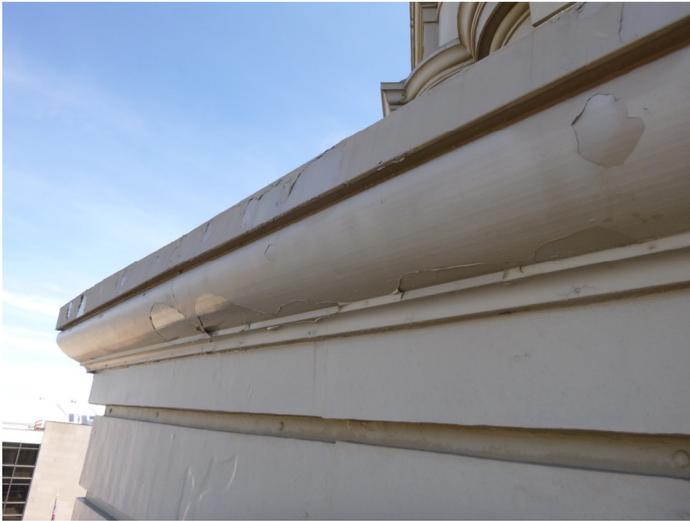
**318-54 SheetMetal\_Seam Sealant Failed 2013-3**

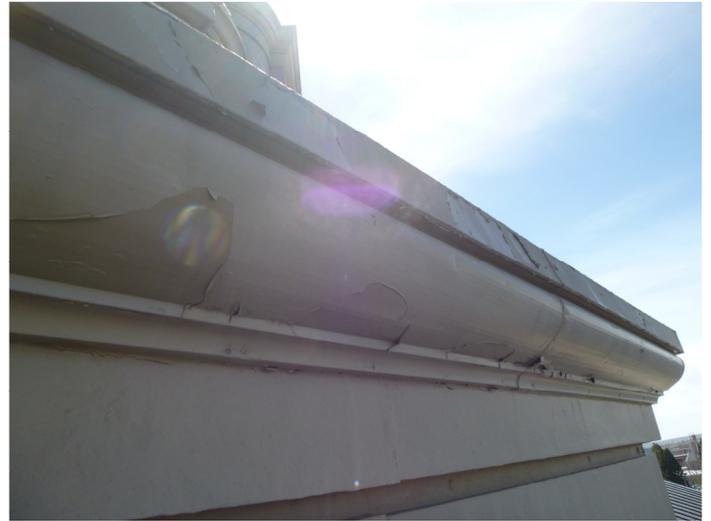
**318-61 SheetMetal\_Coating Coating Failed 2013-1**

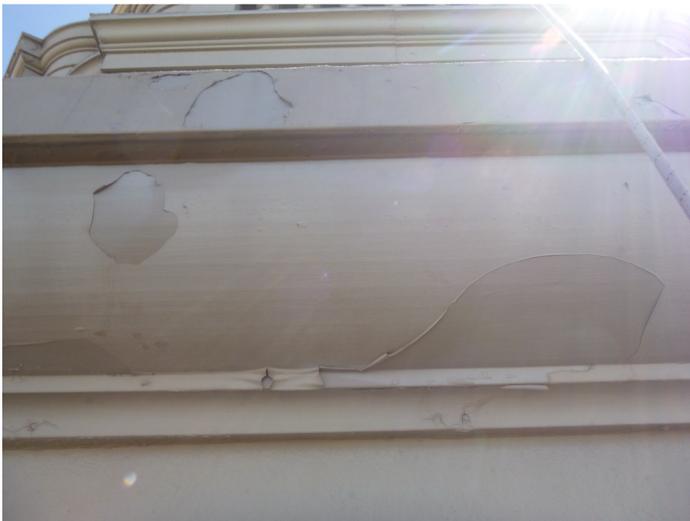
**318-61 SheetMetal\_Coating Coating Failed 2013-2**

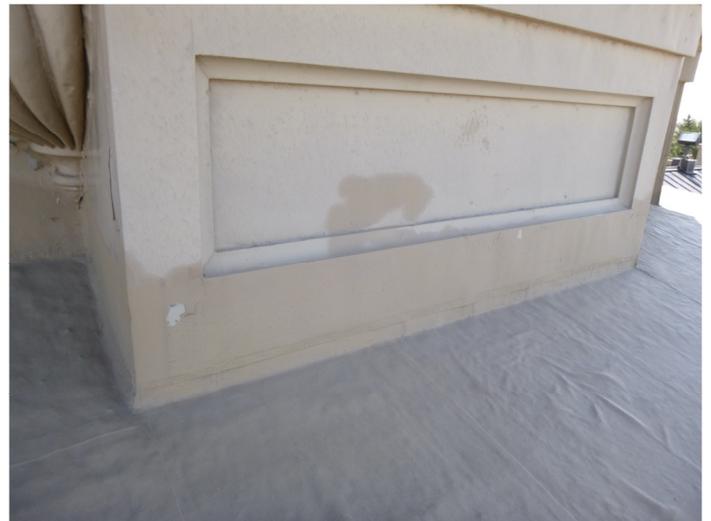
**318-61 SheetMetal\_Coating Coating Failed 2013-3**

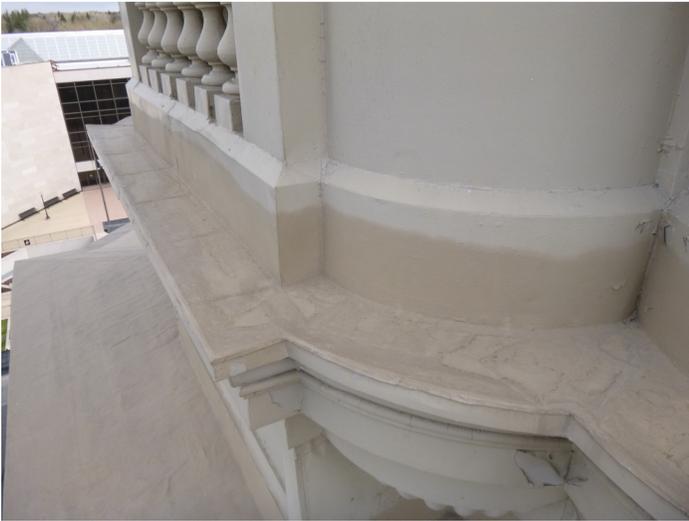
**318-64 SheetMetal\_Coating Coating Failed 2013-1**

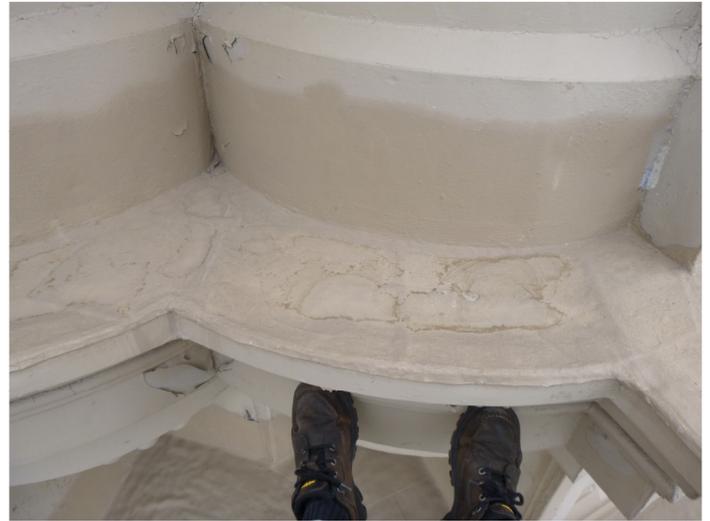
318-69 SheetMetal\_Note Photo-water ponding at ledge

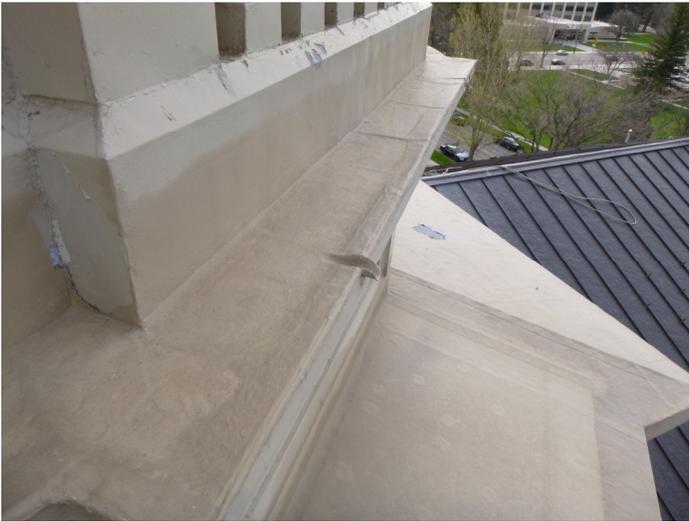
318-69 SheetMetal\_Note Photo-water ponding at ledge

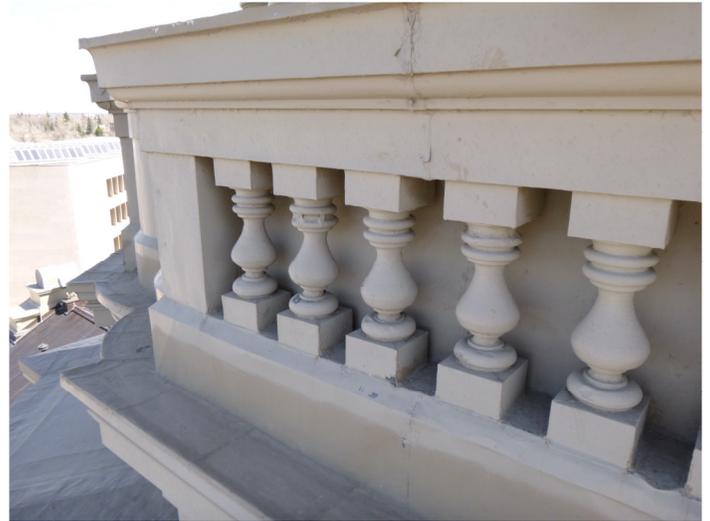
318-69 SheetMetal\_Note Photo-water ponding at ledge

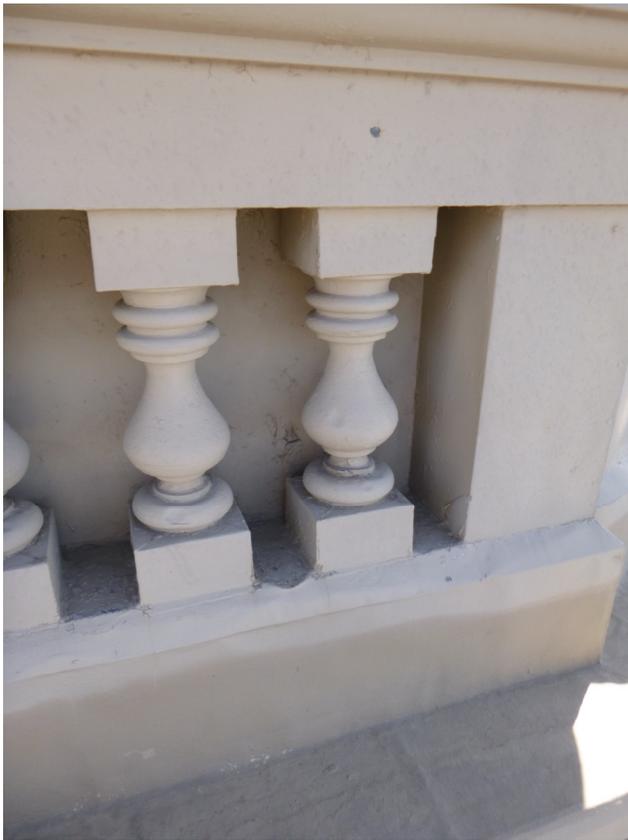
318-71 SheetMetal\_Coating Coating Failed 2013-1

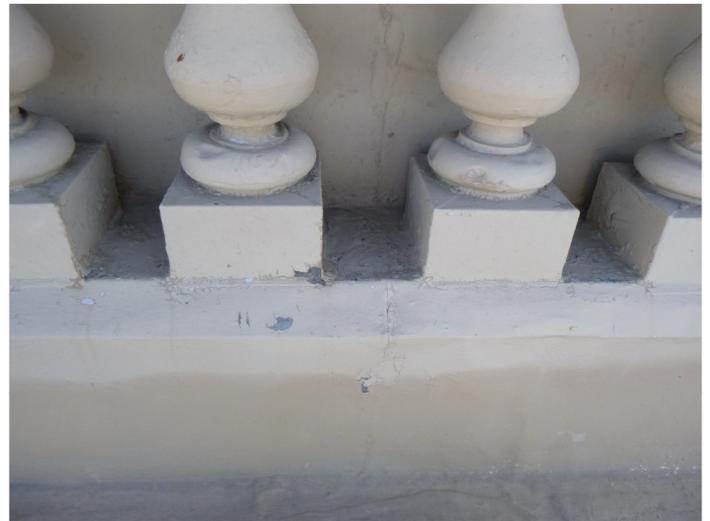
318-71 SheetMetal\_Coating Coating Failed 2013-2

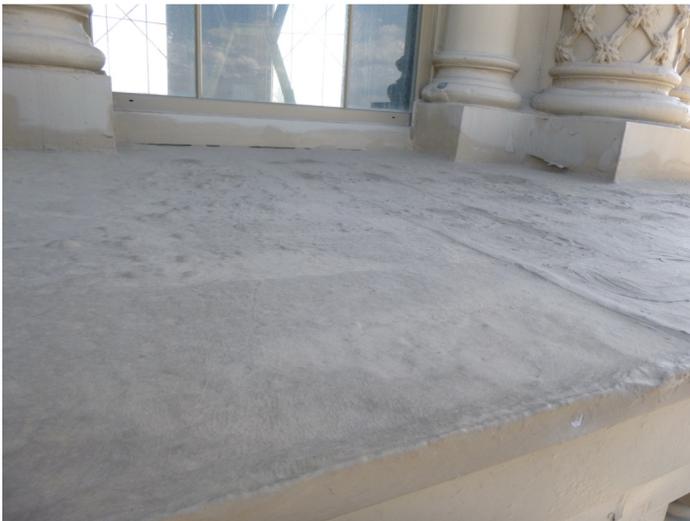
318-71 SheetMetal\_Coating Coating Failed 2013-3

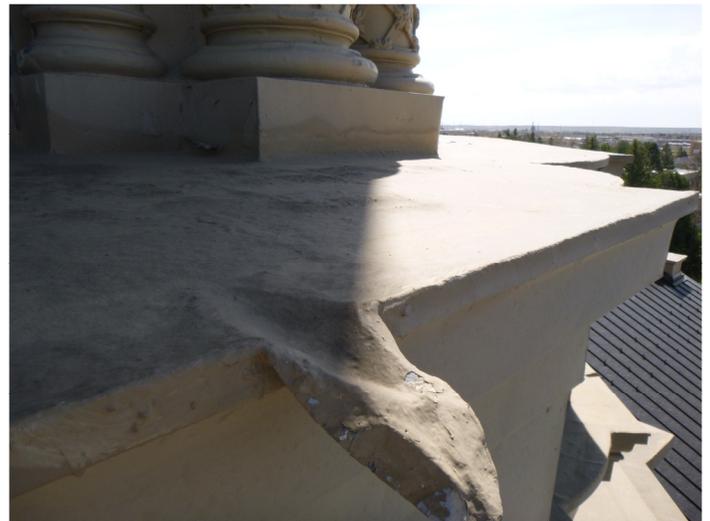
318-74 SheetMetal\_Coating Coating Failed 2013-1

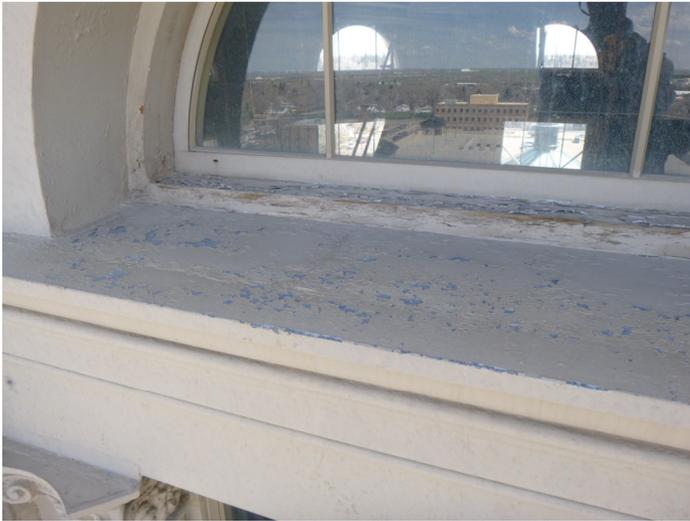
318-74 SheetMetal\_Coating Coating Failed 2013-2

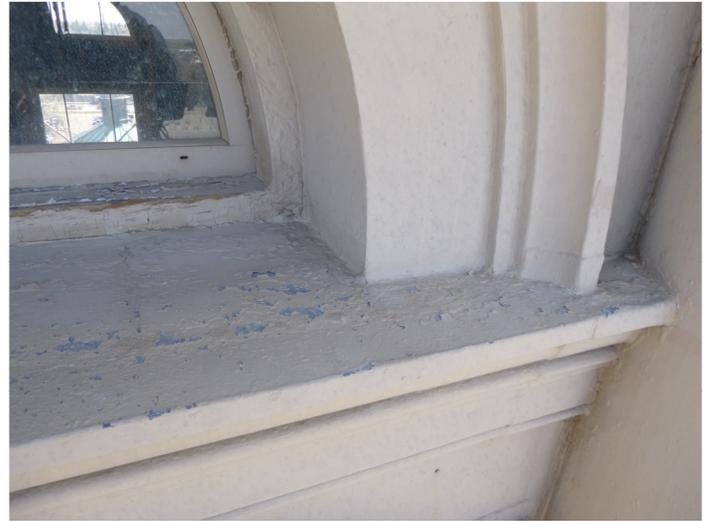
**318-83 SheetMetal\_Coating Coating Failed 2013-1**

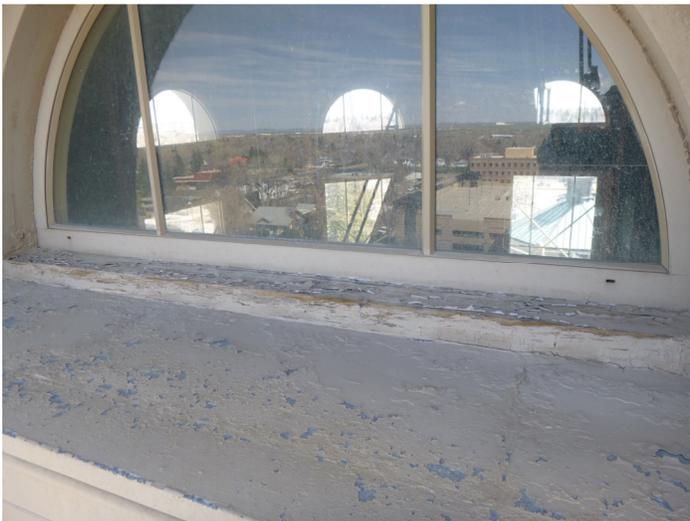
**318-83 SheetMetal\_Coating Coating Failed 2013-2**

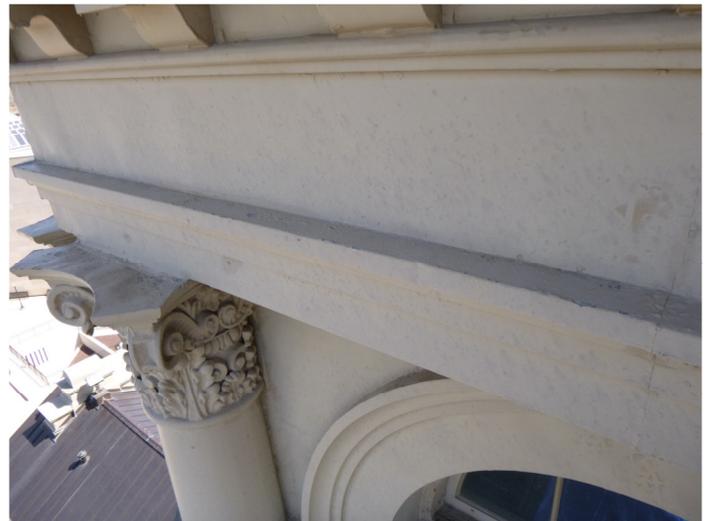
**318-85 Wood\_Coating Coating Failed 2013-1**

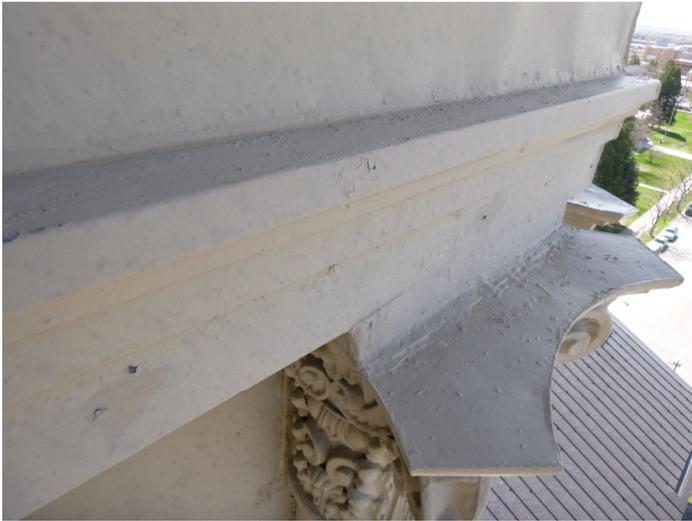
**318-88 SheetMetal\_Coating Coating Failed 2013-1**

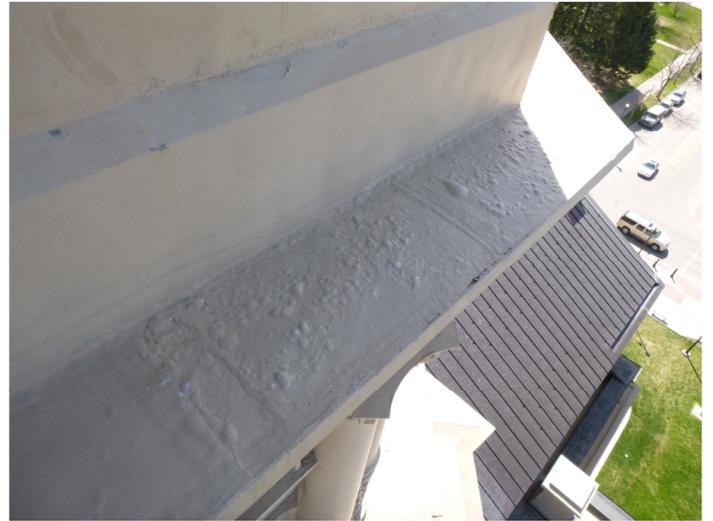
**318-88 SheetMetal\_Coating Coating Failed 2013-2**

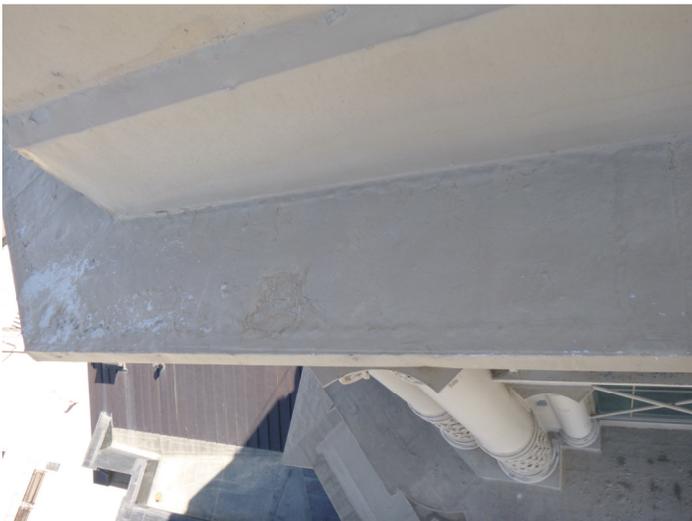
**318-91 SheetMetal\_Coating Coating Failed 2013-1**

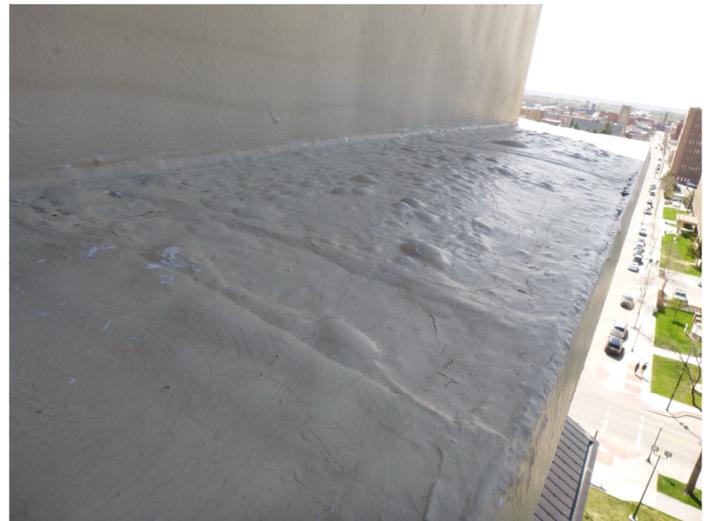
**318-91 SheetMetal\_Coating Coating Failed 2013-2**

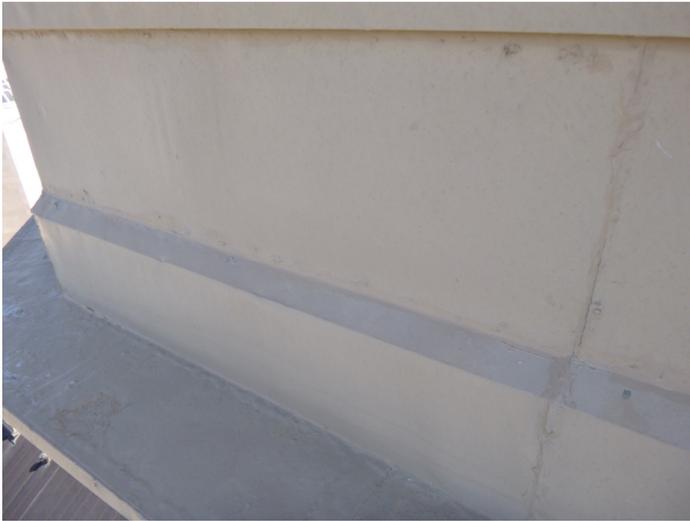
**318-91 SheetMetal\_Coating Coating Failed 2013-3**

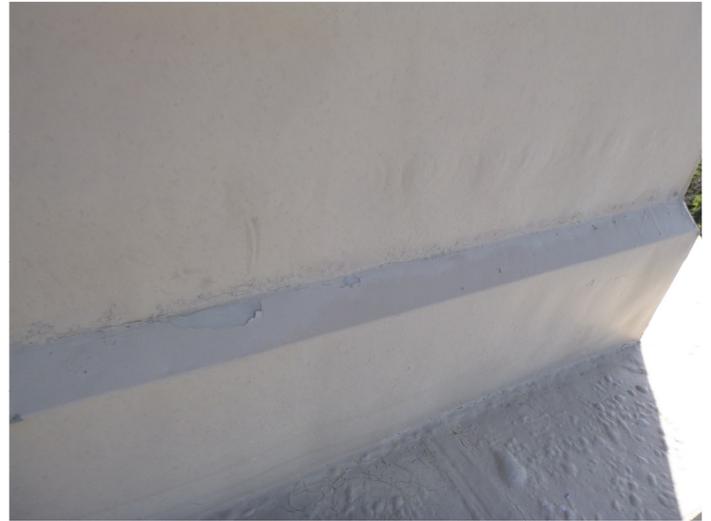
**318-93 SheetMetal\_Coating Coating Failed 2013-1**
