# Report Narrative

## Wyoming State Capitol Dome Investigation Cheyenne, WY

Vertical Access LLC  
PO Box 4135, Ithaca, NY 14852  
Tel: 607 257 4049 / Fax: 607 257 2129

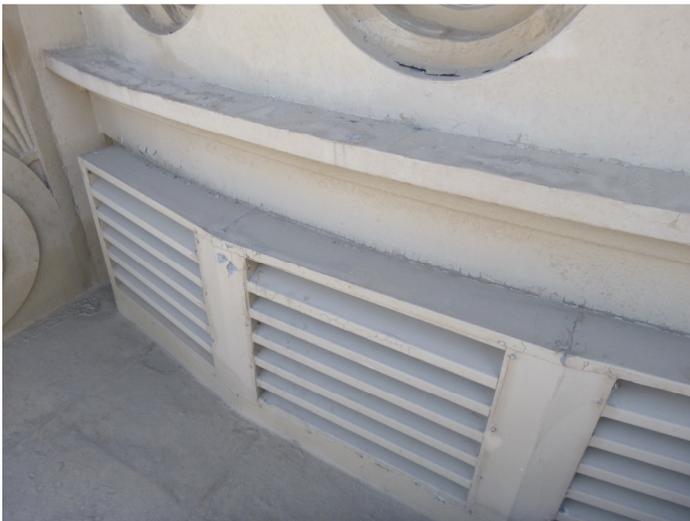
**318-93 SheetMetal\_Coating Coating Failed 2013-2**

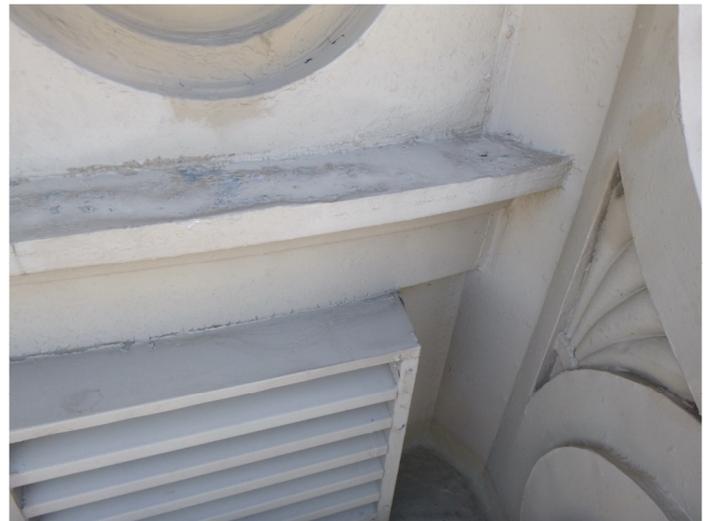
**318-98 SheetMetal\_Coating Coating Failed 2013-1**

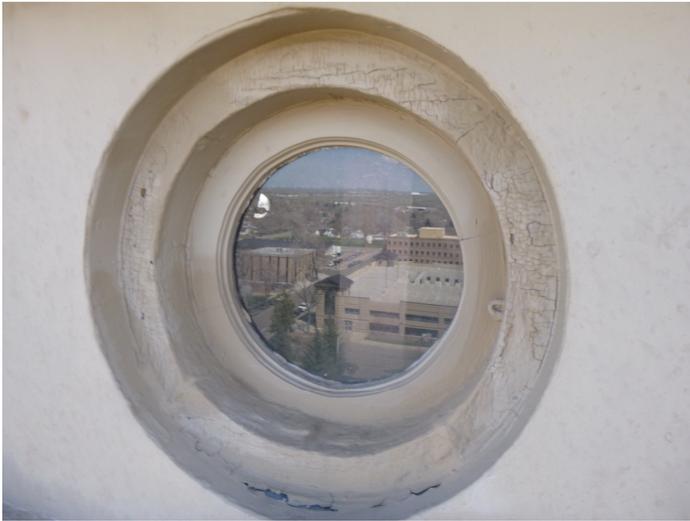
**318-98 SheetMetal\_Coating Coating Failed 2013-2**

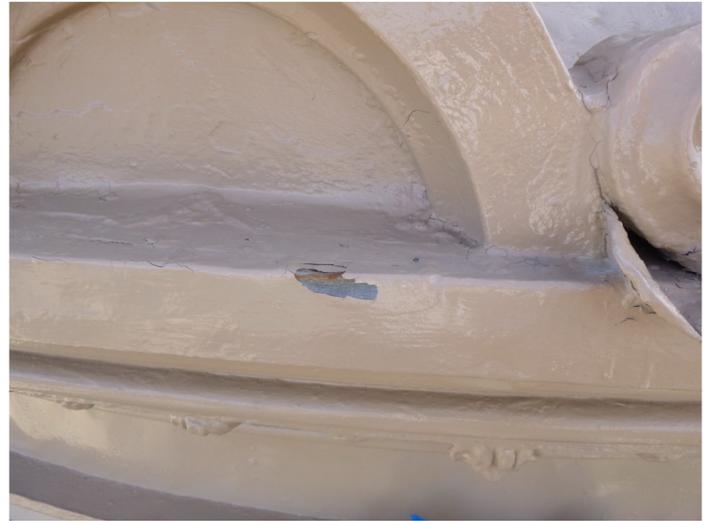
**318-98 Wood\_Deteriorated Weathered 2013-1**

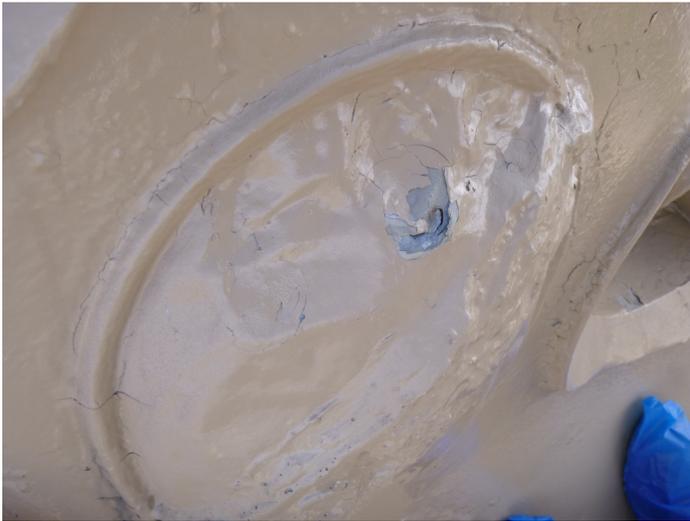
**318-104 SheetMetal\_Corrosion Surface 2013-1**

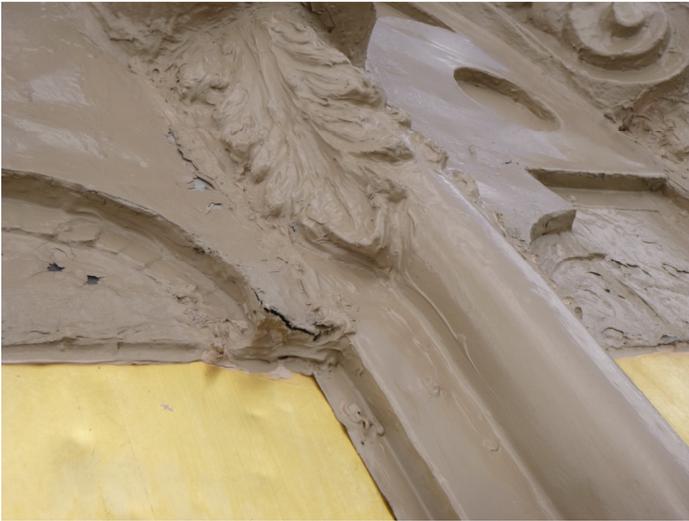
**318-117 SheetMetal\_Damaged Dented 2013-1**

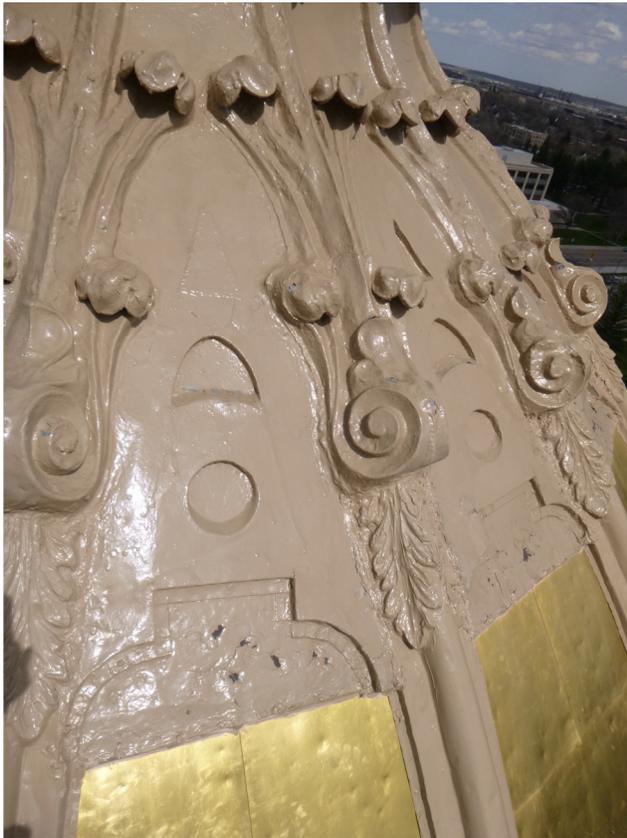
**318-119 SheetMetal\_Damaged Punctured 2013-1**

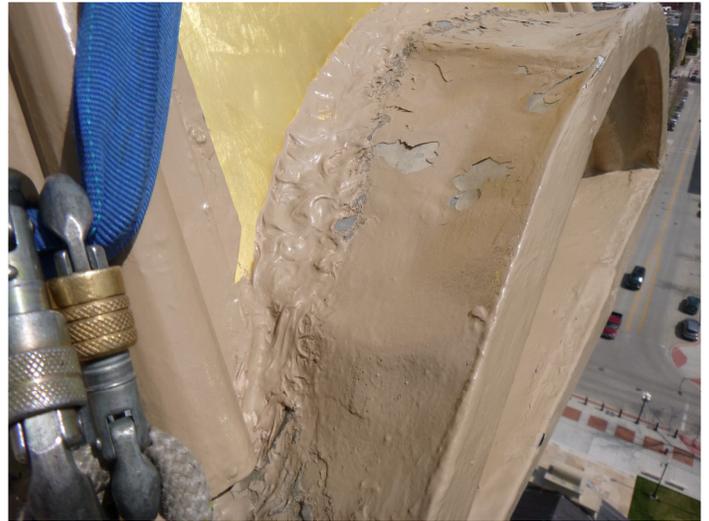
318-127 SheetMetal\_Coating Coating Failed 2013-2

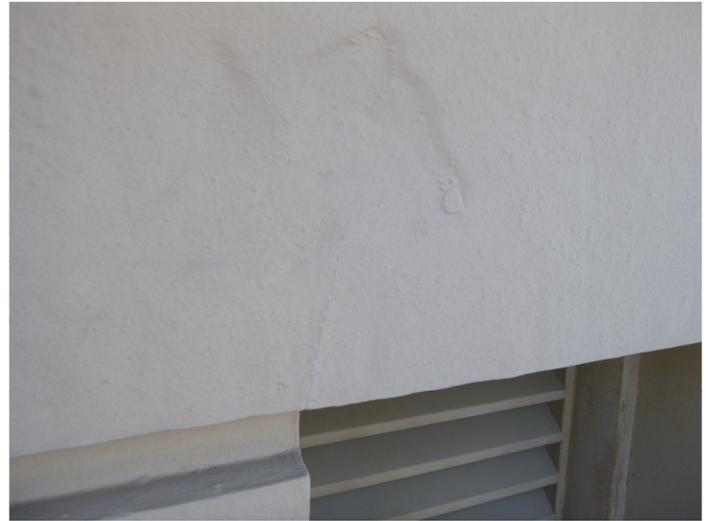
**318-130 SheetMetal\_Coating Coating Failed 2013-2**

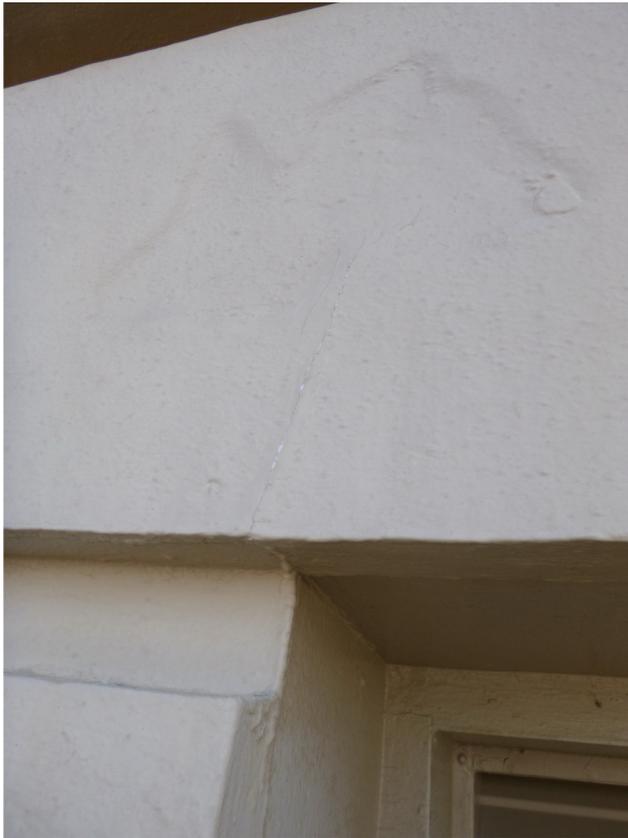
**319-58 ArchMetal\_Crack Repair failed 2013-1**

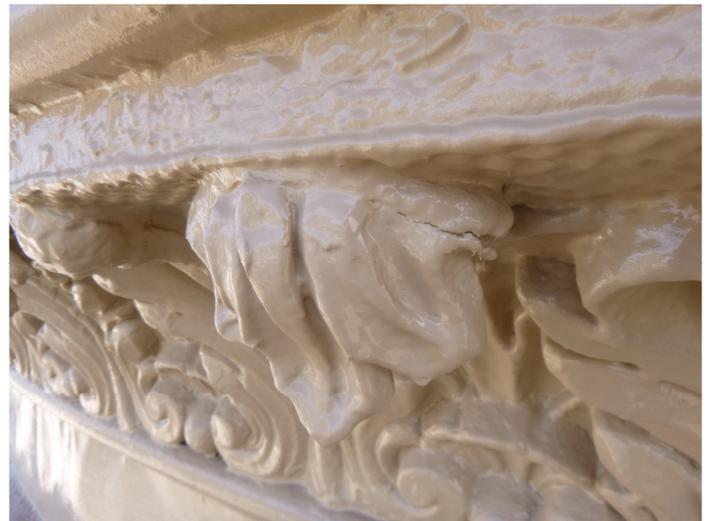
**319-58 ArchMetal\_Crack Repair failed 2013-2**

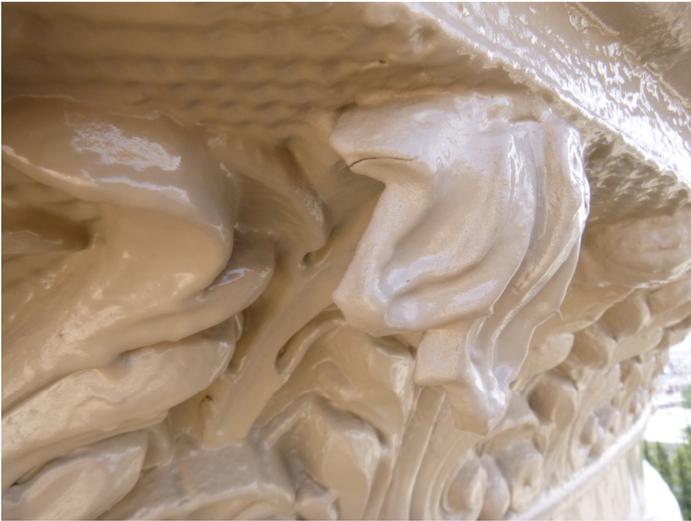
**319-104 SheetMetal\_Unsecured Loose 2013-1**

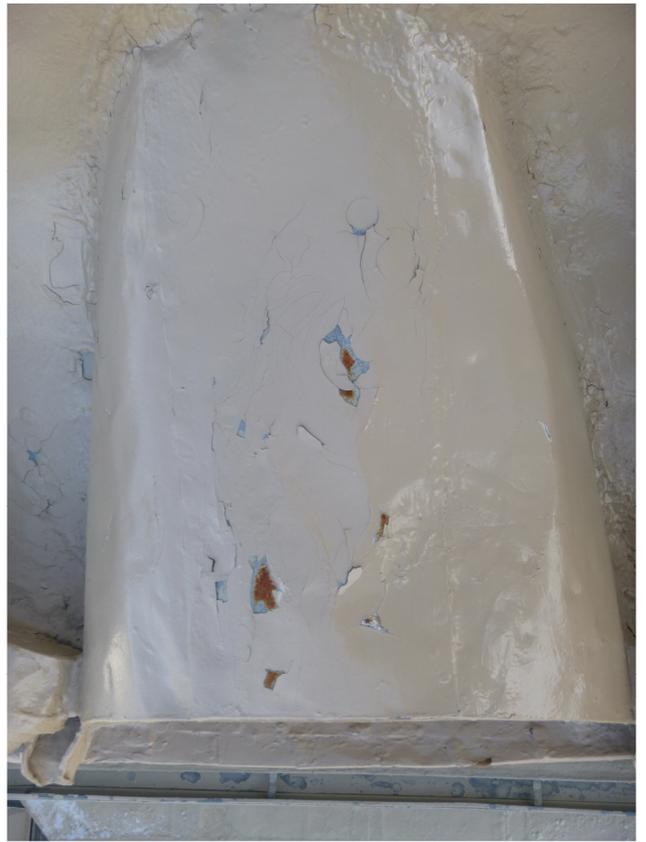
**319-104 SheetMetal\_Unsecured Loose 2013-2**

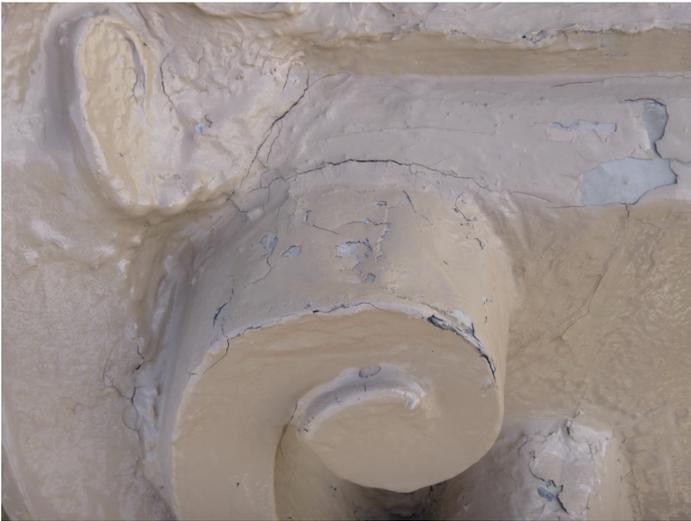
**319-105 SheetMetal\_Corrosion Surface 2013-1**

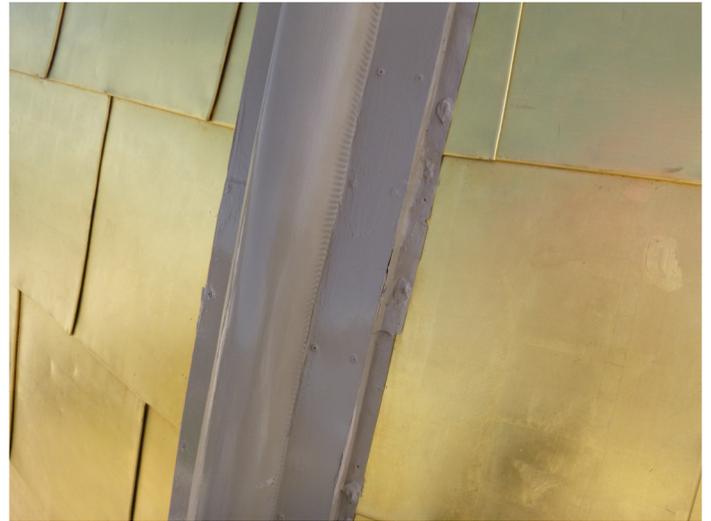
**319-108 SheetMetal\_Seam Solder Failed 2013-1**

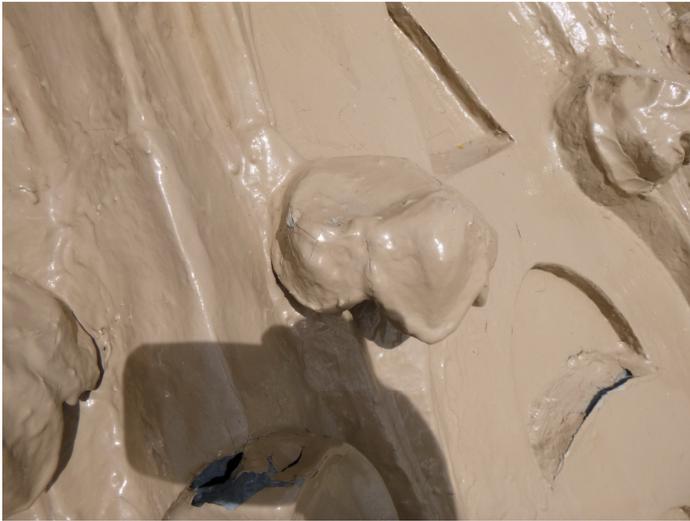
**319-113 SheetMetal\_Seam Solder Failed 2013-1**

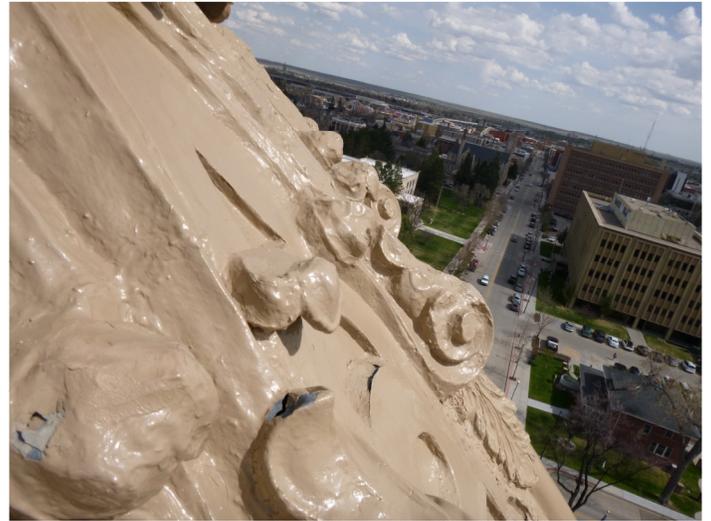
**319-121 SheetMetal\_Damaged Dented 2013-4**

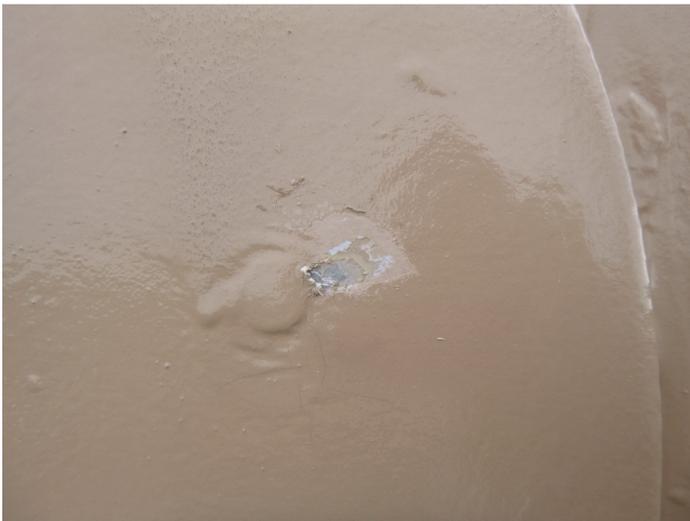
**319-121 SheetMetal\_Damaged Dented 2013-5**

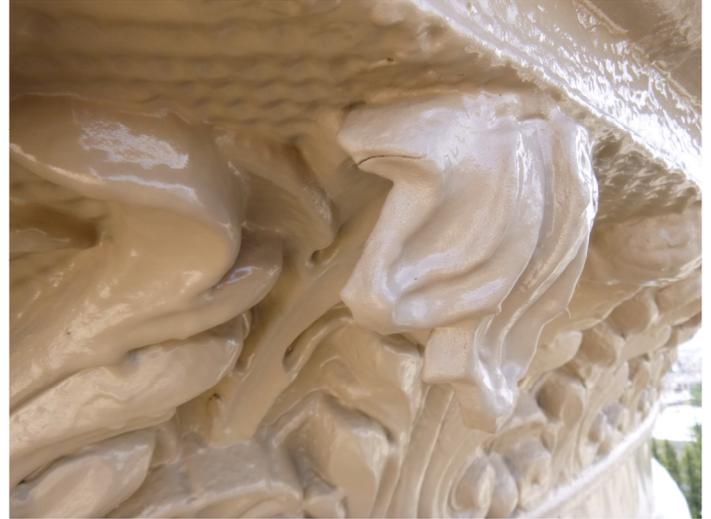
**320-103 SheetMetal\_Damaged Torn 2013-1**

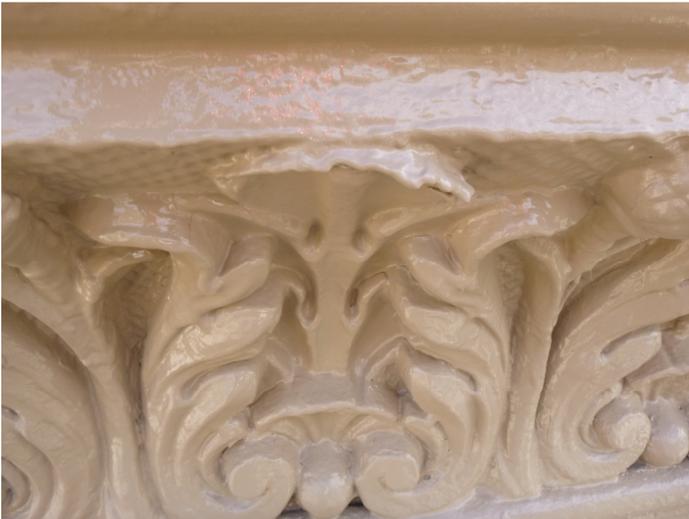
**320-103 SheetMetal\_Damaged Torn 2013-2**

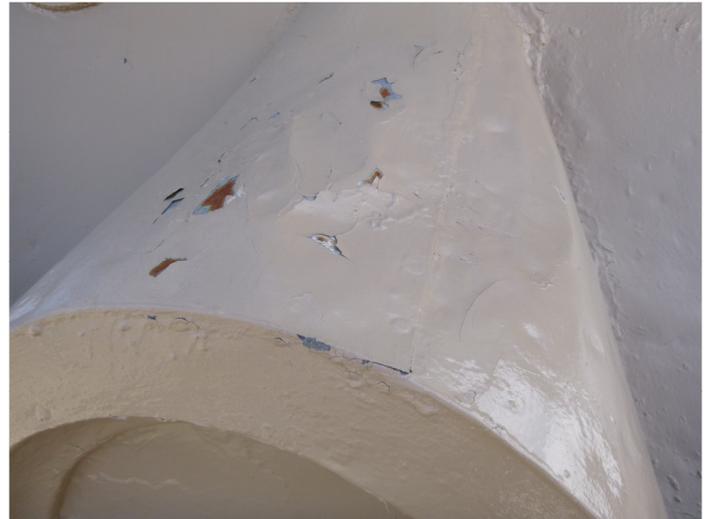
**320-103 SheetMetal\_Unsecured Missing 2013-1**

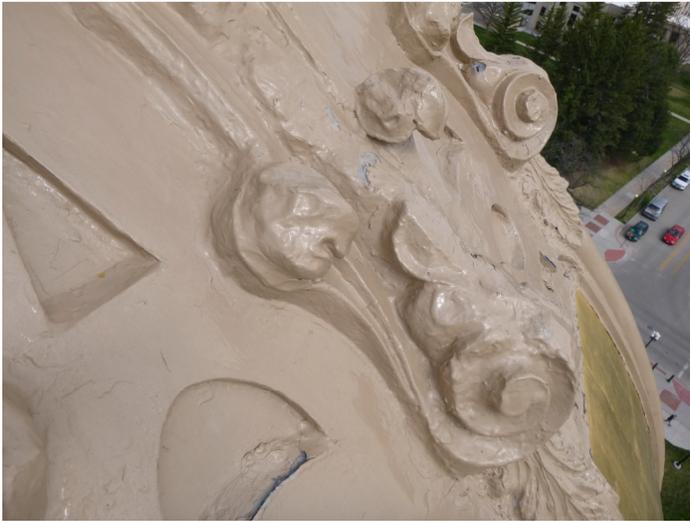
**320-104 SheetMetal\_Seam Solder Failed 2013-1**

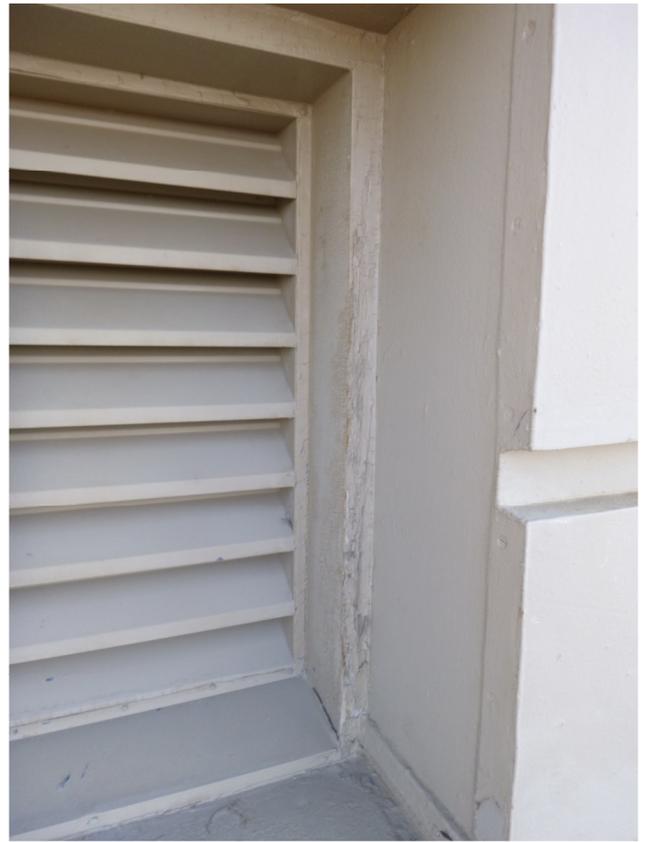
**320-120 SheetMetal\_Damaged Dented 2013-1**

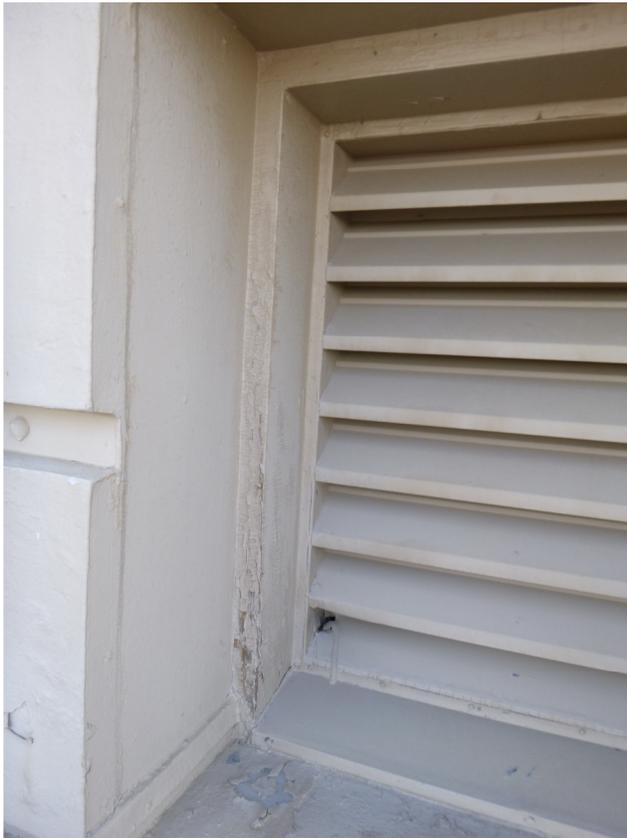
**321-57 Wood\_Coating Coating Failed 2013-1**

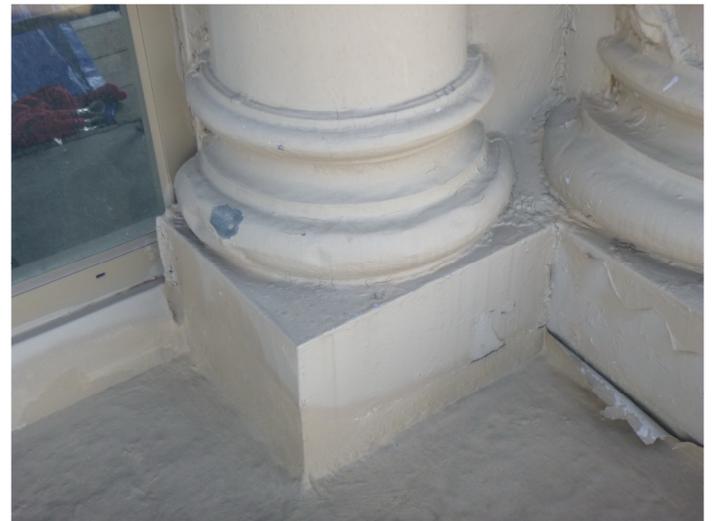
**321-57 Wood\_Coating Coating Failed 2013-2**

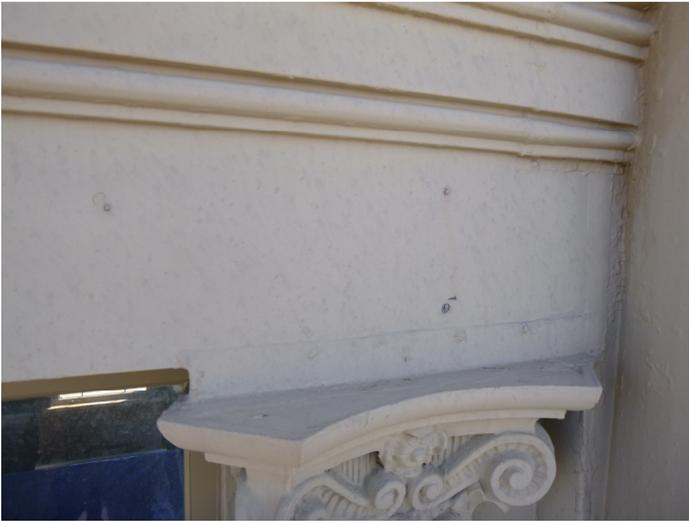
**321-74 SheetMetal\_Coating Coating Failed 2013-1**

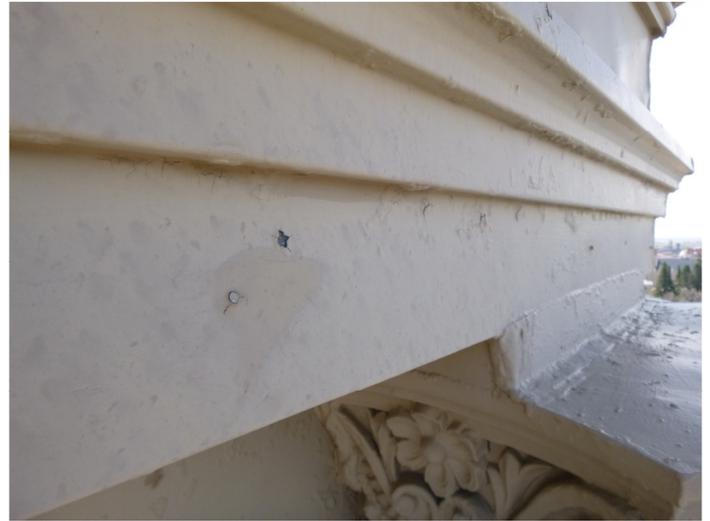
**321-82 SheetMetal\_Seam Fastener Failed 2013-1**

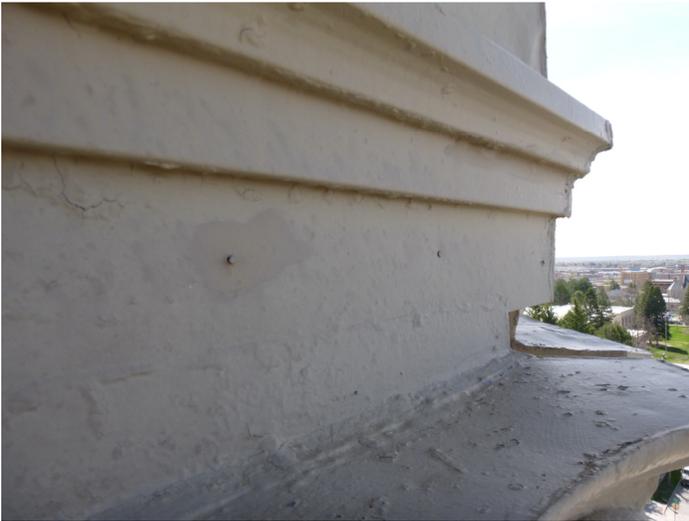
**321-88 SheetMetal\_Seam Fastener Failed 2013-1**

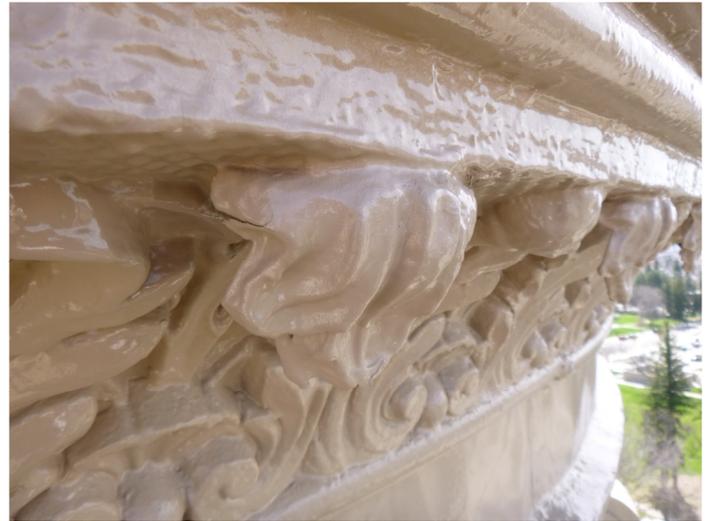
**321-88 SheetMetal\_Seam Fastener Failed 2013-2**

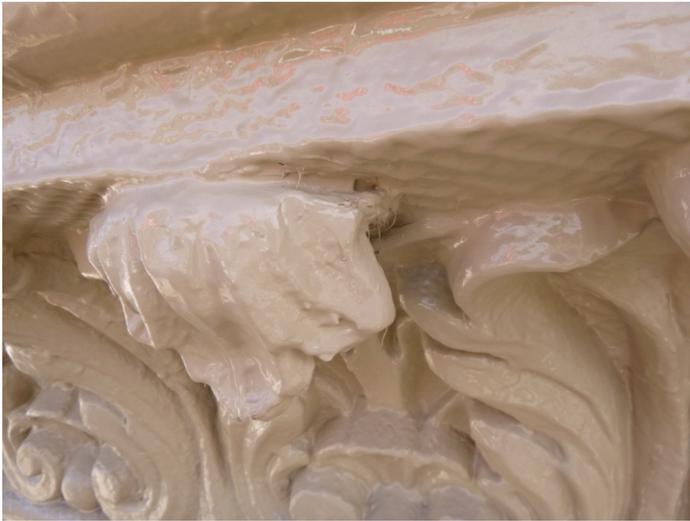
**321-103 SheetMetal\_Damaged Torn 2013-1**

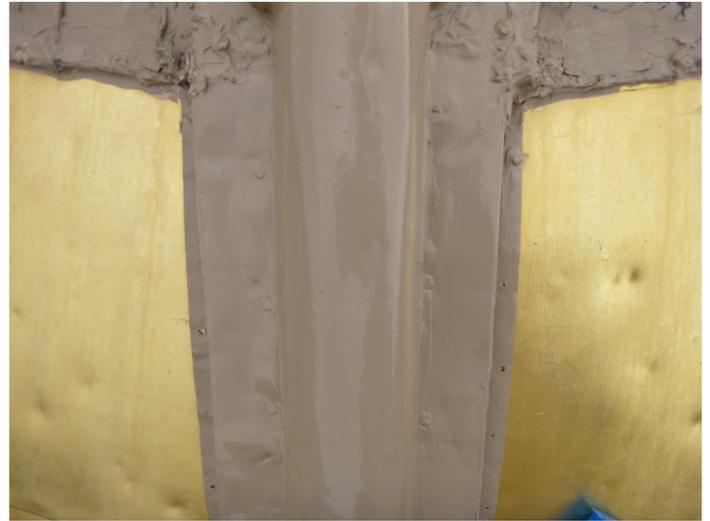
**321-103 SheetMetal\_Damaged Torn 2013-2**

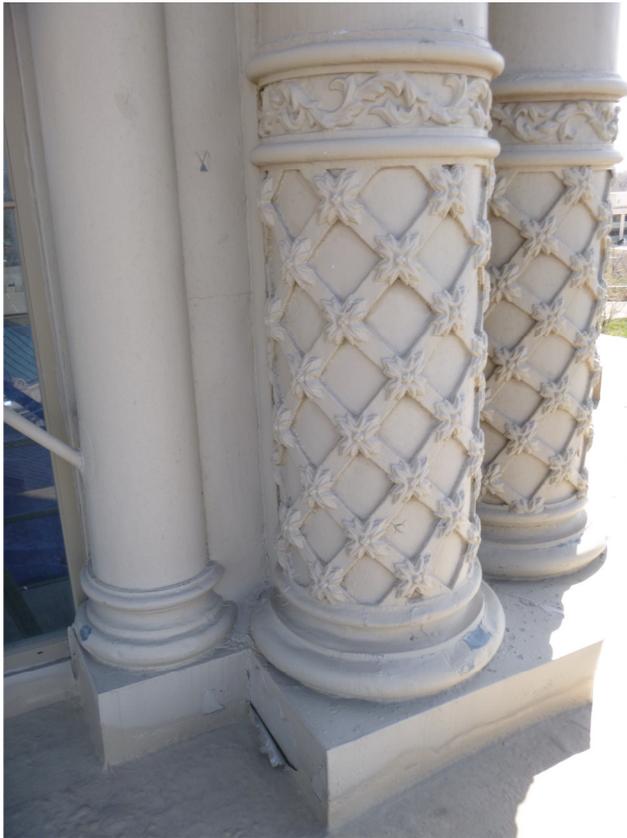
322-74 SheetMetal\_Repair Patch Sound 2013-1

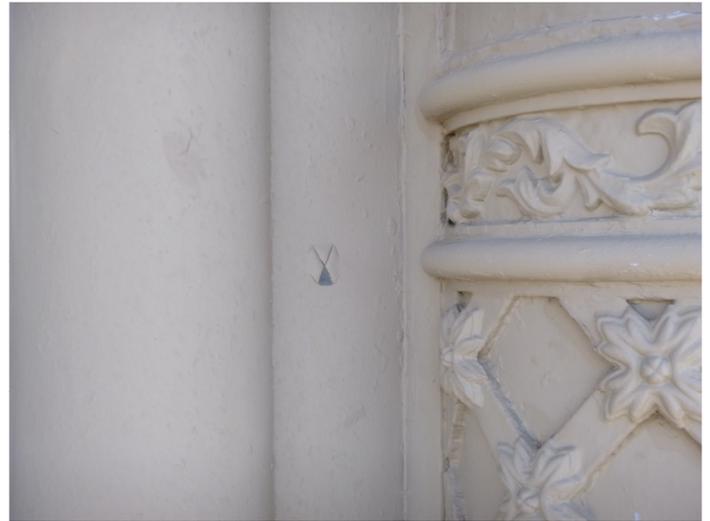
322-77 SheetMetal\_Coating Coating Failed 2013-1

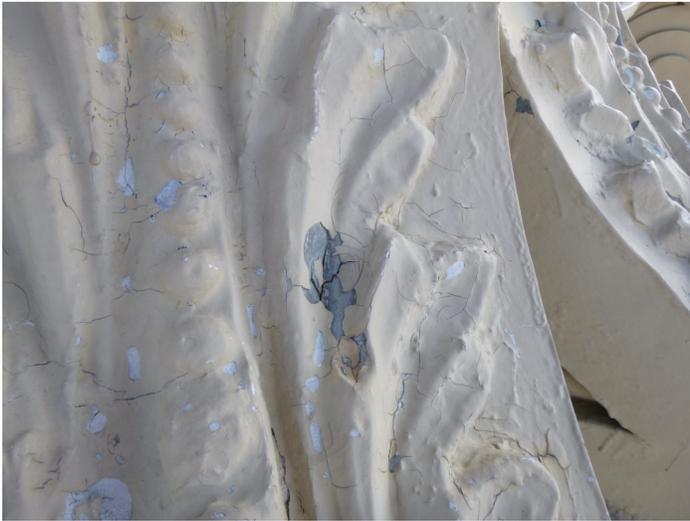
322-79 SheetMetal\_Coating Coating Failed 2013-1

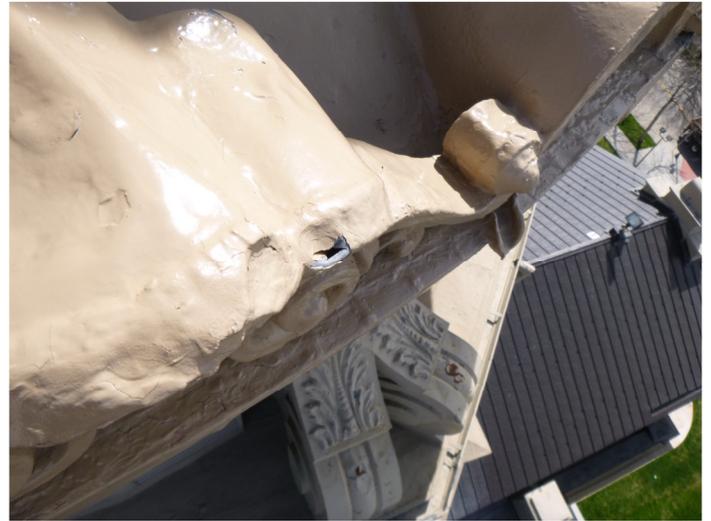
**322-99 SheetMetal\_Damaged Torn 2013-1**

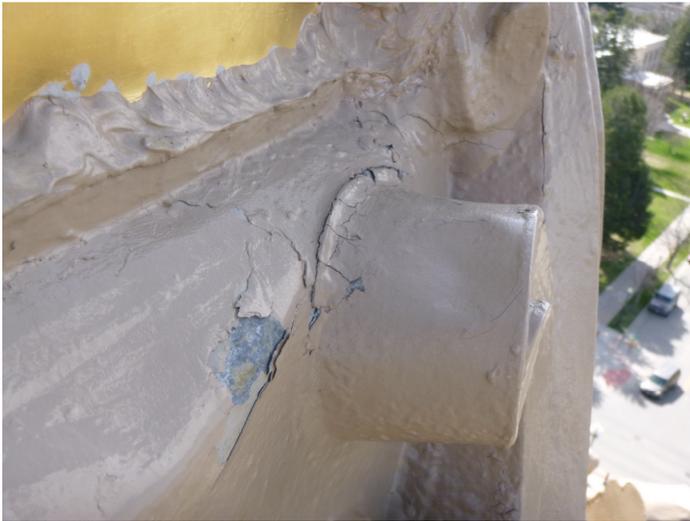
**322-105 SheetMetal\_Damaged Torn 2013-1**

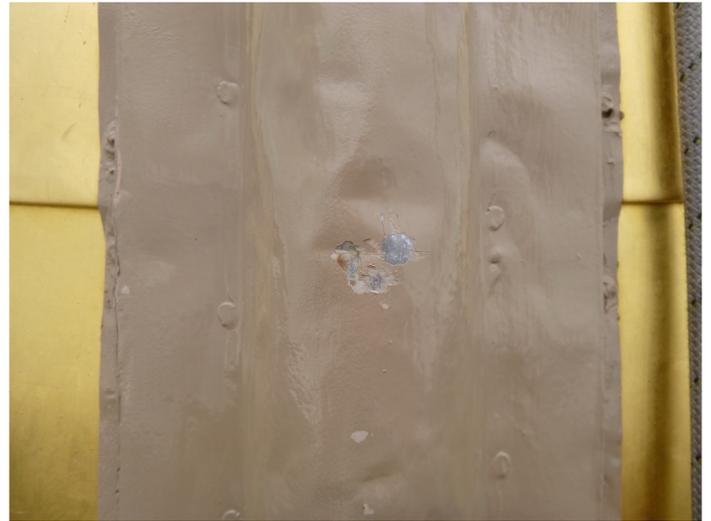
**322-108 SheetMetal\_Seam Solder Failed 2013-1**

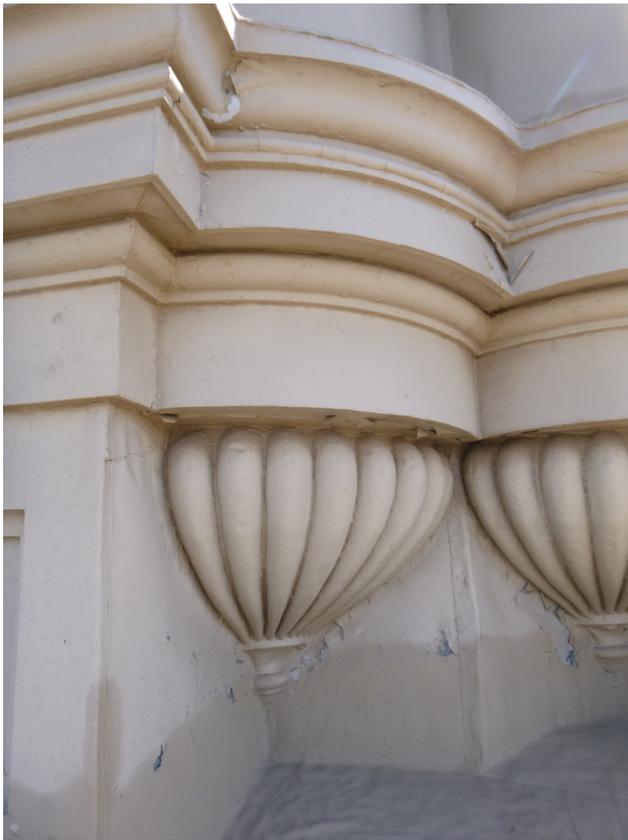
**322-112 SheetMetal\_Note PntSm 10 2013-1**

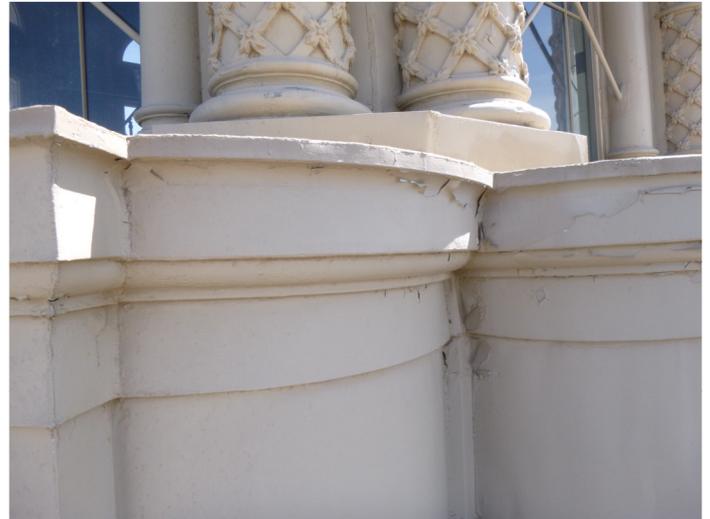
323-66 SheetMetal\_Coating Coating Failed 2013-1

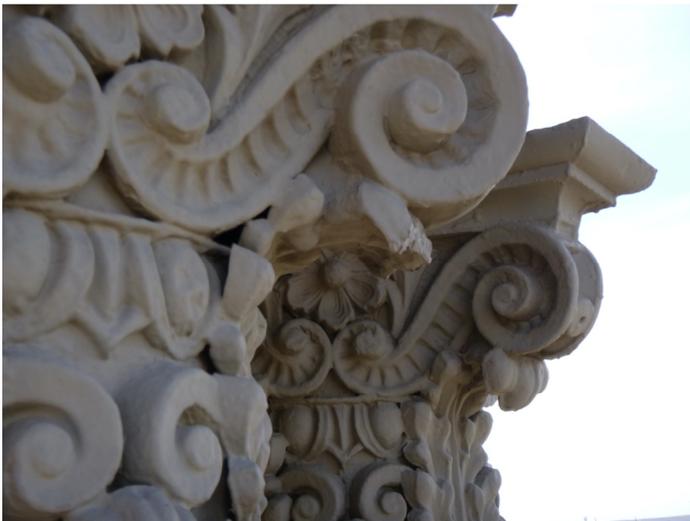
323-72 SheetMetal\_Coating Coating Failed 2013-1

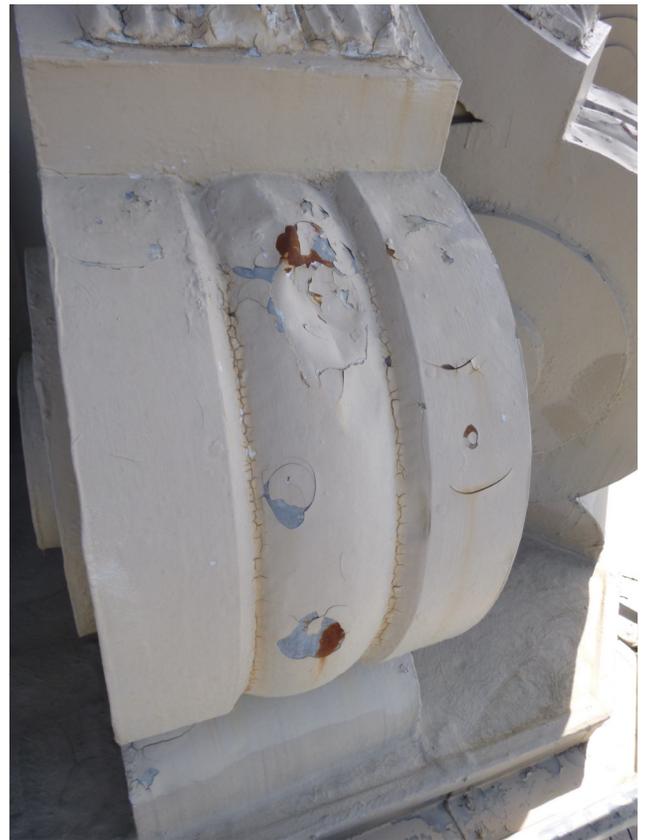
323-86 SheetMetal\_Unsecured Missing 2013-1

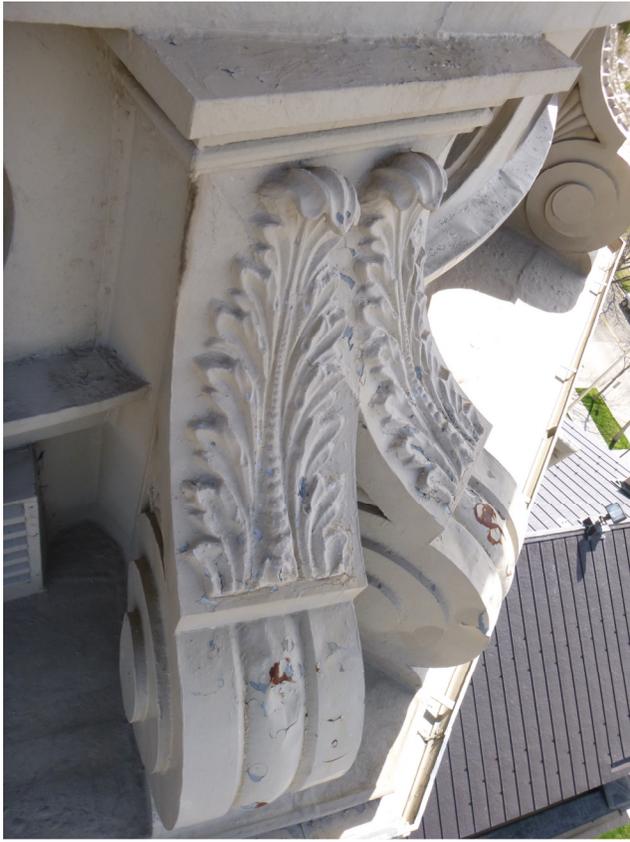
323-97 SheetMetal\_Corrosion Surface 2013-1

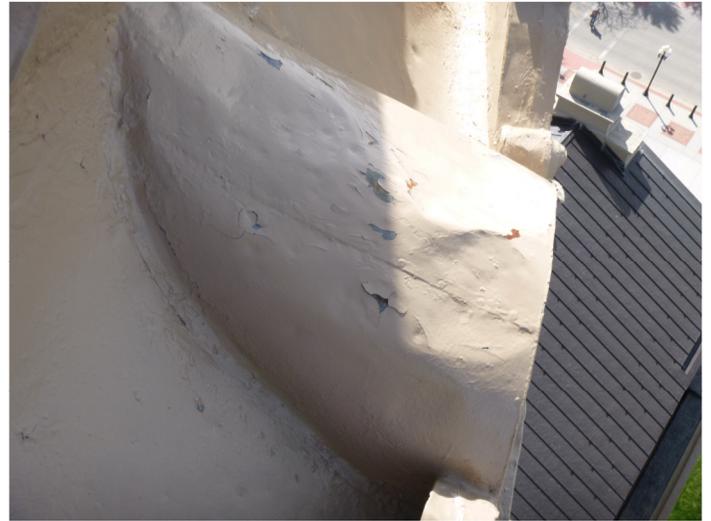
323-100 SheetMetal\_Coating Coating Failed 2013-1

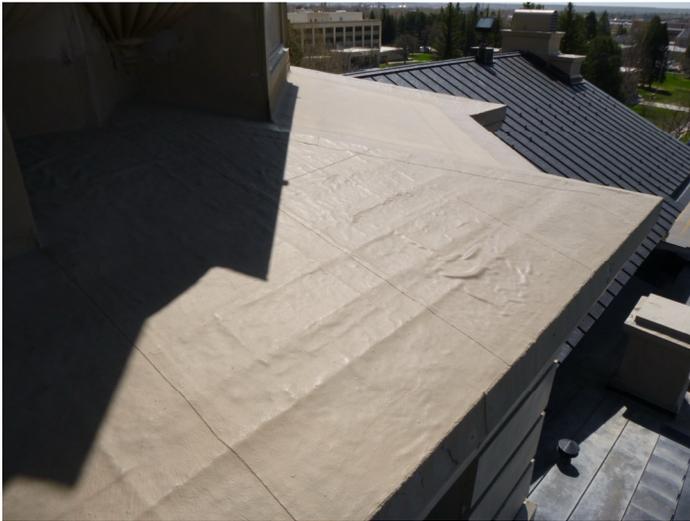
323-105 SheetMetal\_Corrosion Surface 2013-1

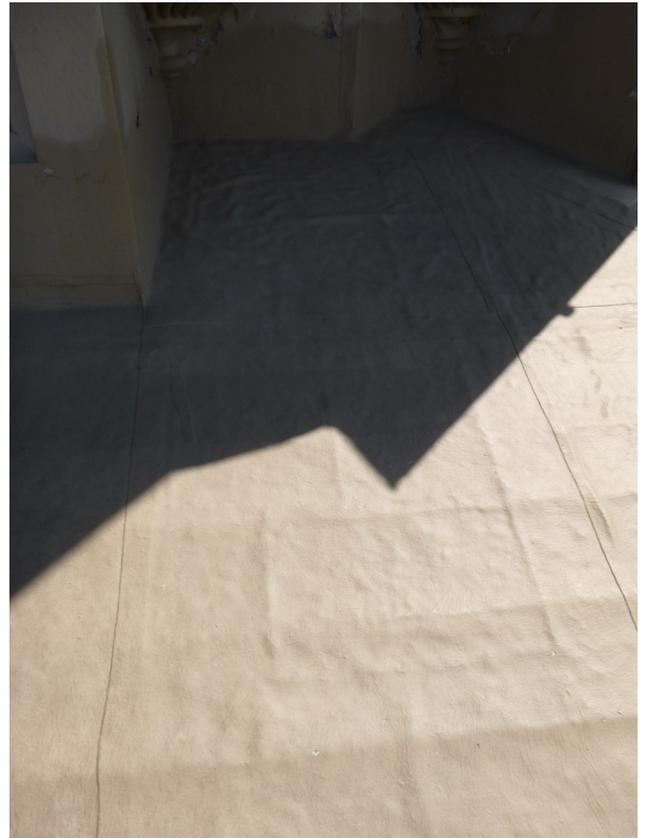
325-63 SheetMetal\_Coating Coating Failed 2013-1

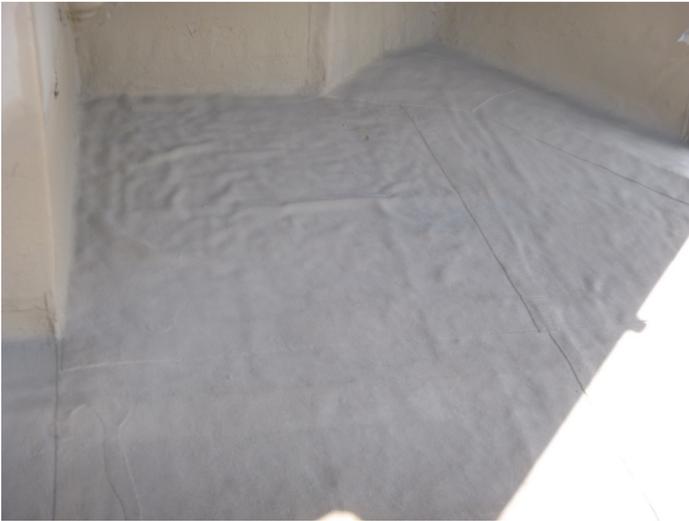
325-63 SheetMetal\_Coating Coating Failed 2013-2

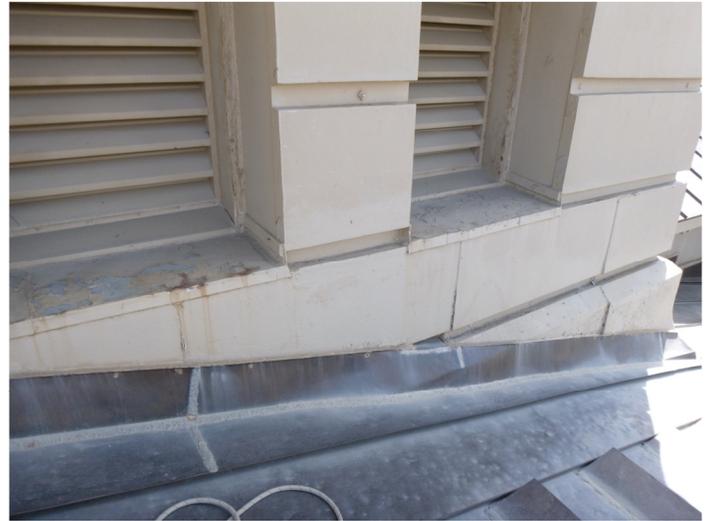
**325-63 SheetMetal\_Coating Coating Failed 2013-3**

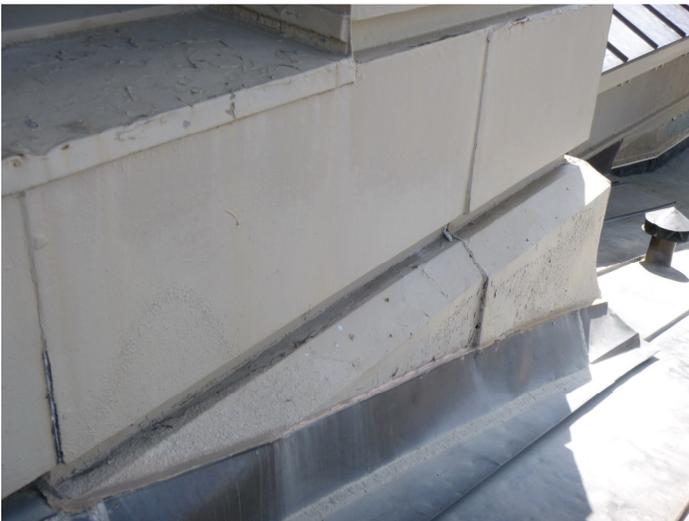
**328-54 ArchMetal\_Coating Coating Failed 2013-1**

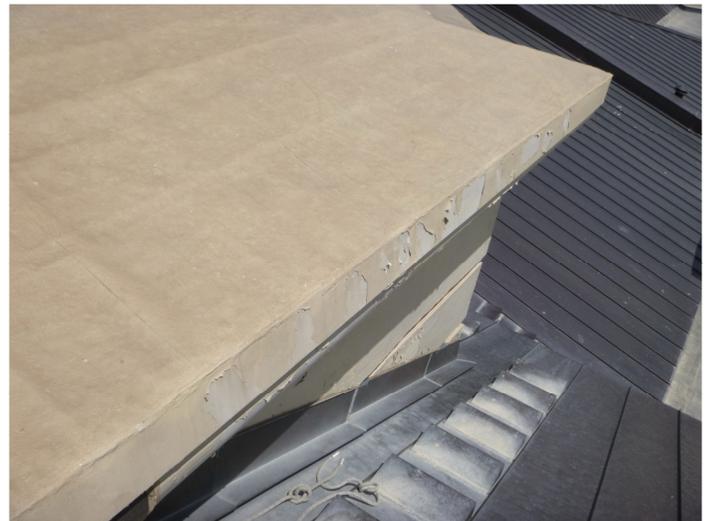
**328-54 ArchMetal\_Coating Coating Failed 2013-2**

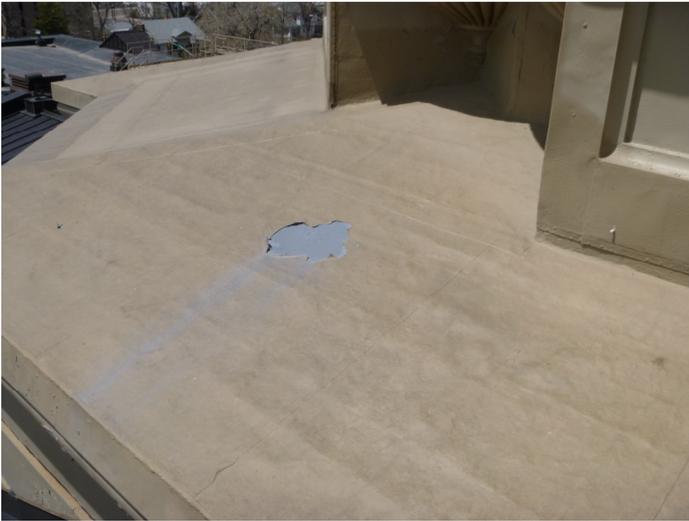
**384-62 SheetMetal\_Coating Coating Failed 2013-1**

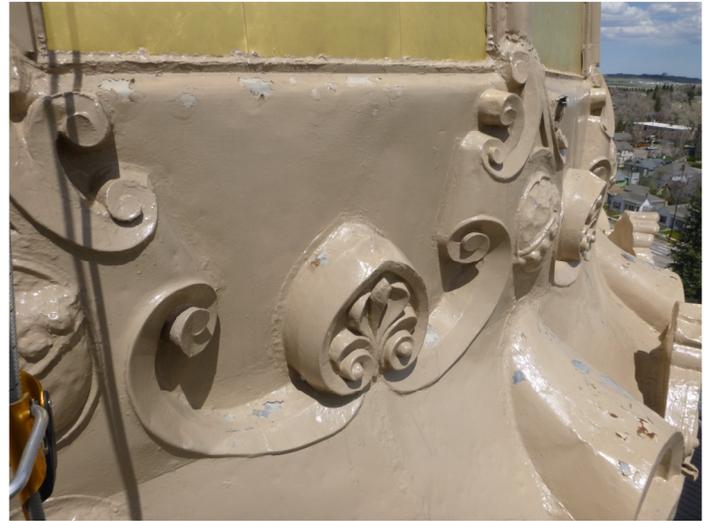
**384-62 SheetMetal\_Coating Coating Failed 2013-2**

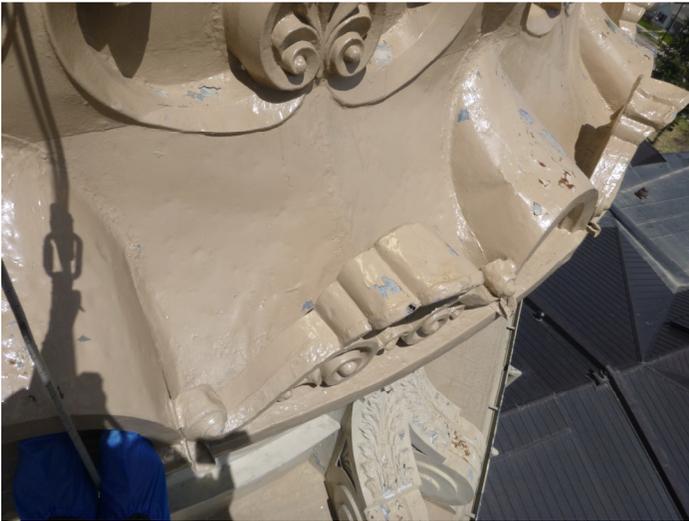
**385-107 SheetMetal\_Coating Coating Failed 2013-1**

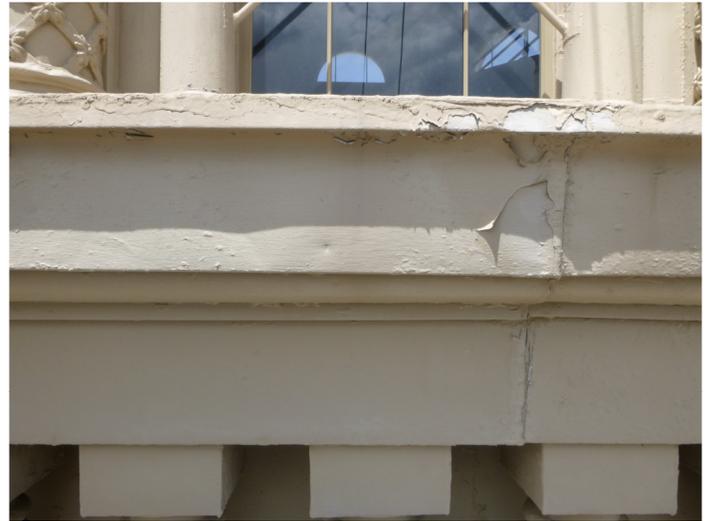
**385-107 SheetMetal\_Coating Coating Failed 2013-2**

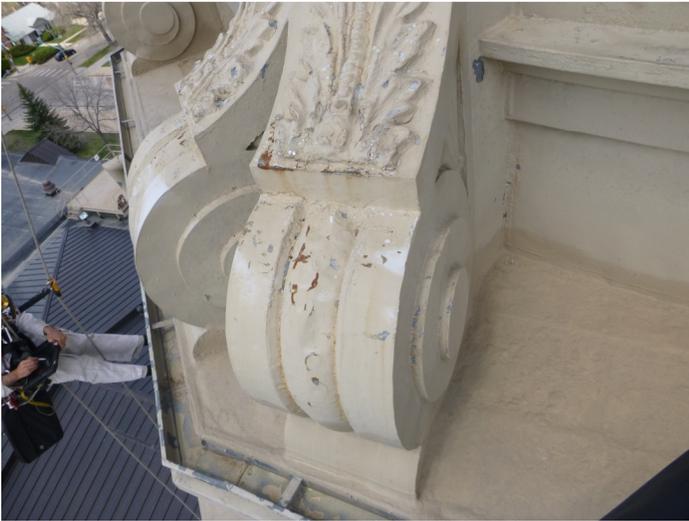
**386-73 SheetMetal\_Coating Coating Failed 2013-1**

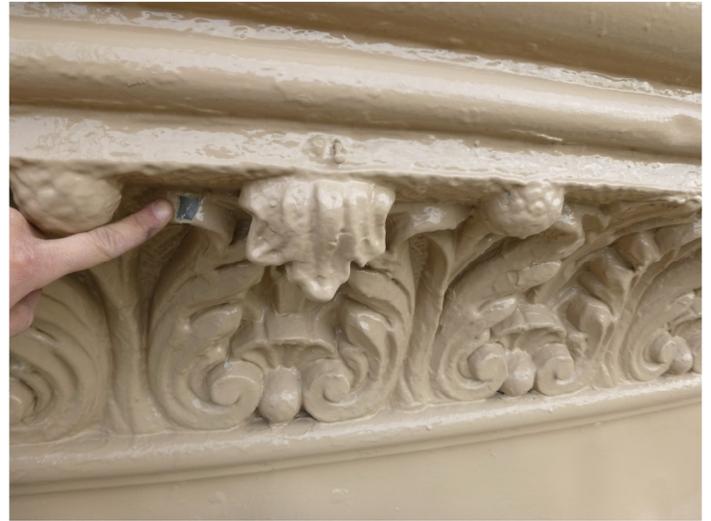
**386-97 SheetMetal\_Corrosion Surface 2013-1**

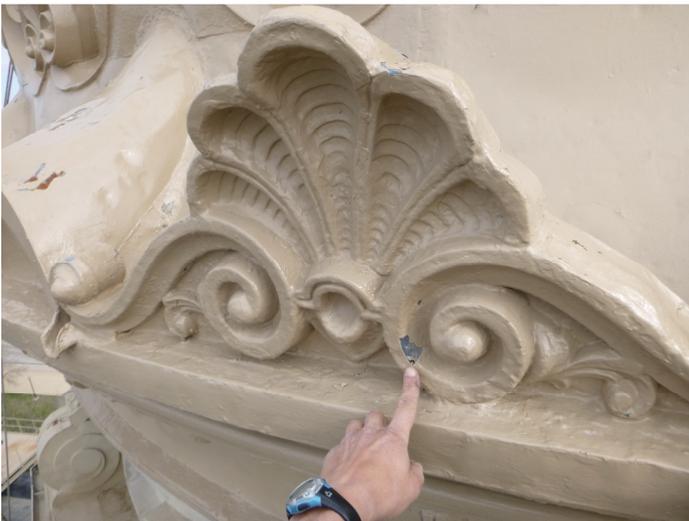
**386-103 SheetMetal\_Note PntSm 16 2013-1**

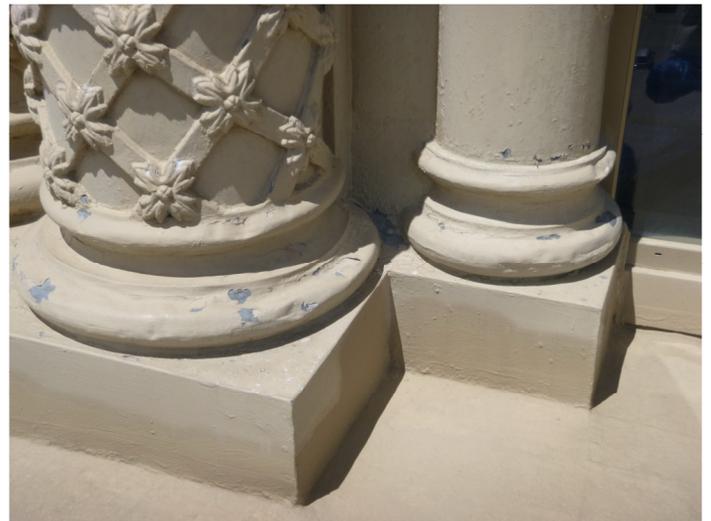
**386-104 SheetMetal\_Note PntSm 15 2013-1**
