# Report Narrative

## Wyoming State Capitol Dome Investigation Cheyenne, WY

Vertical Access LLC  
PO Box 4135, Ithaca, NY 14852  
Tel: 607 257 4049 / Fax: 607 257 2129

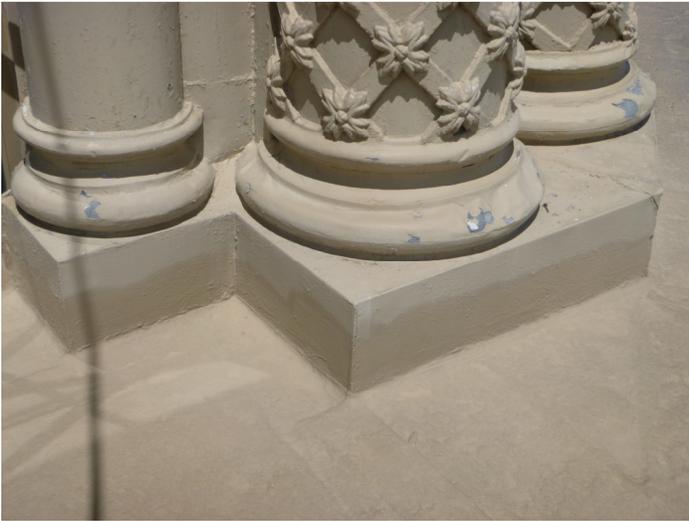
**387-74 SheetMetal\_Damaged Dented 2013-1**

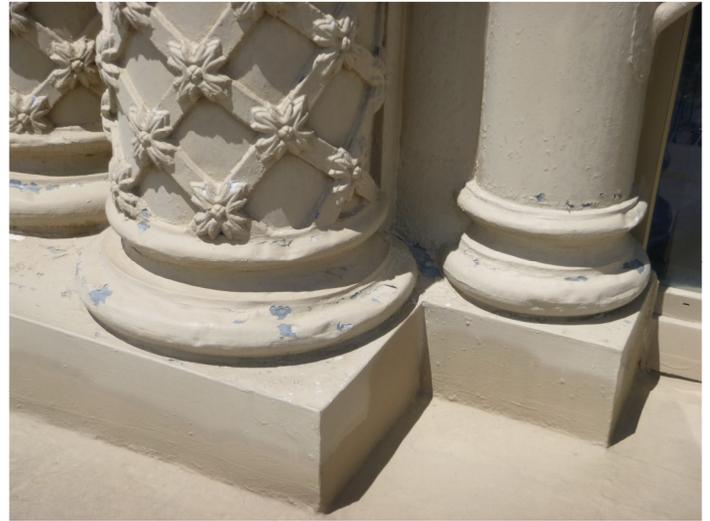
**387-78 SheetMetal\_Coating Coating Failed 2013-1**

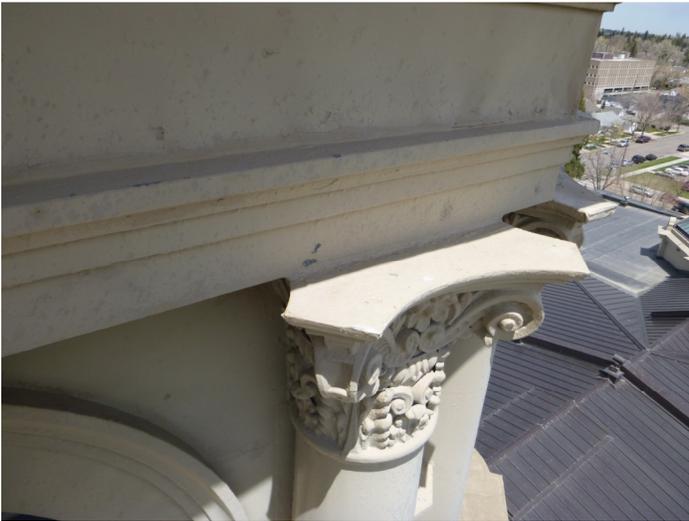
**387-78 SheetMetal\_Coating Coating Failed 2013-2**

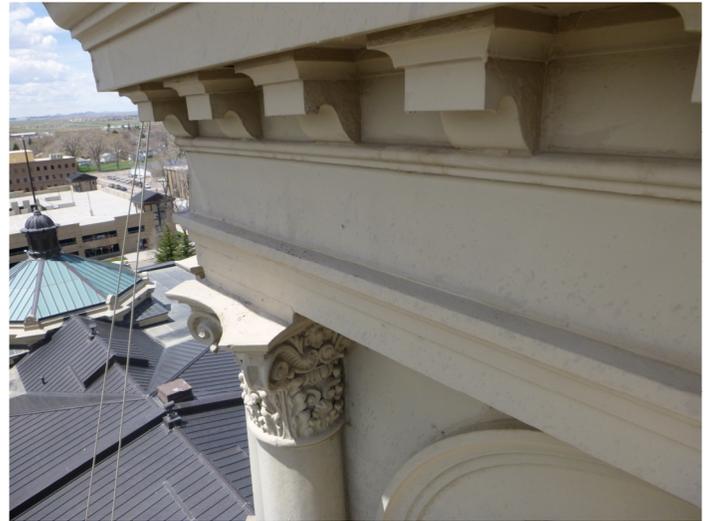
**387-90 SheetMetal\_Coating Coating Failed 2013-1**

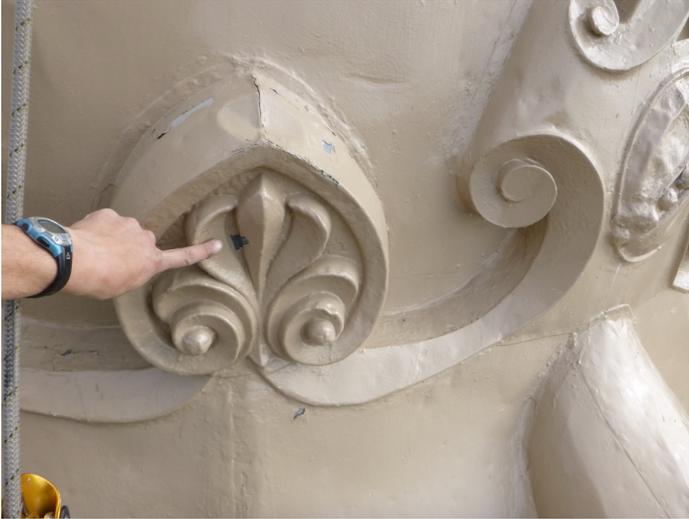
**387-90 SheetMetal\_Coating Coating Failed 2013-2**

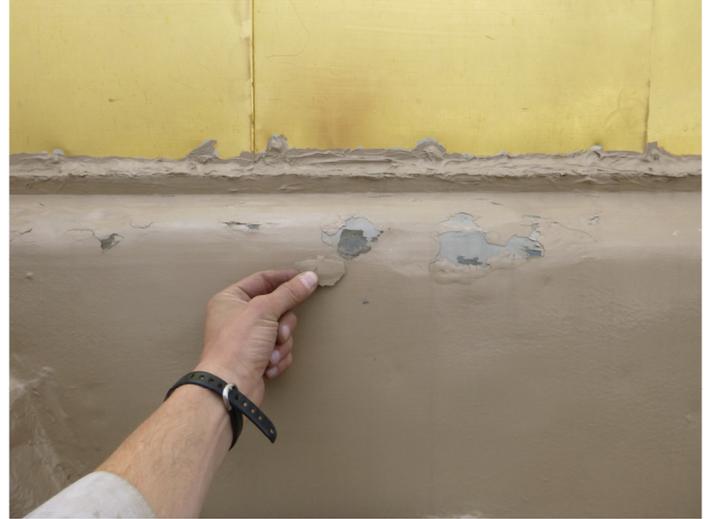
**387-105 SheetMetal\_Note PntSm 14 2013-1**

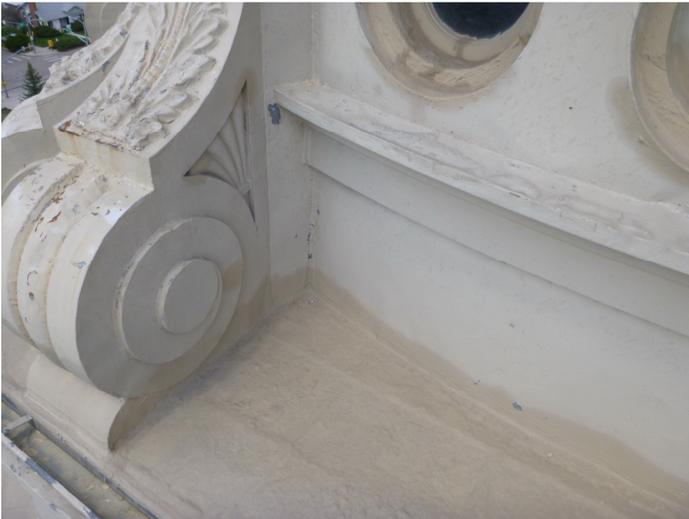
**387-109 SheetMetal\_Note PntSm 11 2013-1**

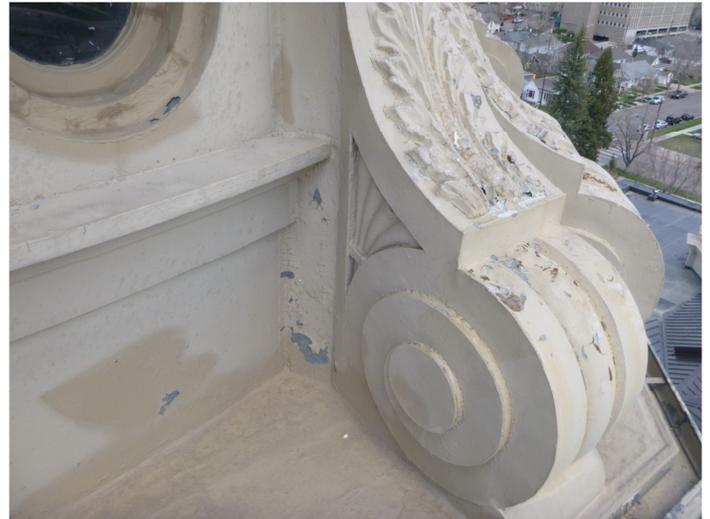
**388-101 SheetMetal\_Coating Coating Failed 2013-1**

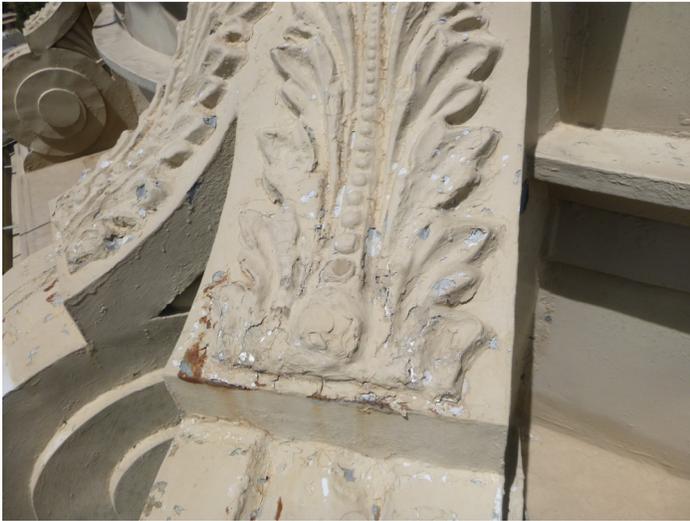
**388-101 SheetMetal\_Coating Coating Failed 2013-2**

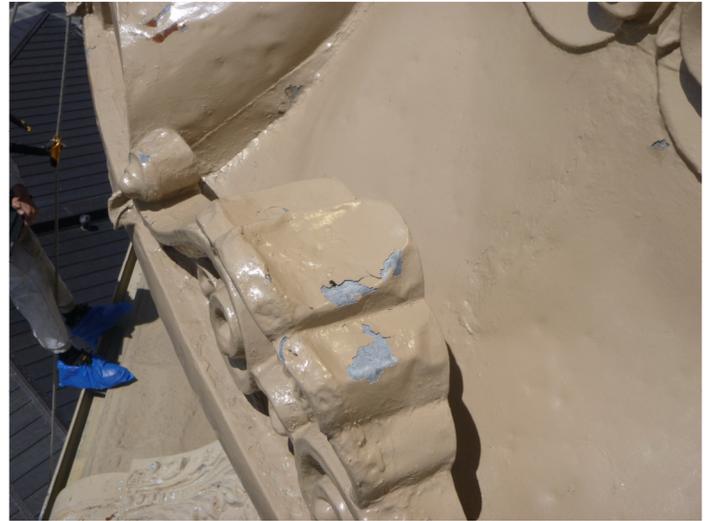
**389-99 SheetMetal\_Damaged Torn 2013-1**

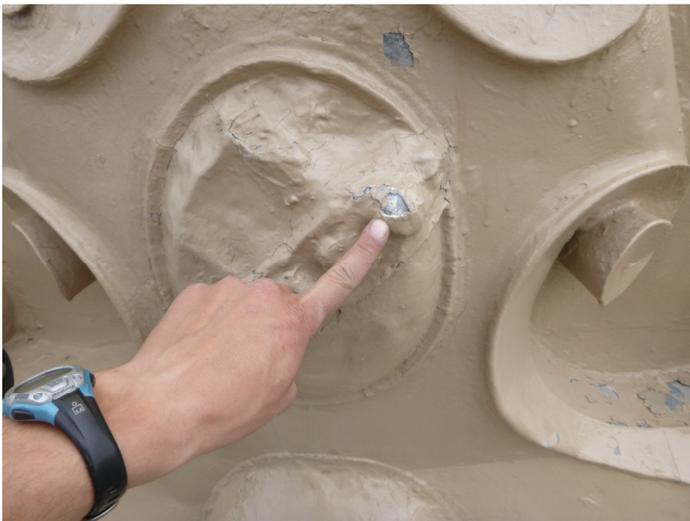
**389-104 SheetMetal\_Damaged Dented 2013-1**

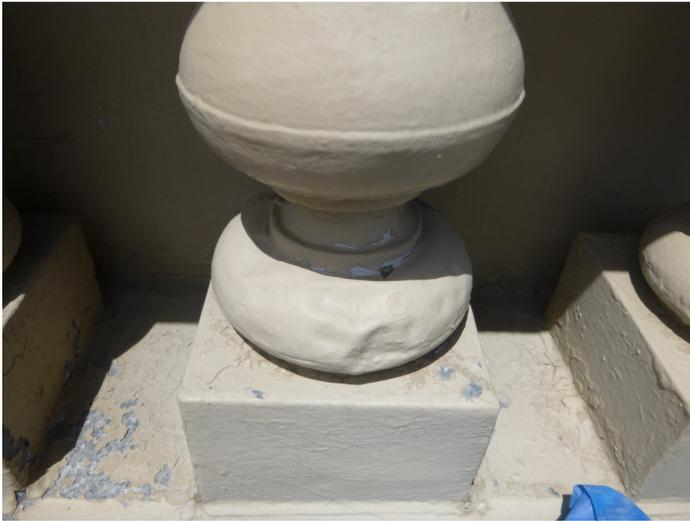
**389-121 SheetMetal\_Damaged Torn 2013-1**

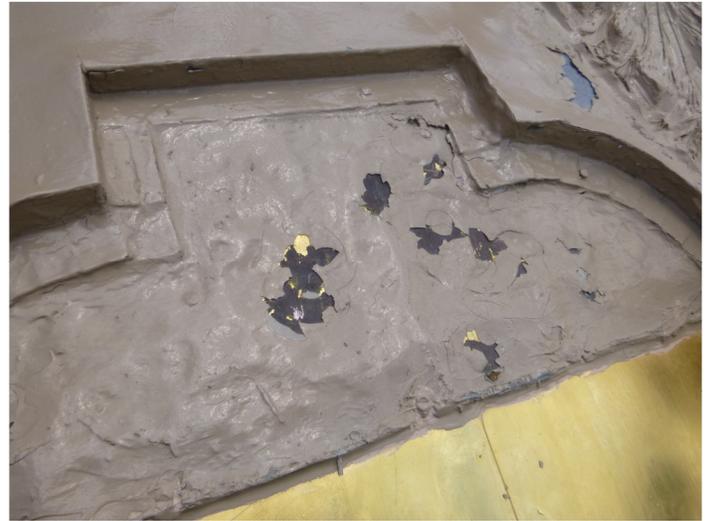
**390-70 SheetMetal\_Damaged Torn 2013-1**

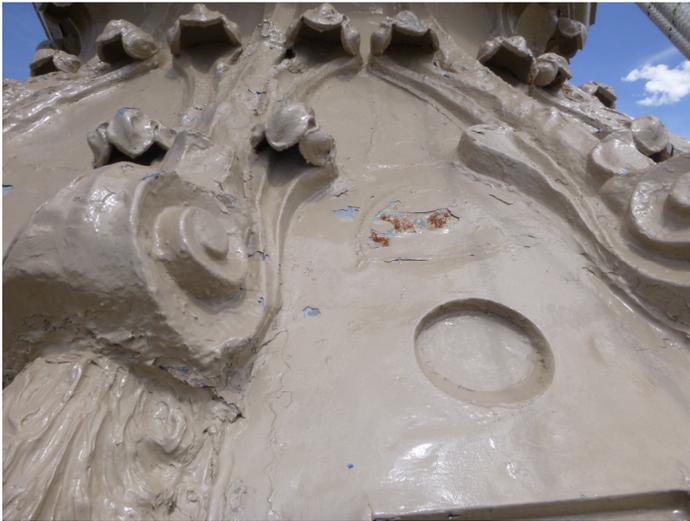
**390-118 SheetMetal\_Corrosion Surface 2013-1**

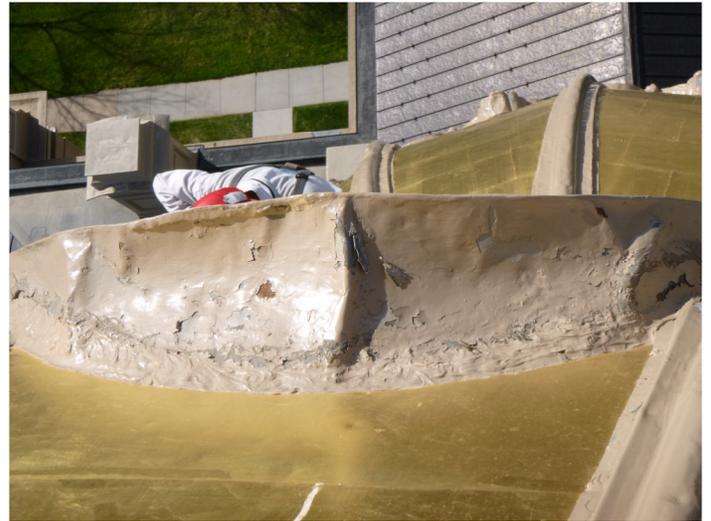
**390-121 SheetMetal\_Corrosion Surface 2013-1**

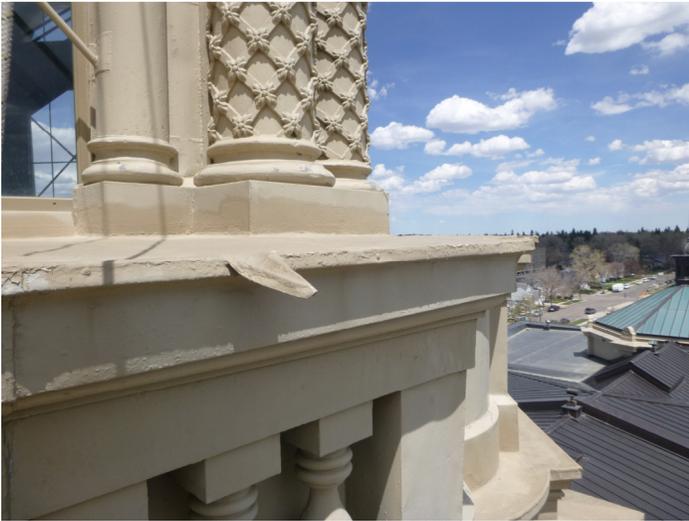
**390-130 SheetMetal\_Corrosion Surface 2013-1**

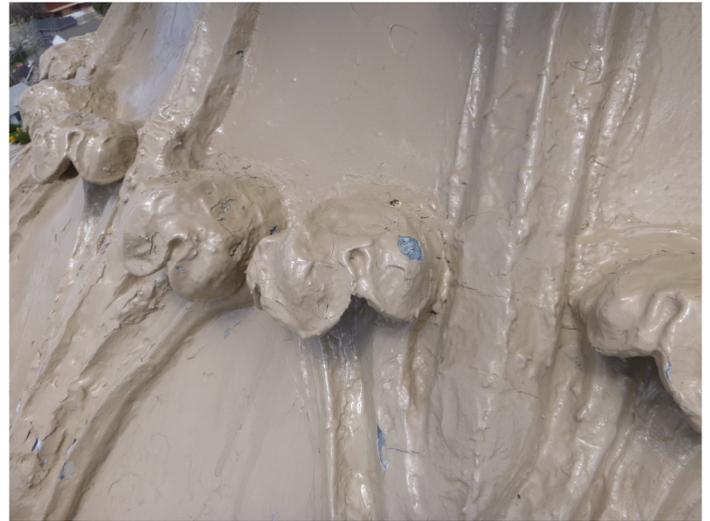
**391-106 SheetMetal\_Damaged Torn 2013-1**

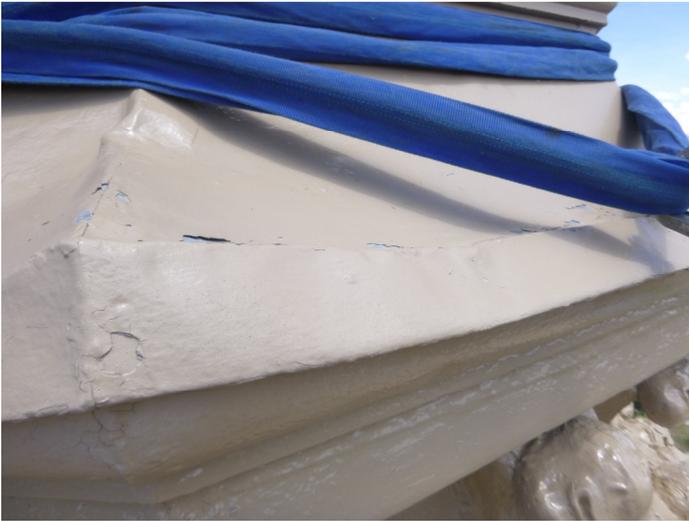
**391-122 SheetMetal\_Damaged Punctured 2013-1**

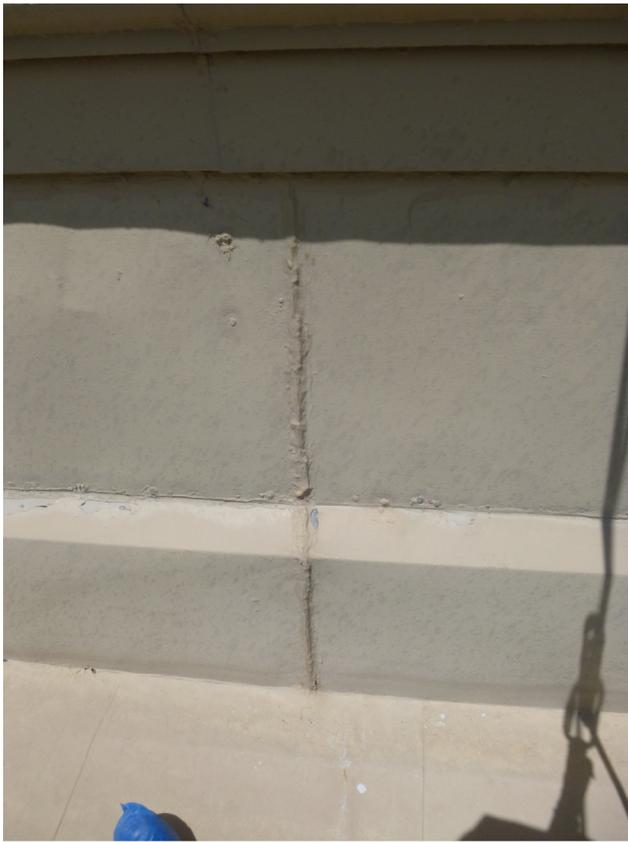
**392-89 SheetMetal\_Seam Sealant Failed 2013-1**

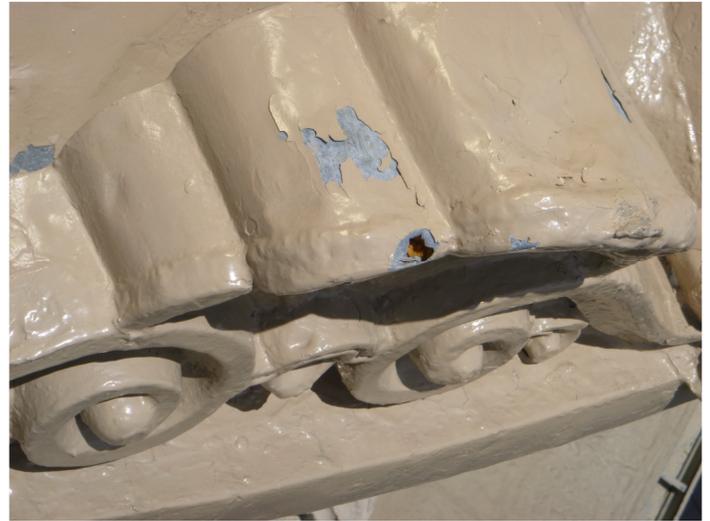
**392-93 SheetMetal\_Seam Sealant Failed 2013-1**

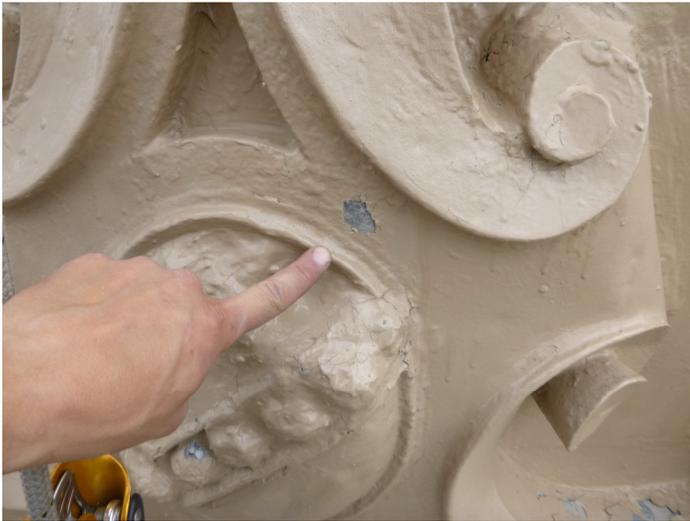
**392-104 SheetMetal\_Damaged Punctured 2013-1**

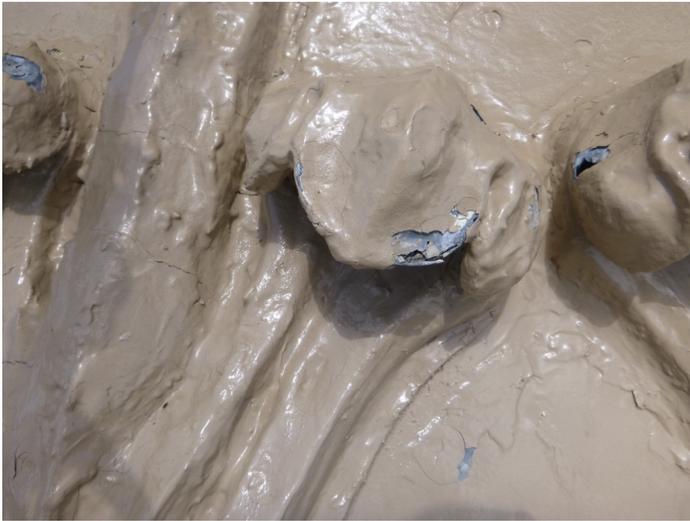
**392-118 SheetMetal\_Damaged Torn 2013-1**

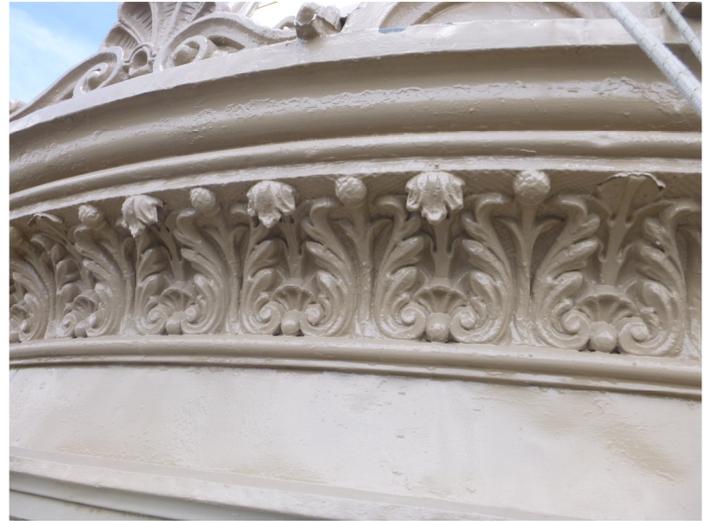
**392-121 SheetMetal\_Damaged Torn 2013-1**

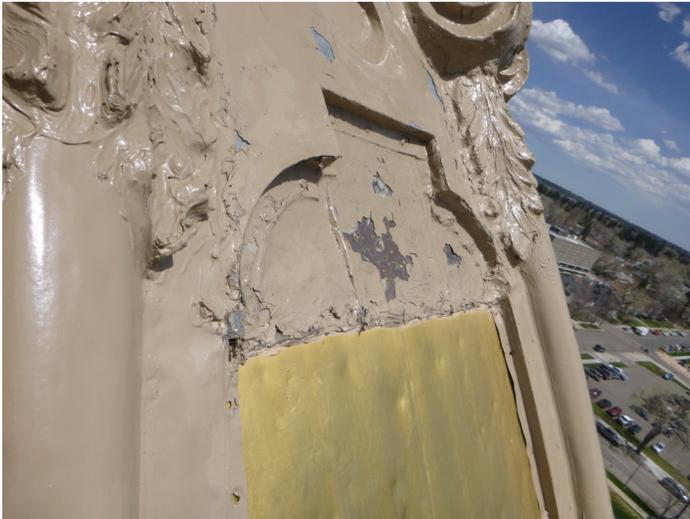
**393-107 SheetMetal\_Corrosion Surface 2013-1**

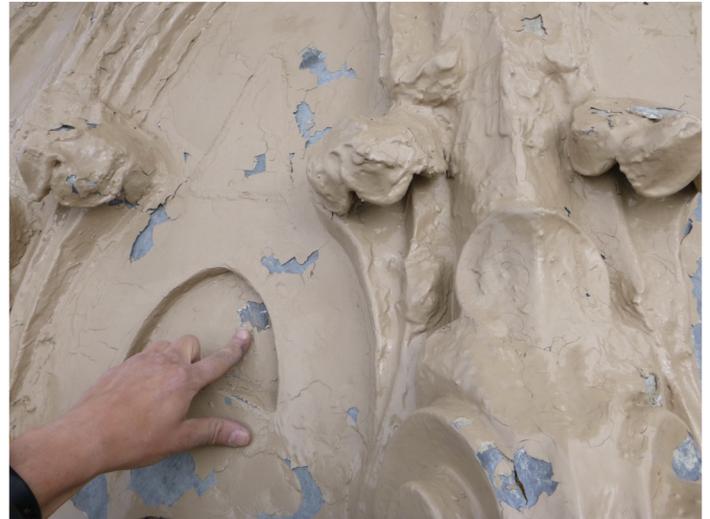
**393-118 SheetMetal\_Corrosion Surface 2013-1**

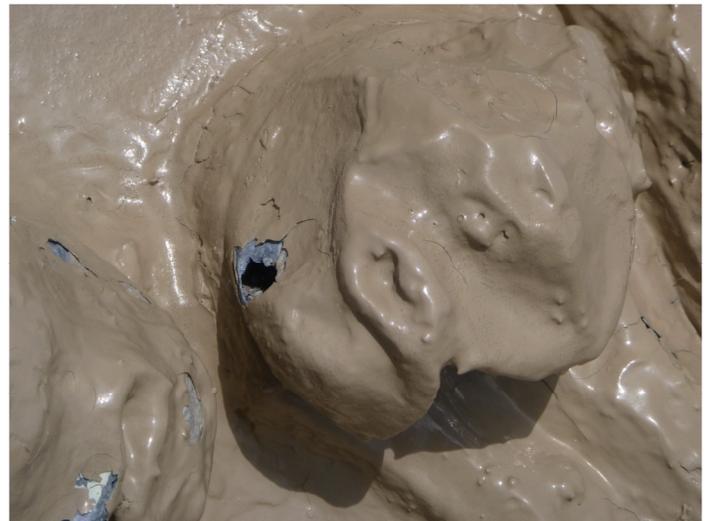
**393-120 SheetMetal\_Damaged Punctured 2013-1**

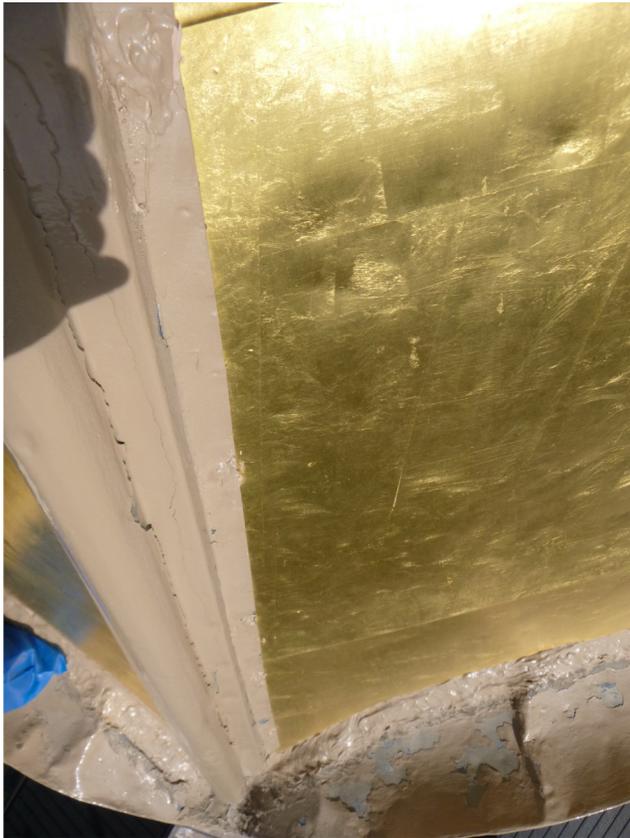
393-132 SheetMetal\_Coating Coating Failed 2013-2

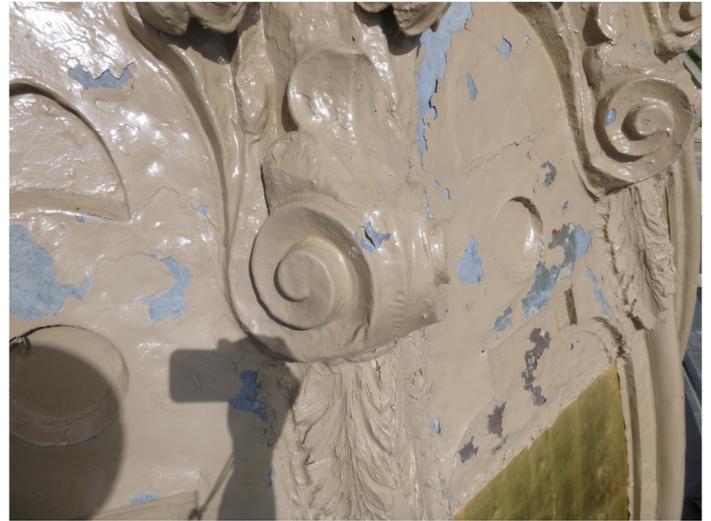
**394-114 SheetMetal\_Damaged Torn 2013-1**

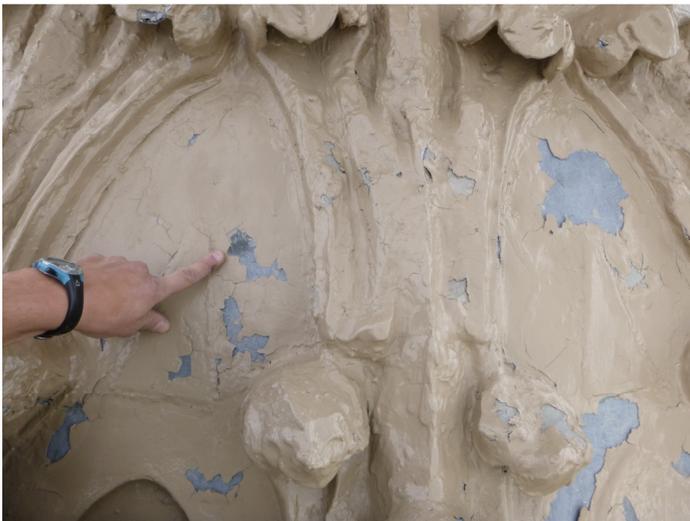
**394-120 SheetMetal\_Damaged Torn 2013-1**

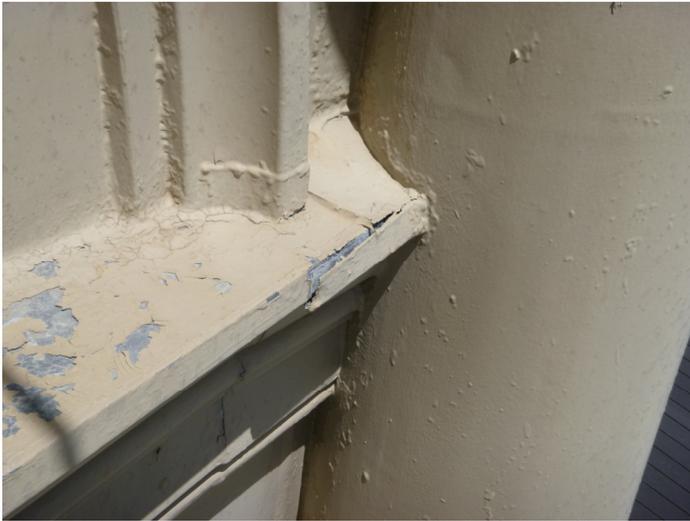
**395-74 SheetMetal\_Damaged Dented 2013-1**

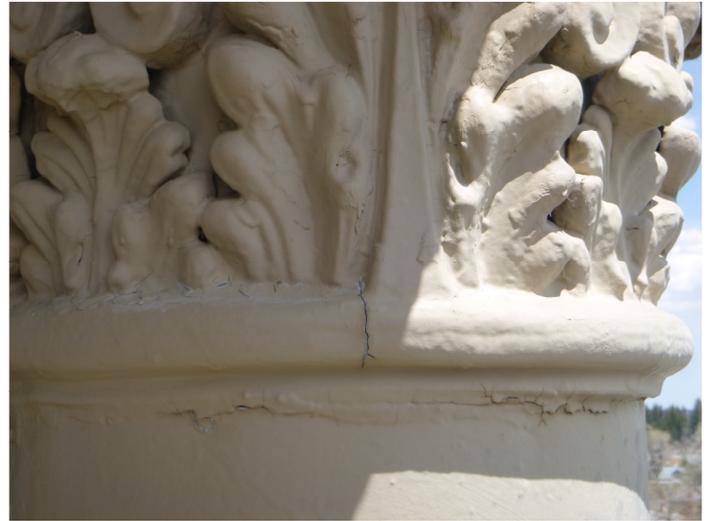
**395-84 SheetMetal\_Unsecured Loose 2013-1**

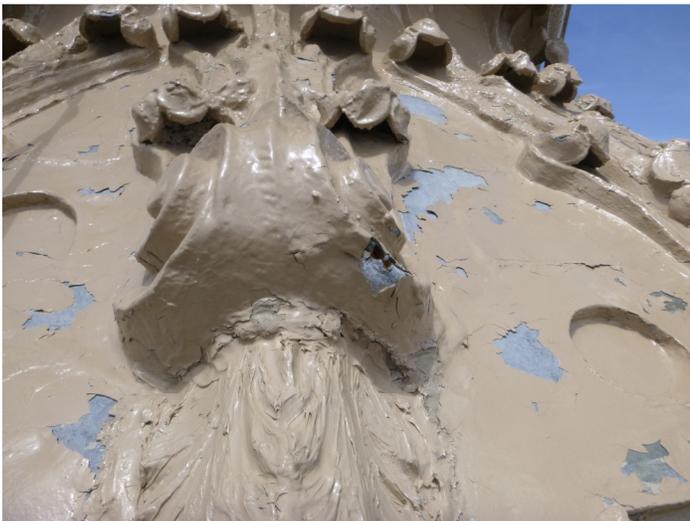
**395-86 SheetMetal\_Damaged Torn 2013-1**

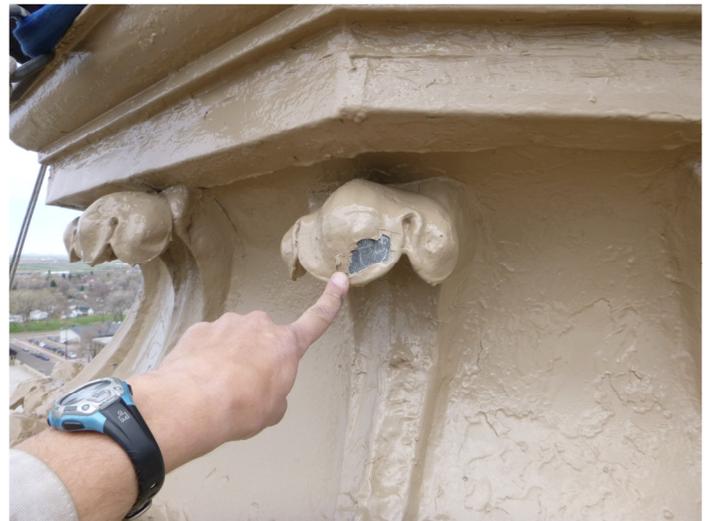
**395-119 SheetMetal\_Damaged Torn 2013-1**

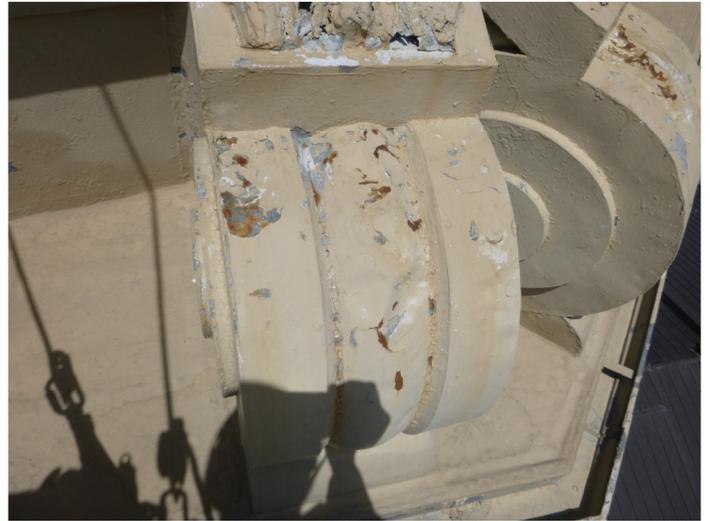
**396-105 SheetMetal\_Corrosion Surface 2013-1**

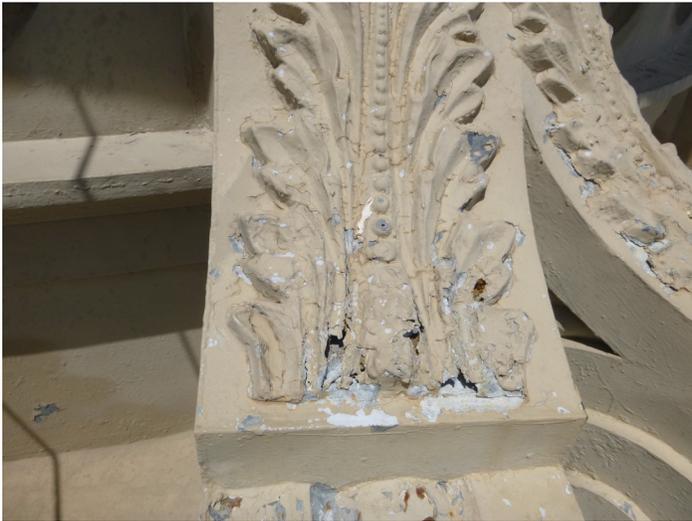
**397-97 SheetMetal\_Corrosion Surface 2013-1**

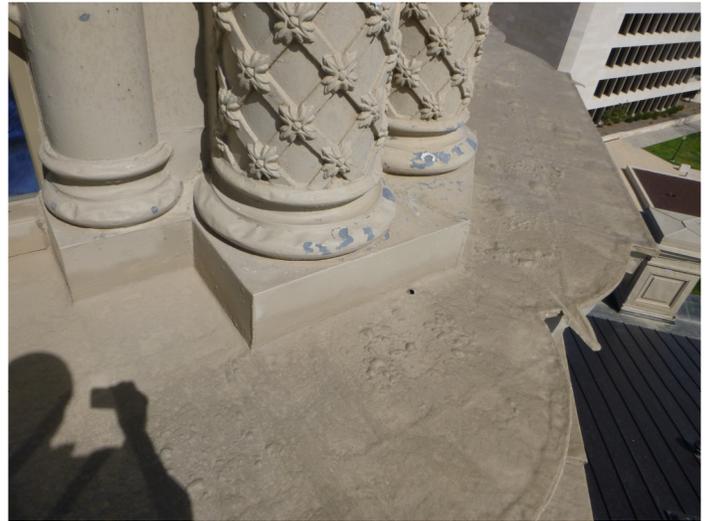
**397-99 SheetMetal\_Damaged Torn 2013-1**

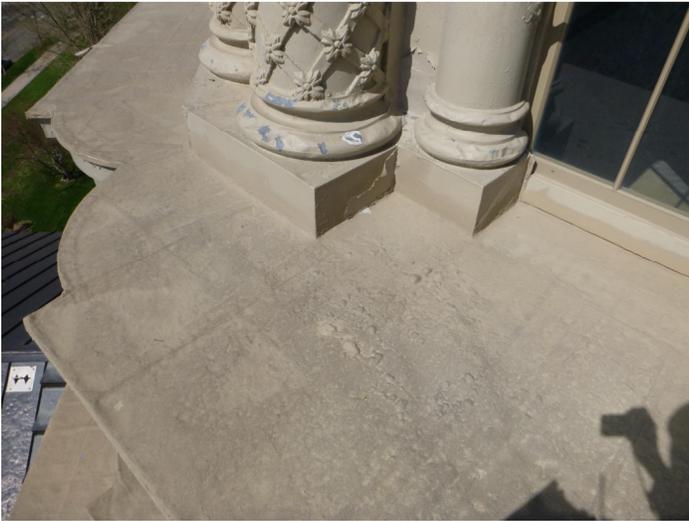
**455-78 SheetMetal\_Coating Coating Failed 2013-1**

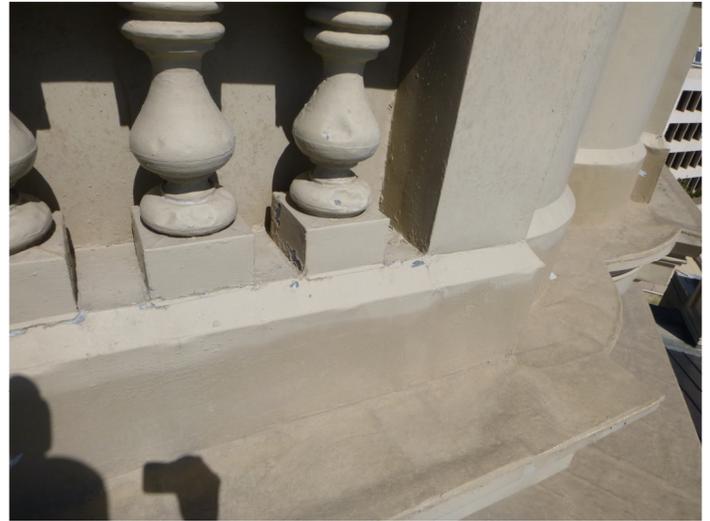
**455-78 SheetMetal\_Coating Coating Failed 2013-2**

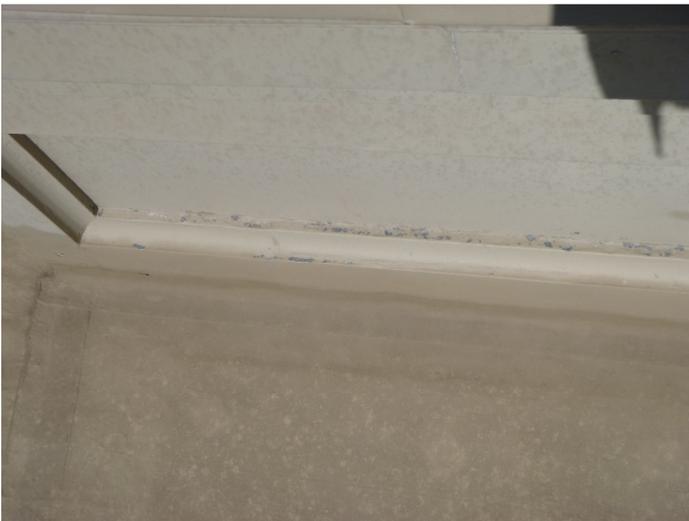
**456-69 SheetMetal\_Coating Coating Failed 2013-1**

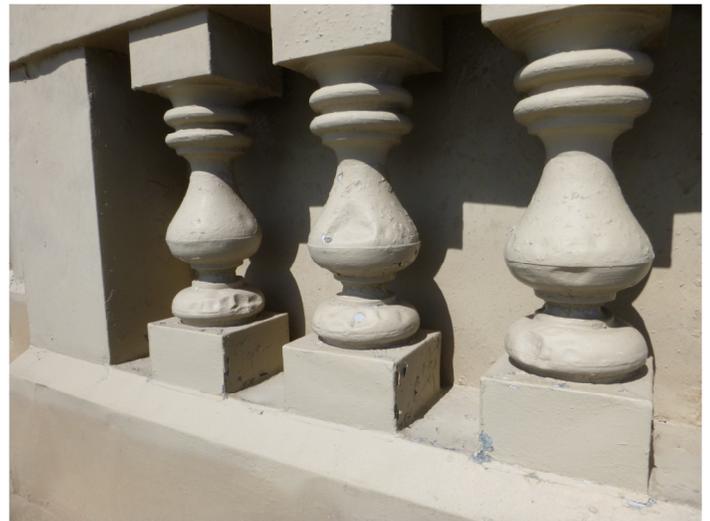
**456-69 SheetMetal\_Coating Coating Failed 2013-2**

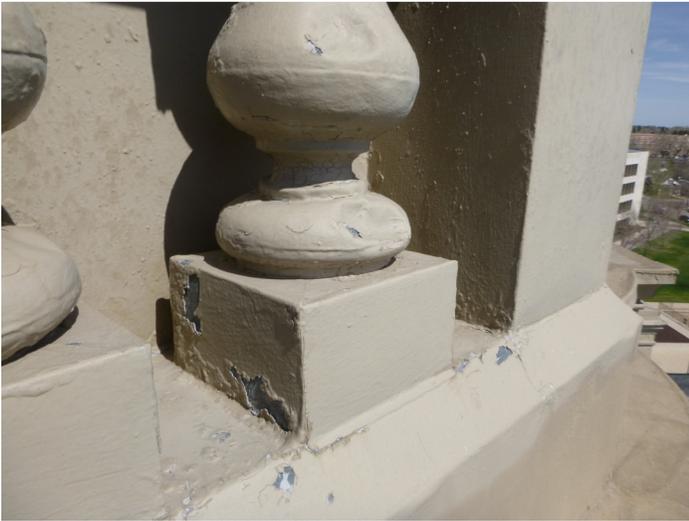
**456-73 SheetMetal\_Damaged Dented 2013-1**

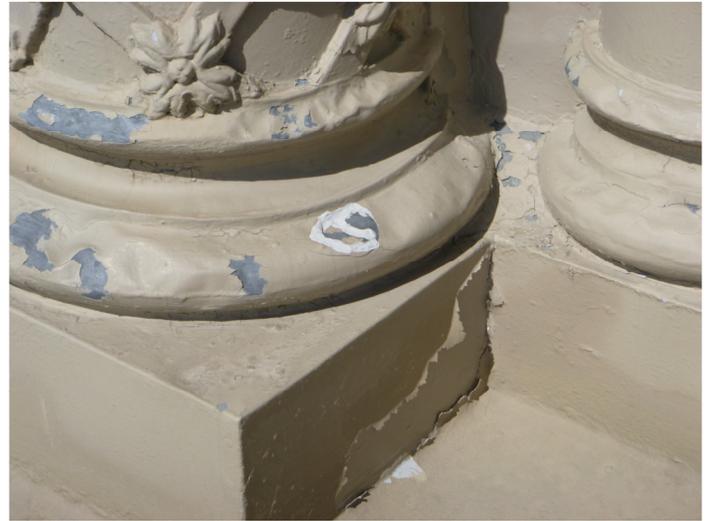
**456-73 SheetMetal\_Damaged Dented 2013-2**

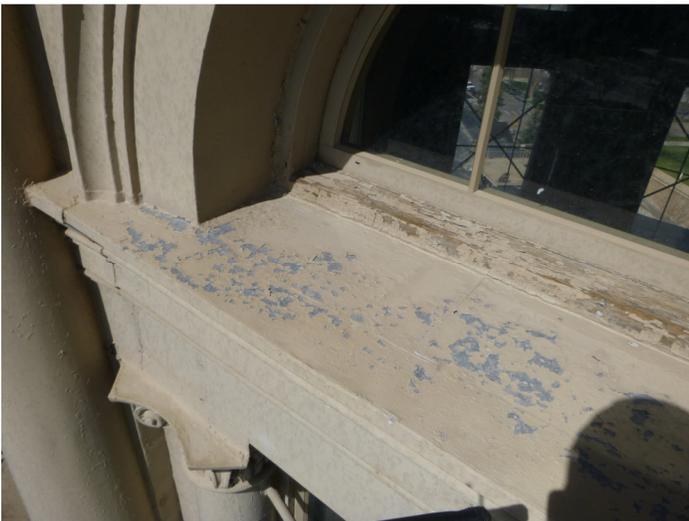
**456-75 SheetMetal\_Repair Patch Failed 2013-1**

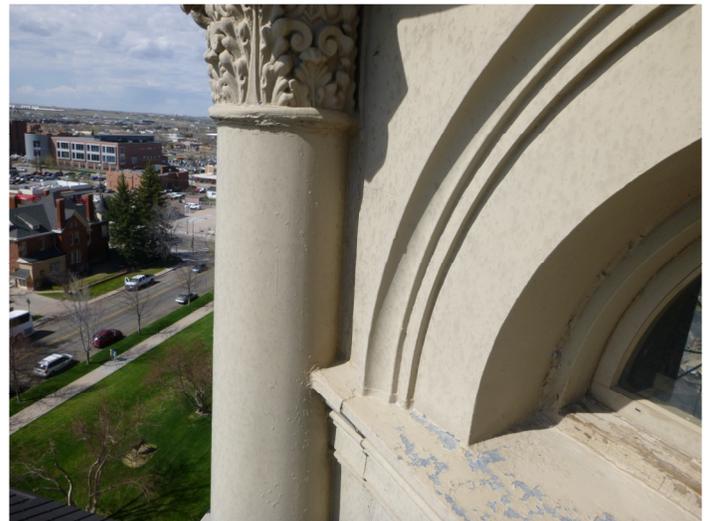
**456-85 SheetMetal\_Coating Coating Failed 2013-1**

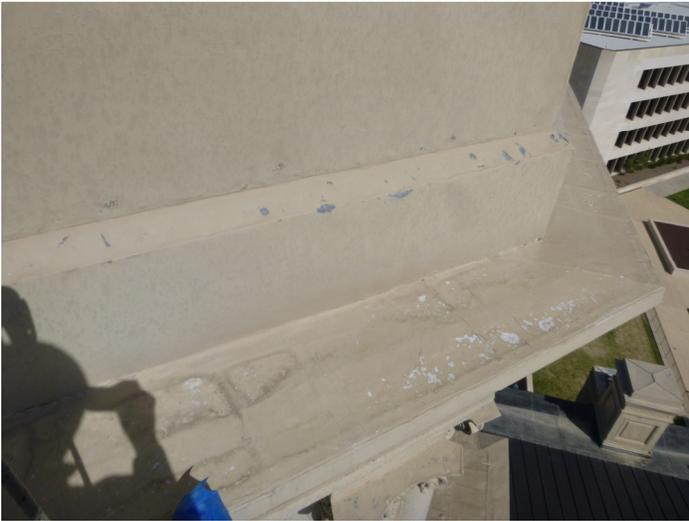
**456-85 SheetMetal\_Coating Coating Failed 2013-2**

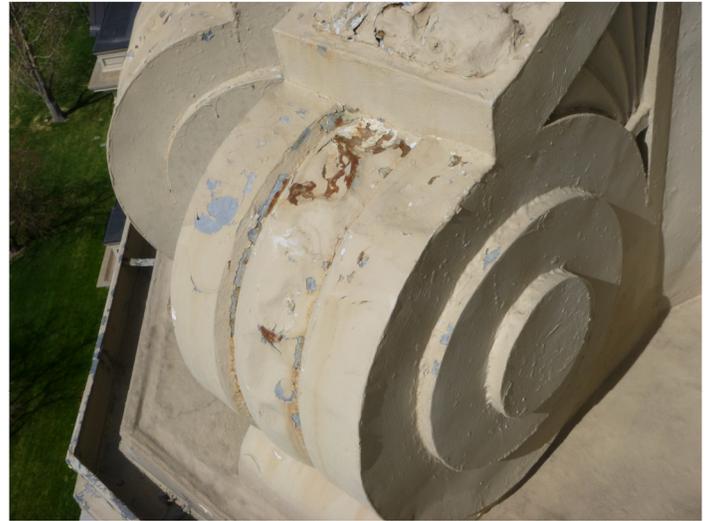
**456-93 SheetMetal\_Coating Coating Failed 2013-1**

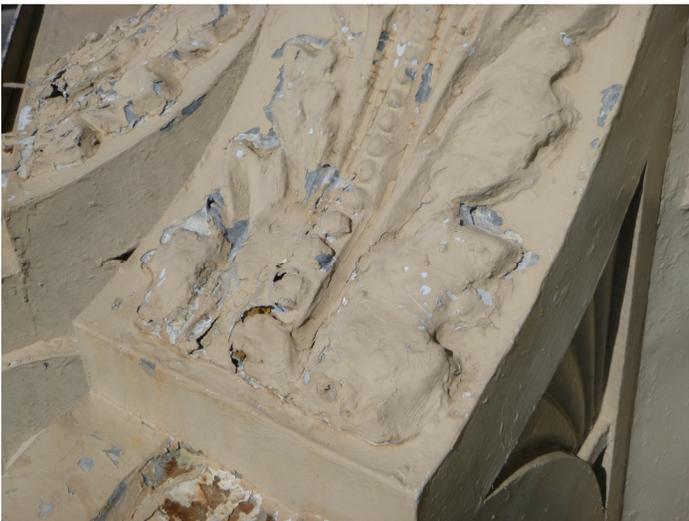
**456-97 SheetMetal\_Corrosion Surface 2013-1**

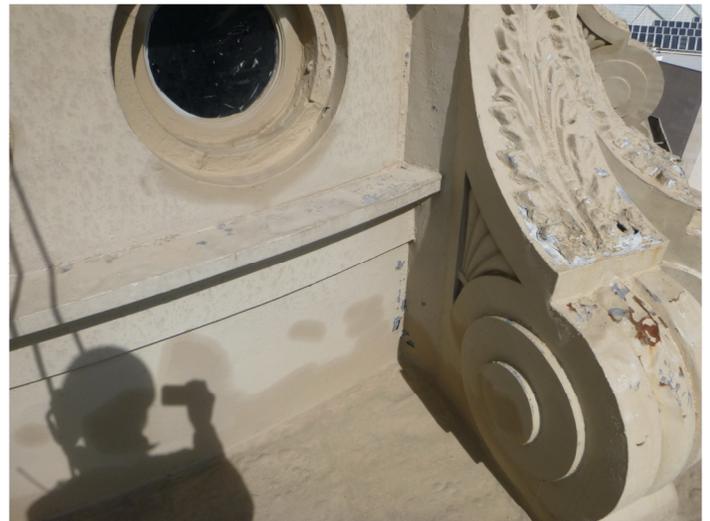
**456-99 SheetMetal\_Damaged Torn 2013-1**

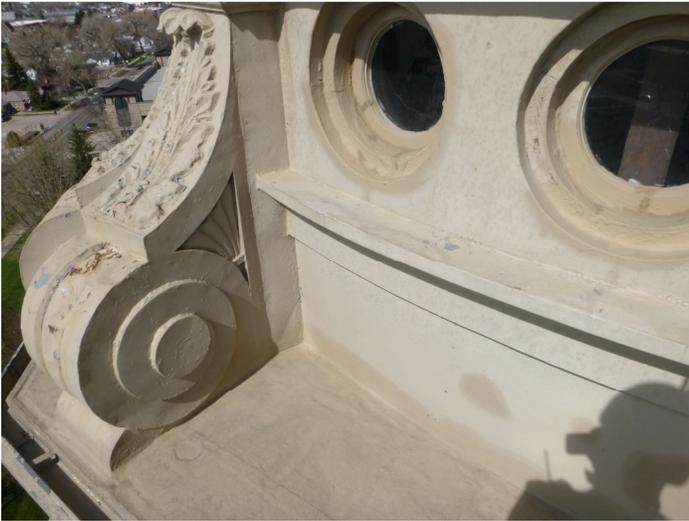
**456-100 SheetMetal\_Coating Coating Failed 2013-1**

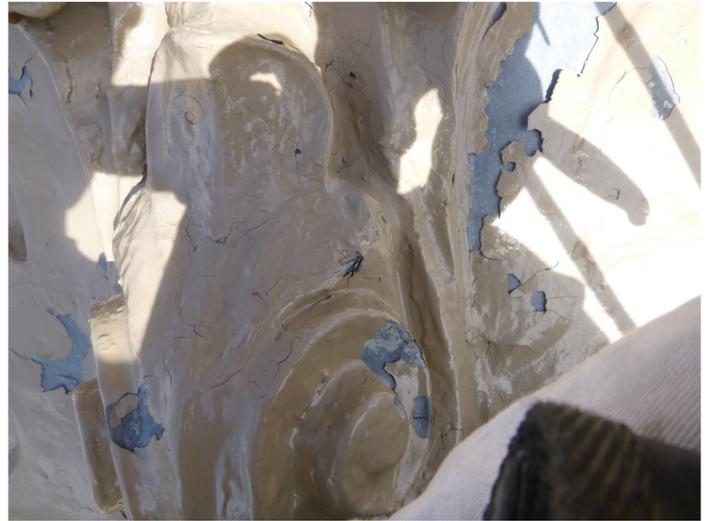
**456-100 SheetMetal\_Coating Coating Failed 2013-2**

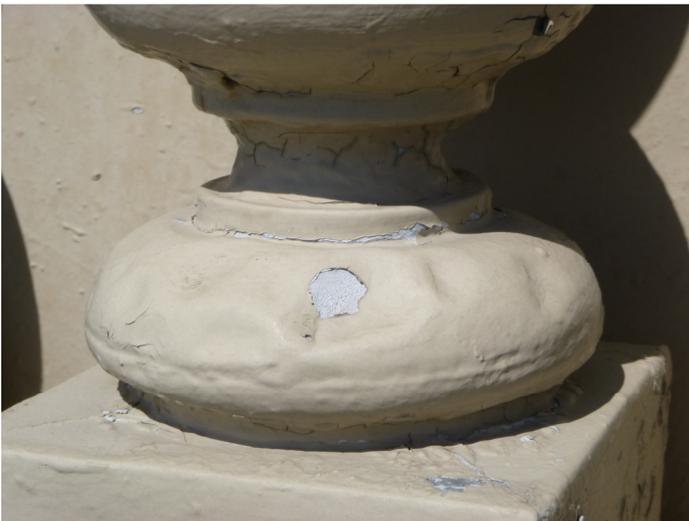
**456-120 SheetMetal\_Damaged Torn 2013-1**

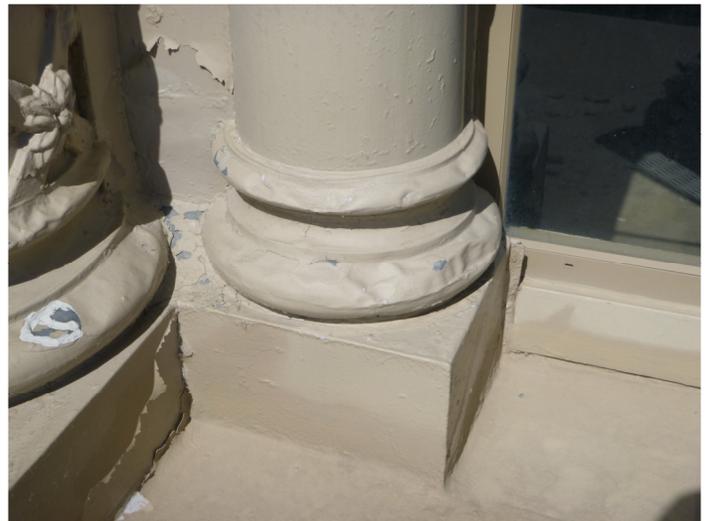
**457-70 SheetMetal\_Damaged Torn 2013-1**

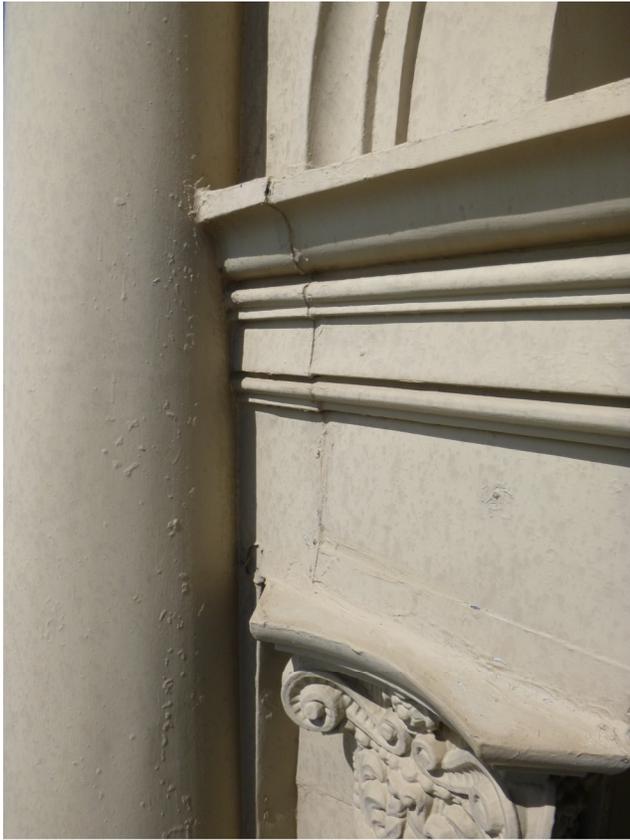
**457-75 SheetMetal\_Damaged Dented 2013-1**

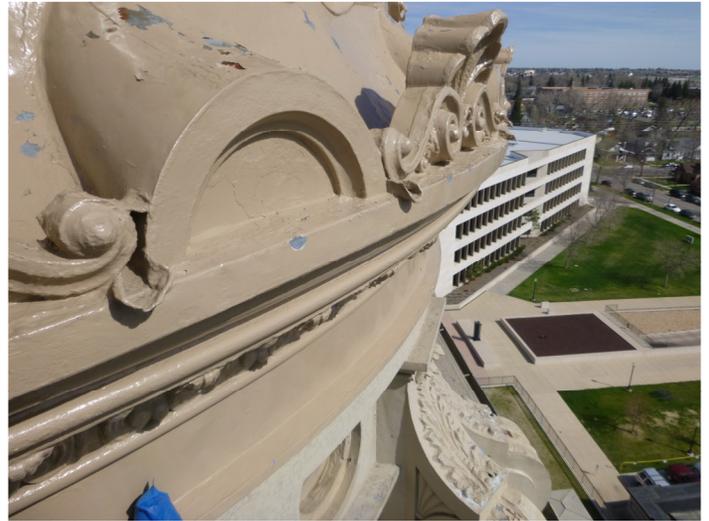
**457-82 SheetMetal\_Seam Sealant Failed 2013-1**

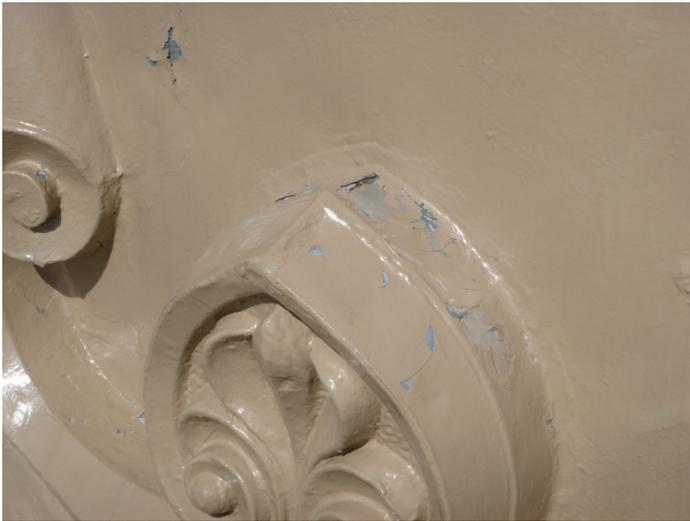
**457-103 SheetMetal\_Note Photo-scuppers 2013-1**

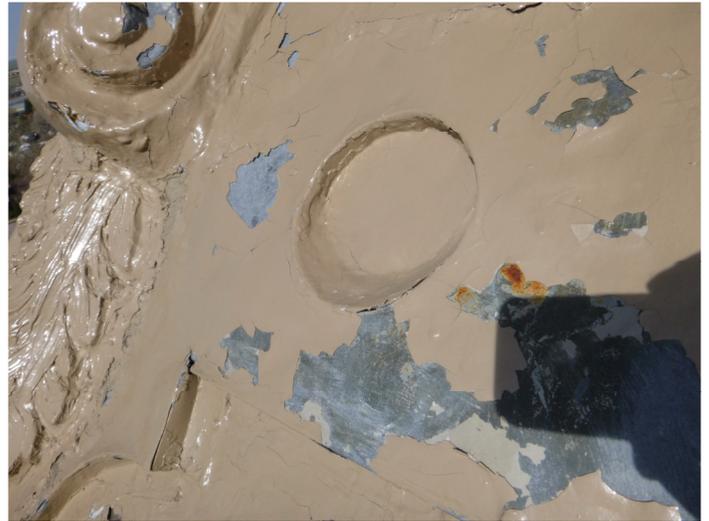
**457-107 SheetMetal\_Damaged Torn 2013-1**

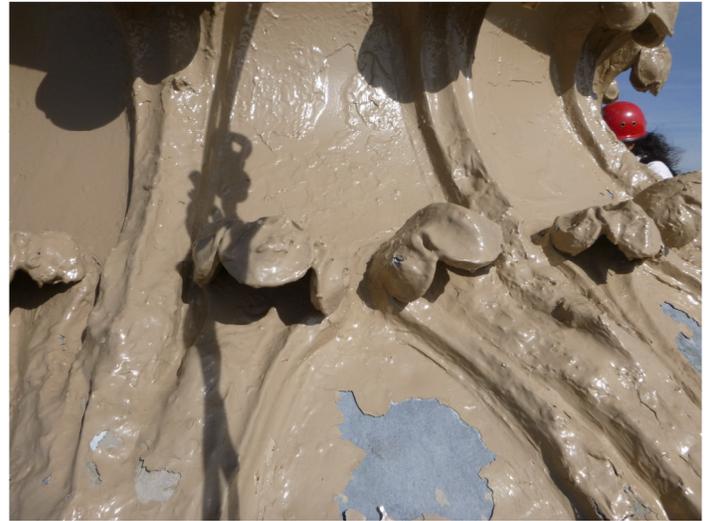
**457-121 SheetMetal\_Damaged Torn 2013-1**

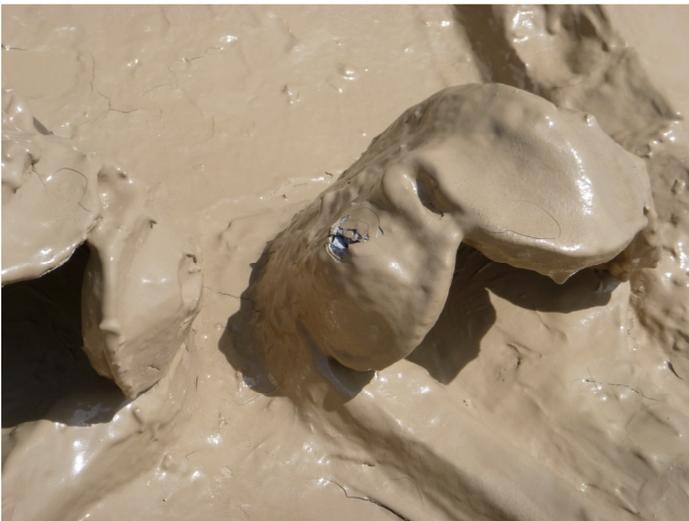
**458-122 SheetMetal\_Damaged Punctured 2013-1**

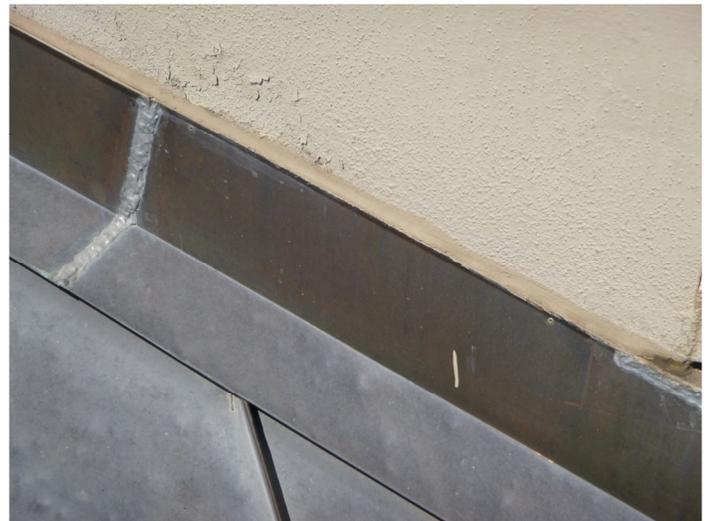
**458-122 SheetMetal\_Damaged Punctured 2013-2**

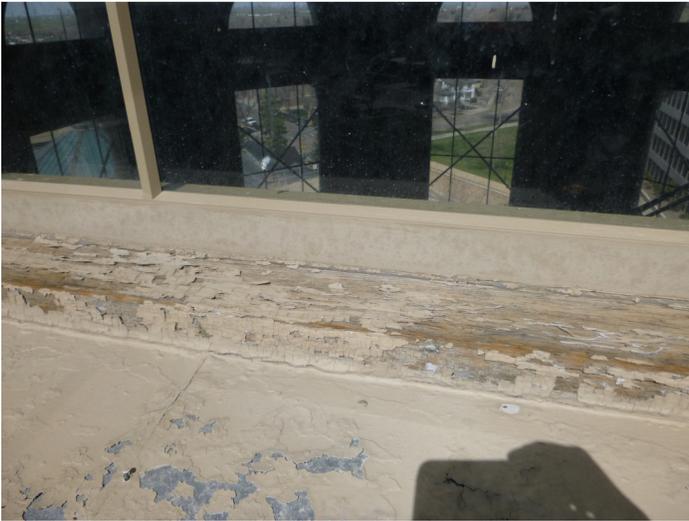
**459-54 SheetMetal\_Seam Sealant Failed 2013-1**
