# Report Narrative

## Wyoming State Capitol Dome Investigation Cheyenne, WY

Vertical Access LLC  
PO Box 4135, Ithaca, NY 14852  
Tel: 607 257 4049 / Fax: 607 257 2129

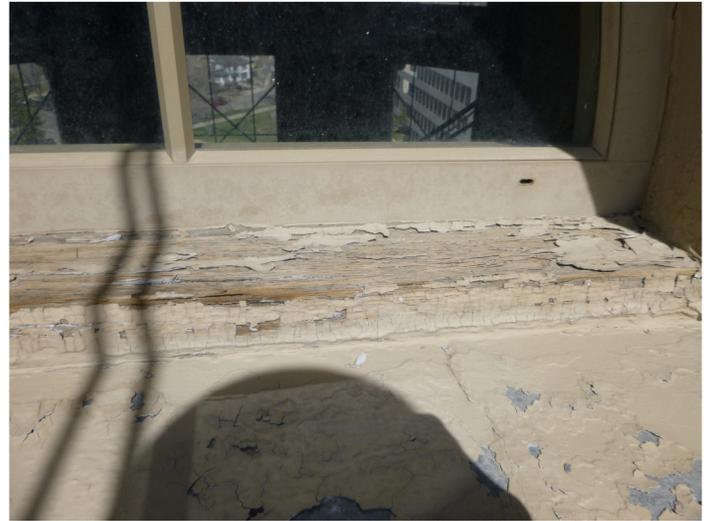
**459-83 Wood\_Crack Checking 2013-1**

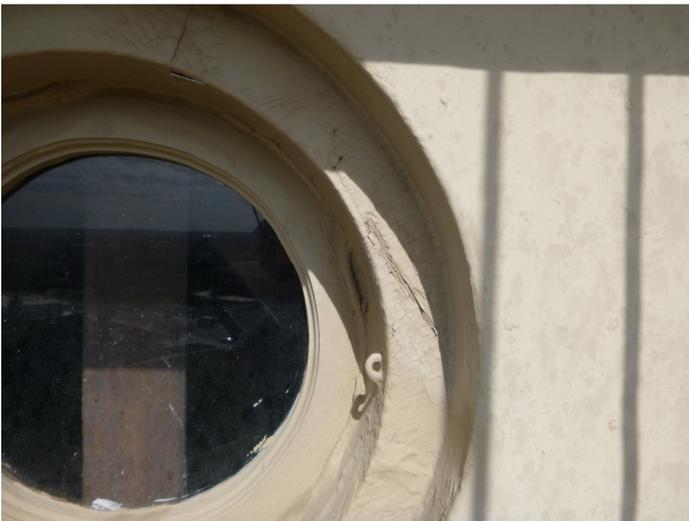
**459-83 Wood\_Crack Checking 2013-2**

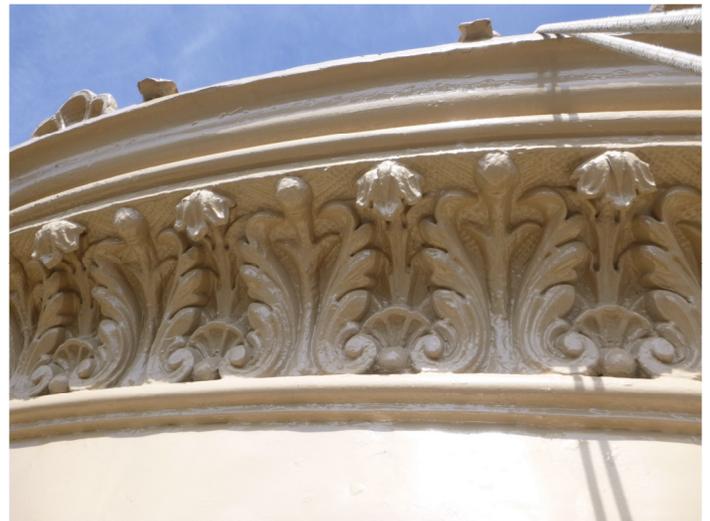
**459-99 Wood\_Crack Checking 2013-1**

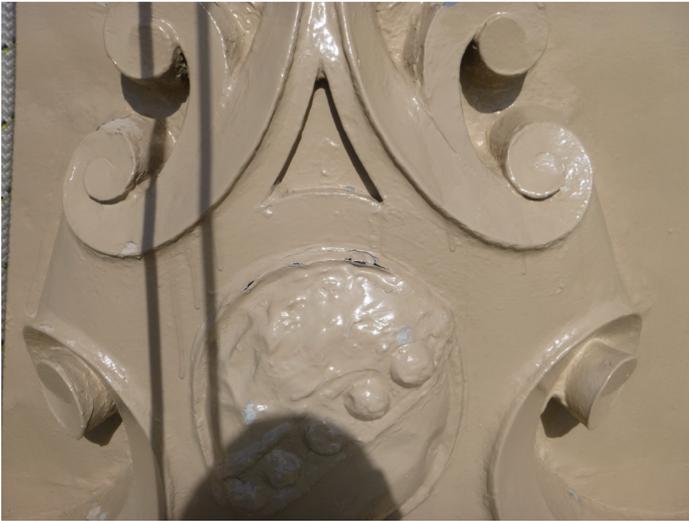
**459-102 SheetMetal\_Note Misc condition 2013-1**

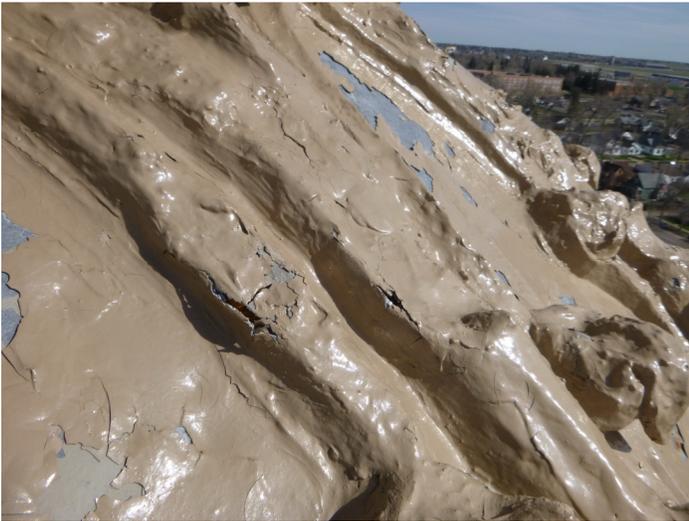
**459-116 SheetMetal\_Corrosion Surface 2013-1**

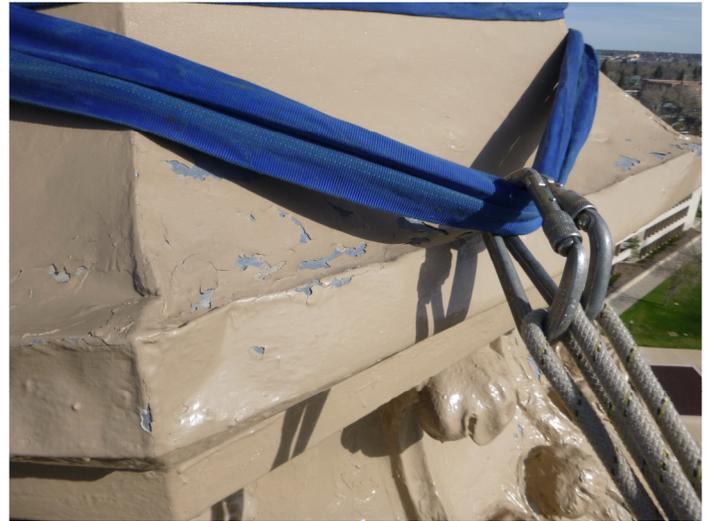
**459-121 SheetMetal\_Damaged Torn 2013-1**

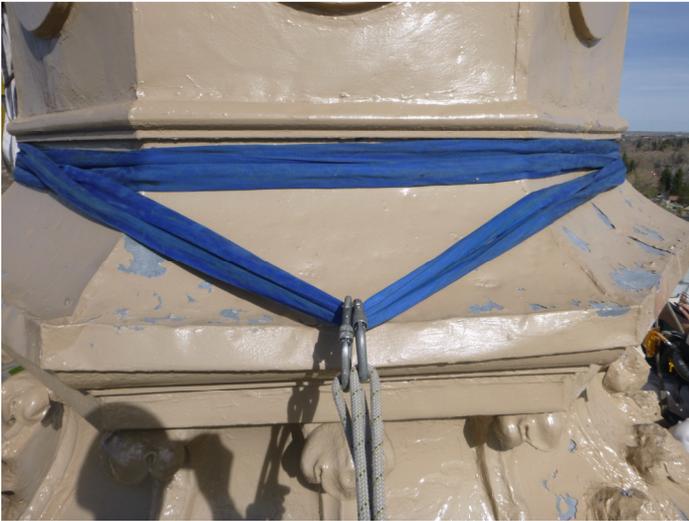
**459-123 SheetMetal\_Damaged Dented 2013-1**

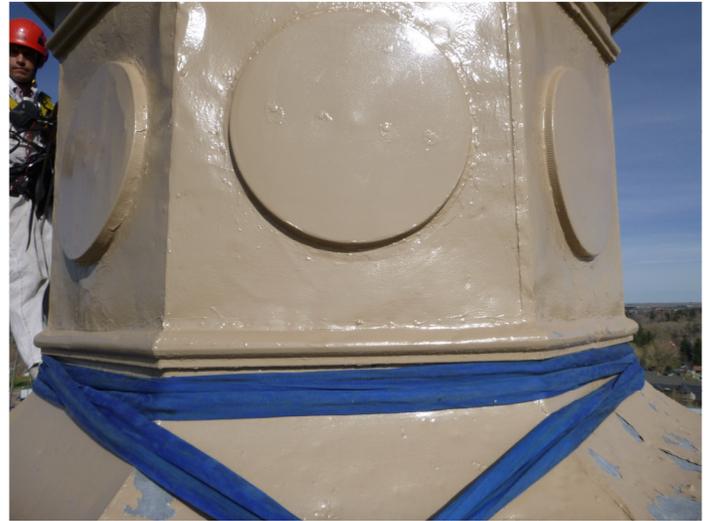
**459-125 SheetMetal\_Coating Coating Failed 2013-1**

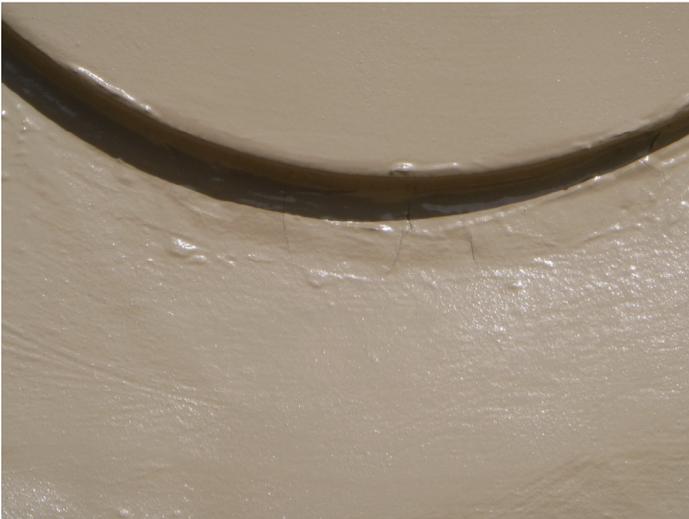
**459-125 SheetMetal\_Coating Coating Failed 2013-2**

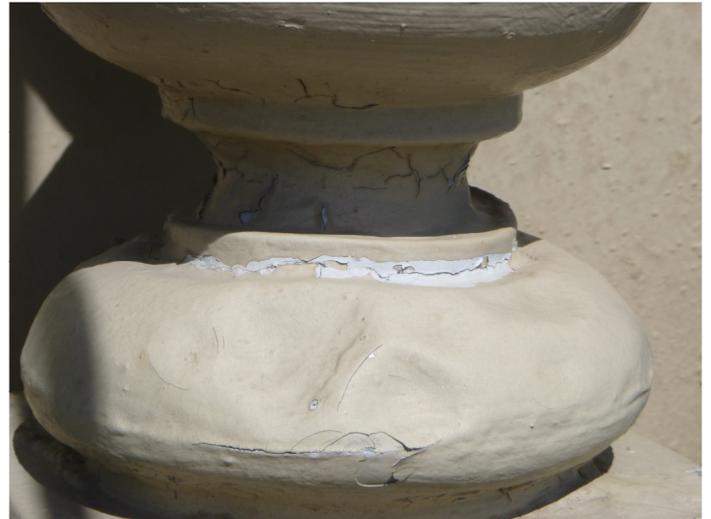
**459-125 SheetMetal\_Coating Coating Failed 2013-3**

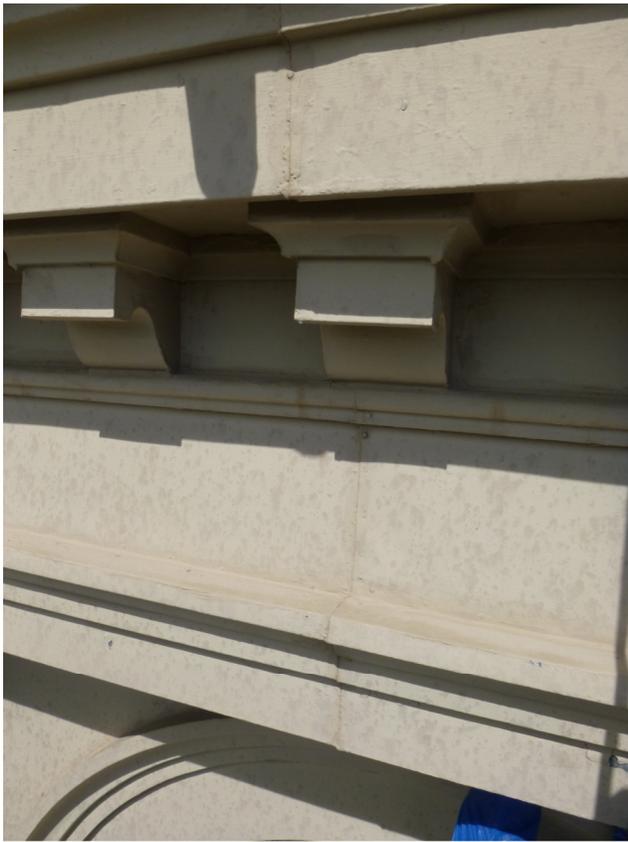
**460-70 SheetMetal\_Damaged Torn 2013-1**

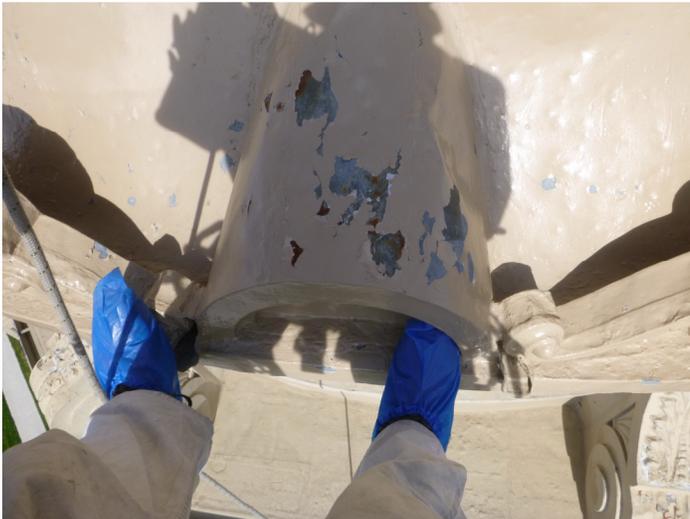
**460-93 SheetMetal\_Seam Folded Failed 2013-1**

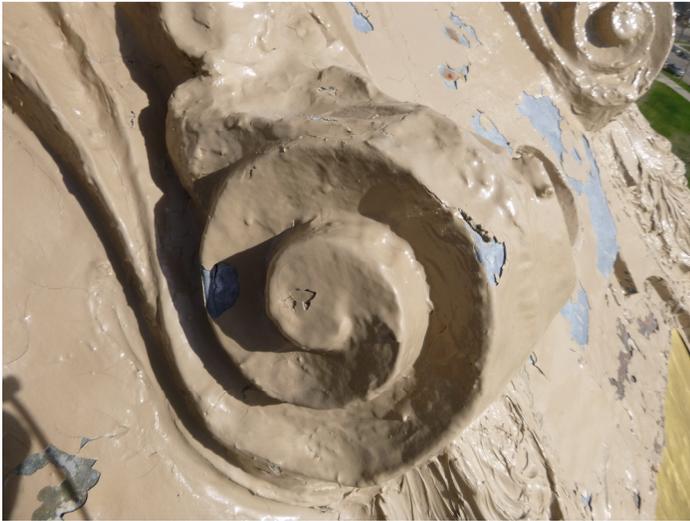
**460-114 SheetMetal\_Damaged Torn 2013-1**

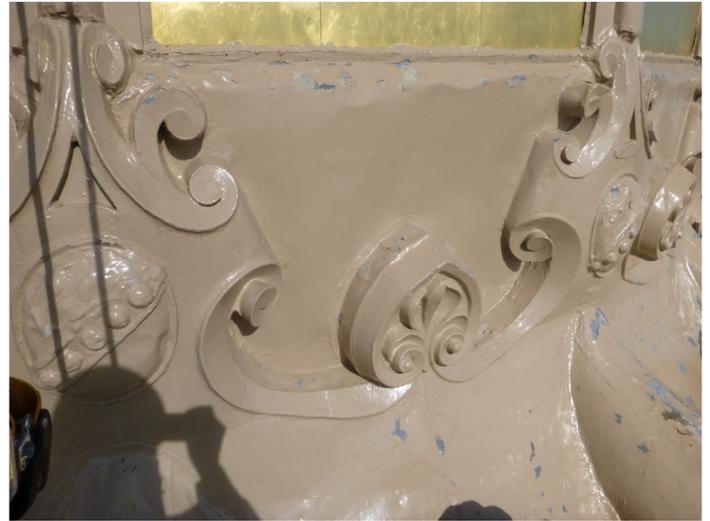
**460-120 SheetMetal\_Damaged Torn 2013-1**

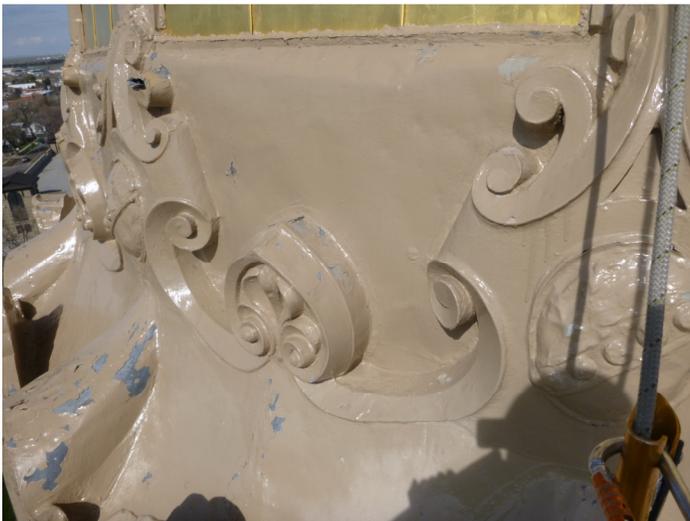
**461-108 SheetMetal\_Coating Coating Failed 2013-1**

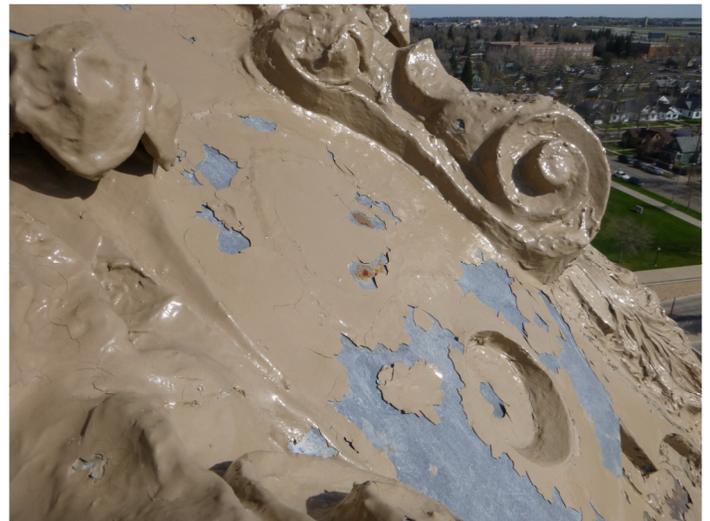
**461-108 SheetMetal\_Coating Coating Failed 2013-2**

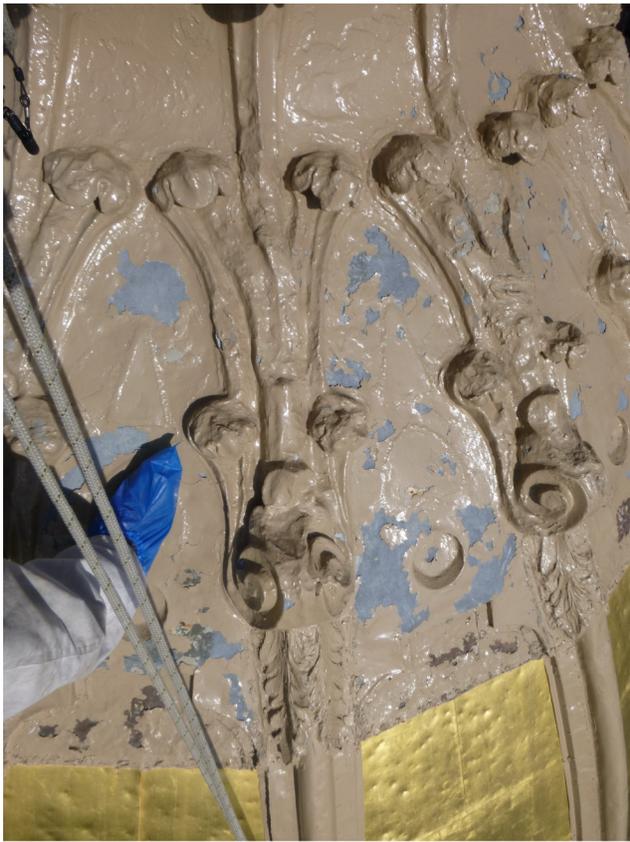
**461-121 SheetMetal\_Corrosion Surface 2013-1**

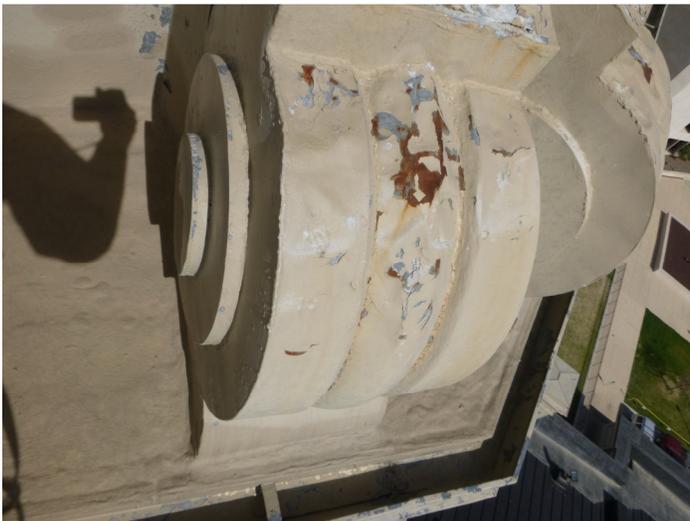
462-73 SheetMetal\_Note Photo-scupper 2013-1

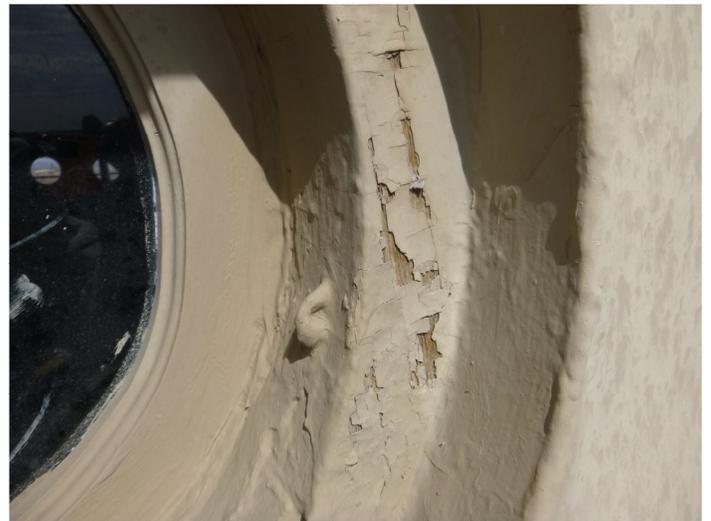
462-97 SheetMetal\_Corrosion Surface 2013-1

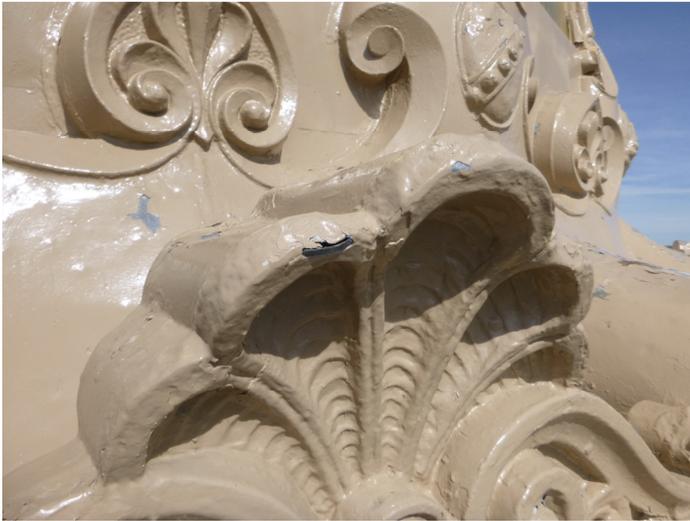
462-99 Wood\_Crack Checking 2013-1

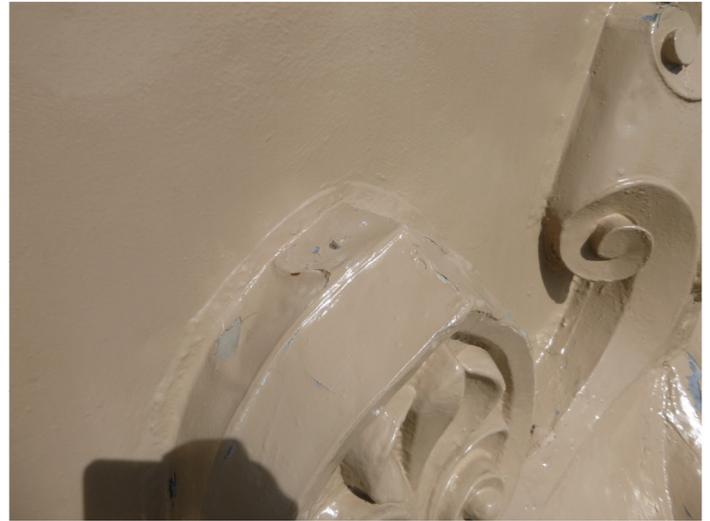
**462-104 SheetMetal\_Damaged Torn 2013-1**

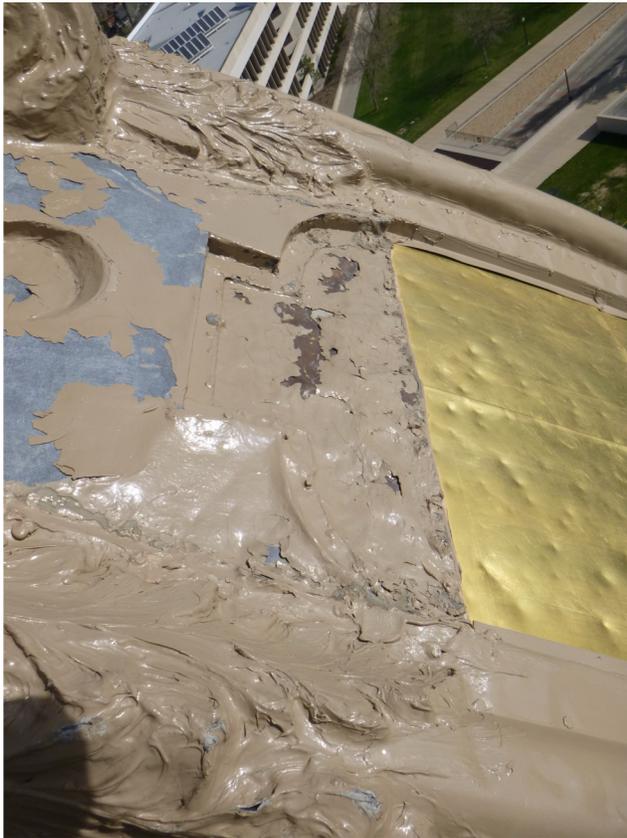
**462-107 SheetMetal\_Corrosion Surface 2013-1**

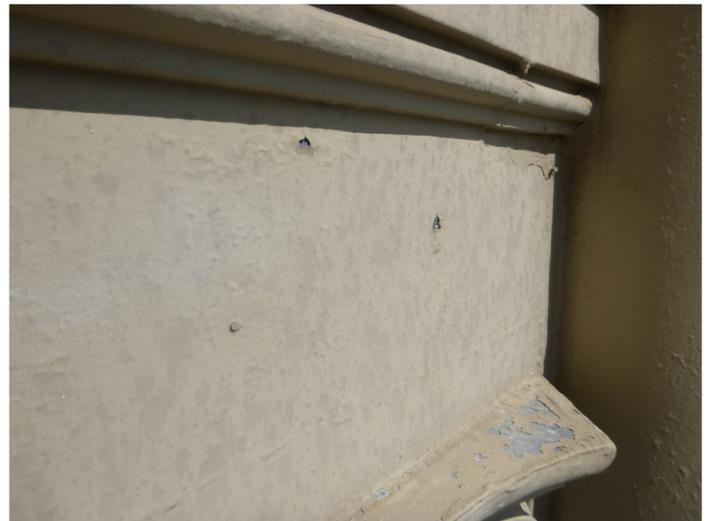
**462-119 SheetMetal\_Corrosion Surface 2013-1**

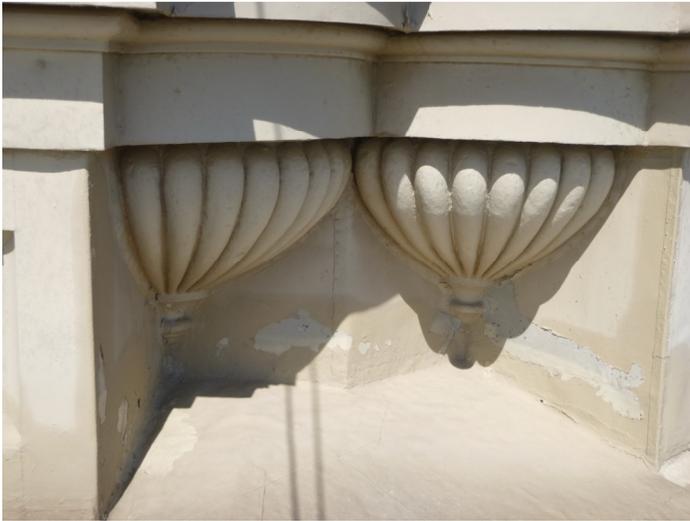
**463-83 SheetMetal\_Seam Fastener Failed 2013-1**

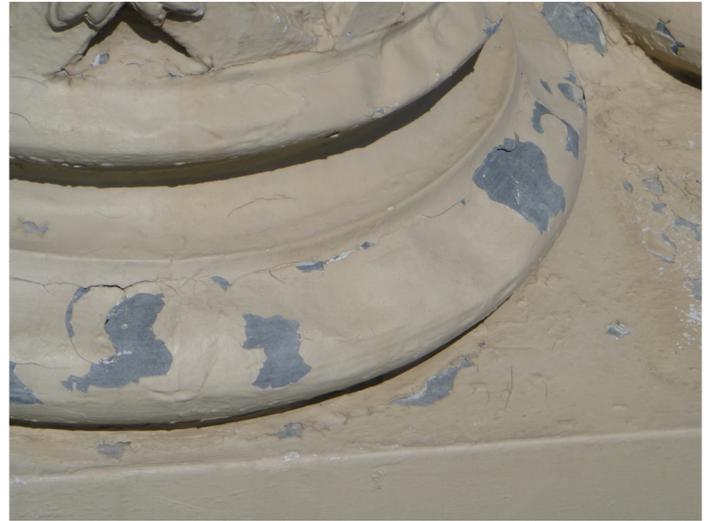
**464-66 SheetMetal\_Coating Coating Failed 2013-1**

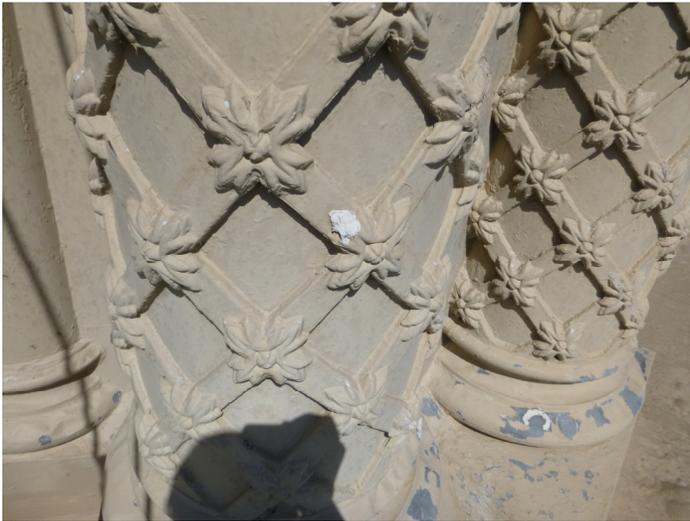
**464-74 SheetMetal\_Damaged Torn 2013-1**

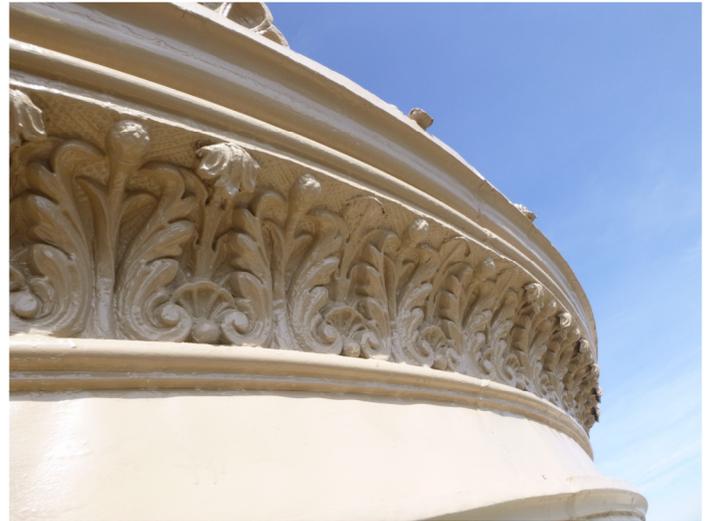
**464-77 SheetMetal\_Repair Patch Failed 2013-1**

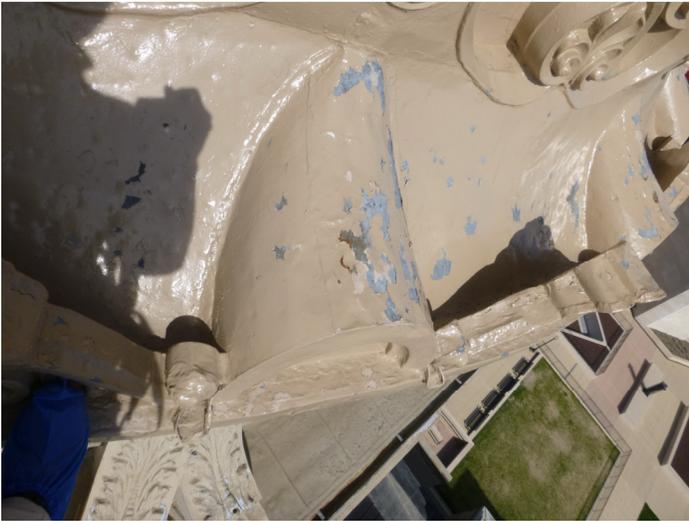
**464-102 SheetMetal\_Unsecured Missing 2013-1**

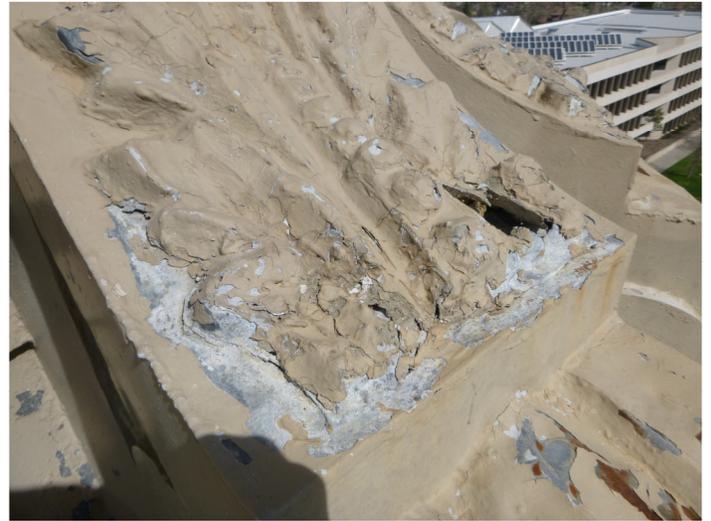
**464-105 SheetMetal\_Corrosion Surface 2013-1**

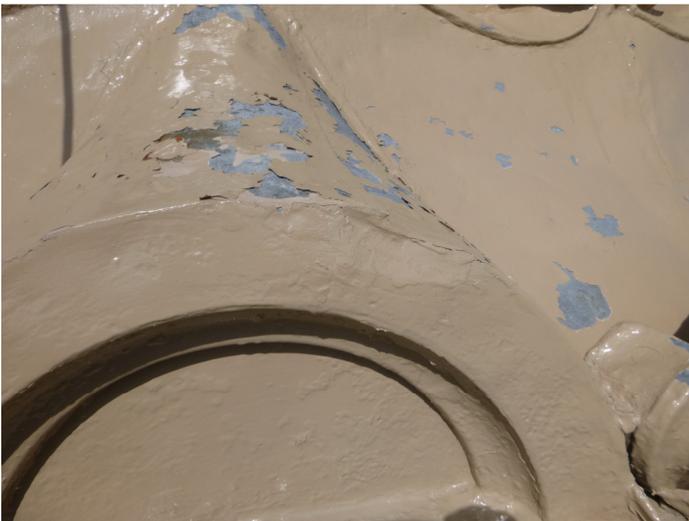
**465-98 SheetMetal\_Damaged Torn 2013-1**

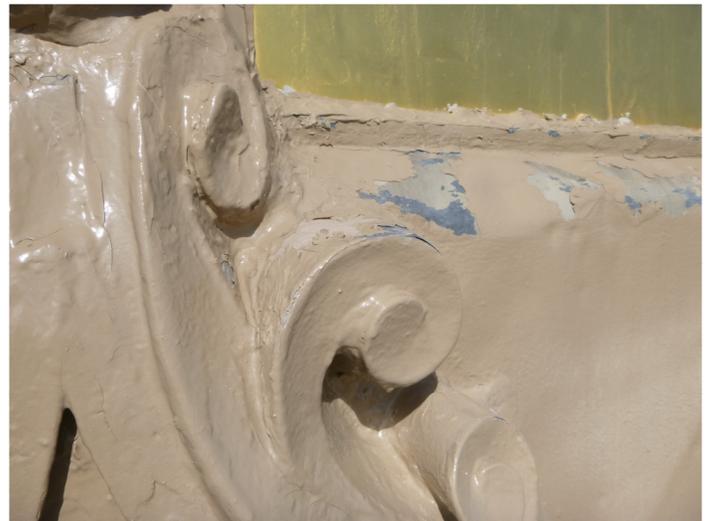
**465-104 SheetMetal\_Damaged Torn 2013-1**

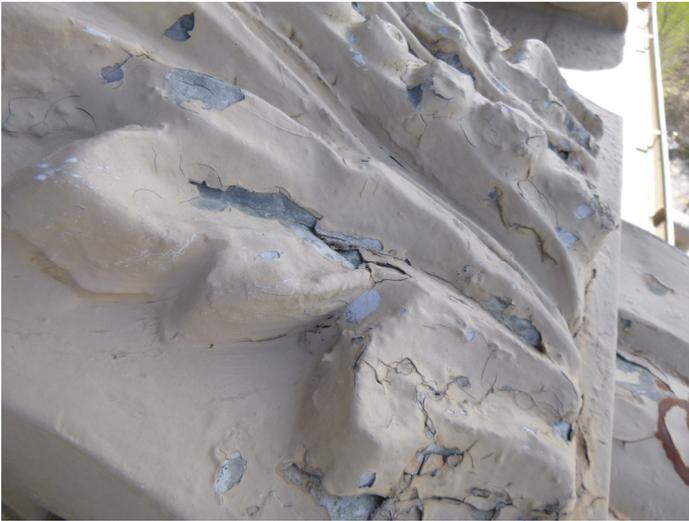
**465-108 SheetMetal\_Damaged Torn 2013-1**

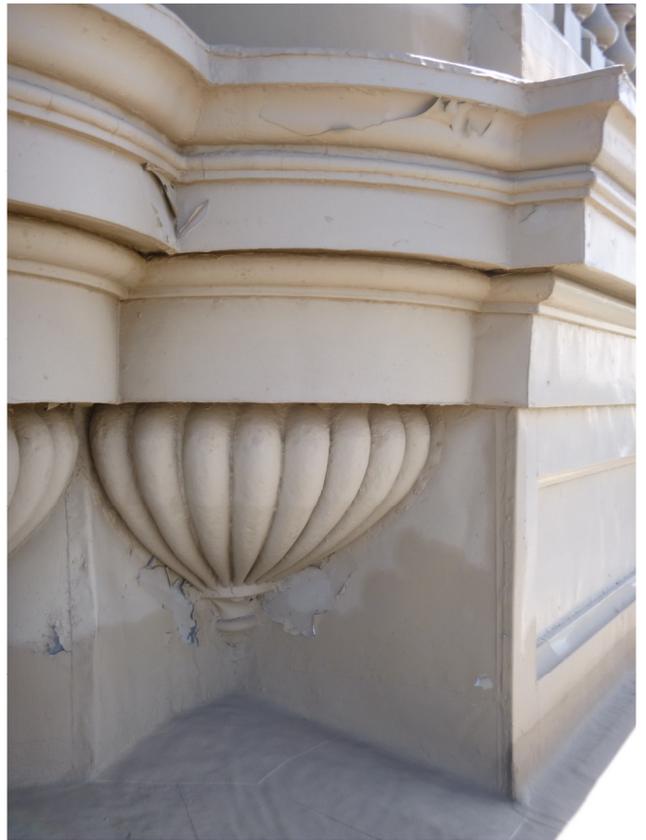
523-98 SheetMetal\_Damaged Torn 2013-1

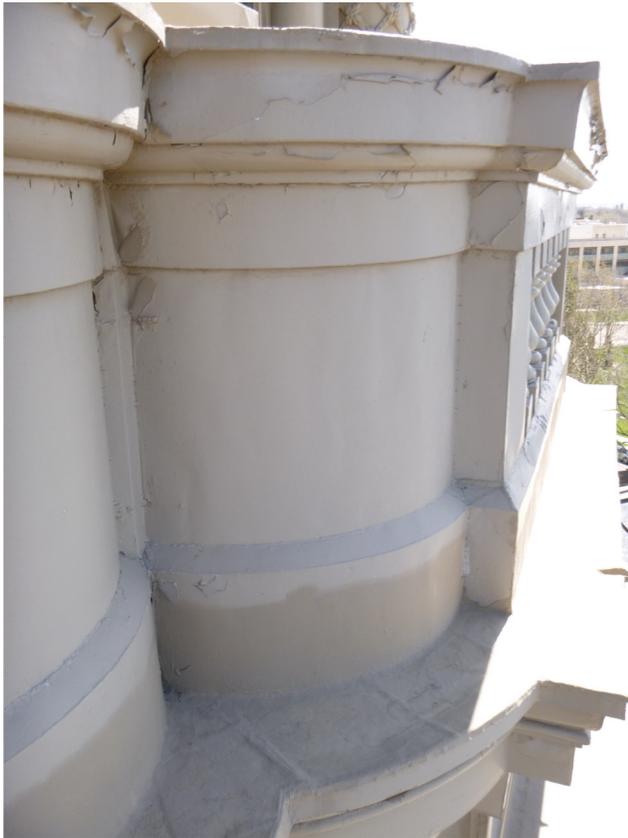
524-66 SheetMetal\_Coating Coating Failed 2013-1

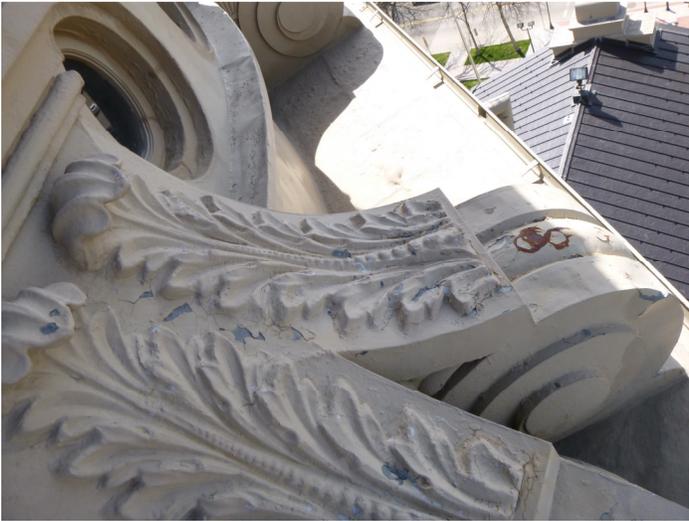
525-96 SheetMetal\_Corrosion Surface 2013-1

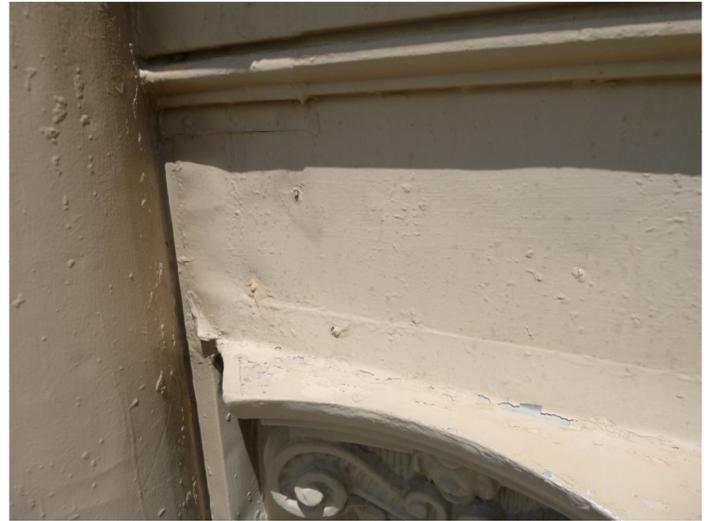
**525-99 SheetMetal\_Coating Coating Failed 2013-1**

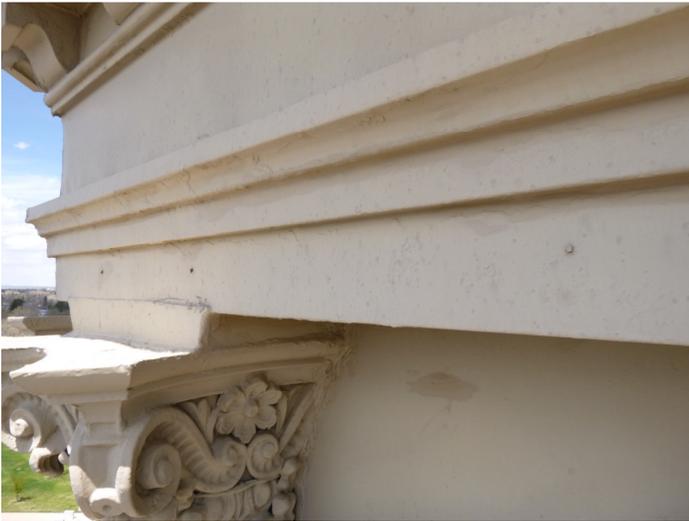
**526-82 SheetMetal\_Seam Fastener Failed 2013-1**

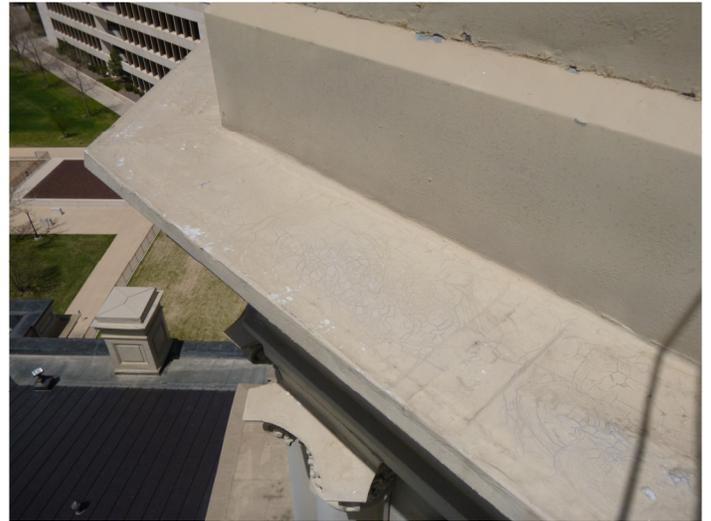
**526-87 SheetMetal\_Seam Fastener Failed 2013-1**

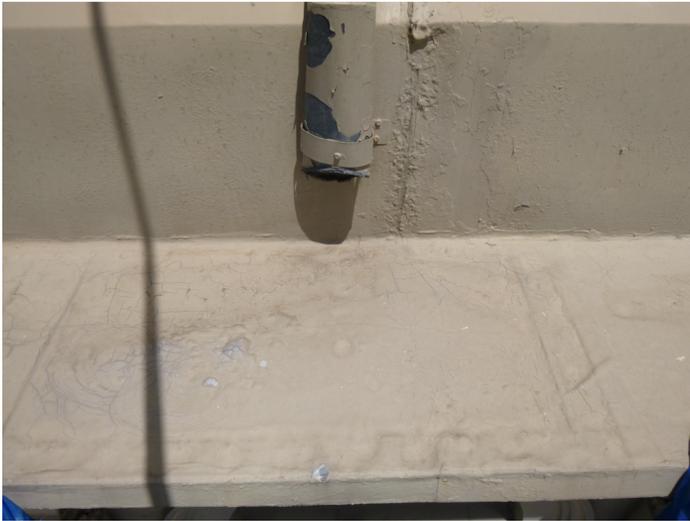
**526-91 SheetMetal\_Coating Coating Failed 2013-1**

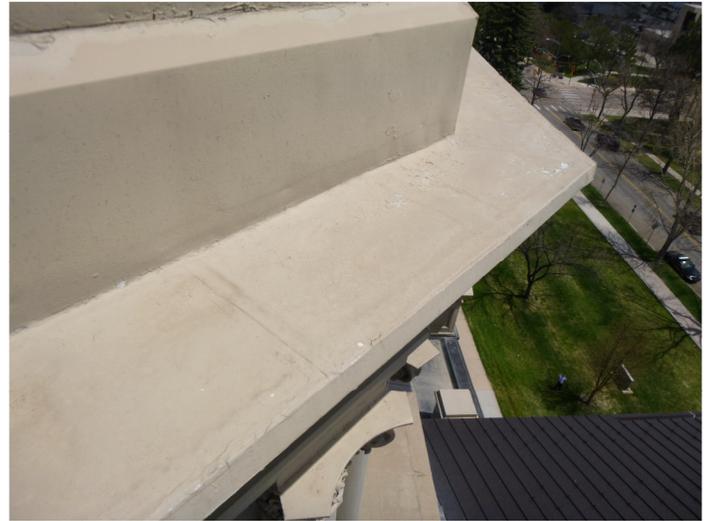
**526-91 SheetMetal\_Coating Coating Failed 2013-2**

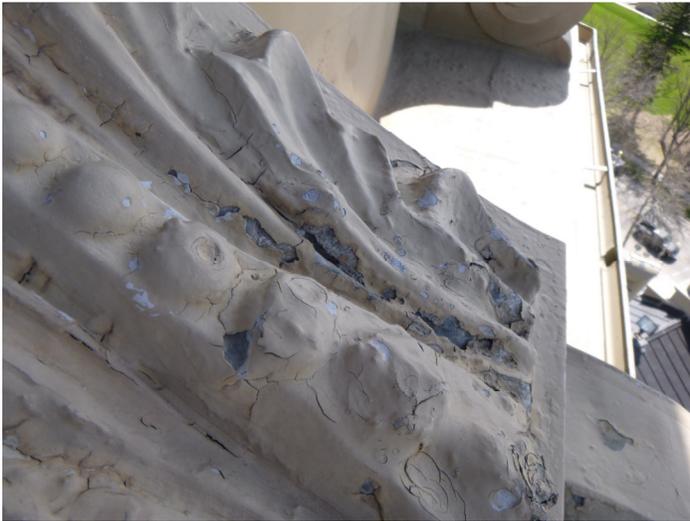
**526-91 SheetMetal\_Coating Coating Failed 2013-3**

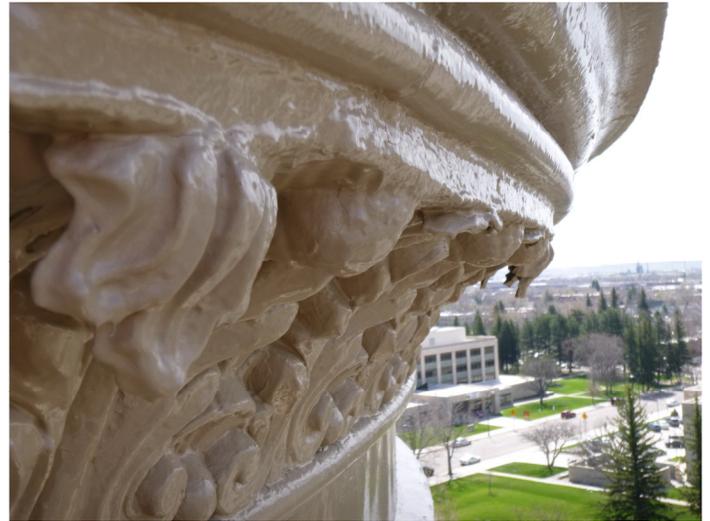
**526-98 SheetMetal\_Damaged Torn 2013-1**

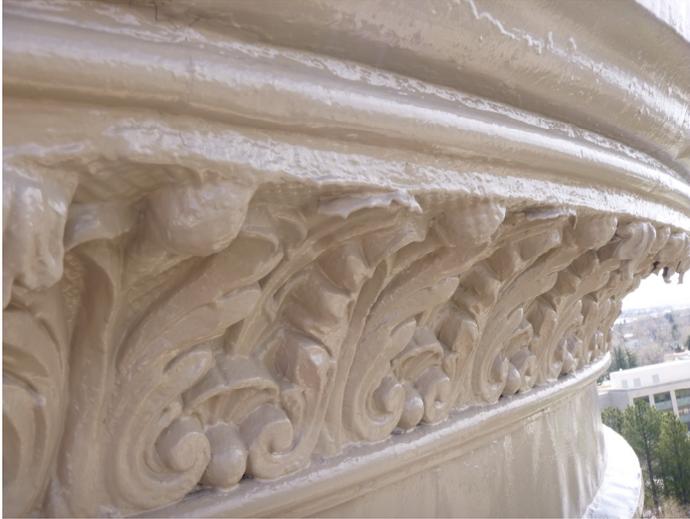
**526-103 SheetMetal\_Unsecured Missing 2013-1**

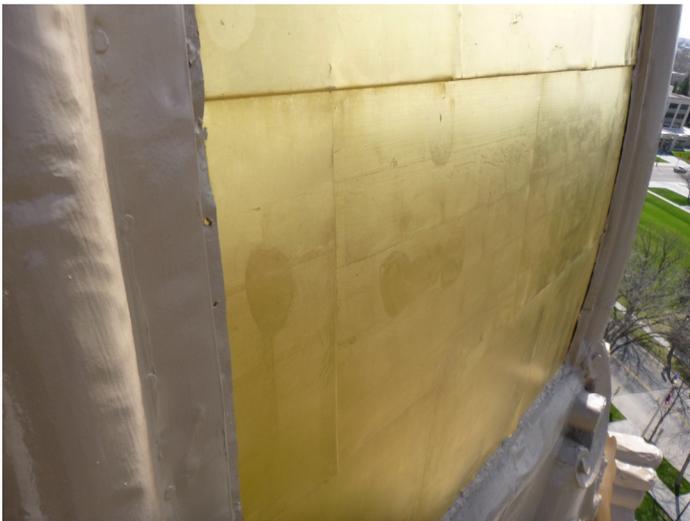
526-111 SheetMetal\_Note Photo-touch up gilding 2013-1

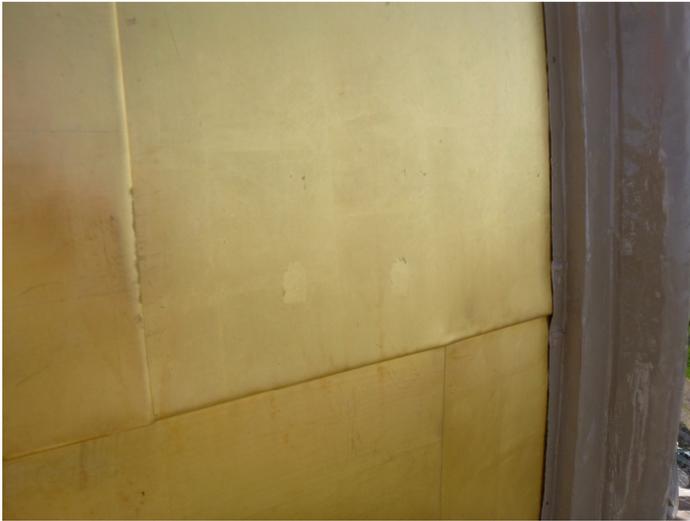
526-111 SheetMetal\_Note Photo-touch up gilding 2013-3

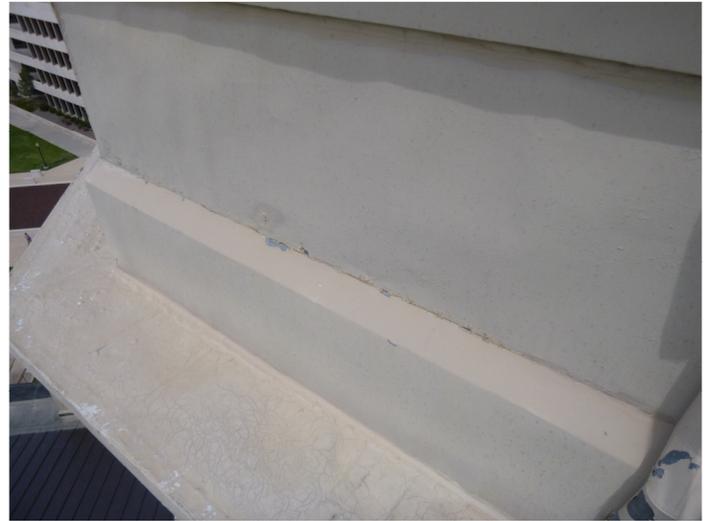
**526-111 SheetMetal\_Note Photo-touch up gilding 2013-4**

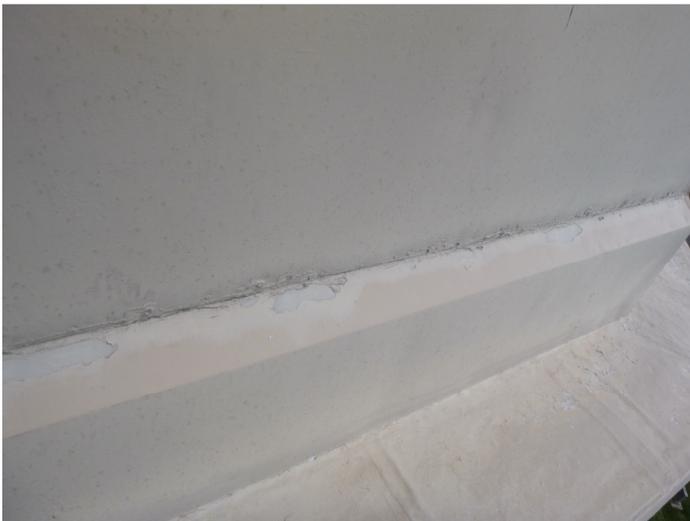
**527-93 SheetMetal\_Coating Coating Failed 2013-1**

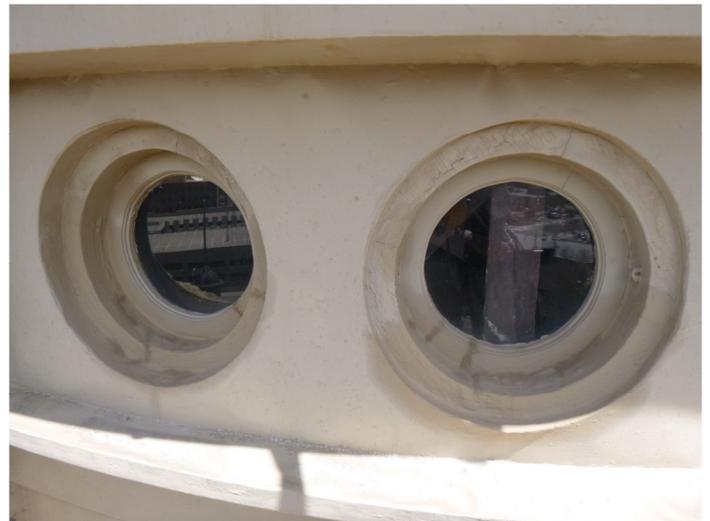
**527-93 SheetMetal\_Coating Coating Failed 2013-2**

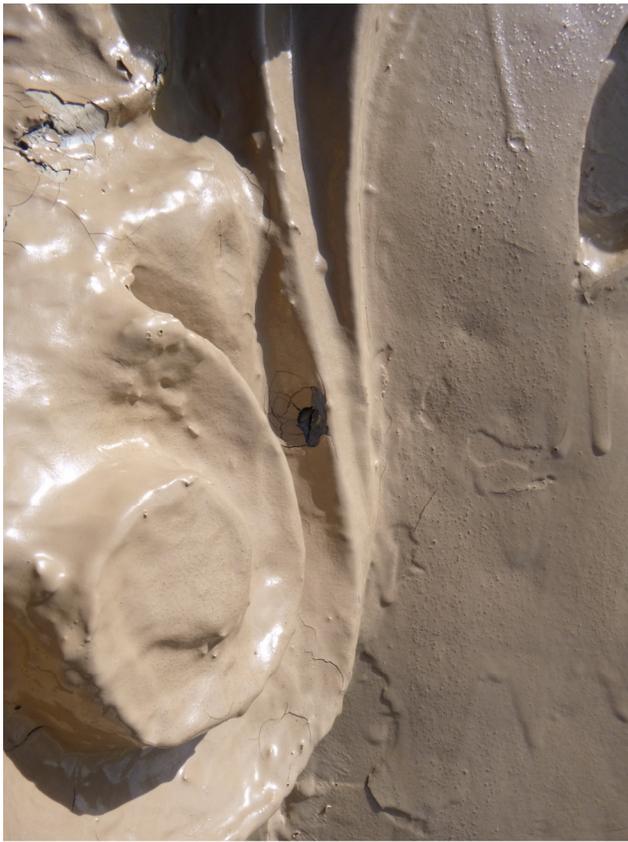
**527-99 Wood\_Coating Coating Failed 2013-1**

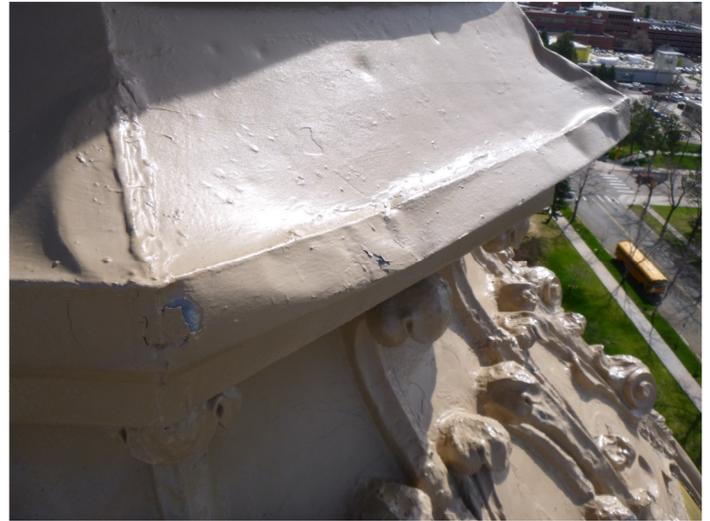
**527-119 SheetMetal\_Damaged Torn 2013-1**

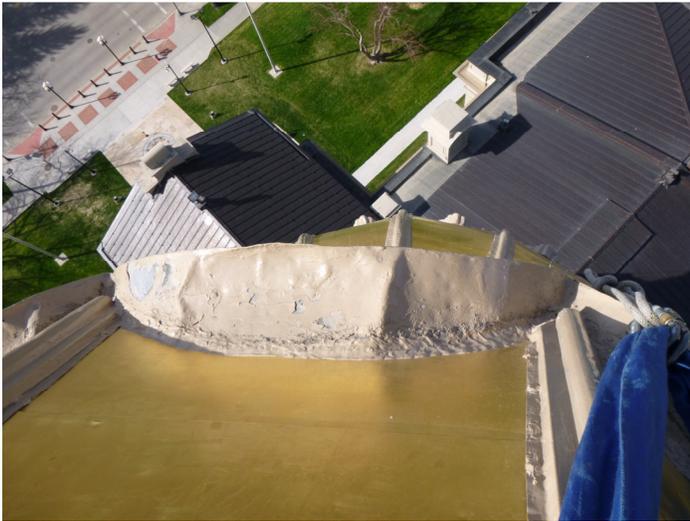
**527-123 SheetMetal\_Coating Coating Failed 2013-1**

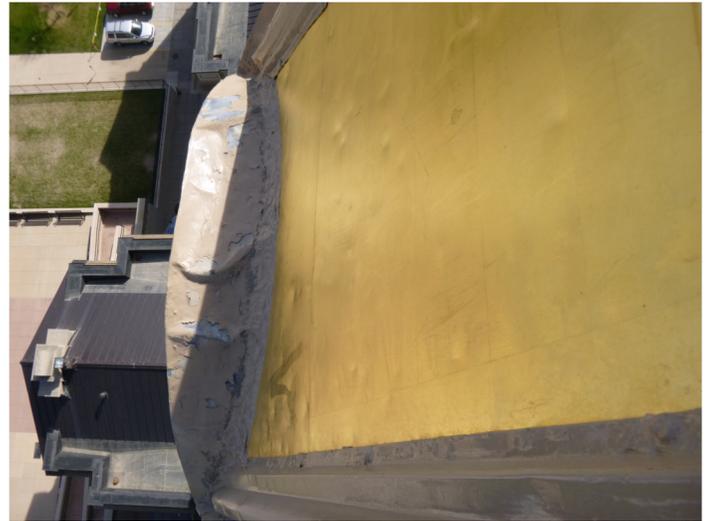
**527-129 SheetMetal\_Damaged Dented 2013-1**

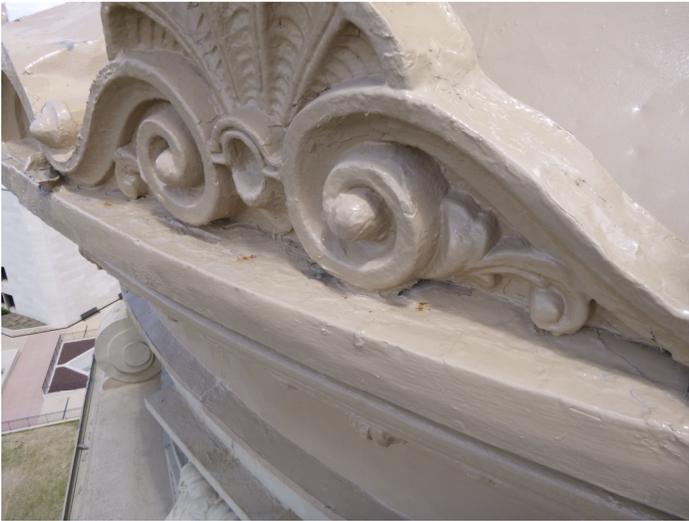
**527-129 SheetMetal\_Damaged Dented 2013-2**

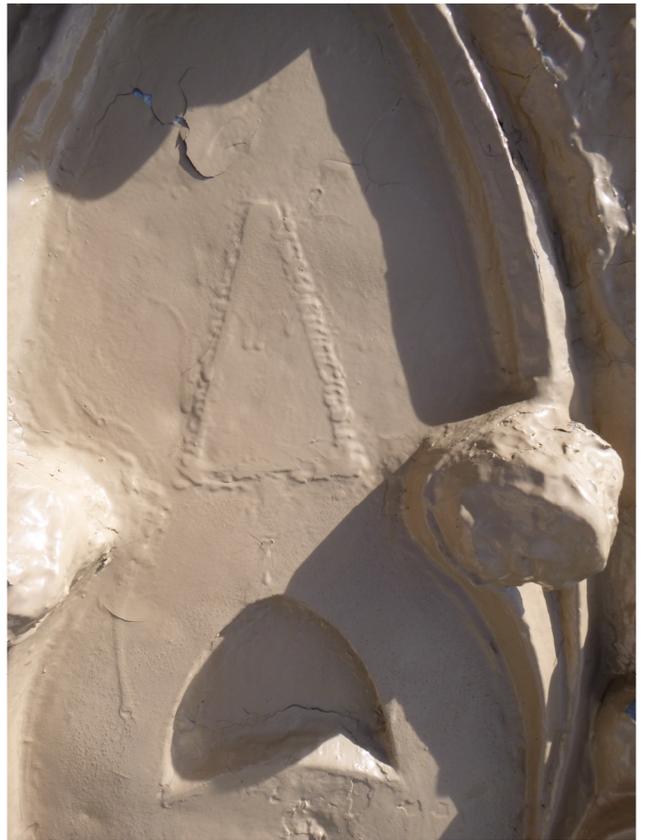
**528-104 SheetMetal\_Corrosion Surface 2013-1**

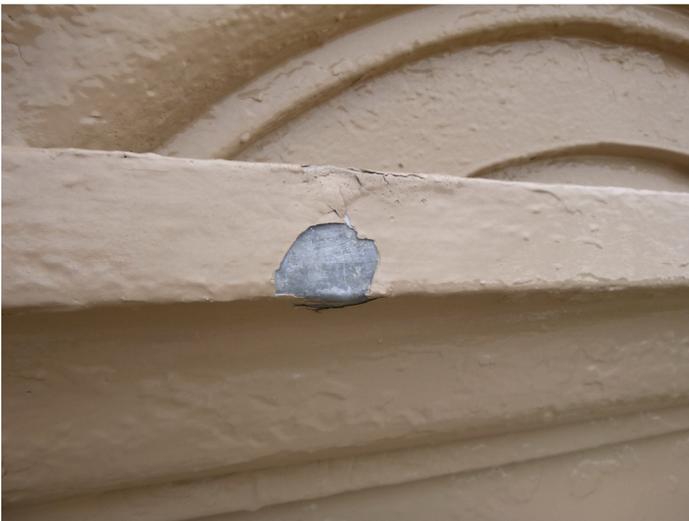
**528-121 SheetMetal\_Repair Patch Sound 2013-1**

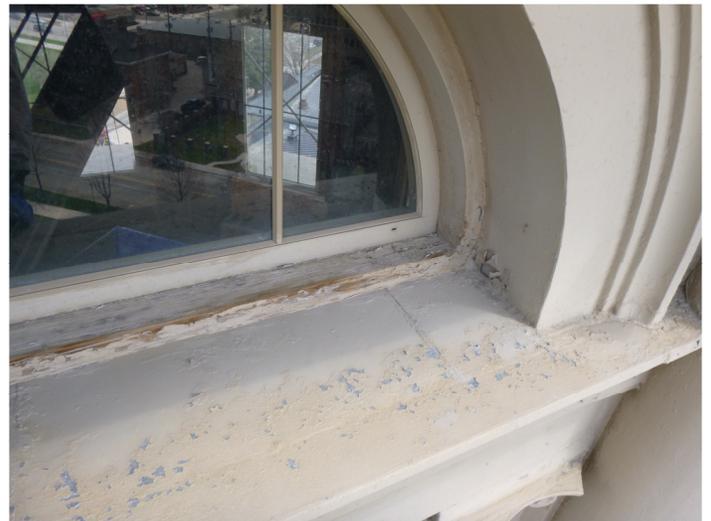
**528-129 SheetMetal\_Note PntSm 3 2013-1**

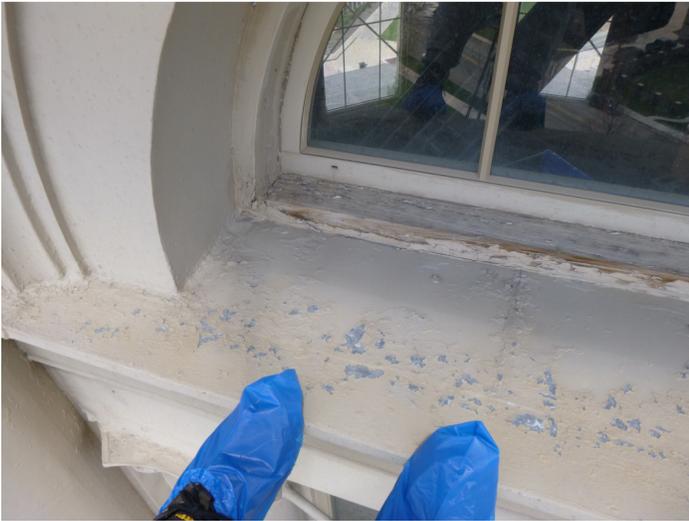
**529-83 SheetMetal\_Coating Coating Failed 2013-1**

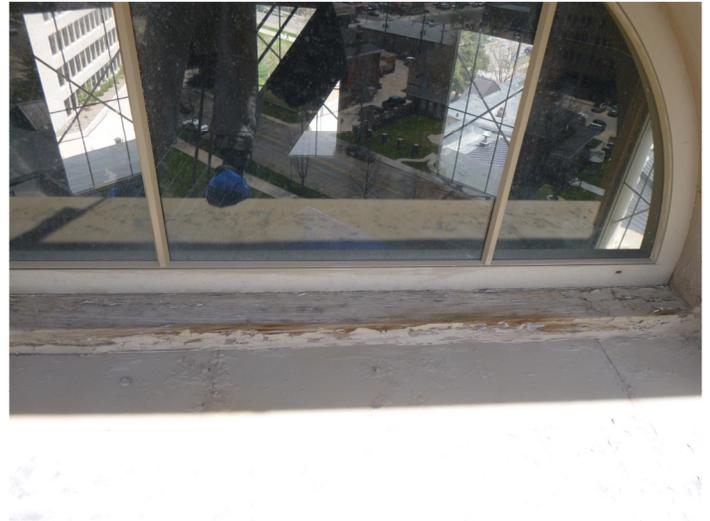
**529-83 SheetMetal\_Coating Coating Failed 2013-2**
