# Report Narrative

## Wyoming State Capitol Dome Investigation Cheyenne, WY

Vertical Access LLC  
PO Box 4135, Ithaca, NY 14852  
Tel: 607 257 4049 / Fax: 607 257 2129

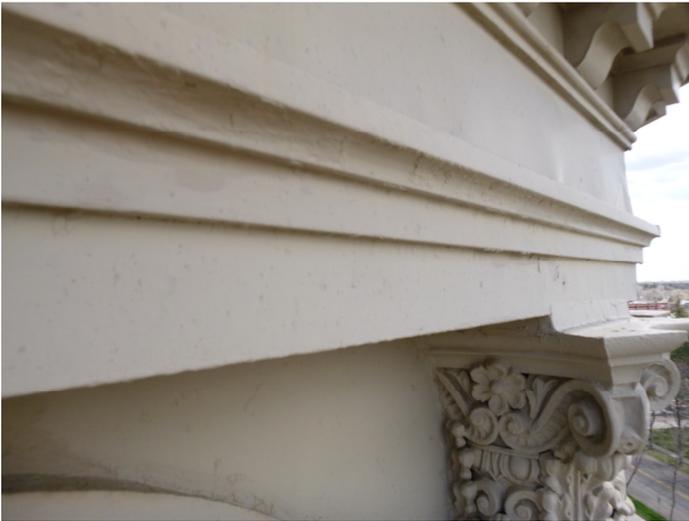
**529-84 Wood\_Coating Coating Failed 2013-1**

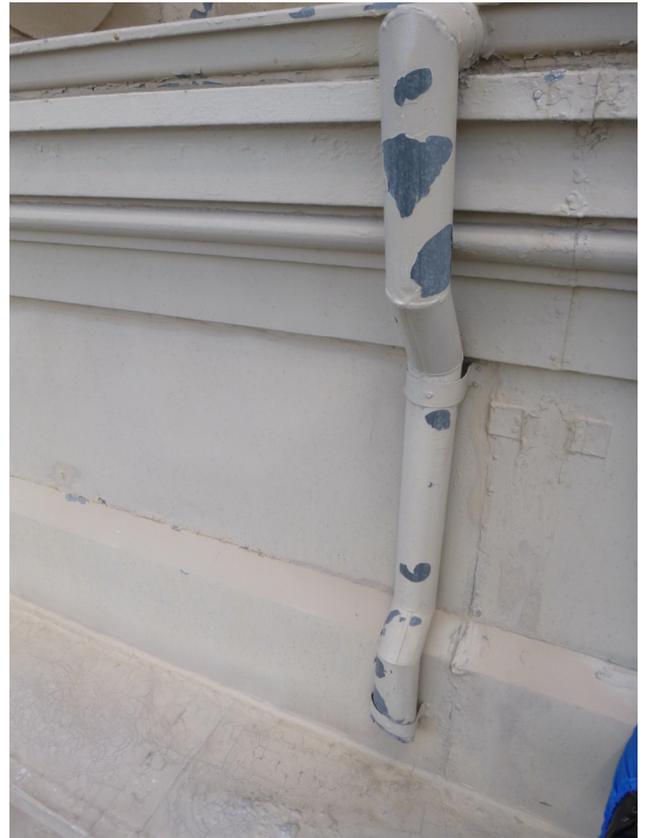
**529-88 SheetMetal\_Coating Coating Failed 2013-1**

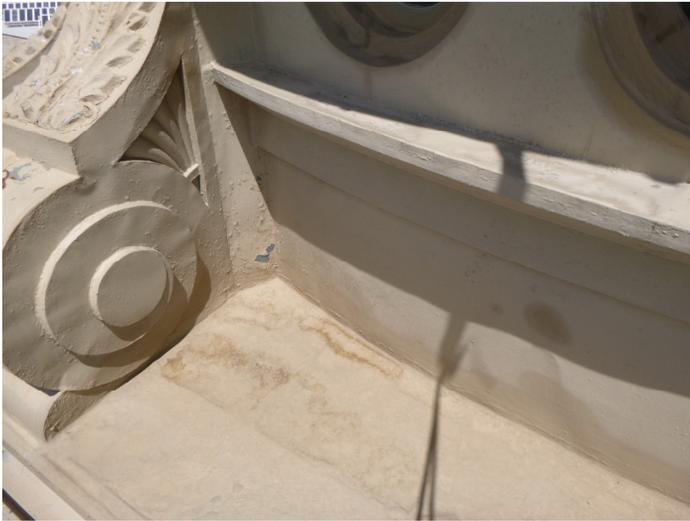
**529-95 SheetMetal\_Note Photo-downspout 2013-1**

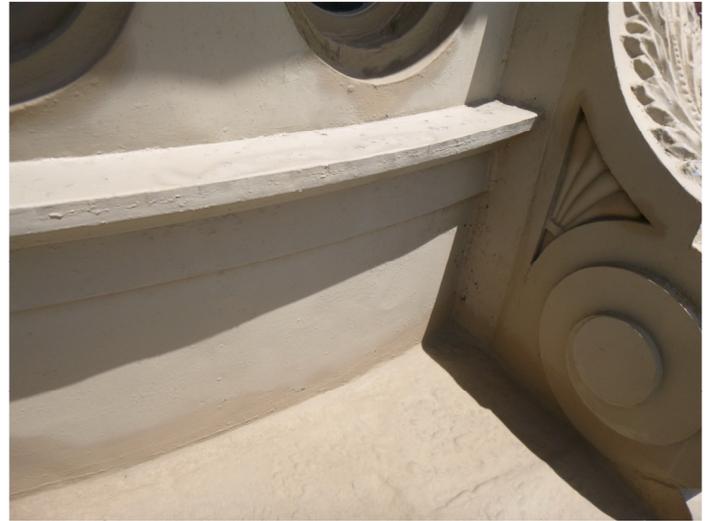
**529-97 SheetMetal\_Coating Coating Failed 2013-1**

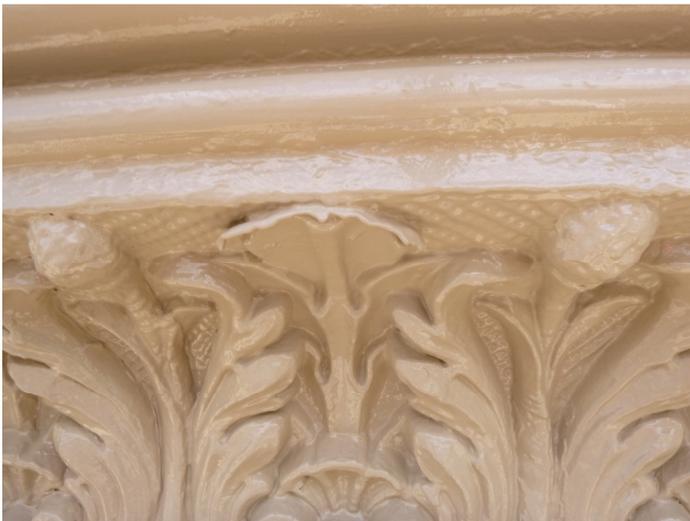
**529-97 SheetMetal\_Coating Coating Failed 2013-2**

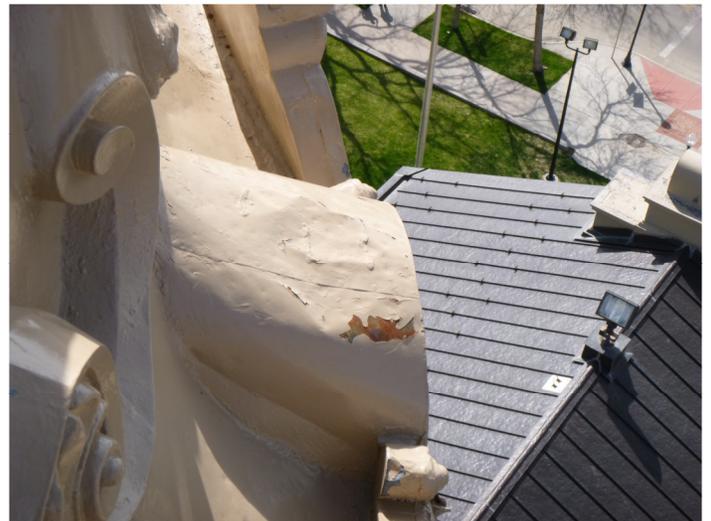
**529-103 SheetMetal\_Unsecured Missing 2013-1**

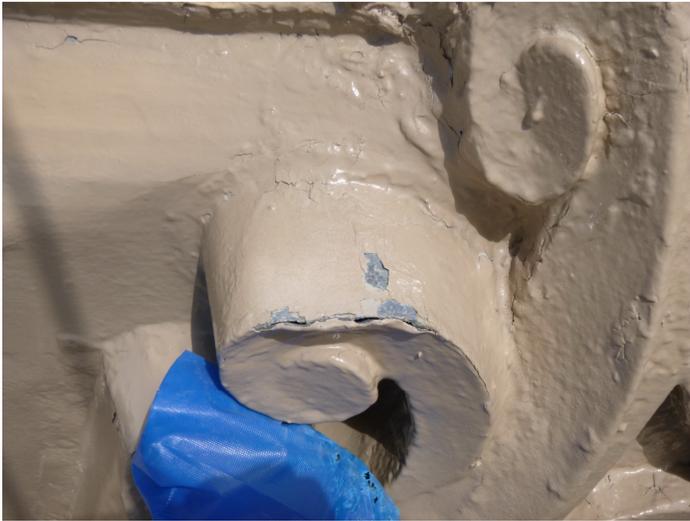
**529-105 SheetMetal\_Corrosion Surface 2013-1**

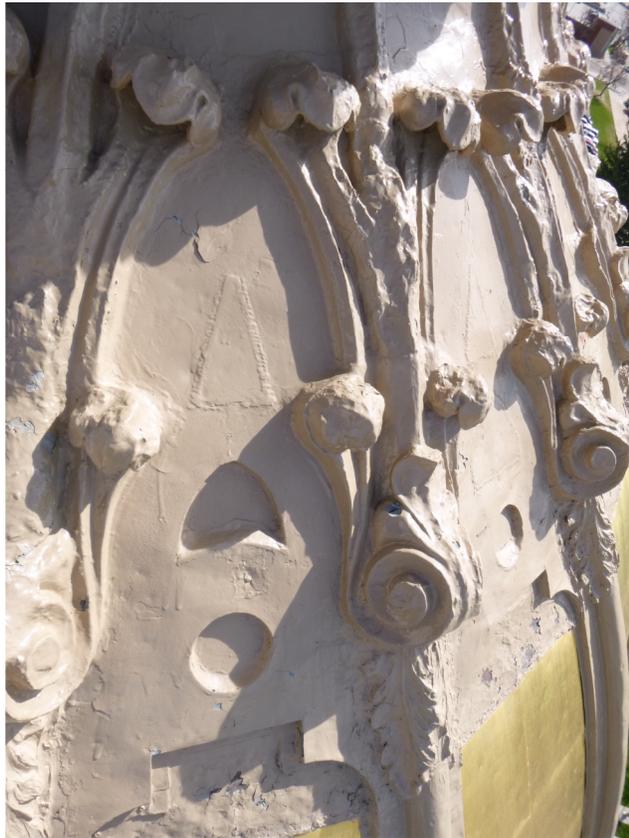
**529-119 SheetMetal\_Damaged Torn 2013-1**

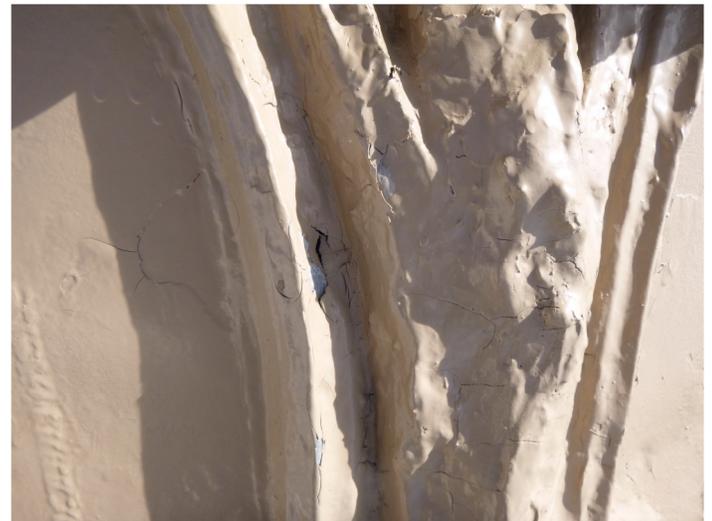
**529-120 SheetMetal\_Coating Coating Failed 2013-1**

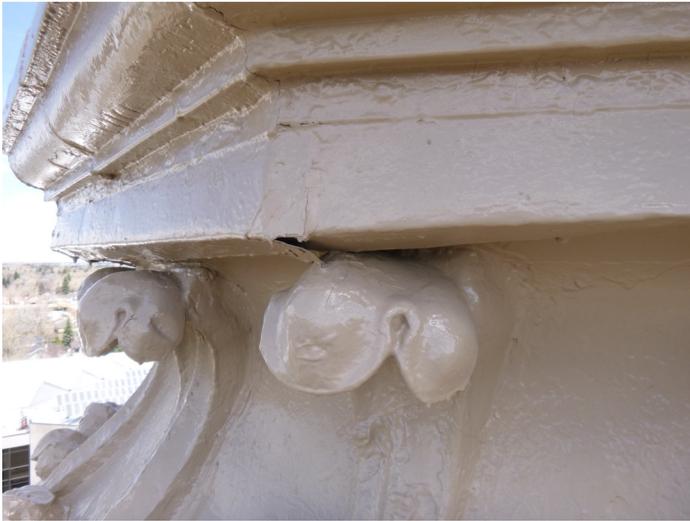
**529-122 SheetMetal\_Damaged Torn 2013-1**

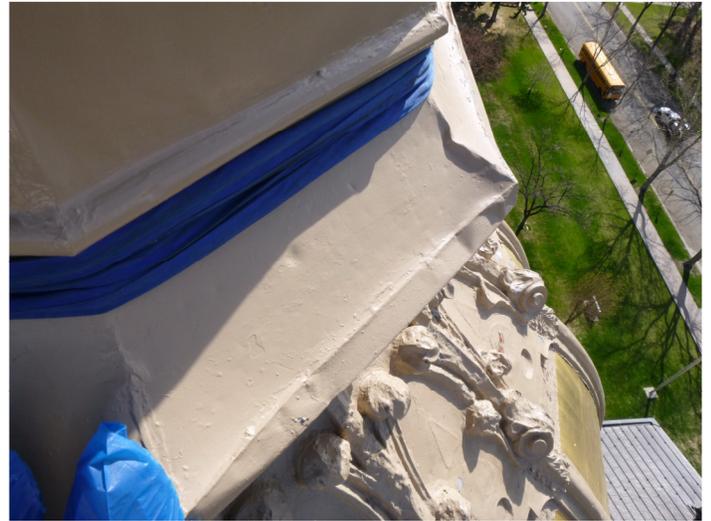
**529-123 SheetMetal\_Seam Folded Failed 2013-1**

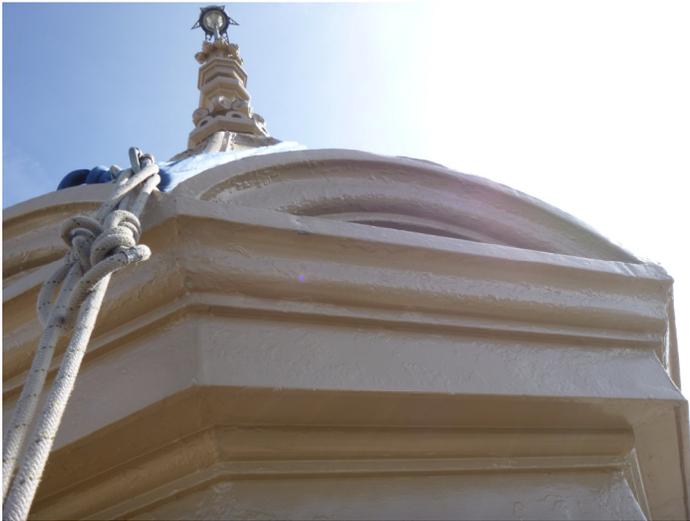
**529-124 SheetMetal\_Damaged Dented 2013-1**

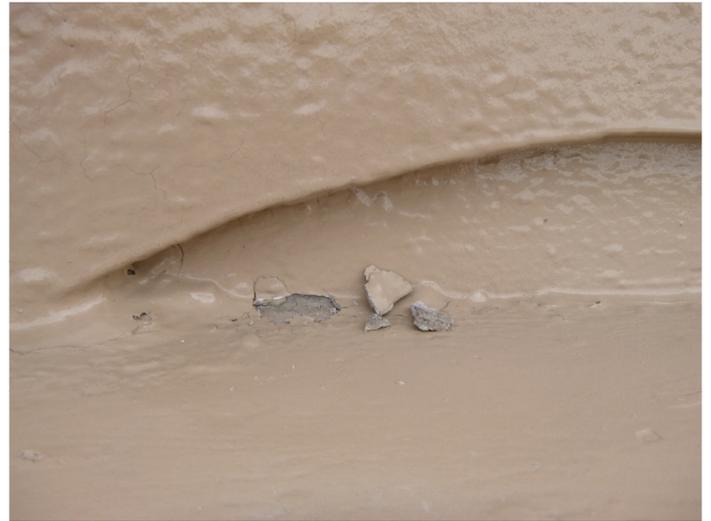
**529-129 SheetMetal\_Coating Coating Failed 2013-1**

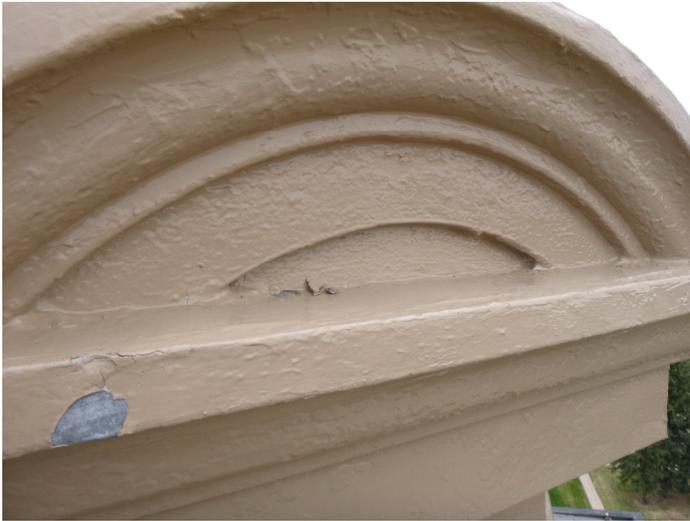
**529-129 SheetMetal\_Note PntSm 4 2013-1**

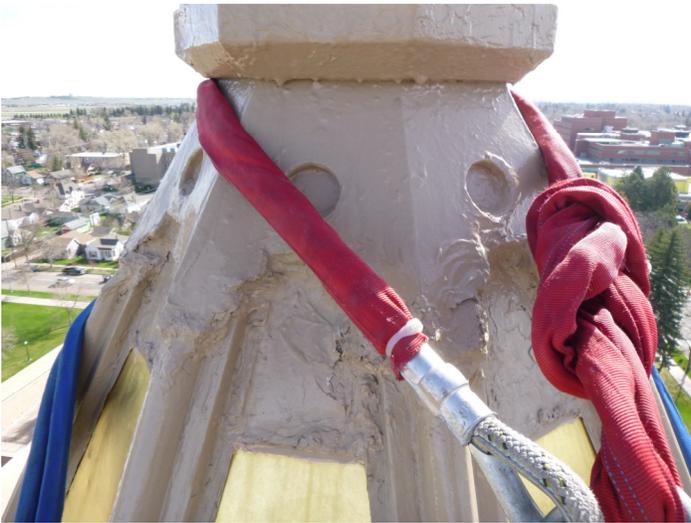
**529-131 SheetMetal\_Damaged Dented 2013-3**

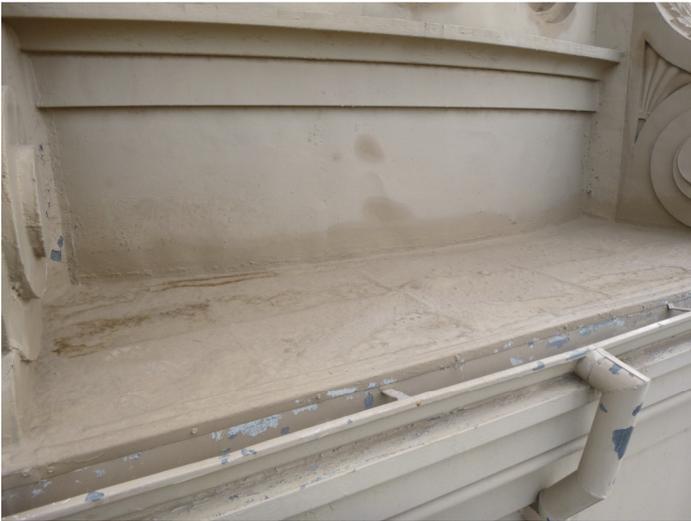
529-135 SheetMetal\_Coating Coating Failed 2013-2

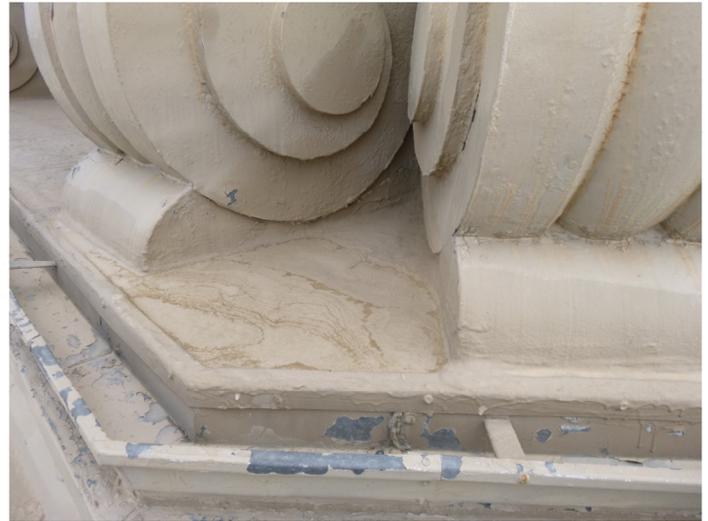
530-96 SheetMetal\_Note Photo-water ponding at ledge

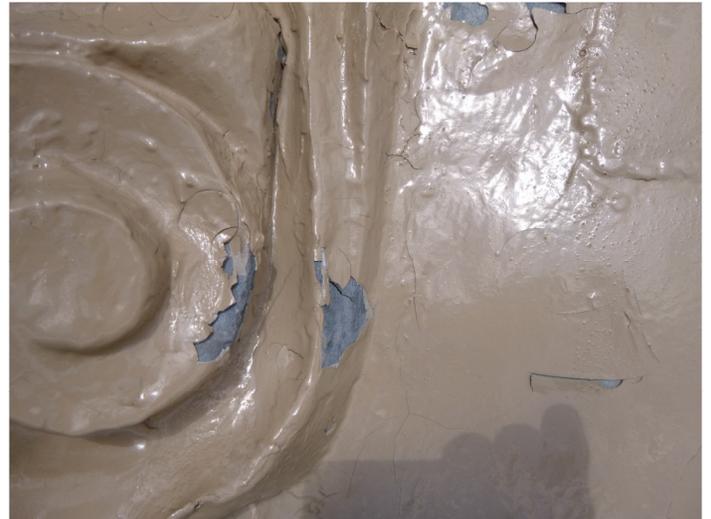
**530-116 SheetMetal\_Damaged Dented 2013-2**

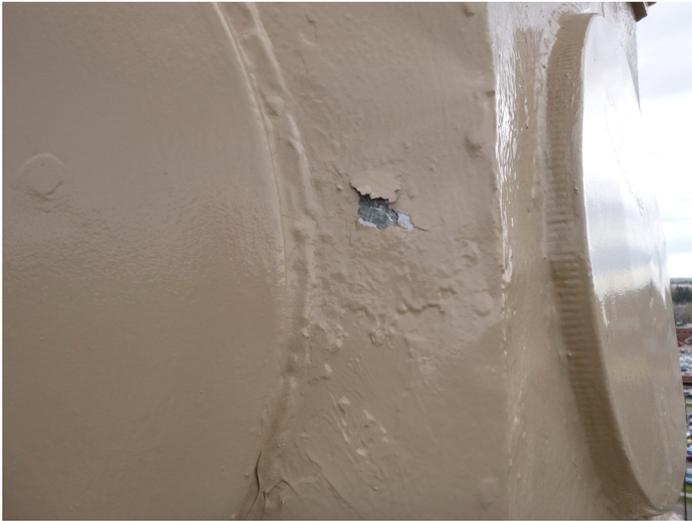
**530-120 SheetMetal\_Damaged Torn 2013-1**

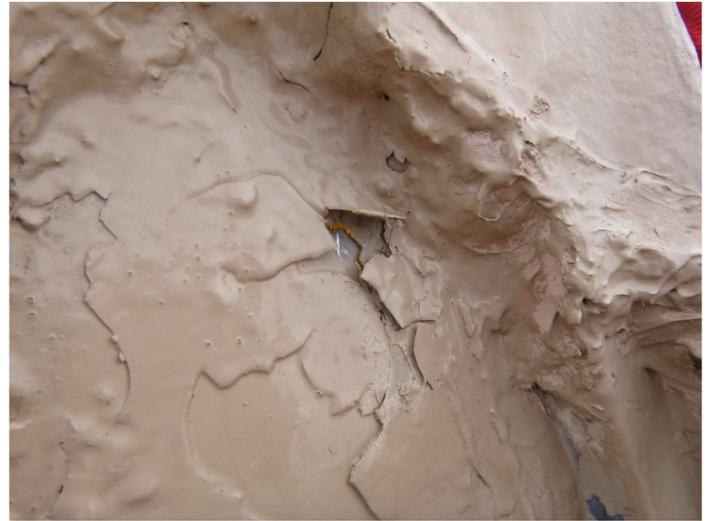
**530-127 SheetMetal\_Note PntSm 6 2013-1**

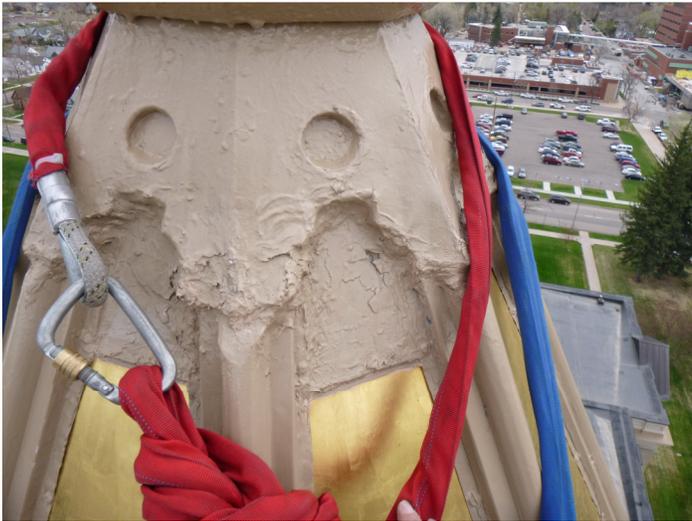
**530-134 SheetMetal\_Note PntSm 2 2013-1**

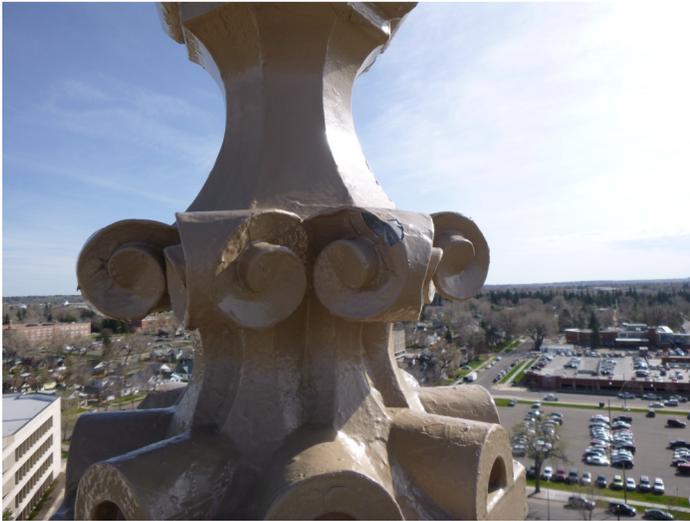
**530-134 SheetMetal\_Note PntSm 2 2013-3**

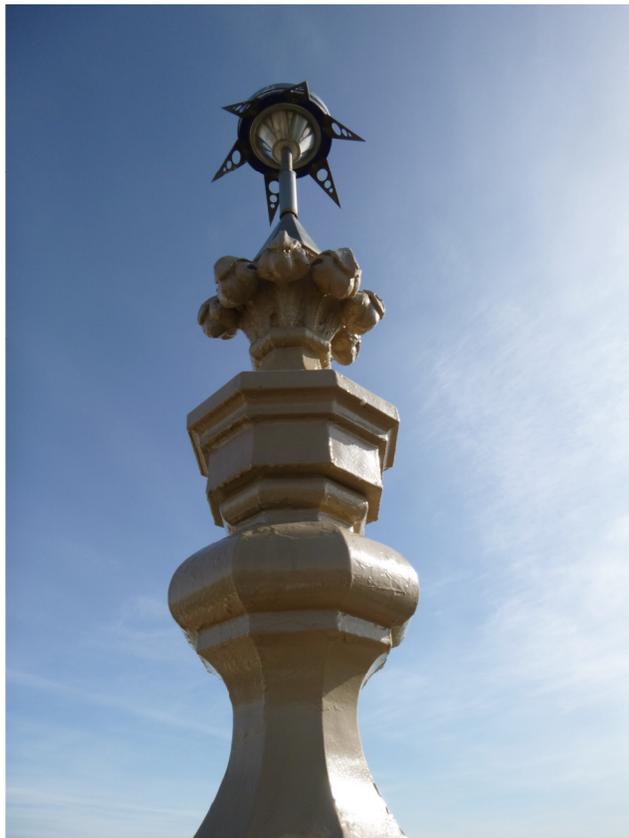
530-138 SheetMetal\_Note Photo-lightning protection

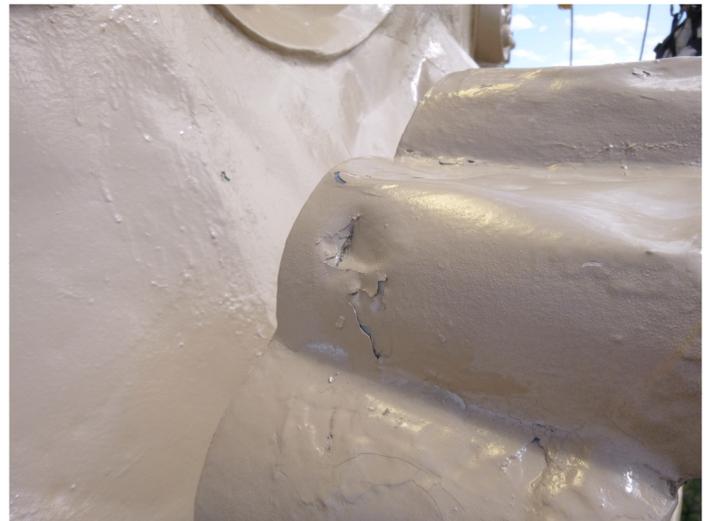
531-105 SheetMetal\_Damaged Torn 2013-1

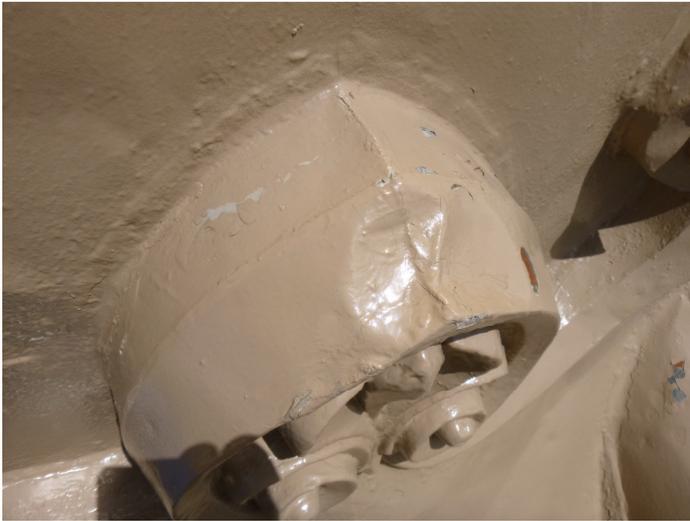
**531-106 SheetMetal\_Damaged Dented 2013-1**

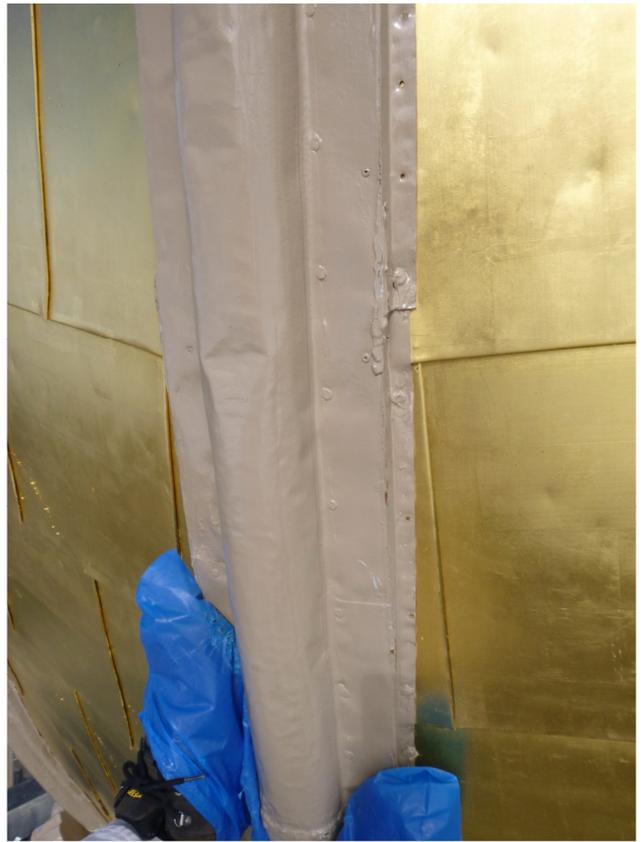
**531-113 SheetMetal\_Seam Solder Failed 2013-1**

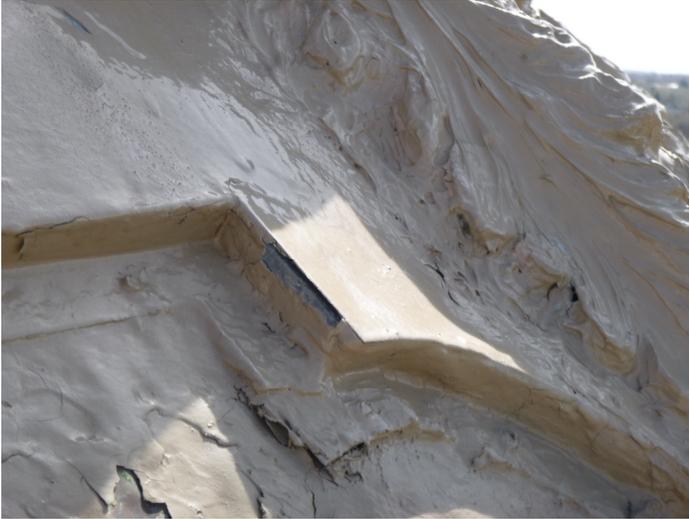
**531-119 SheetMetal\_Seam Solder Failed 2013-1**

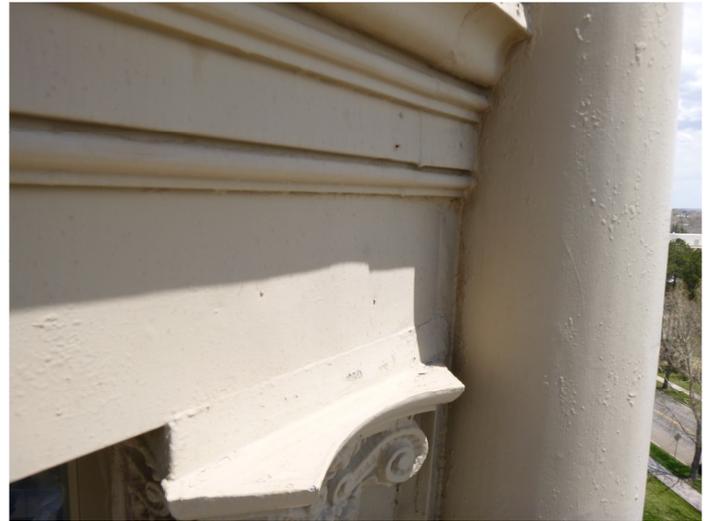
**532-82 SheetMetal\_Seam Fastener Failed 2013-1**

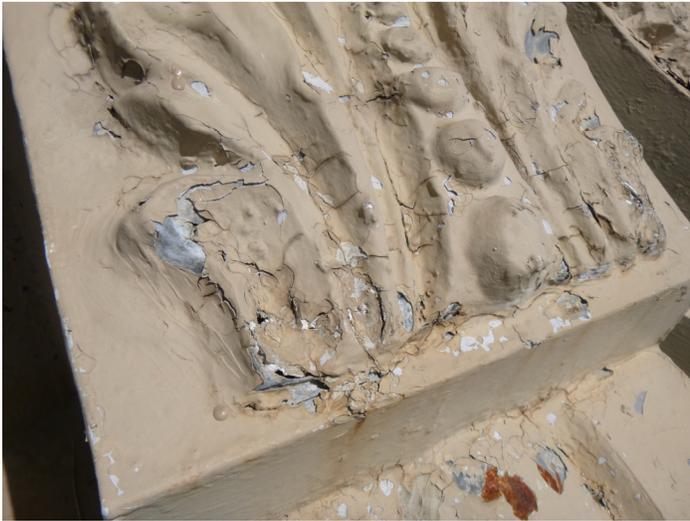
**532-98 SheetMetal\_Damaged Punctured 2013-1**

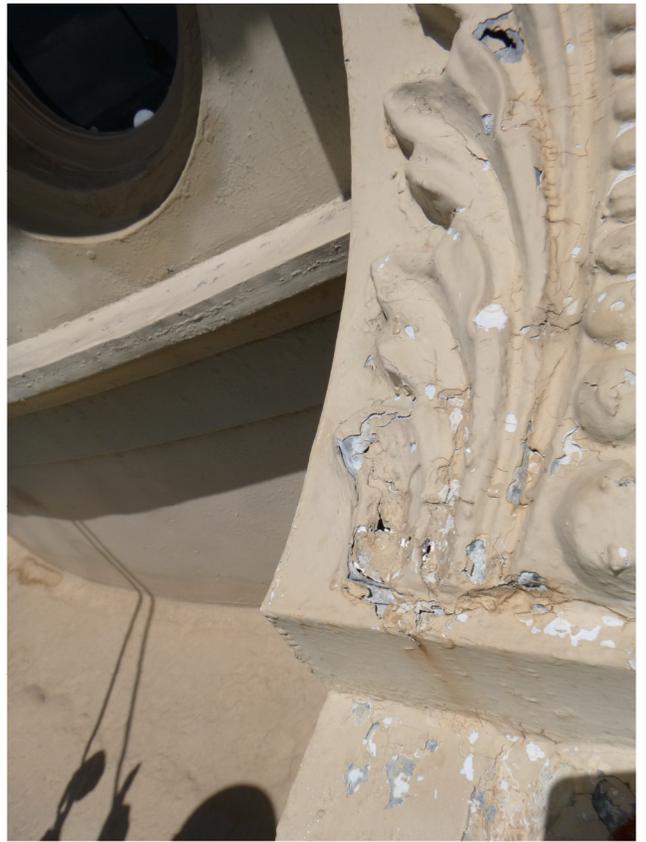
**532-98 SheetMetal\_Damaged Punctured 2013-2**

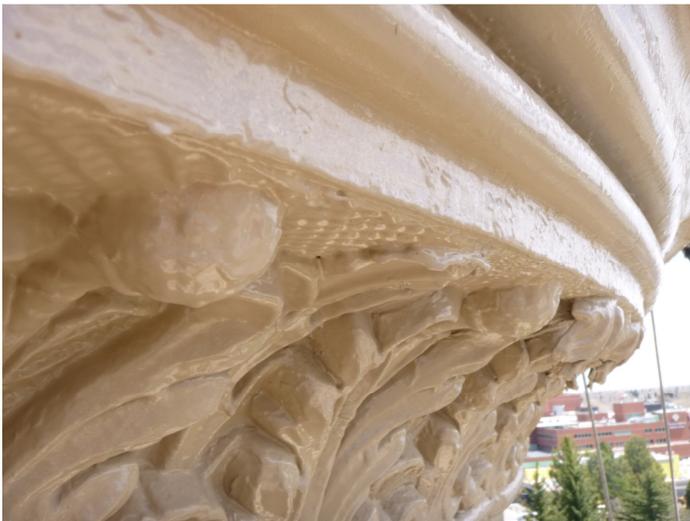
**532-103 SheetMetal\_Unsecured Missing 2013-1**

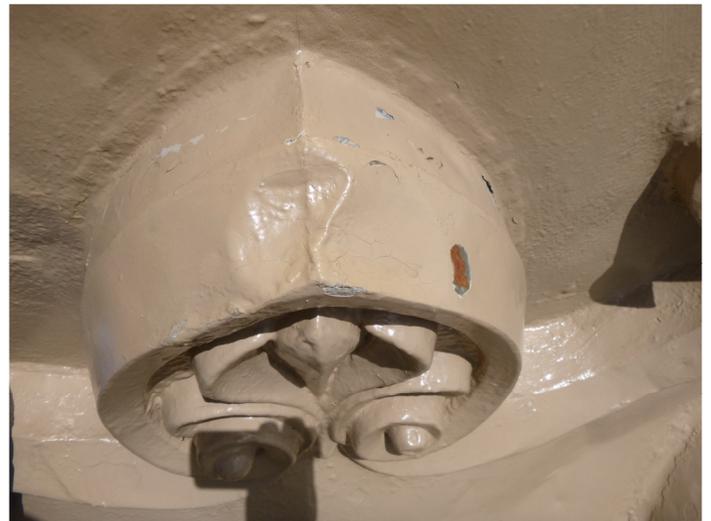
**532-105 SheetMetal\_Corrosion Surface 2013-1**

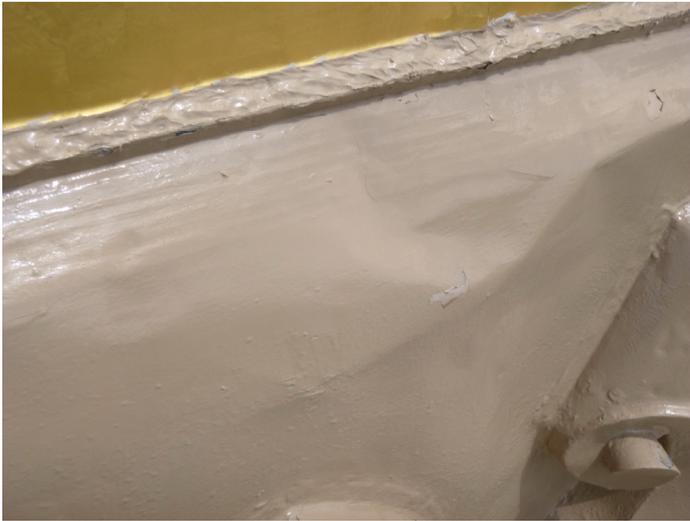
**532-107 SheetMetal\_Damaged Dented 2013-1**

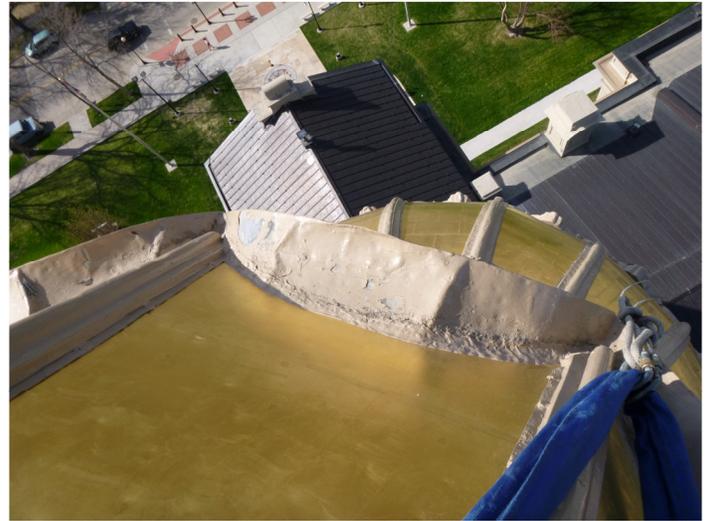
**532-129 SheetMetal\_Coating Coating Failed 2013-1**

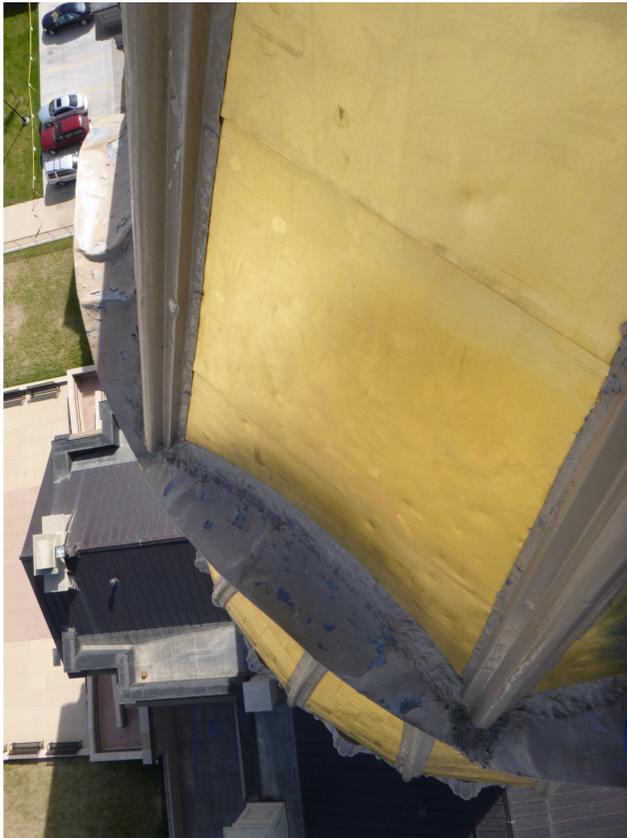
**532-129 SheetMetal\_Coating Coating Failed 2013-2**

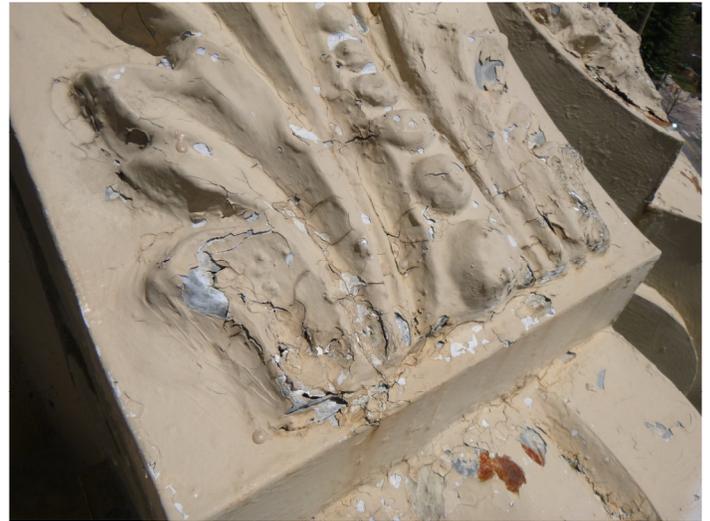
**533-98 SheetMetal\_Damaged Dented 2013-1**

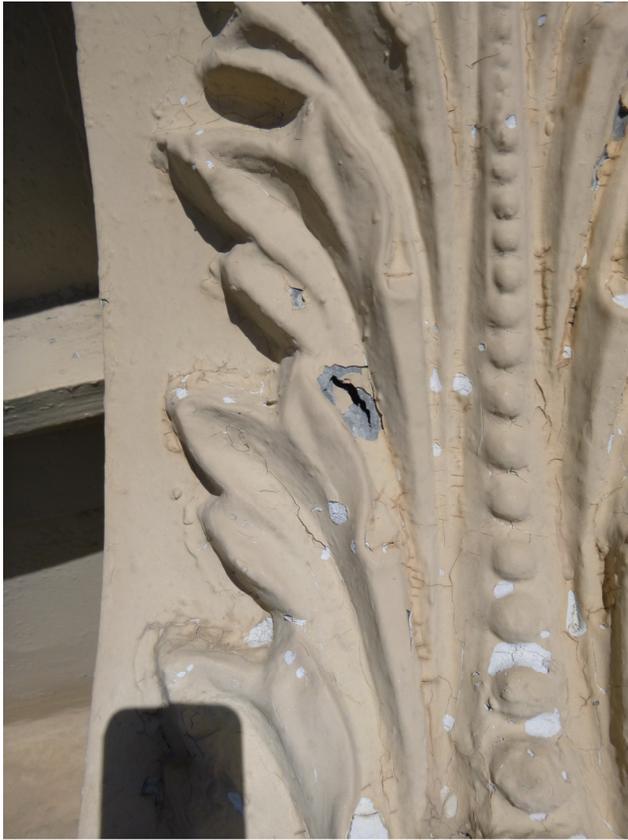
533-99 SheetMetal\_Damaged Punctured 2013-1

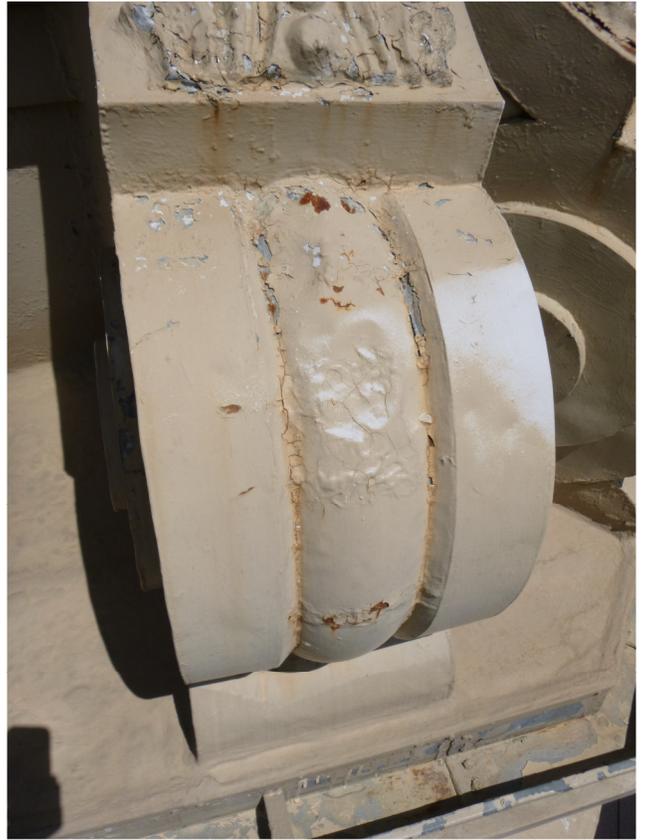
534-97 SheetMetal\_Corrosion Surface 2013-1

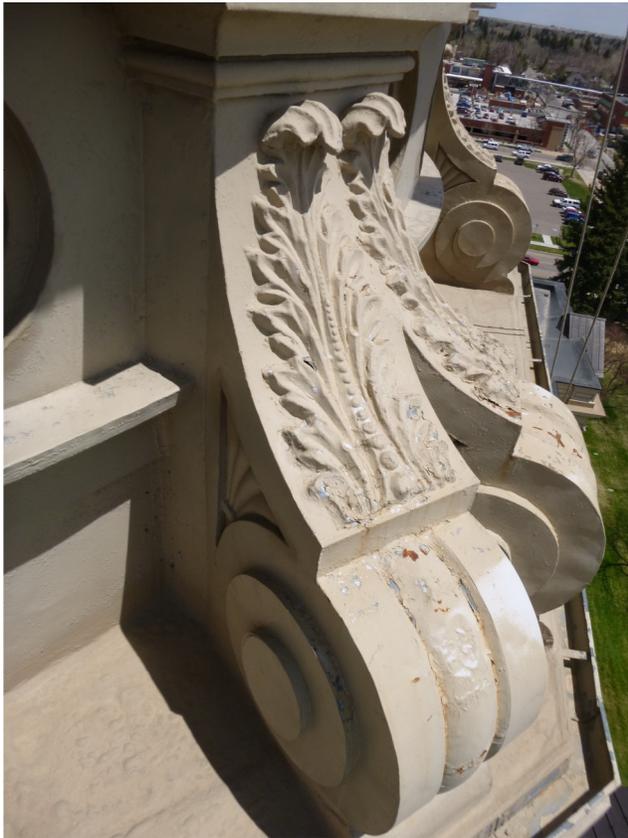
534-99 SheetMetal\_Coating Coating Failed 2013-1

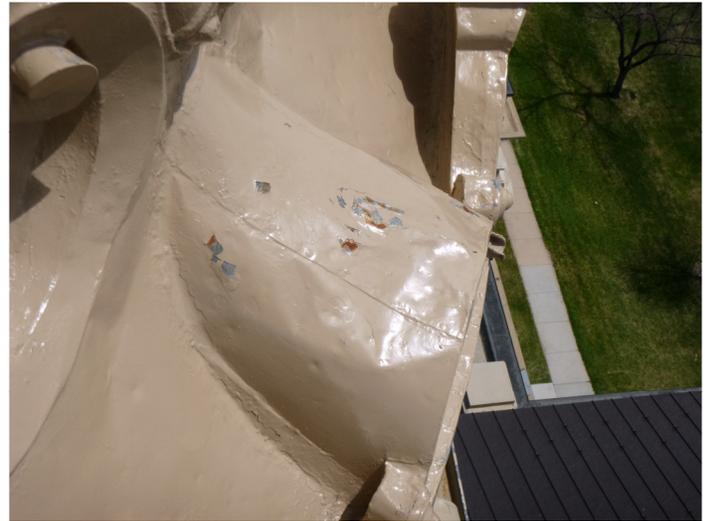
535-105 SheetMetal\_Corrosion Surface 2013-1

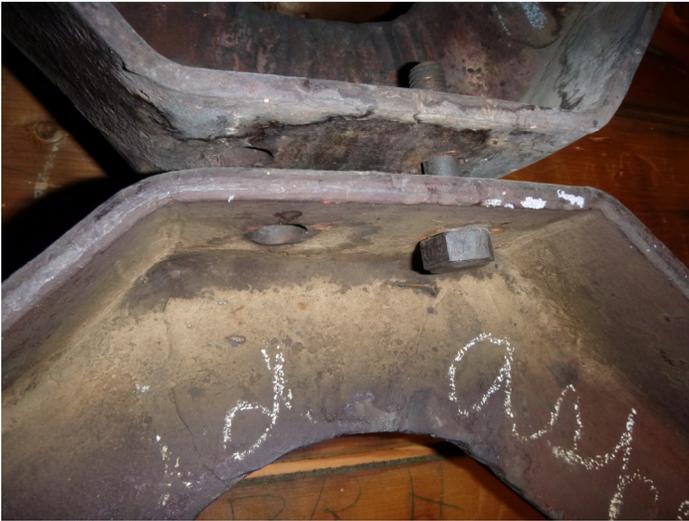
570-113 ArchMetal\_Note Photo-missing bolt 2013-1

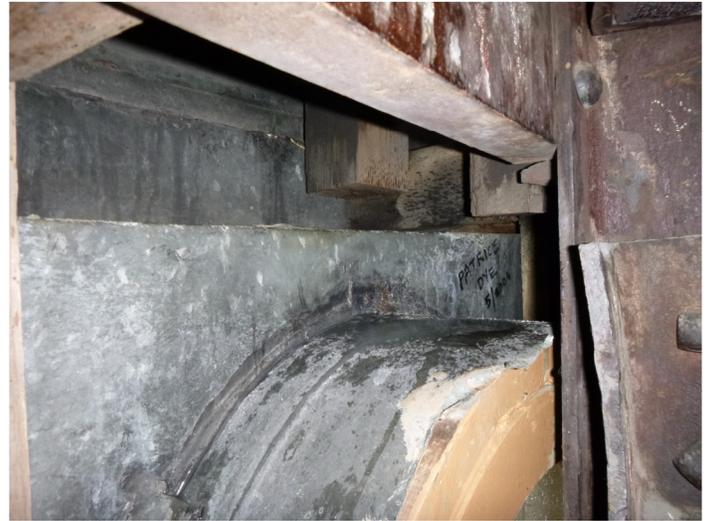
572-99 SheetMetal\_Note Photo-active leak 2013-1

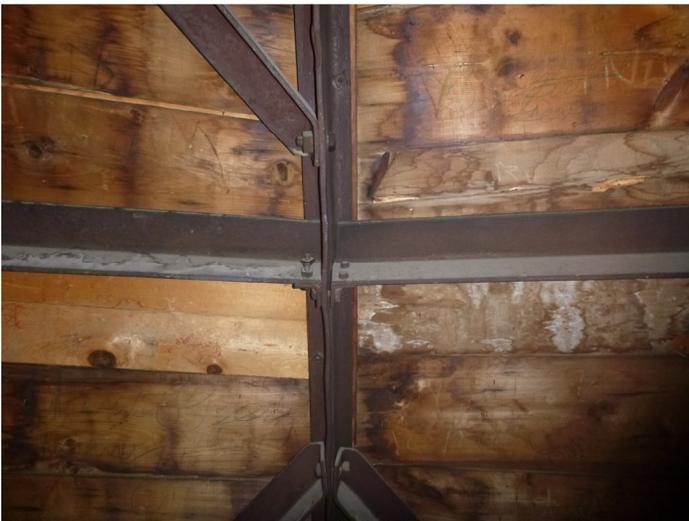
573-118 ArchMetal\_Note Joint condition 2013-1

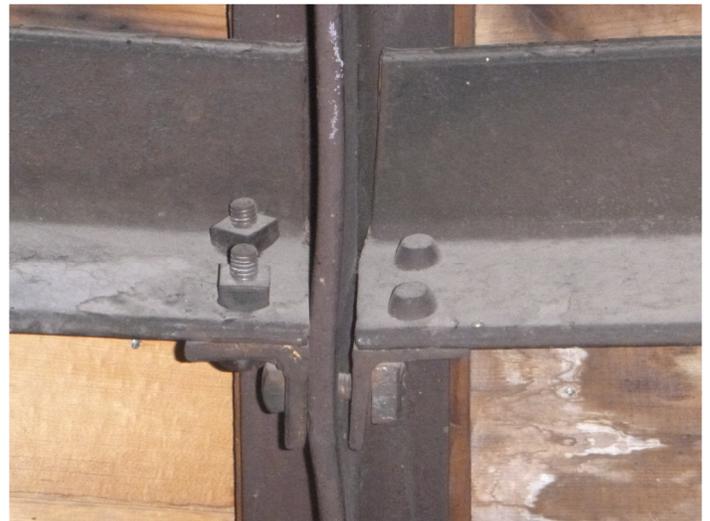
573-118 ArchMetal\_Note Joint condition 2013-2

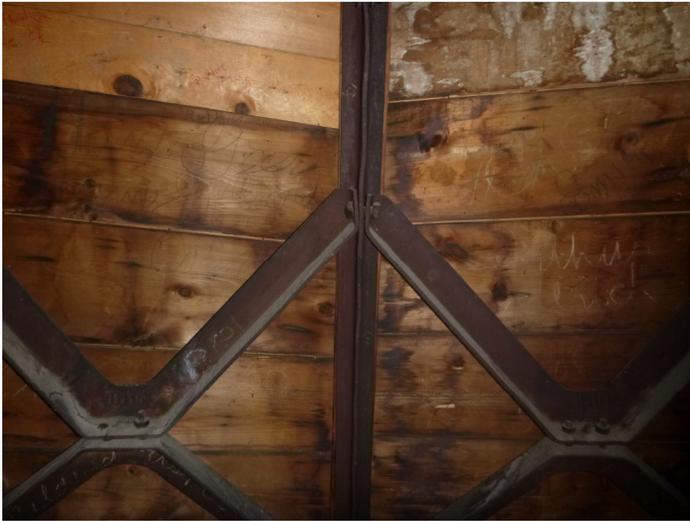
574-116 ArchMetal\_Note Joint condition 2013-1

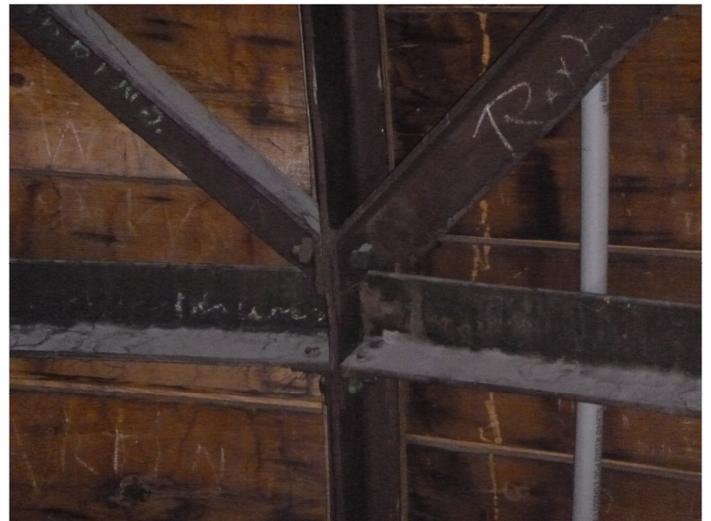
576-111 ArchMetal\_Note Joint condition 2013-1

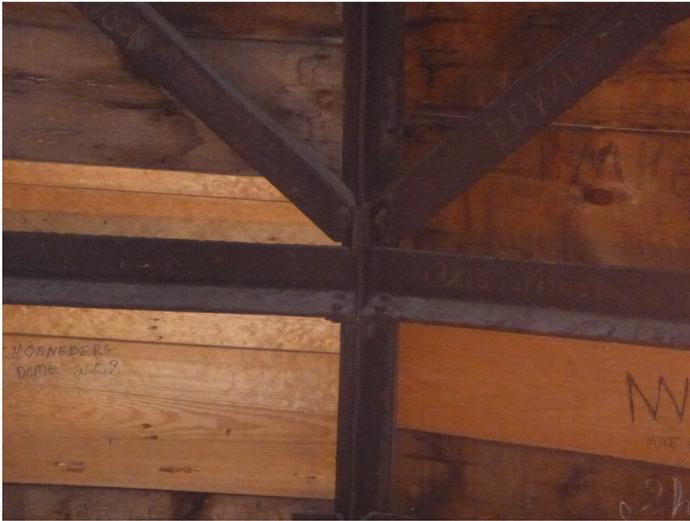
576-111 ArchMetal\_Note Joint condition 2013-2

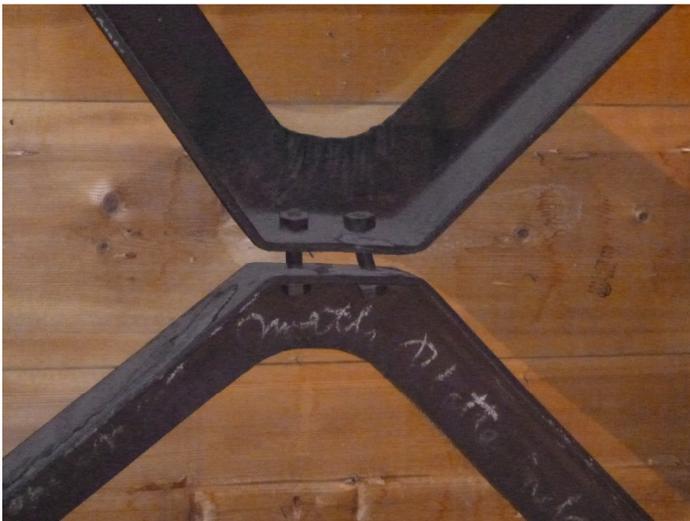
586-114 ArchMetal\_Note Joint condition 2013-1

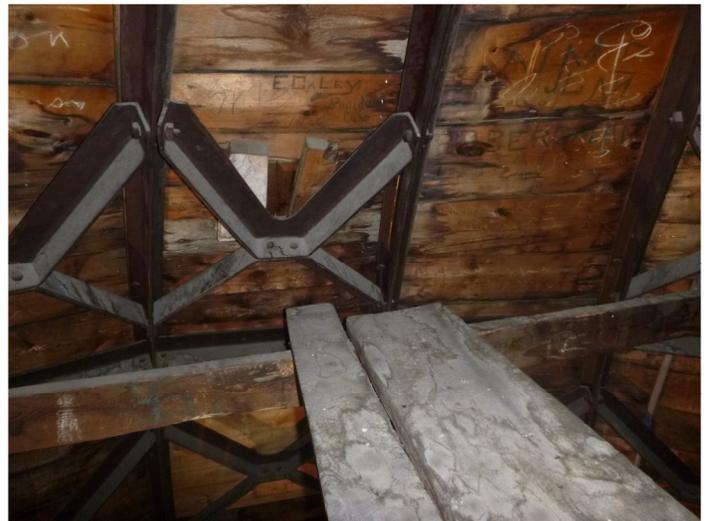
588-119 ArchMetal\_Note Joint condition 2013-1

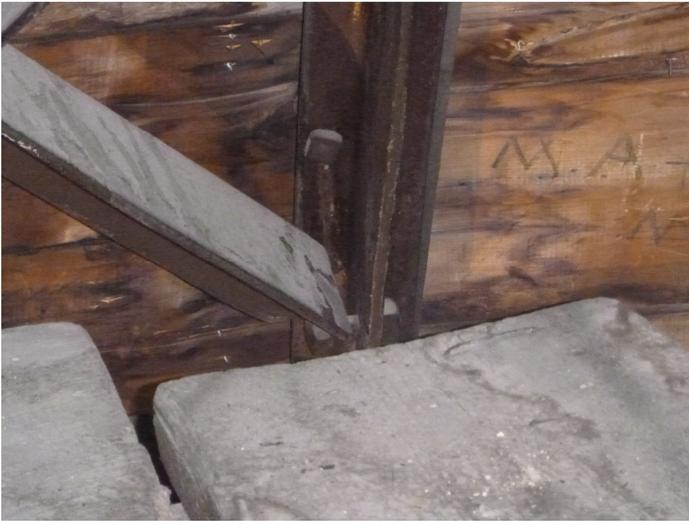
**588-119 ArchMetal\_Note Joint condition 2013-2**

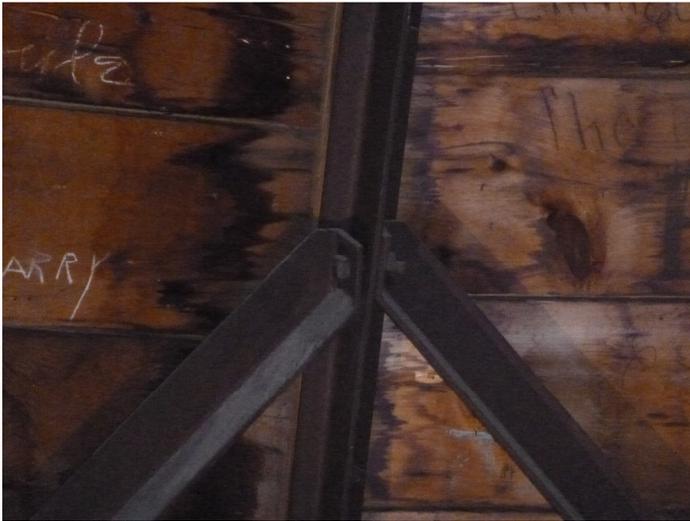
596-115 ArchMetal\_Note Joint condition 2013-1

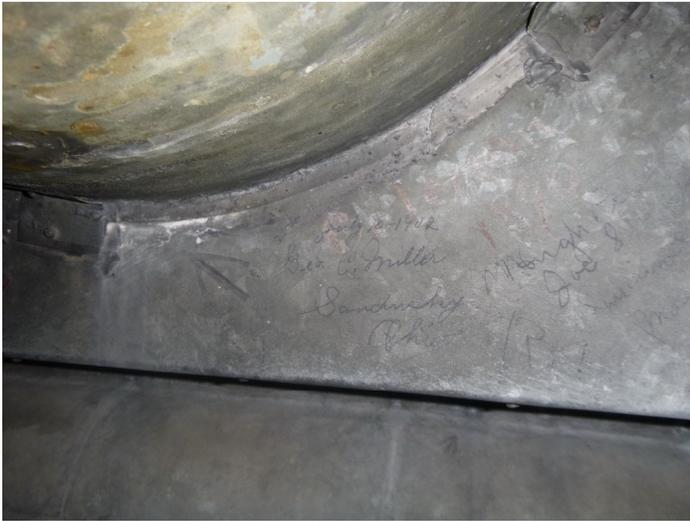
600-121 ArchMetal\_Note Joint condition 2013-1

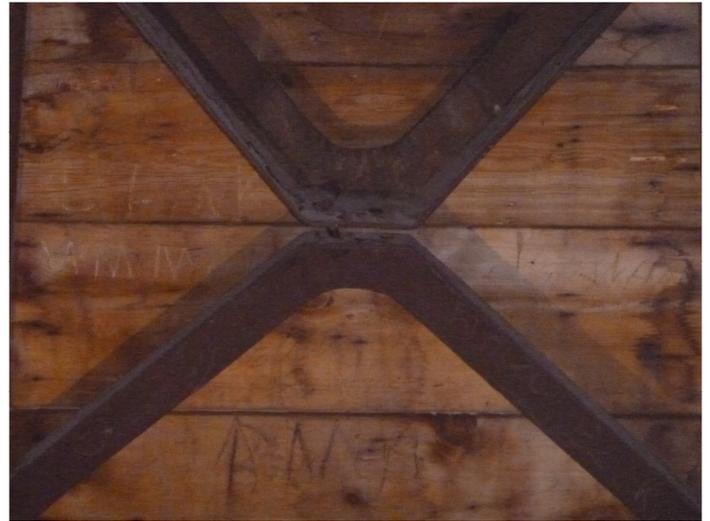
604-110 ArchMetal\_Note Joint condition 2013-1

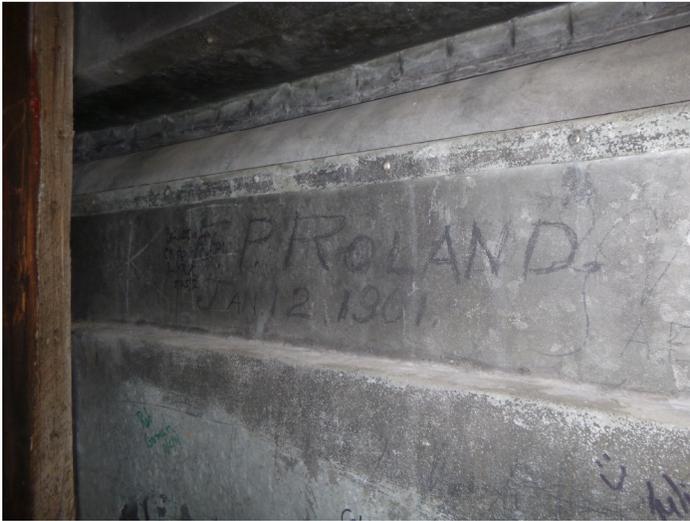
607-112 ArchMetal\_Note Joint condition 2013-1

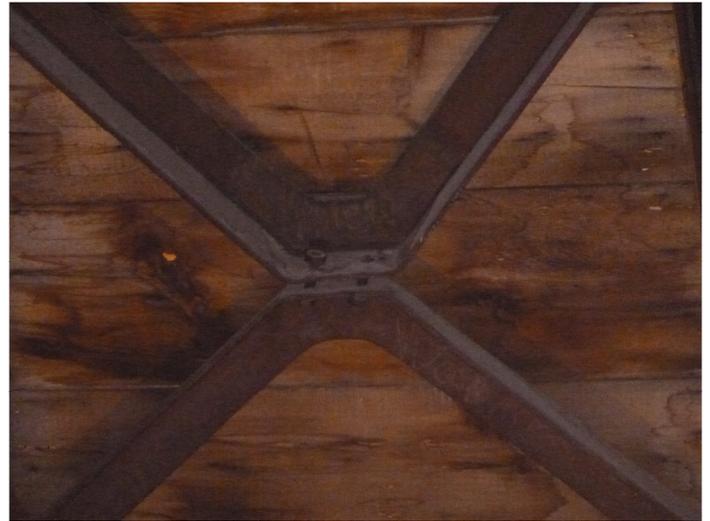
611-113 ArchMetal\_Note Joint condition 2013-1

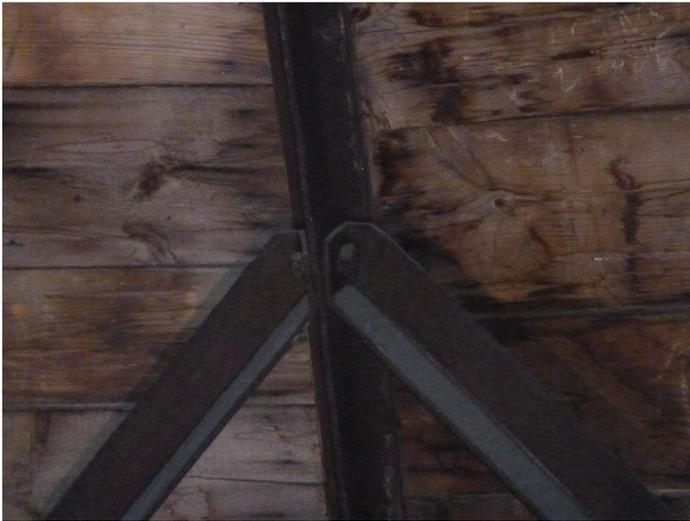
613-116 ArchMetal\_Note Joint condition 2013-1

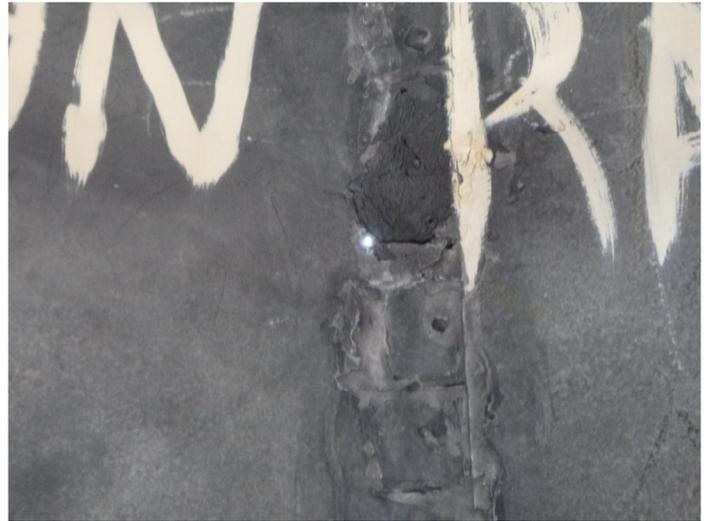
613-116 ArchMetal\_Note Joint condition 2013-2
