# Report Narrative

## Wyoming State Capitol Dome Investigation Cheyenne, WY

Vertical Access LLC  
PO Box 4135, Ithaca, NY 14852  
Tel: 607 257 4049 / Fax: 607 257 2129

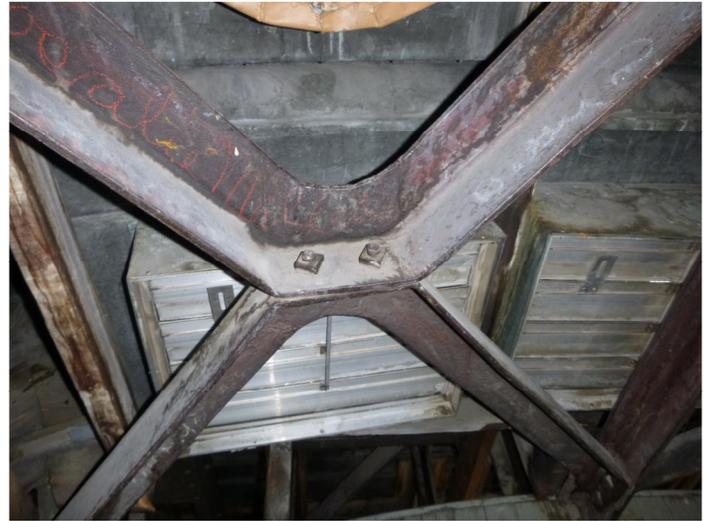
618-116 ArchMetal\_Note Joint condition 2013-1

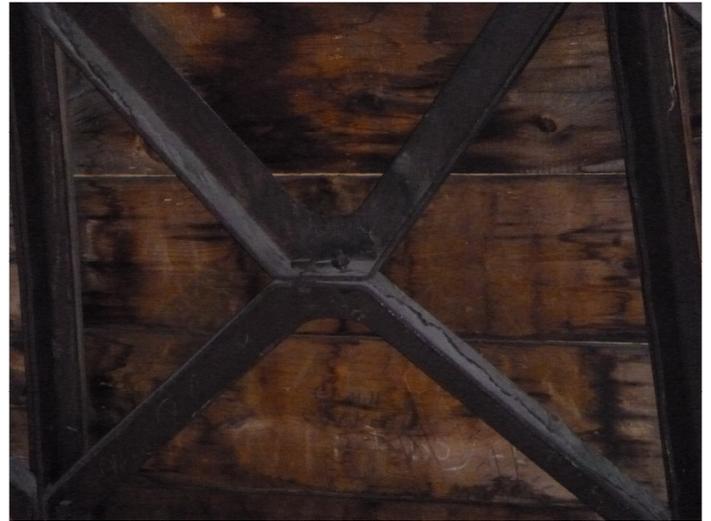
619-114 ArchMetal\_Note Joint condition 2013-1

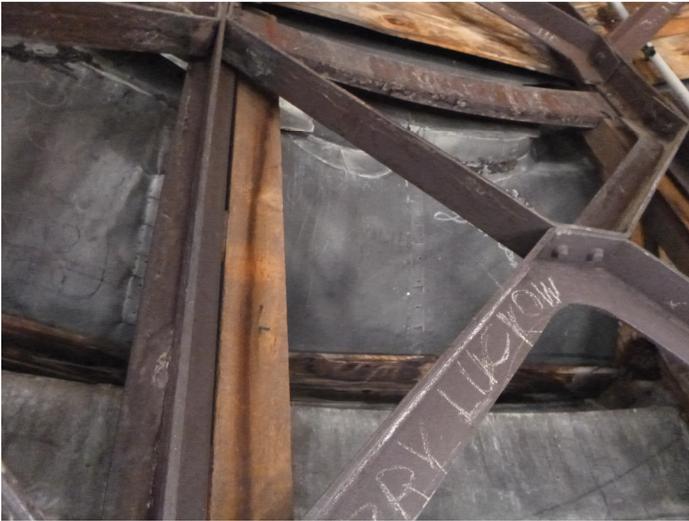
619-114 ArchMetal\_Note Joint condition 2013-2

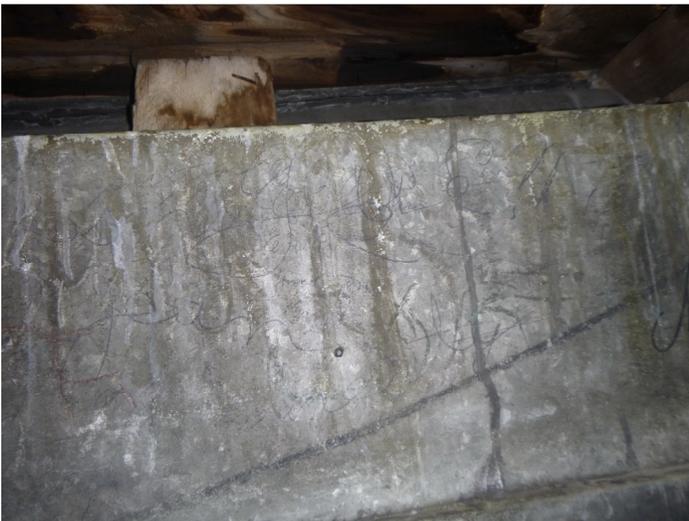
623-104 SheetMetal\_Damaged Punctured 2013-2

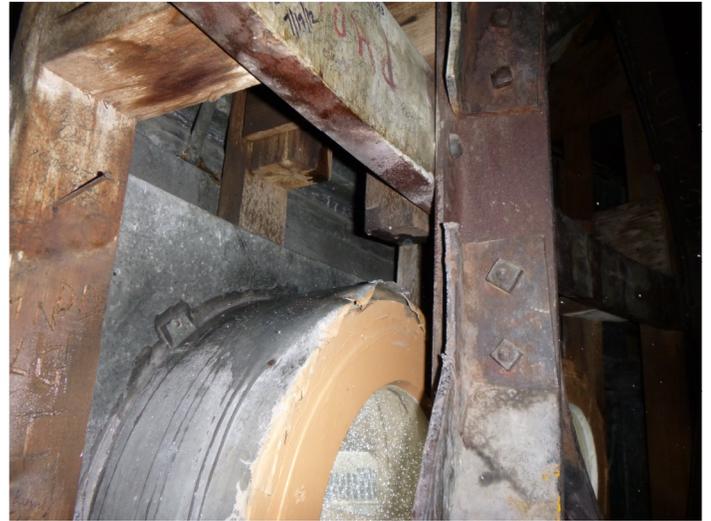
626-116 ArchMetal\_Note Joint condition 2013-1

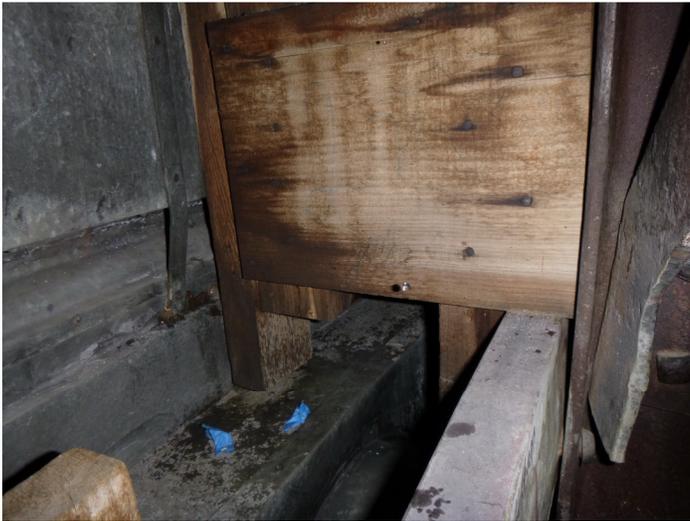
630-105 SheetMetal\_Note Photo-active leaks 2013-1

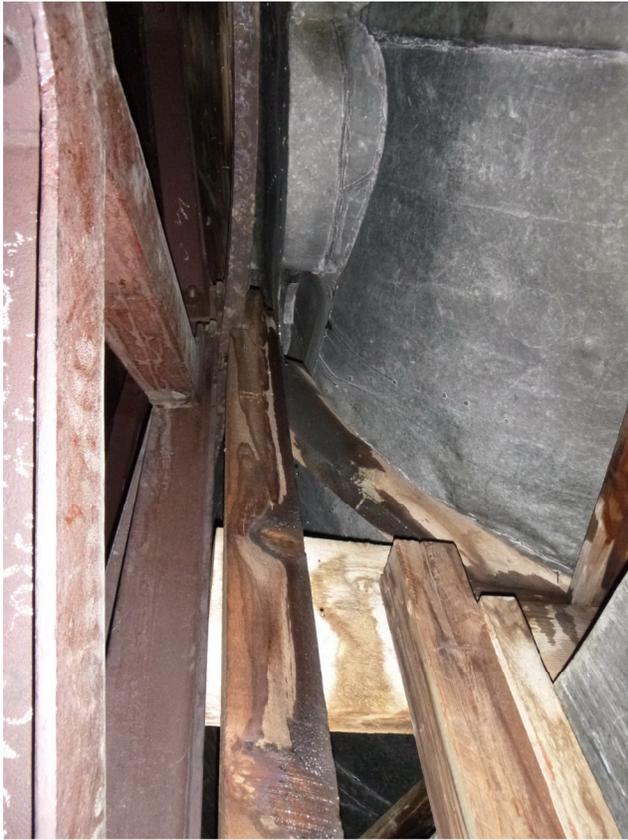
630-105 SheetMetal\_Note Photo-active leaks 2013-3

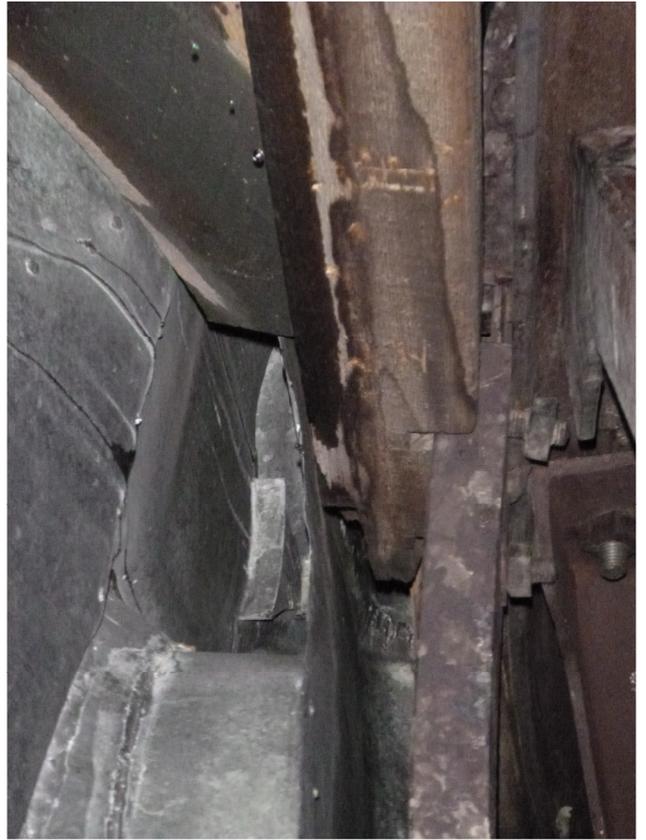
630-105 SheetMetal\_Note Photo-active leaks 2013-4

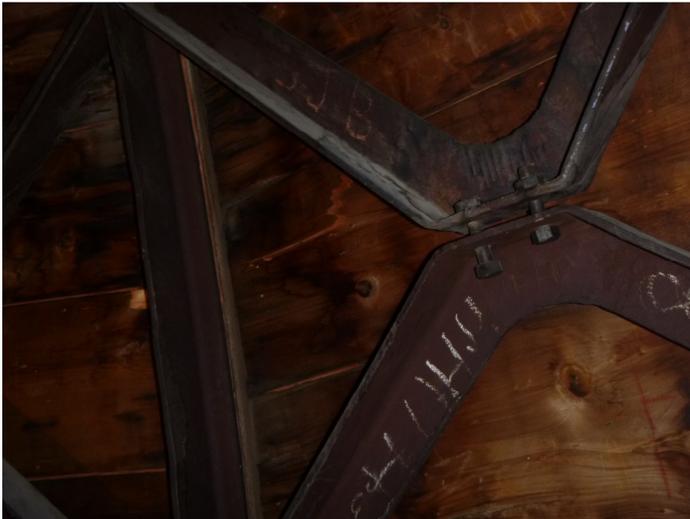
630-105 SheetMetal\_Note Photo-active leaks 2013-5

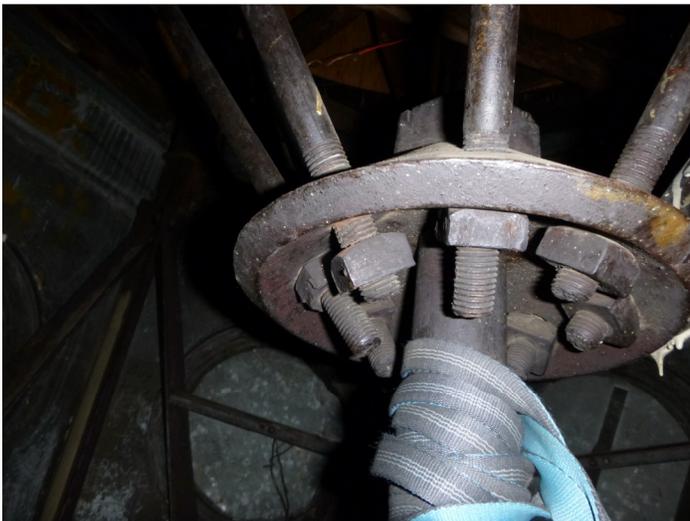
652-127 ArchMetal\_Note Photo-slack tension rod 2013-1

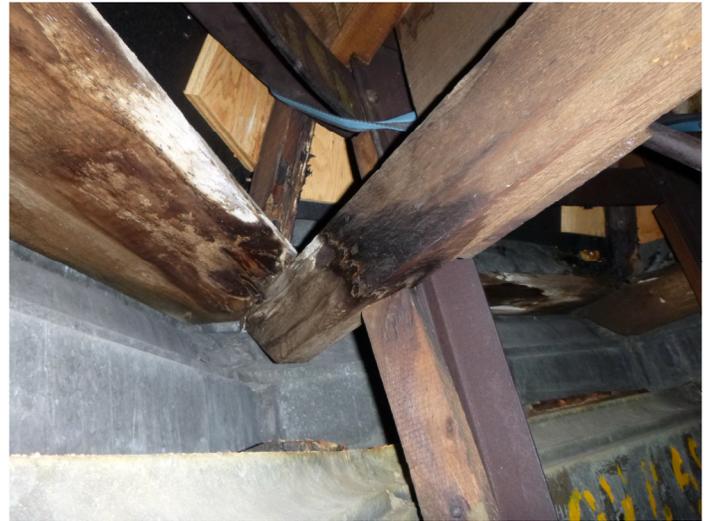
655-128 Wood\_Deteriorated Rotten 2013-1

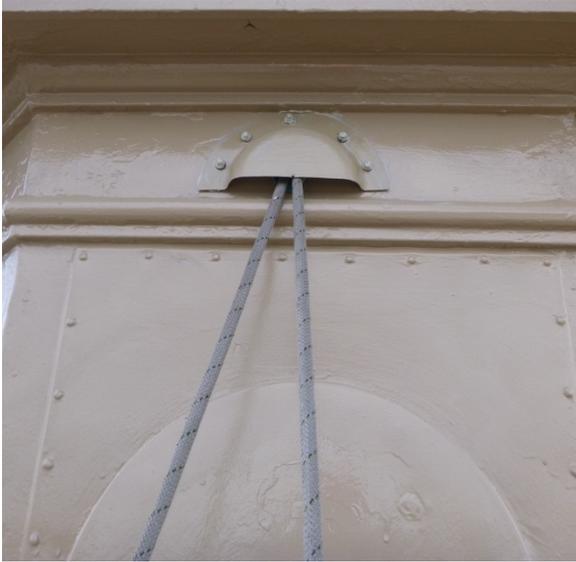
Figure 2. The painted copper cowl was screwed and caulked in place from the exterior.

At project completion, VA removed all rigging equipment from the building and installed a cowl over the rigging hole to prevent water infiltration. The copper cowl was painted to match the lantern exterior, with paint supplied by Suzanne Norton, then was screwed and caulked in place over the rigging hole (see Figure 2). The cowl permits future use of the rigging hole without need of removal. From the interior, VA installed an expandable rubber plug to prevent bats, debris and other material from going through the rigging hole (see Figure 3).

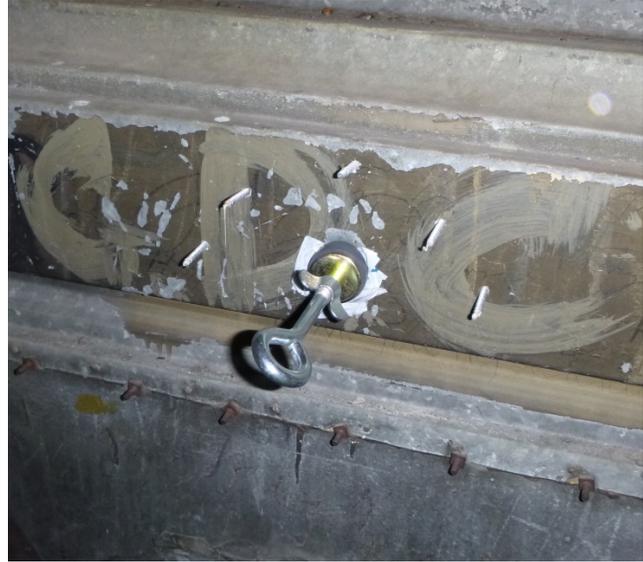
Figure 3. An expandable rubber plug was installed from the interior of the rigging hole
